**TOWN OF LONGBOAT KEY CANAL DREDGING
FEASIBILITY STUDY**

**Prepared For:
Town of Longboat Key**

February 1996

COASTAL PLANNING & ENGINEERING, INC.

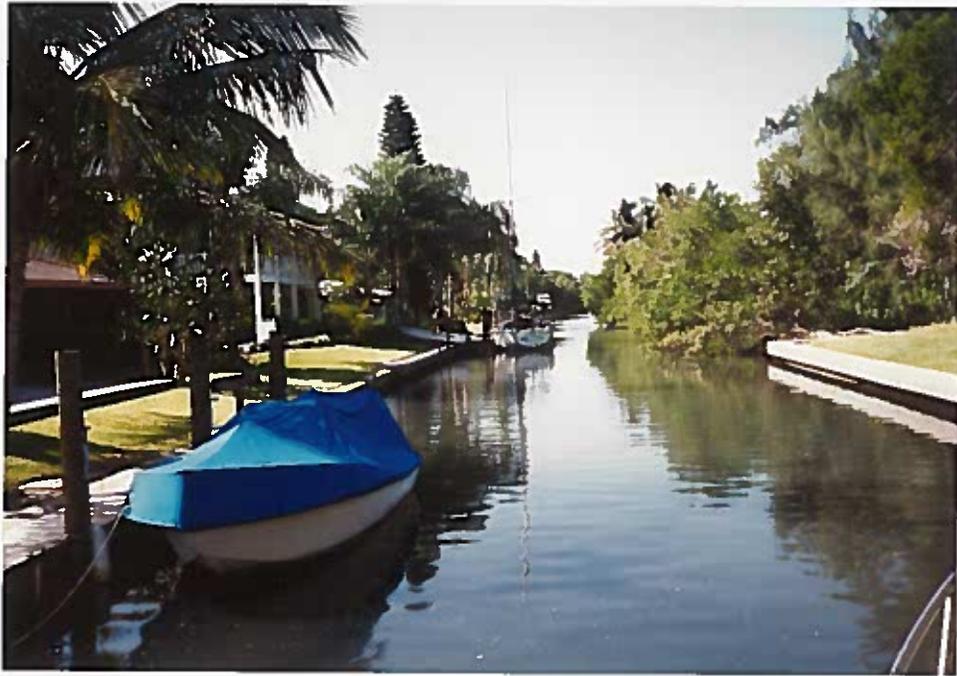
Canal 5 (between DeNarvaez Drive and Bayview Drive) is of average width and contains seawalls on both sides intermittently. Some areas contain mangrove shorelines with the mangroves encroaching into the canal.

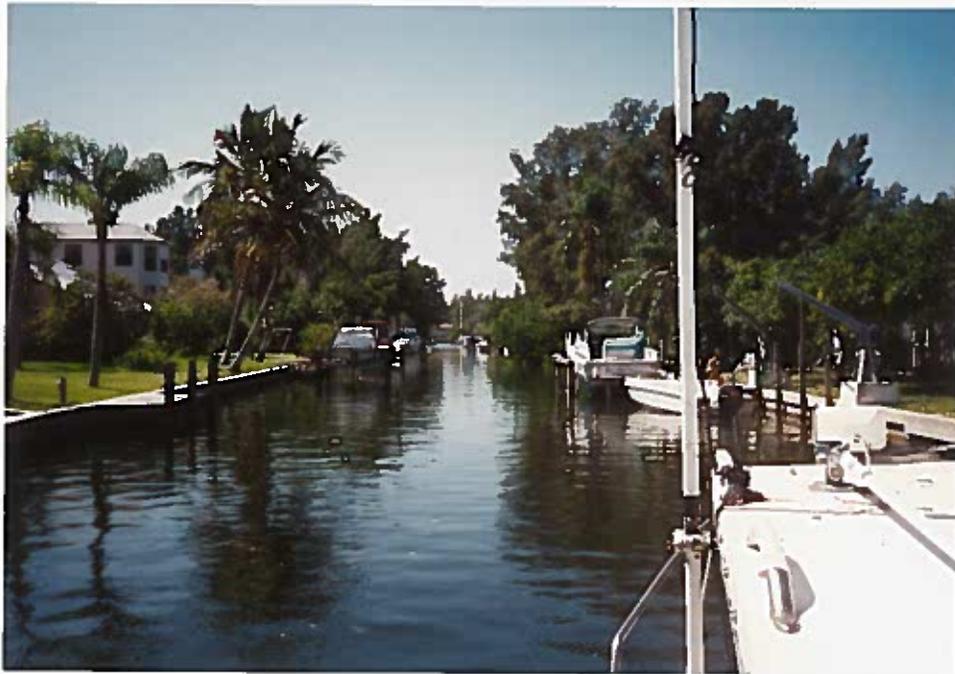
Canal 8 (between Norton Street and Marbury Lane) has greater development than Canal 5, with nearly continuous seawalls on the north and south sides. Docks have been built out from the seawalls to moor boats.

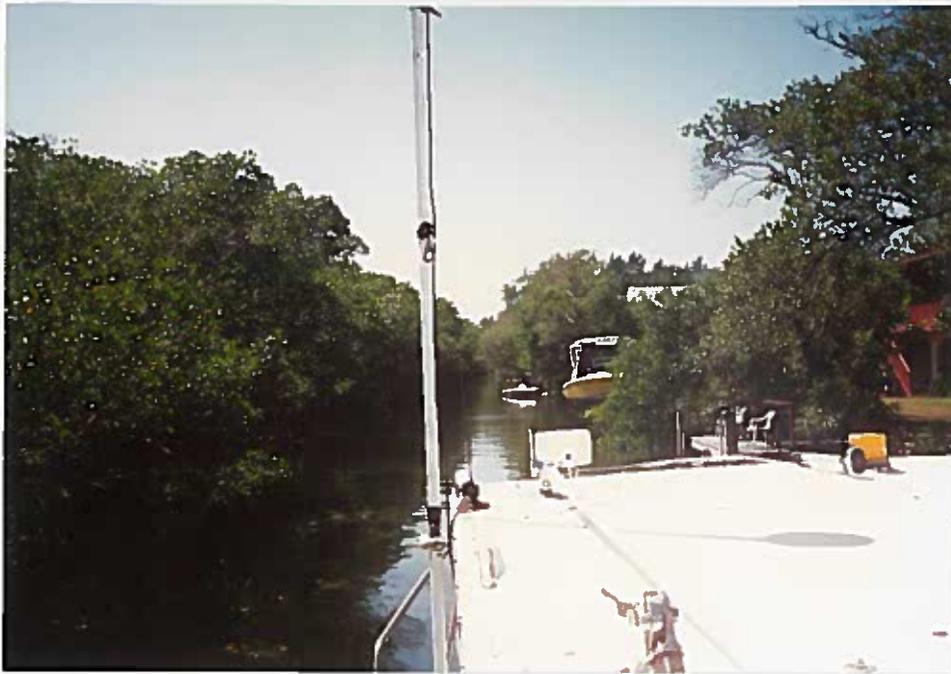
Canal 10 (South of Penfield Street) is unique to the Town because it is developed only on the north side and the limited development has installed revetments to protect some of the upland property. The south side and the western end of the north side contain mature mangroves which grow into and over the canal. The canal is utilized by only a few small boats.

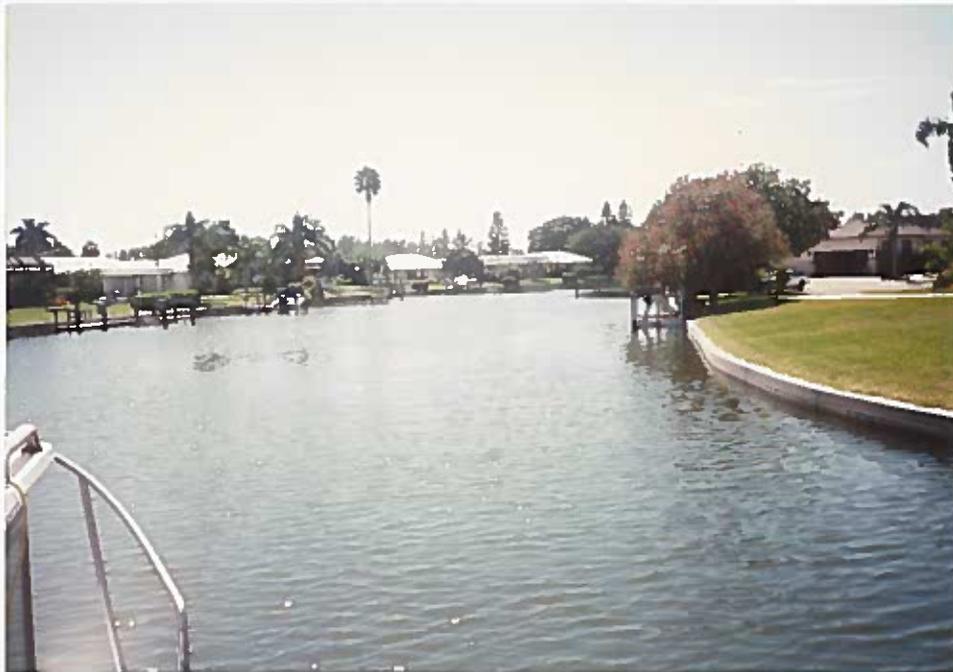
Canal 13 (between Emerald Harbor Drive and Old Compass Road) is typical of the Canals 12 through 14. The canals are generally wide and deep. The canals are continuously lined with concrete seawalls.

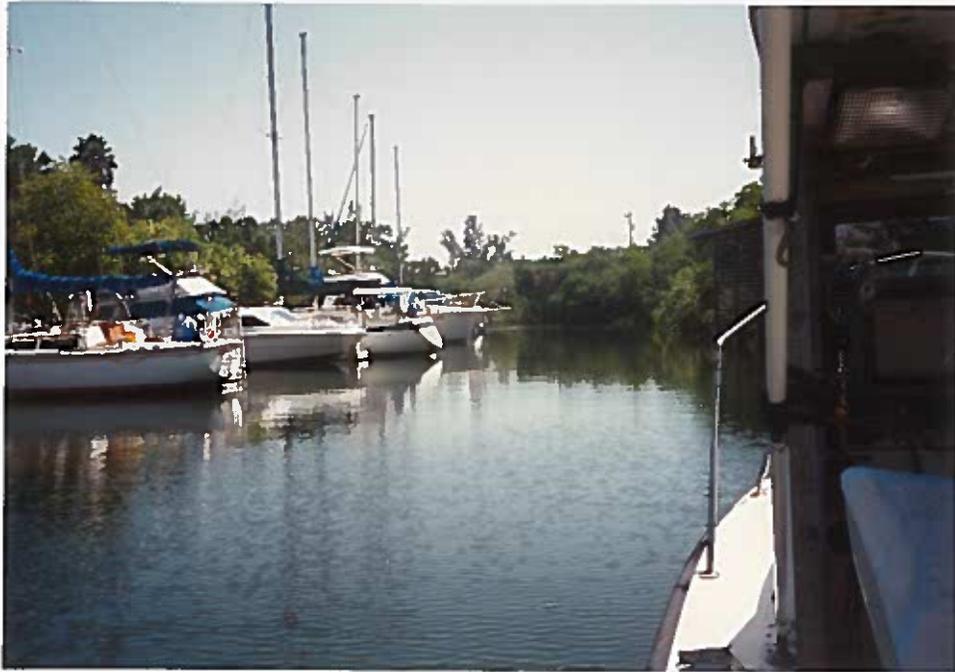
Canal 15 (north) is located west of the Buccaneer Inn. The canal is deep and has large boats moored at the Buccaneer Inn Marina. The south end of the canal has mangroves on the west side.

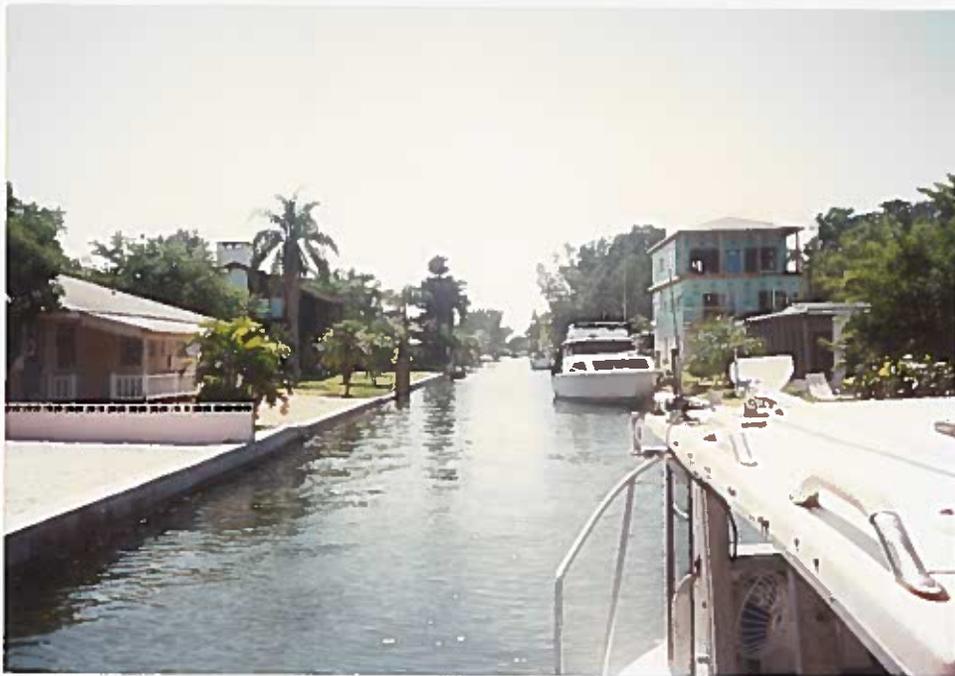
Canal 17 (between Jungle Queen Way and Tarawitt Drive) is typical of Canals 17 through 19. The canals are narrow (less than 40 feet between the seawalls) and are shallow. The canal contains several seawalls that have failed due to lack of sufficient toe penetration. Canal 18 also contains one stand of mangroves which is encroaching into the canal. The narrow width of these canals may preclude further dredging.

16	EMERALD HARBOR DRIVE	GULF OF MEXICO DRIVE	SEAWALL	SEAWALL	GOOD	1	4 TO 5	N/A
17	JUNGLE QUEEN WAY	JUNGLE QUEEN WAY	MANGROVE	MANGROVE	N/A	0	4 TO 5	SURVEY TERMINATED DUE TO SHALLOW BAR AT MOUTH. WALLS AT ENTRANCE FAILED BY TIEROD AND PANEL FAILURE.
18	TARAWITT DRIVE	TARAWITT DRIVE	SEAWALL	SEAWALL	FAILURES(4)	0	4 TO 5	3 VACANT LOTS. NARROW CANAL.
19	ST JUDES NORTH	ST JUDES NORTH	SEAWALL	MANGROVE/WALL	GOOD	1	4 TO 5	MANGROVE ENCRACHES ON WEST END OF CANAL.
20	GULF BAY ROAD(END OF)	N/A	SEAWALL	SEAWALL	FAILURE(1)	1	4 TO 5	1 TIEBACK FAILURE. NARROW CANAL.
21	SANDHAMN PLACE	N/A	MANGROVE	MANGROVE	N/A	0	N/A	SOUTH ENTRANCE WALL DETERIORATING.
22	5056 GULF OF MEXICO	DF5050 GULF OF MEXICO	MANGROVE	MANGROVE	N/A	0	N/A	SURVEY TERMINATED DUE TO SHALLOW BAR AT MOUTH. CANAL NOT FOUND DURING SURVEY.
23	5000 GULF OF MEXICO	DFLONGBOAT HARBOR	NOR SEAWALL	SEAWALL	GOOD	0	0	CANAL TO 3 PRIVATE RESIDENCES.
24	LONGBOAT HARBOR	NOR NORTH BOAT BASIN	SEAWALL	MANGROVE	FAILURE(1)	0	7	TIEBACK FAILURE ON NORTH SEAWALL.

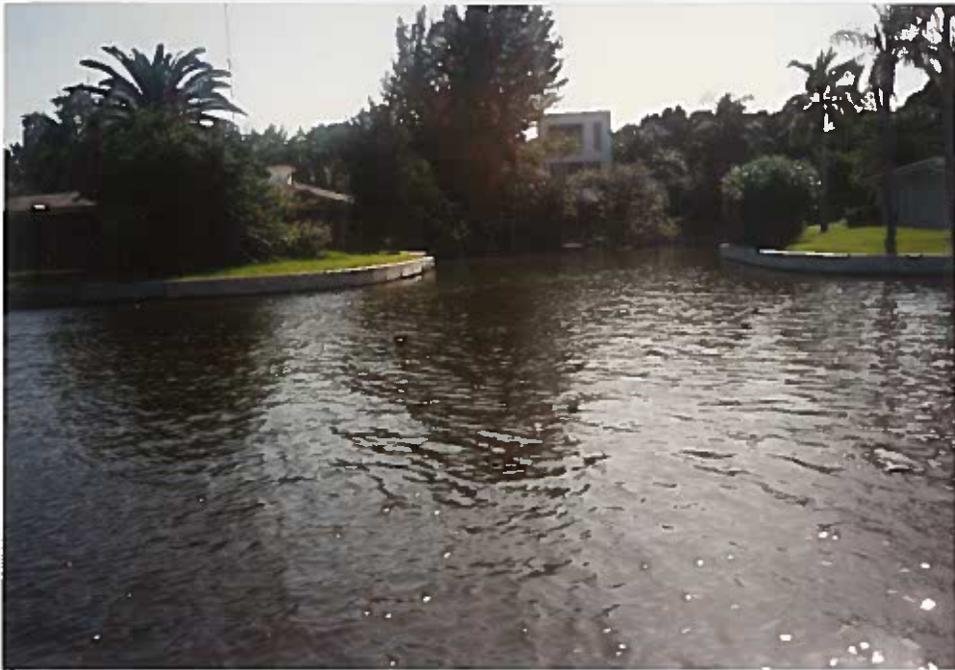
Canal 22 (between 5050 and 5056 Gulf of Mexico Drive) is a short canal which provides water access to only three upland residential properties.

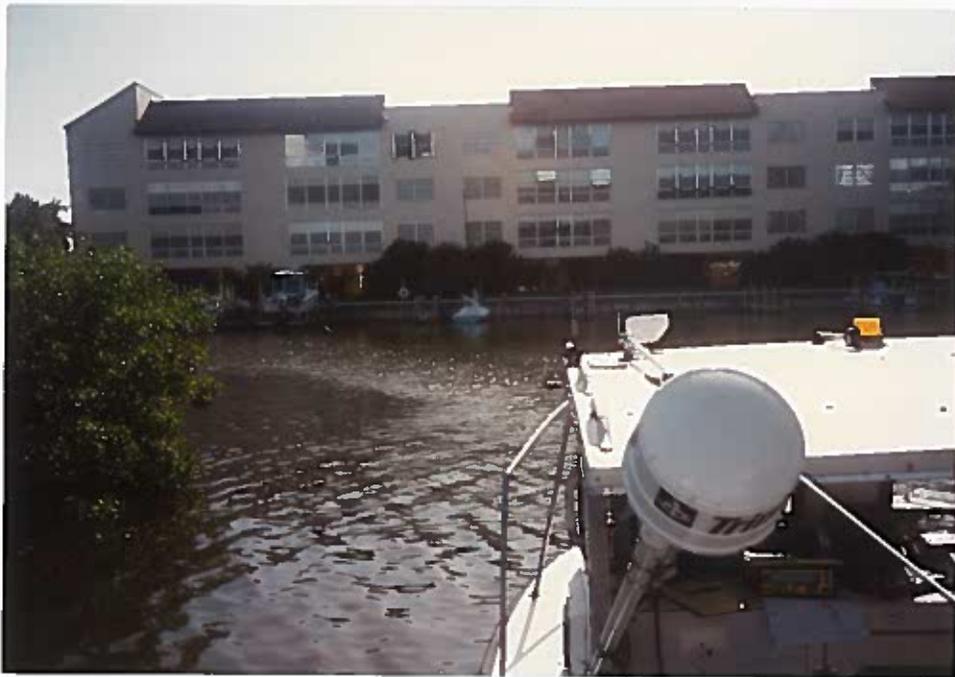
Canal 24 is a short canal to the northern boat basin at the Longboat Harbor development. The basin is constructed of concrete seawalls on three sides with mangroves on the fourth side. Canal 25 is similar.

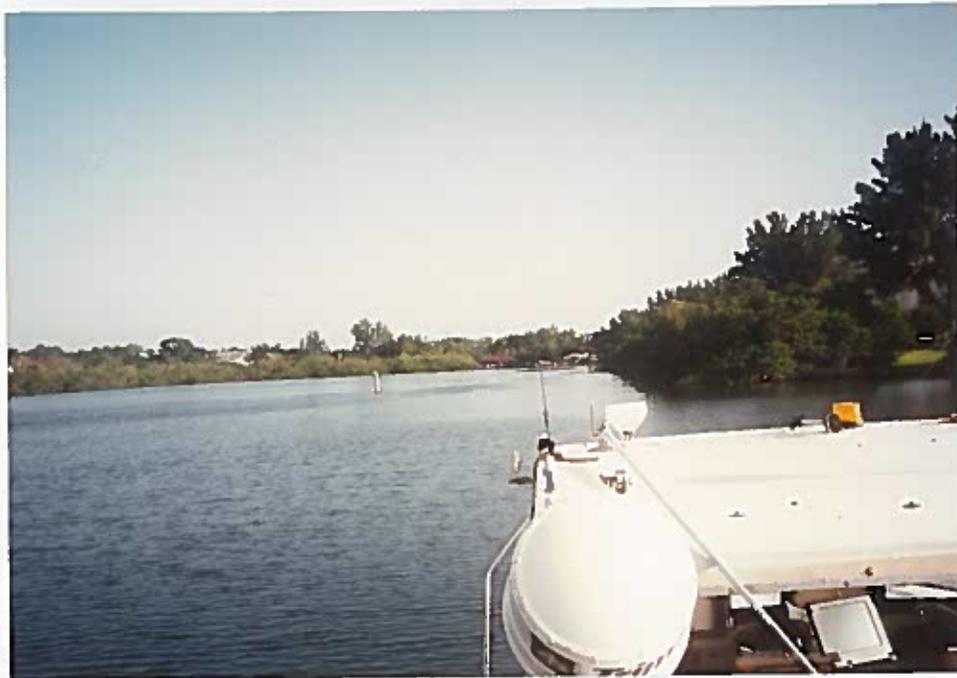
Canal 31 is the entrance channel into Buttonwood Harbor. The channel is marked with navigational buoys.

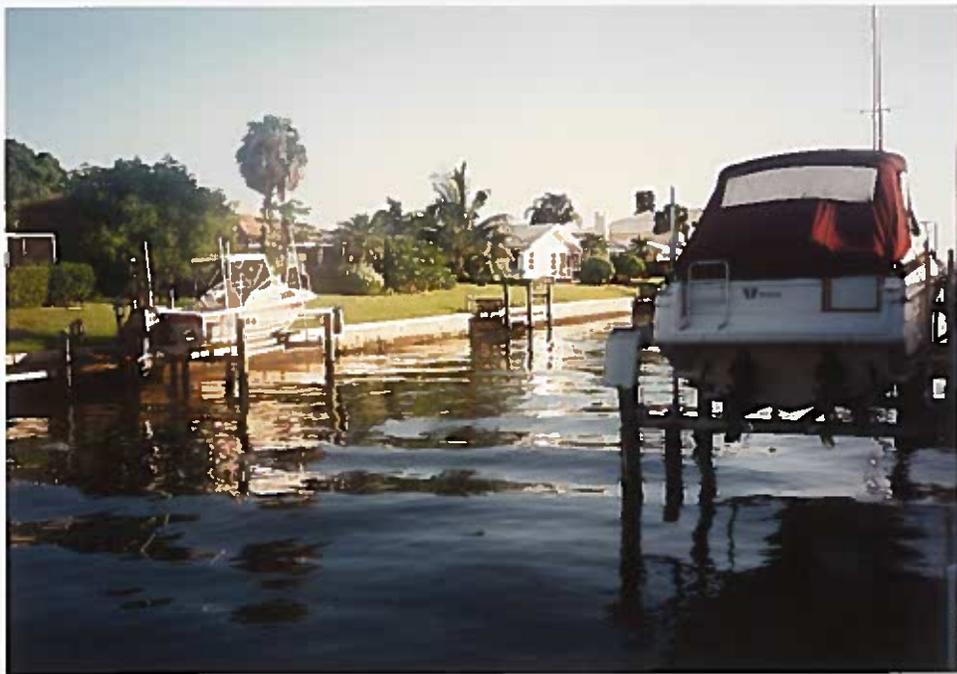
Canal 36 (between Chipping Lane and Wedge Lane) is typical of the canals in Country Club Shores. The canals are wide with concrete seawalls. Most of the homes along the canal have marginal docks, many with boat lifts. The seawall in the photograph shows evidence of tieback replacement which is common in Country Club shores.

34	PUTTER LANE	GOLF LINKS LANE	SEAWALL	SEAWALL	GOOD	0	8	
35	GOLF LINKS LANE	CHIPPING LANE	SEAWALL	SEAWALL	GOOD	1	8	EXTERNAL PATCHES ON SOME JOINTS.
36	CHIPPING LANE	WEDGE LANE	SEAWALL	SEAWALL	GOOD	1	8	SOME NEW CAPS AND TIEROD BOLTS EXPOSED.
37	WEDGE LANE	BIRDIE LANE	SEAWALL	SEAWALL	GOOD	2	8	
38	BIRDIE LANE	PUTTING GREEN LANE	SEAWALL	SEAWALL	GOOD	2	8	
39	PUTTING GREEN LANE	YARDARM LANE	SEAWALL	SEAWALL	GOOD	0	8	
40	YARDARM LANE	BOWSPRIT LANE	SEAWALL	SEAWALL	GOOD	1	8	EXTERNAL PATCHES ON SOME JOINTS.
41	BOWSPRIT LANE	RANGER LANE	SEAWALL	SEAWALL	GOOD	1	7	SOME NEW CAPS. SOME CORROSION ON PANELS.
42	RANGER LANE	HALYARD LANE	SEAWALL	SEAWALL	GOOD	2	8	BREAKWATER AT ENTRANCE TO CANAL. EXTERNAL PATCHES ON SOME JOINTS.

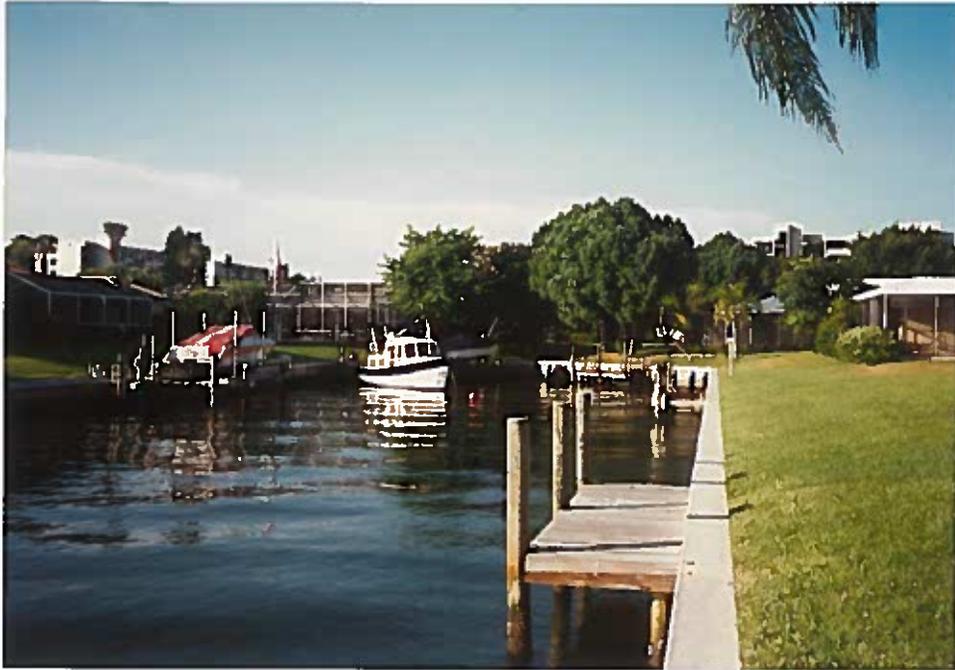
Canal 38 (between Birdie Lane and Putting Green Lane) shows evidence of seawall failure with the installation of wood piles at the face of the wall to prevent toe or tieback failure.

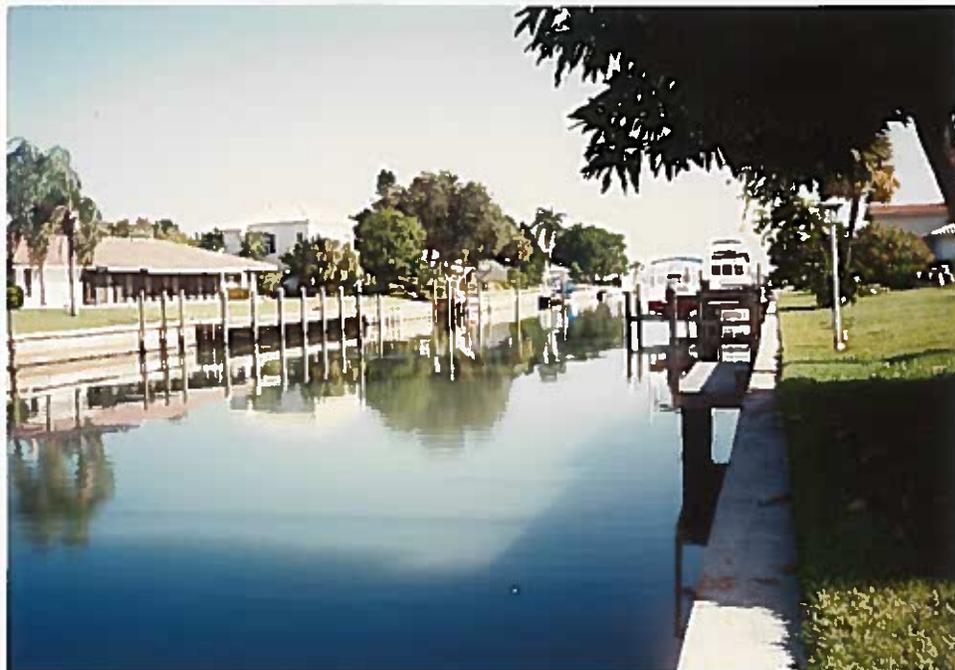
Canal 47 (between Outrigger Lane and Cutter Lane) is unique in the Town since it contained an algae bloom on the day it was inspected. This suggests that this canal does not flush well with Sarasota Bay. The seawall shows evidence that the joints were externally patched which is common on the seawalls in Country Club Shores.

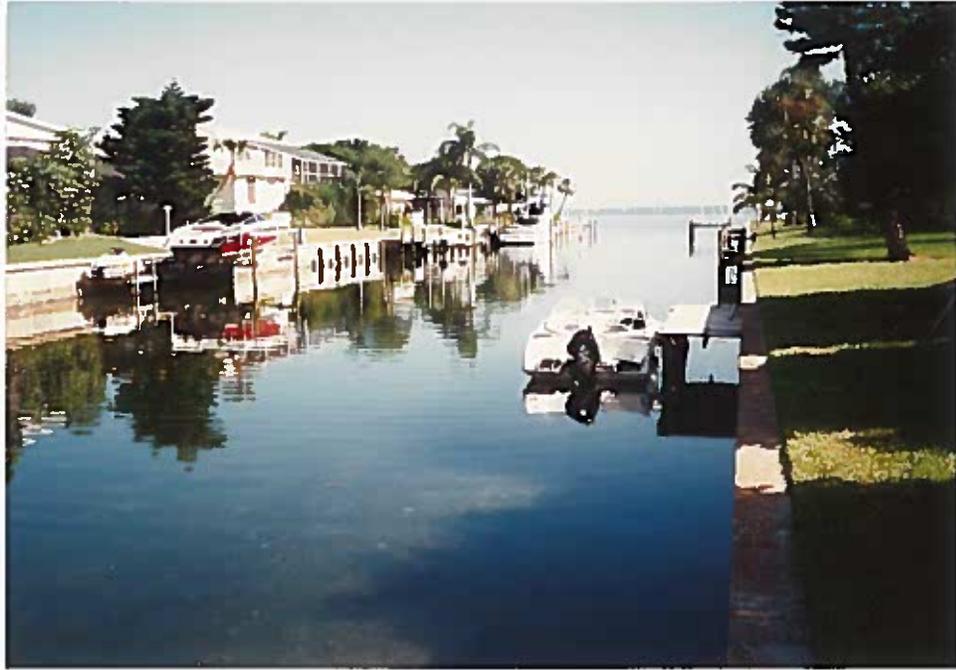
Canal 49 (between Yawl Lane and Schooner Lane) contains a sandy, shell, and limestone rubble (<1 inch) bottom which supports brown and green algae. Note the external patches on the seawall.

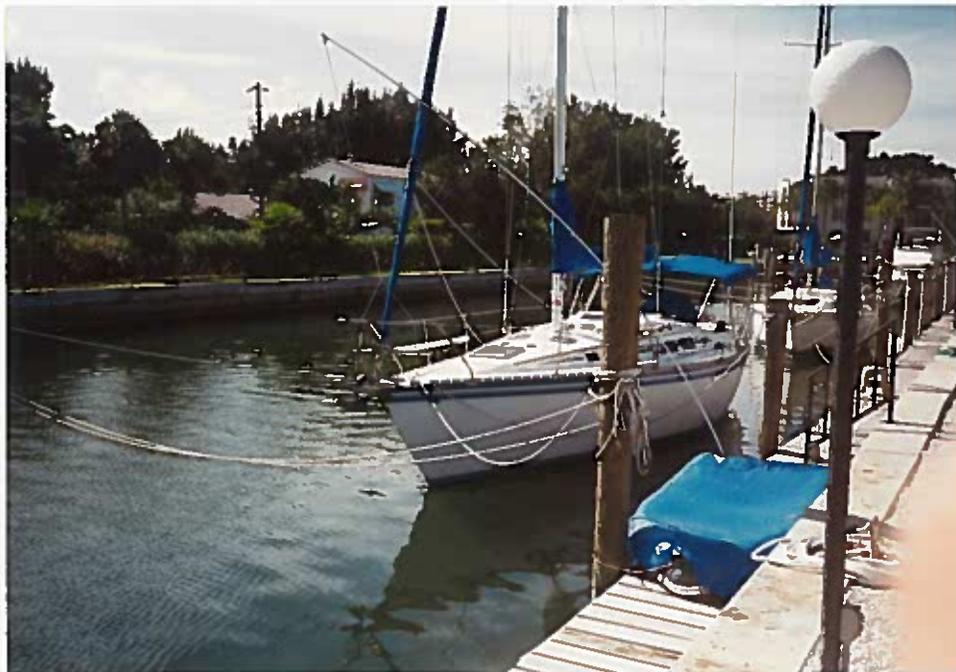
Canal 52 is a canal into the common areas of the Bay Harbor Apartments. A marginal dock lines the north and west sides of the canal.

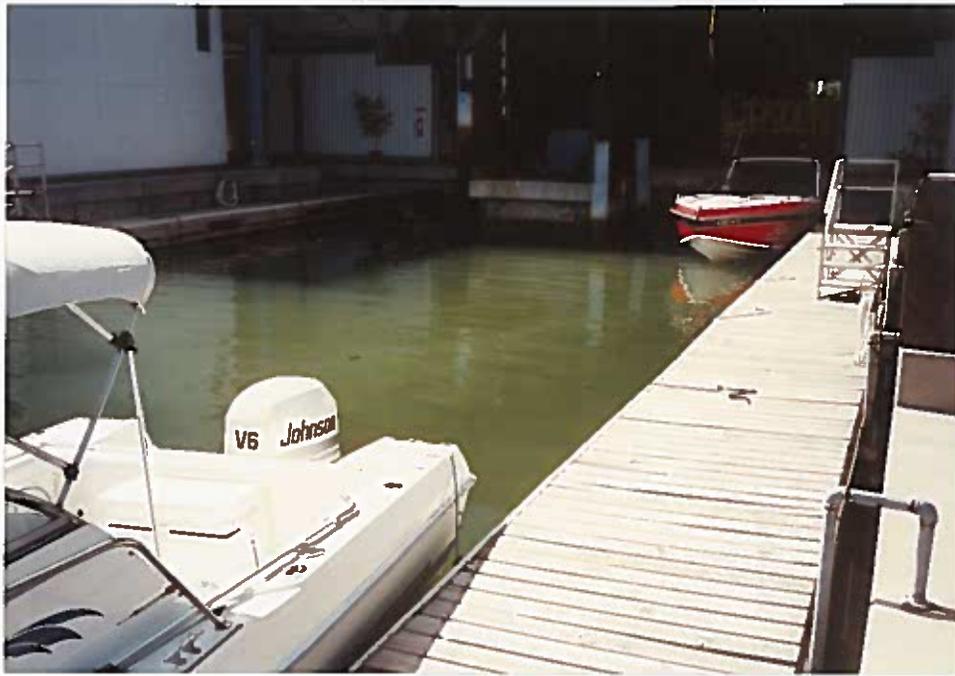
Canal 53 is a short entrance canal to the Marina Boat House.

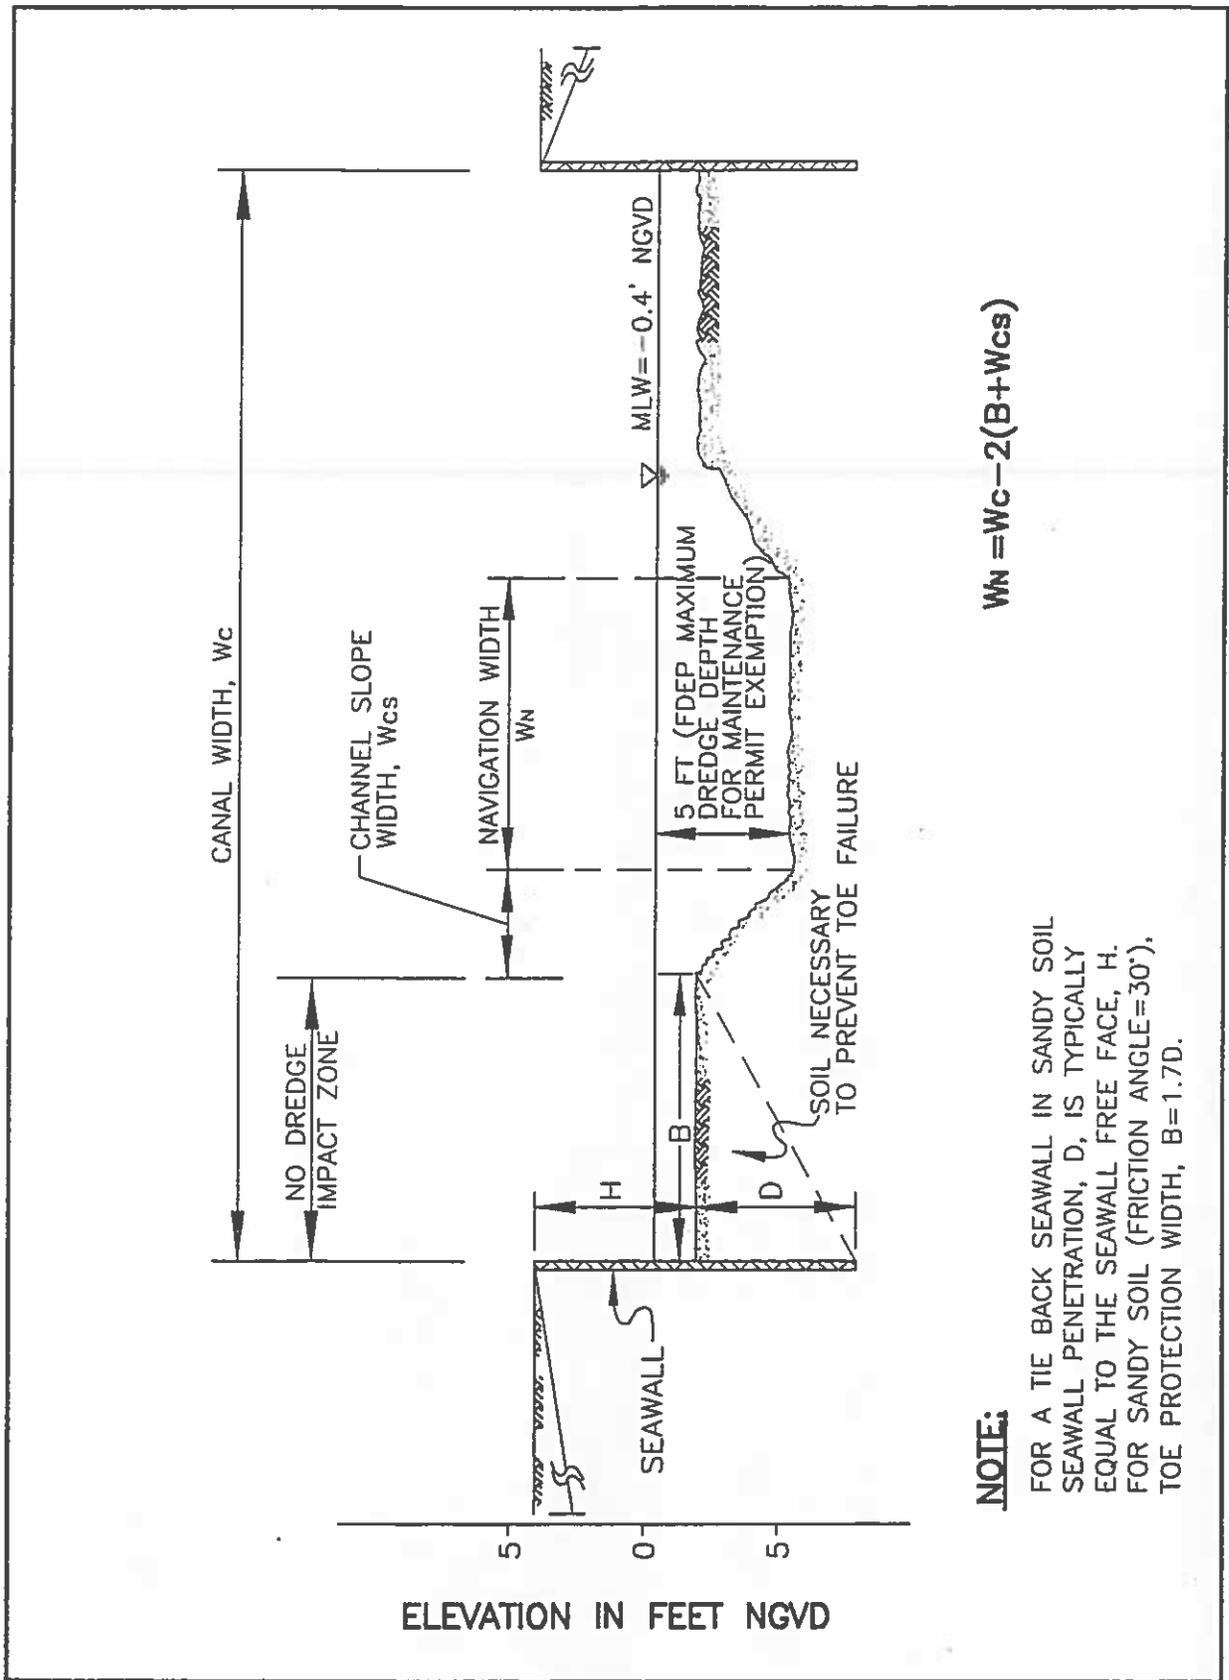
FIGURE 2

Tieback failure occurs when the tieback system (deadmen and tierod) fails to prevent the top of the seawall from overturning. Figure 2 shows a schematic representation of a tieback seawall. A typical tieback seawall design for sandy soil will consist of a sheet pile penetration, D , equal to the free face, H . Many times tieback systems are designed with no safety factor. Therefore, a change in the soil forces (heavy rain, dredging, surcharge load, etc) and corrosion of the tieback rod can often lead to failure of the seawall.

Toe failure occurs when the passive resistance offered by the soil in front of the seawall is less than active soil forces. In this failure mode, the seawall rotates (counterclockwise in the left seawall in Figure 2) about the tieback rod and a loss of soil occurs behind the seawall. For sandy soil (angle of repose equal to 30 degrees), the width of soil required to prevent toe failure is 1.7 times the penetration depth, D . As with the tiebacks, the seawalls are often designed with no safety factor on the seawall penetration. Therefore, a change in the soil forces in front of the seawall can lead to toe failure.

Based on the limited soil samples collected from the Longboat Key Canals, the preceding assumption of sandy soils is optimistic in many areas but is probably appropriate for the Country Club Shores area. The soil samples collected are weaker and less dense than sand; therefore, the required width of soil to prevent toe failure would be greater and the required seawall penetration, D , to prevent tieback failure would increase.

Table 2 shows that the seawalls were designed with greater free faces than penetration depths. Therefore, they are susceptible to toe failure and overturning failure. During the observations a repair indicative of toe failure was observed and many of the seawalls showed evidence of tieback replacement.

With the exception of the widest canals, dredging any canals in Longboat Key could potentially result in seawall failure. Additional seawall analyses should be performed for each canal during the final design to better understand the potential for seawall failure as a result of dredging the canals. This analysis will provide data to evaluate the appropriate distance from the walls to the dredged channel. Depending on the channel width selected by the Town it may be prudent to inform the residents and consider obtaining waivers from the upland owners.
