Agenda Item: Consideration of Canal Dredging Feasibility Study

TO: Town Commission  
FROM: Griff Roberts, Town Manager  
SUBJECT: Canal Dredging Study

SUBJECT: **CANAL DREDGING FEASIBILITY STUDY**

**TOWN OF LONGBOAT KEY CANAL DREDGING  
FEASIBILITY STUDY**

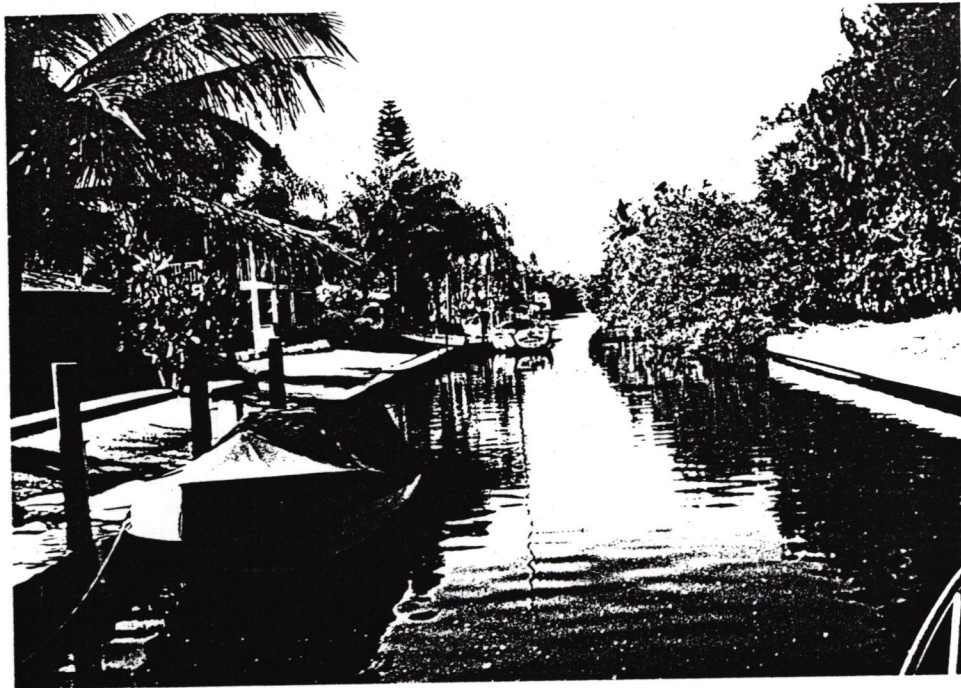
Canal 5 (between DeNarvaez Drive and Bayview Drive) is of average width and contains seawalls on both sides intermittently. Some areas contain mangrove shorelines with the mangroves encroaching into the canal.

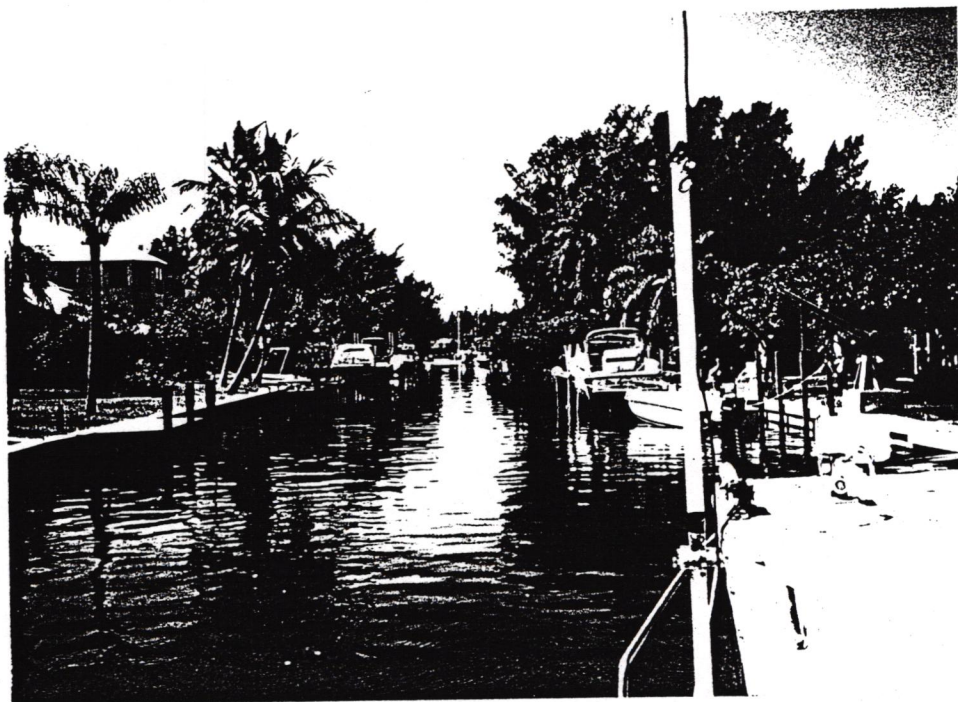
Canal 8 (between Norton Street and Marbury Lane) has greater development than Canal 5, with nearly continuous seawalls on the north and south sides. Docks have been built out from the seawalls to moor boats.

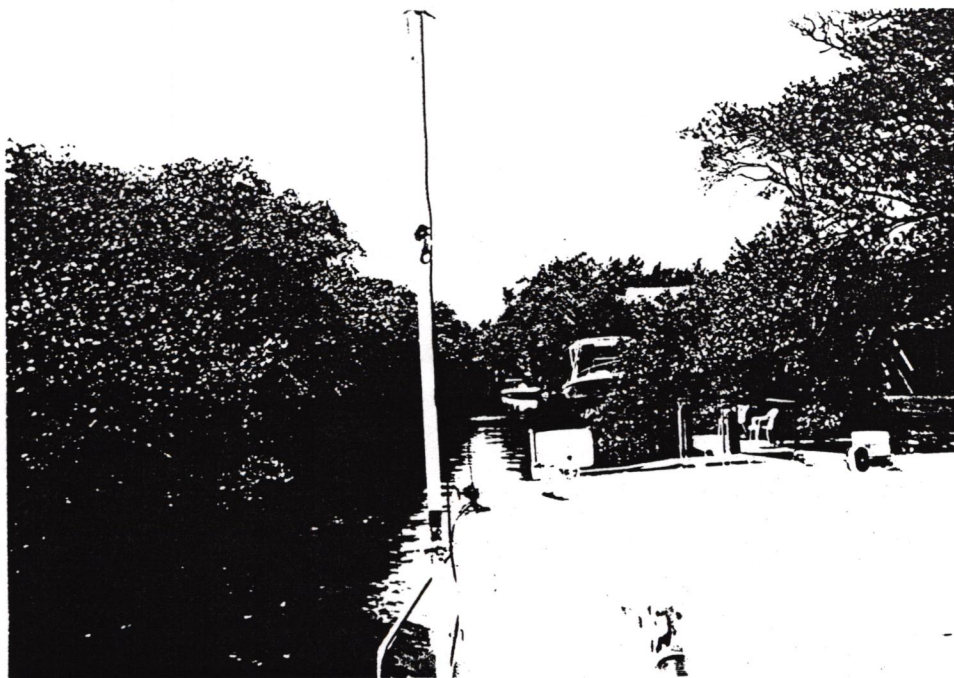
Canal 10 (South of Penfield Street) is unique to the Town because it is developed only on the north side and the limited development has installed revetments to protect some of the upland property. The south side and the western end of the north side contain mature mangroves which grow into and over the canal. The canal is utilized by only a few small boats.

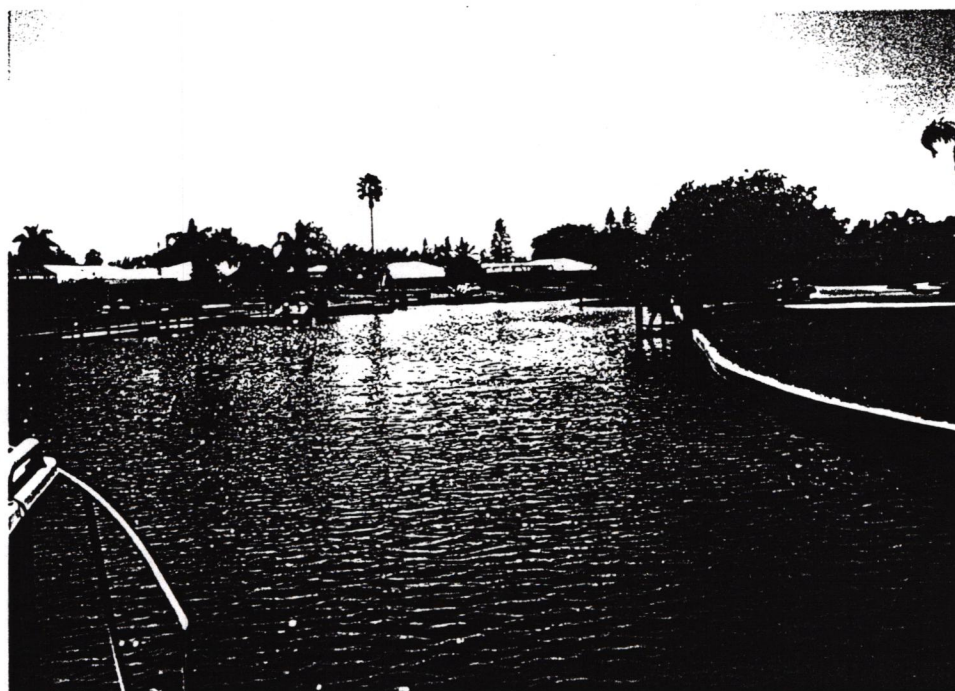
Canal 13 (between Emerald Harbor Drive and Old Compass Road) is typical of the Canals 12 through 14. The canals are generally wide and deep. The canals are continuously lined with concrete seawalls.

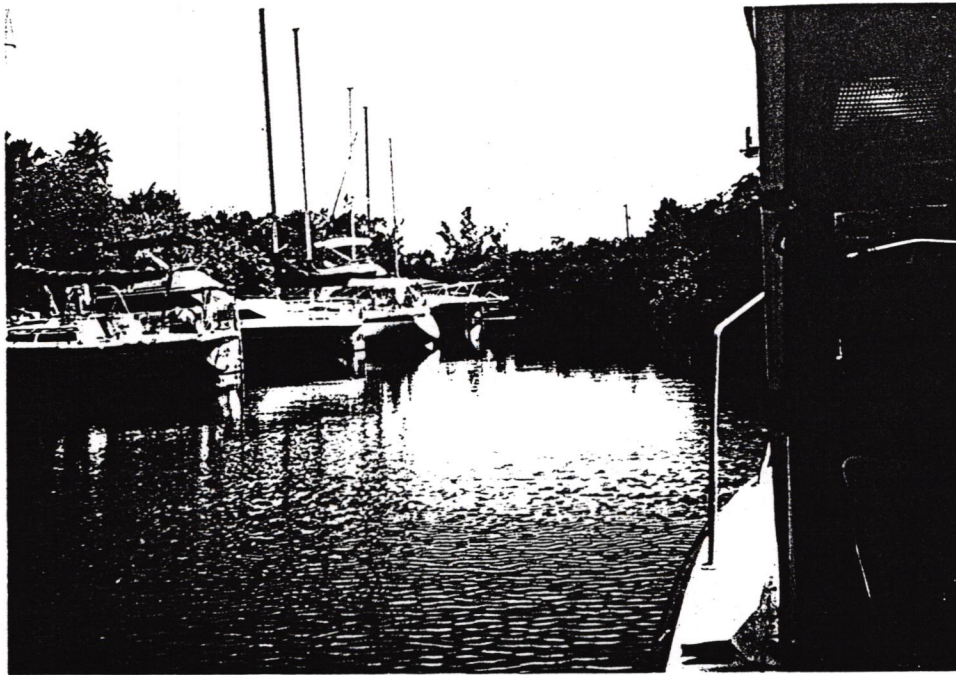
Canal 15 (north) is located west of the Buccaneer Inn. The canal is deep and has large boats moored at the Buccaneer Inn Marina. The south end of the canal has mangroves on the west side.

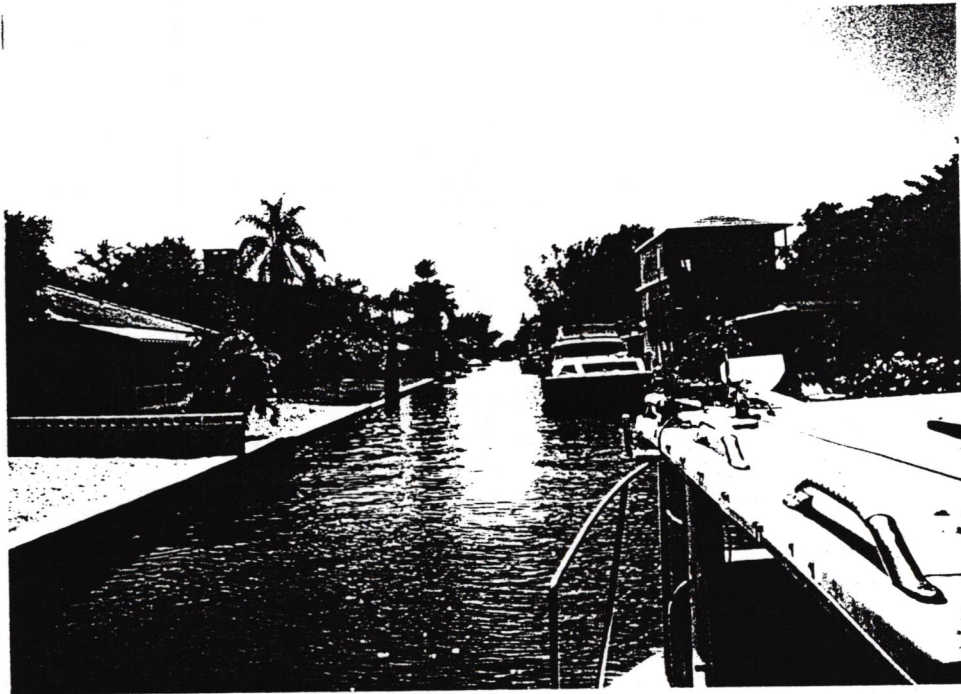
Canal 17 (between Jungle Queen Way and Tarawitt Drive) is typical of Canals 17 through 19. The canals are narrow (less than 40 feet between the seawalls) and are shallow. The canal contains several seawalls that have failed due to lack of sufficient toe penetration. Canal 18 also contains one stand of mangroves which is encroaching into the canal. The narrow width of these canals may preclude further dredging.

16	EVERGREEN WAY	JUNGLE QUEEN WAY	MANGROVE	MANGROVE	N/A	0		N/A SURVEY TERMINATED DUE TO SHALLOW BAR AT MOUTH.
17	JUNGLE QUEEN WAY	TARAWITT DRIVE	SEAWALL	SEAWALL	FAILURES(4)	0	4 TO 5	4 WALLS FAILED AT TOE OF WALL. NARROW CANAL. WALLS AT ENTRANCE FAILED BY TIEROD AND PANEL FAILURE.
18	TARAWITT DRIVE	ST JUDES NORTH	SEAWALL	MANGROVE/WALL	GOOD	1	4 TO 5	3 VACANT LOTS. NARROW CANAL. MANGROVE ENCROACHES ON WEST END OF CANAL.
19	ST JUDES NORTH	ST JUDES SOUTH	SEAWALL	SEAWALL	FAILURE(1)	1	4 TO 5	1 TIEBACK FAILURE. NARROW CANAL. SOUTH ENTRANCE WALL DETERIORATING.
20	GULF BAY ROAD(END OF)	N/A	MANGROVE	MANGROVE	N/A	0		N/A SURVEY TERMINATED DUE TO SHALLOW BAR AT MOUTH.
21	SANDHAMN PLACE	N/A	MANGROVE	MANGROVE	N/A	0		CANAL NOT FOUND DURING SURVEY.
22	5056 GULF OF MEXICO DF	5050 GULF OF MEXICO DF	SEAWALL	SEAWALL	GOOD	0		CANAL TO 3 PRIVATE RESIDENCES.
23	5000 GULF OF MEXICO DFL	LONGBOAT HARBOR NOR	SEAWALL	SEAWALL	FAILURE(1)	0		TIEBACK FAILURE ON NORTH SEAWALL.

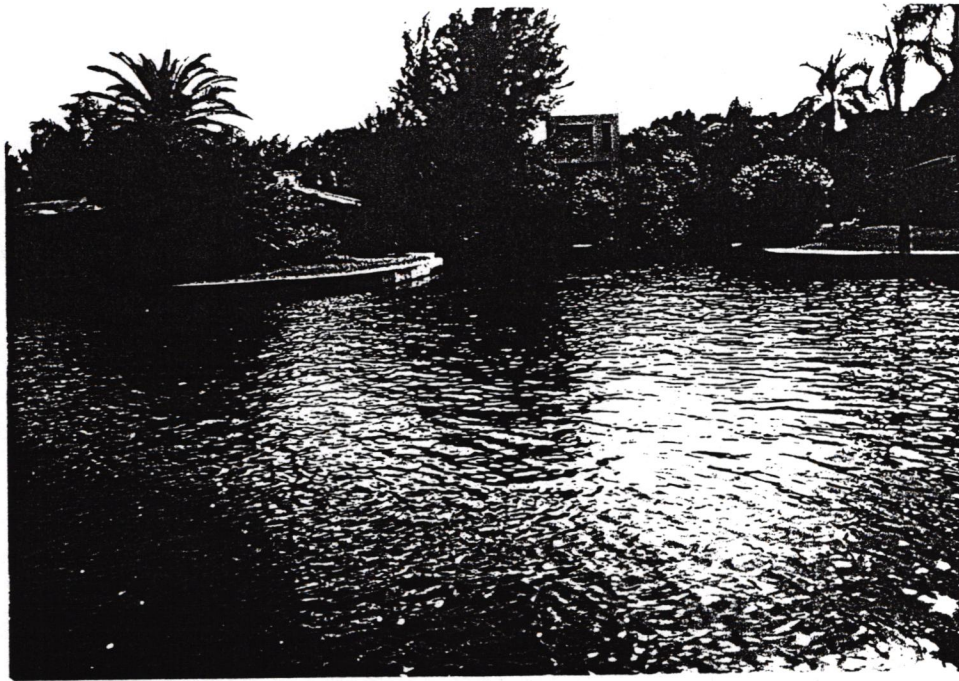
Canal 22 (between 5050 and 5056 Gulf of Mexico Drive) is a short canal which provides water access to only three upland residential properties.

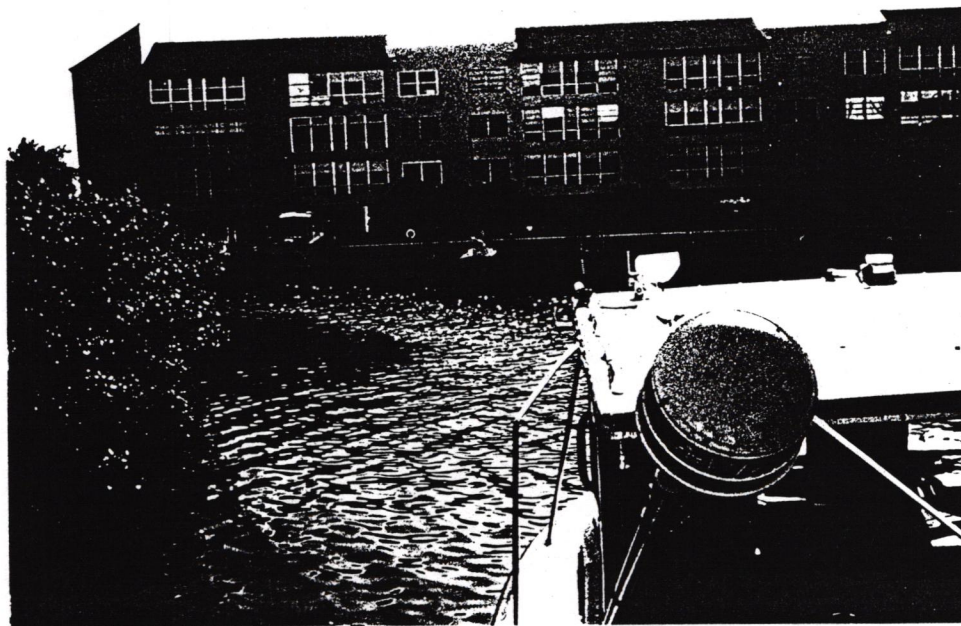
Canal 24 is a short canal to the northern boat basin at the Longboat Harbor development. The basin is constructed of concrete seawalls on three sides with mangroves on the fourth side. Canal 25 is similar.

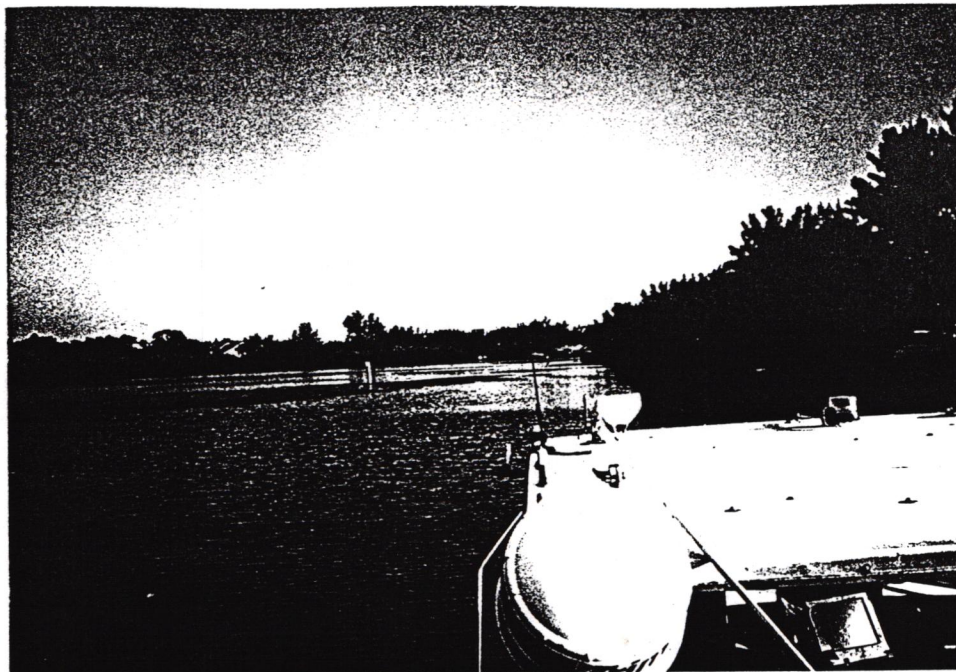
Canal 31 is the entrance channel into Buttonwood Harbor. The channel is marked with navigational buoys.

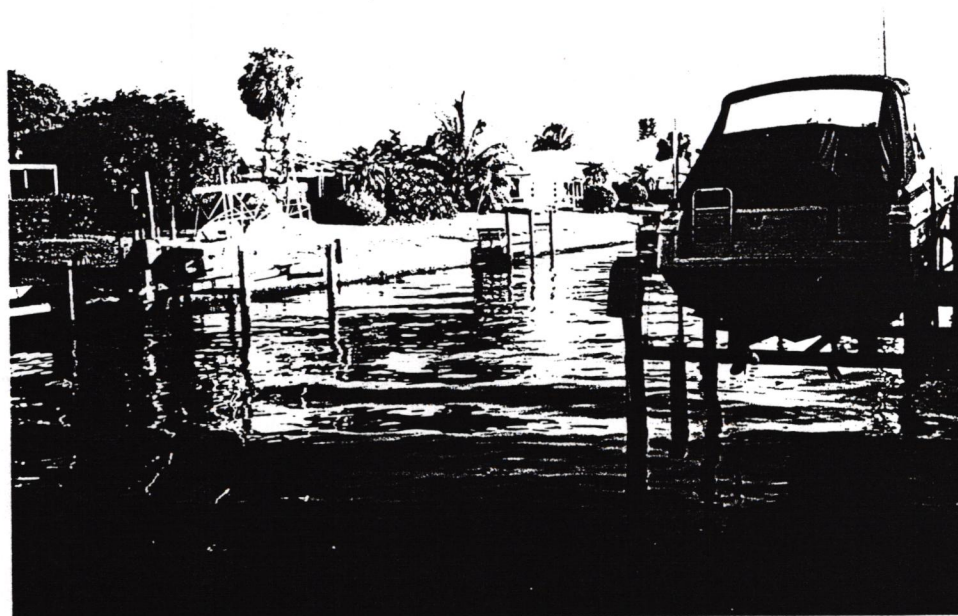
Canal 36 (between Chipping Lane and Wedge Lane) is typical of the canals in Country Club Shores. The canals are wide with concrete seawalls. Most of the homes along the canal have marginal docks, many with boat lifts. The seawall in the photograph shows evidence of tieback replacement which is common in Country Club shores.

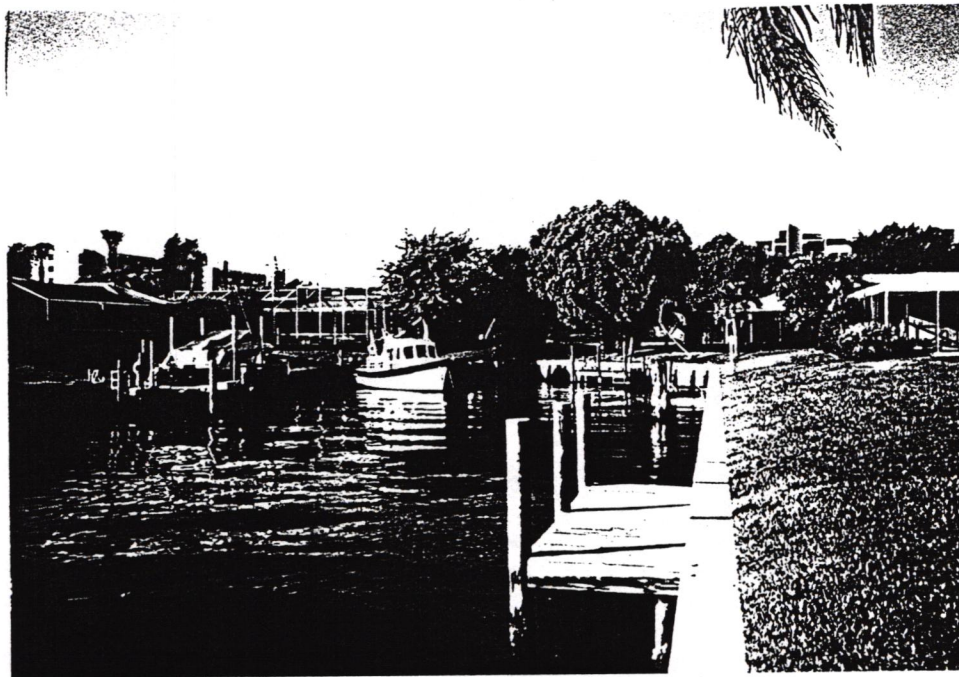
Canal 38 (between Birdie Lane and Putting Green Lane) shows evidence of seawall failure with the installation of wood piles at the face of the wall to prevent toe or tieback failure.

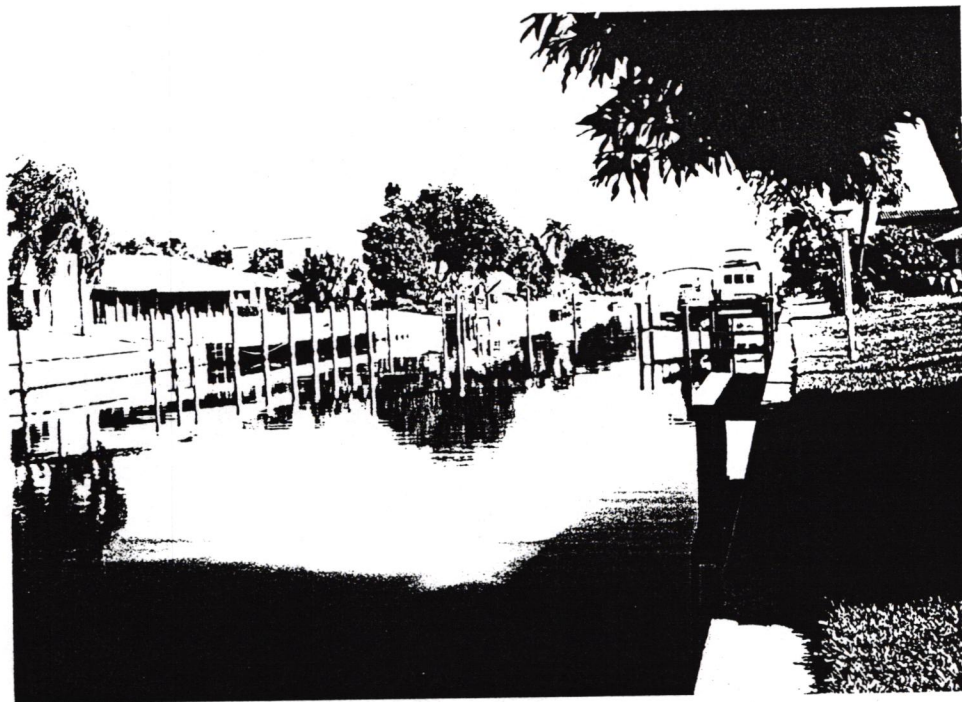
Canal 47 (between Outrigger Lane and Cutter Lane) is unique in the Town since it contained an algae bloom on the day it was inspected. This suggests that this canal does not flush well with Sarasota Bay. The seawall shows evidence that the joints were externally patched which is common on the seawalls in Country Club Shores.

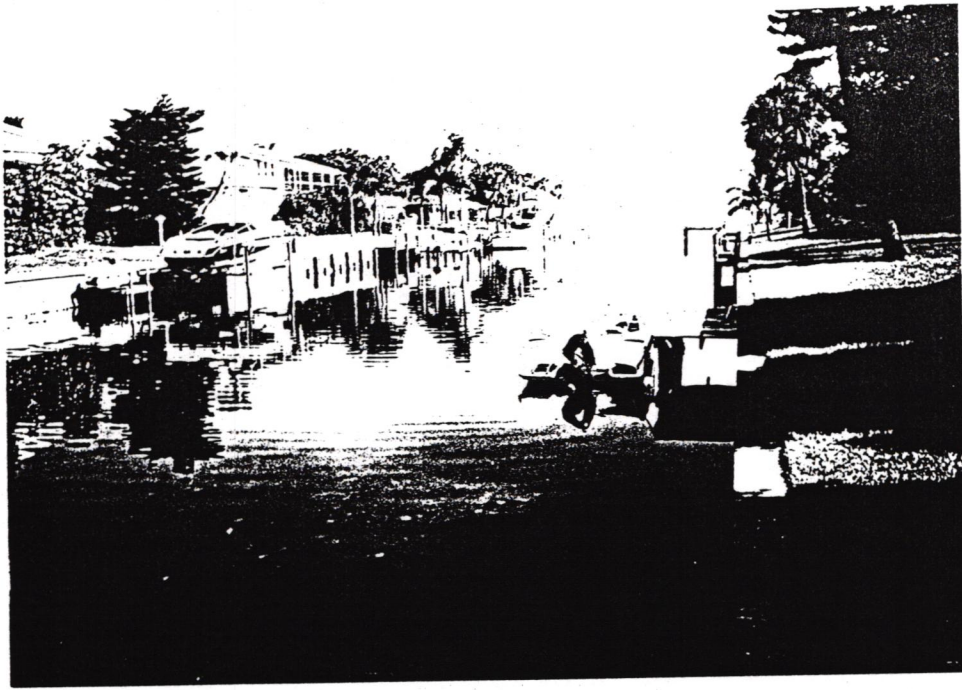
Canal 49 (between Yawl Lane and Schooner Lane) contains a sandy, shell, and limestone rubble ( $<1$  inch) bottom which supports brown and green algae. Note the external patches on the seawall.

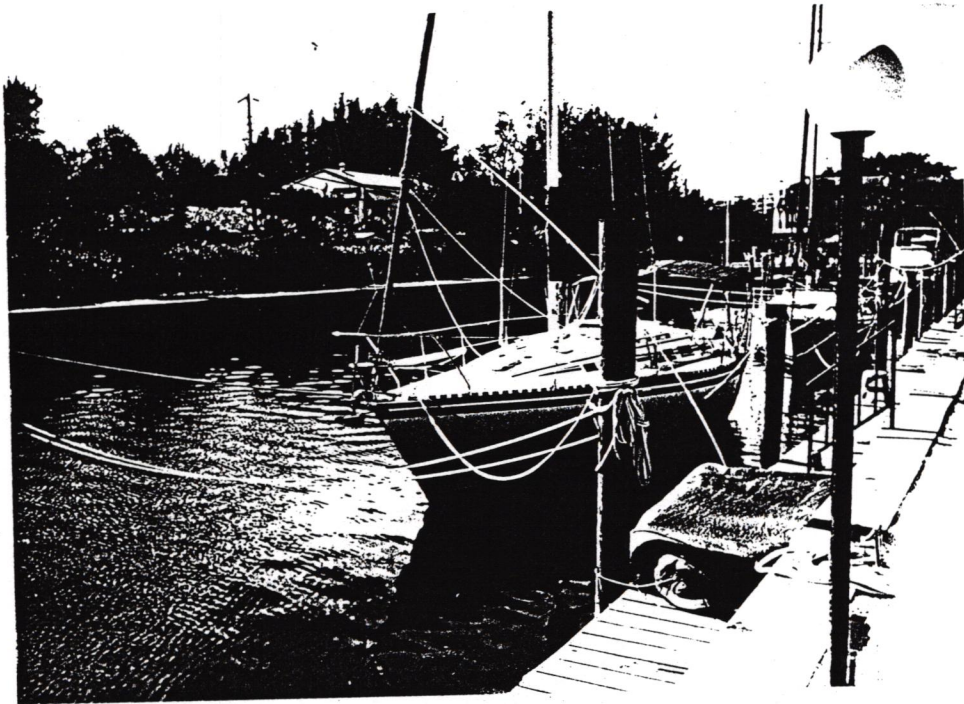
Canal 52 is a canal into the common areas of the Bay Harbor Apartments. A marginal dock lines the north and west sides of the canal.

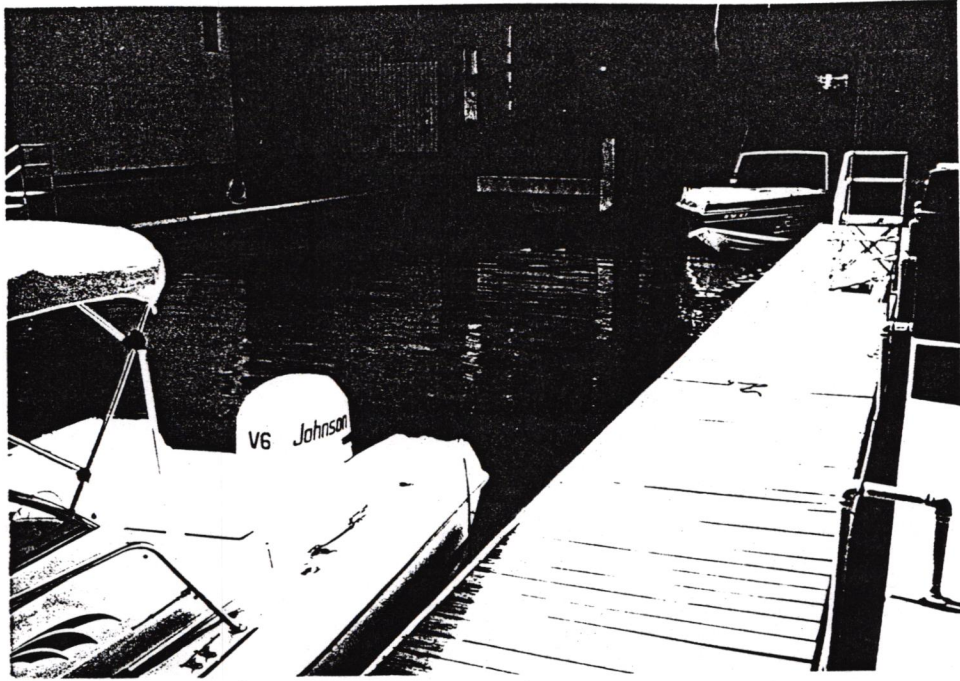
Canal 53 is a short entrance canal to the Marina Boat House.

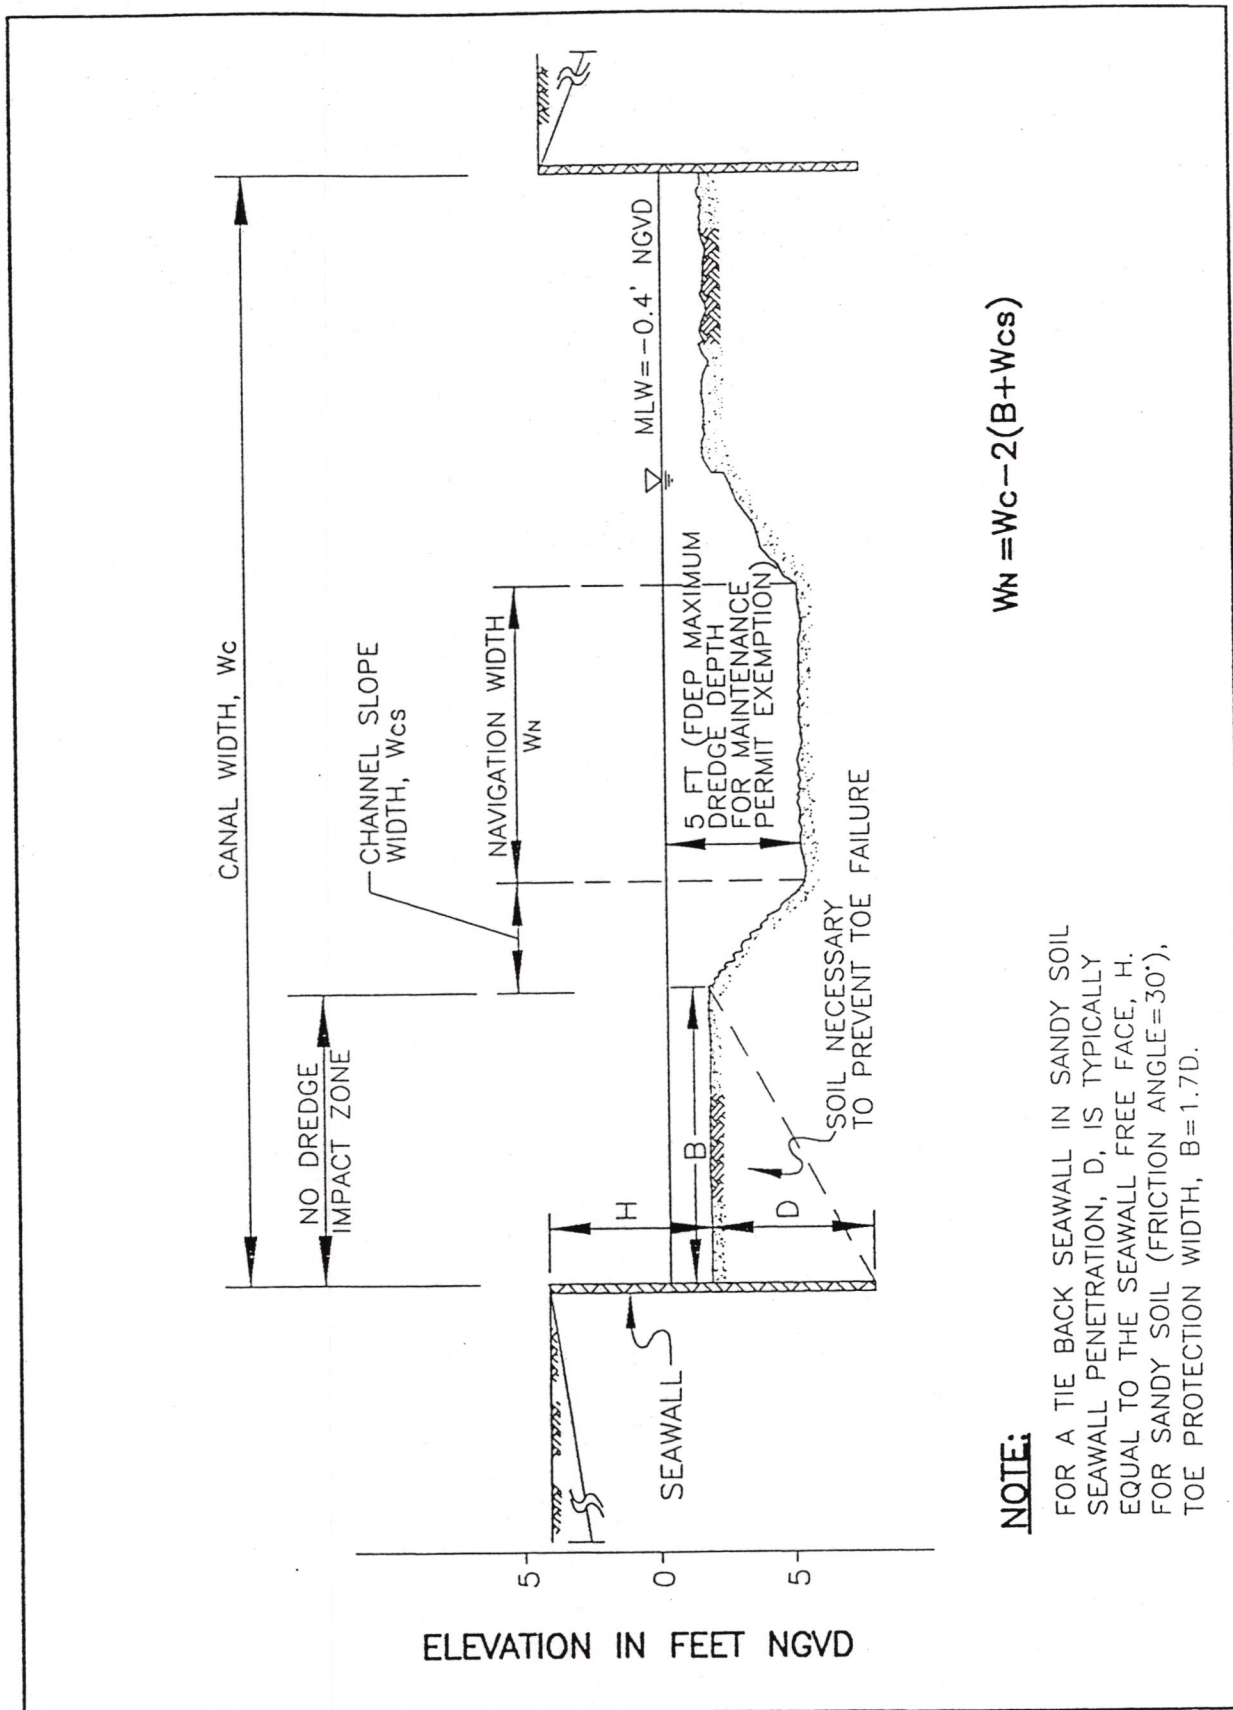
FIGURE 2

Tieback failure occurs when the tieback system (deadmen and tierod) fails to prevent the top of the seawall from overturning. Figure 2 shows a schematic representation of a tieback seawall. A typical tieback seawall design for sandy soil will consist of a sheet pile penetration, D, equal to the free face, H. Many times tieback systems are designed with no safety factor. Therefore, a change in the soil forces (heavy rain, dredging, surcharge load, etc) and corrosion of the tieback rod can often lead to failure of the seawall.

Toe failure occurs when the passive resistance offered by the soil in front of the seawall is less than active soil forces. In this failure mode, the seawall rotates (counterclockwise in the left seawall in Figure 2) about the tieback rod and a loss of soil occurs behind the seawall. For sandy soil (angle of repose equal to 30 degrees), the width of soil required to prevent toe failure is 1.7 times the penetration depth, D. As with the tiebacks, the seawalls are often designed with no safety factor on the seawall penetration. Therefore, a change in the soil forces in front of the seawall can lead to toe failure.

Based on the limited soil samples collected from the Longboat Key Canals, the preceding assumption of sandy soils is optimistic in many areas but is probably appropriate for the Country Club Shores area. The soil samples collected are weaker and less dense than sand; therefore, the required width of soil to prevent toe failure would be greater and the required seawall penetration, D, to prevent tieback failure would increase.

Table 2 shows that the seawalls were designed with greater free faces than penetration depths. Therefore, they are susceptible to toe failure and overturning failure. During the observations a repair indicative of toe failure was observed and many of the seawalls showed evidence of tieback replacement.

With the exception of the widest canals, dredging any canals in Longboat Key could potentially result in seawall failure. Additional seawall analyses should be performed for each canal during the final design to better understand the potential for seawall failure as a result of dredging the canals. This analysis will provide data to evaluate the appropriate distance from the walls to the dredged channel. Depending on the channel width selected by the Town it may be prudent to inform the residents and consider obtaining waivers from the upland owners.
