**Building Official Inspection Report**  
**February 26, 2014**  
**1620 Gulf of Mexico Drive**  
**The Colony**

### Building Official Report

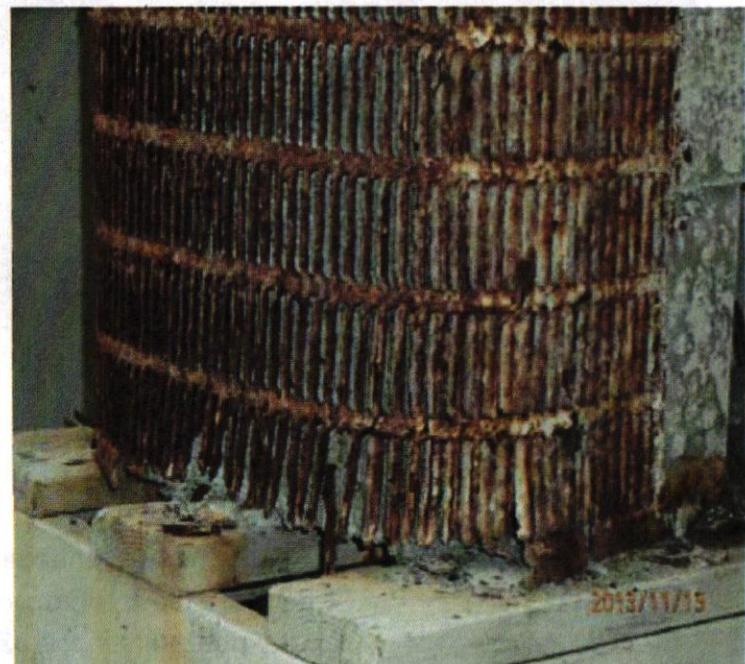
DETERIORATED STEEL AT AIR CONDITIONING UNIT. COULD ALSO

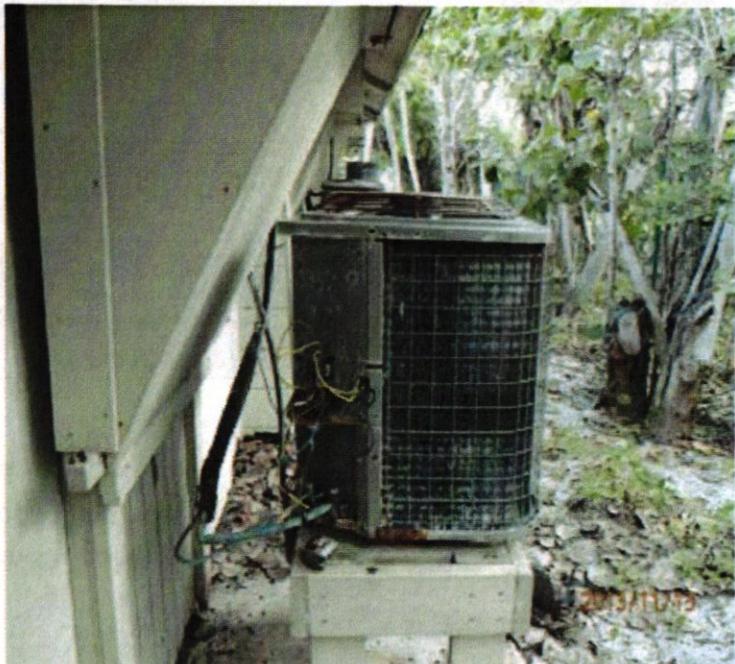
DETERIORATION OF METAL AT MULTIPLE AREAS OF AN AIR CONDITIONING UNIT.

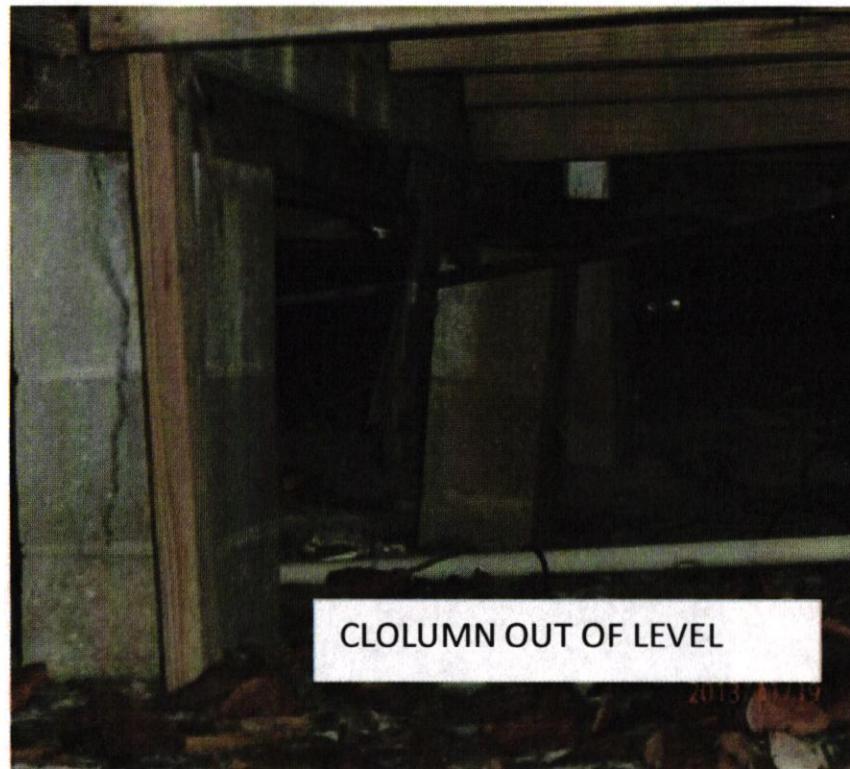
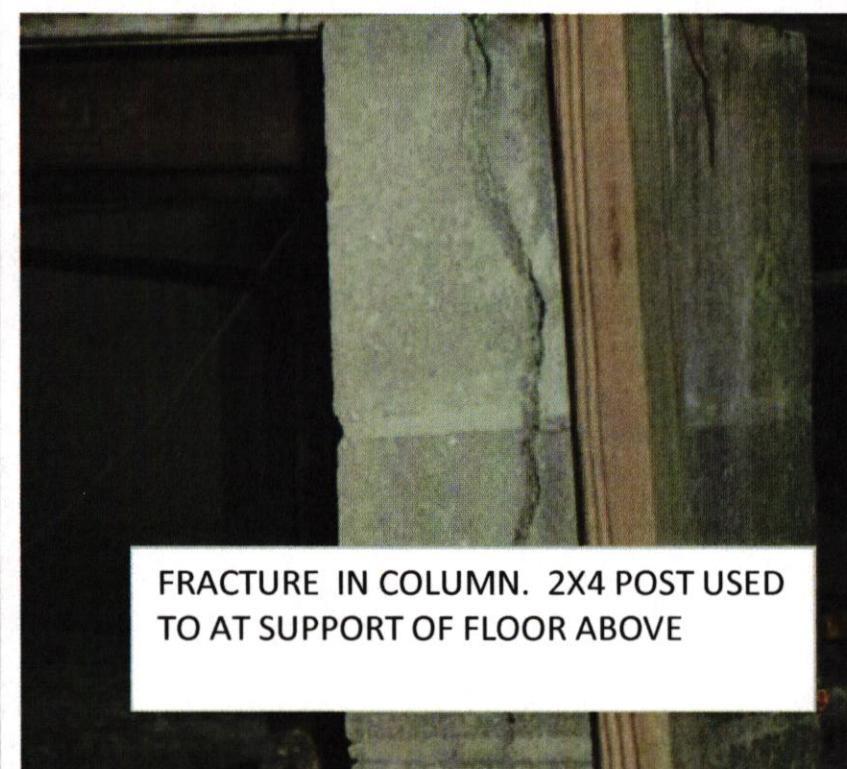
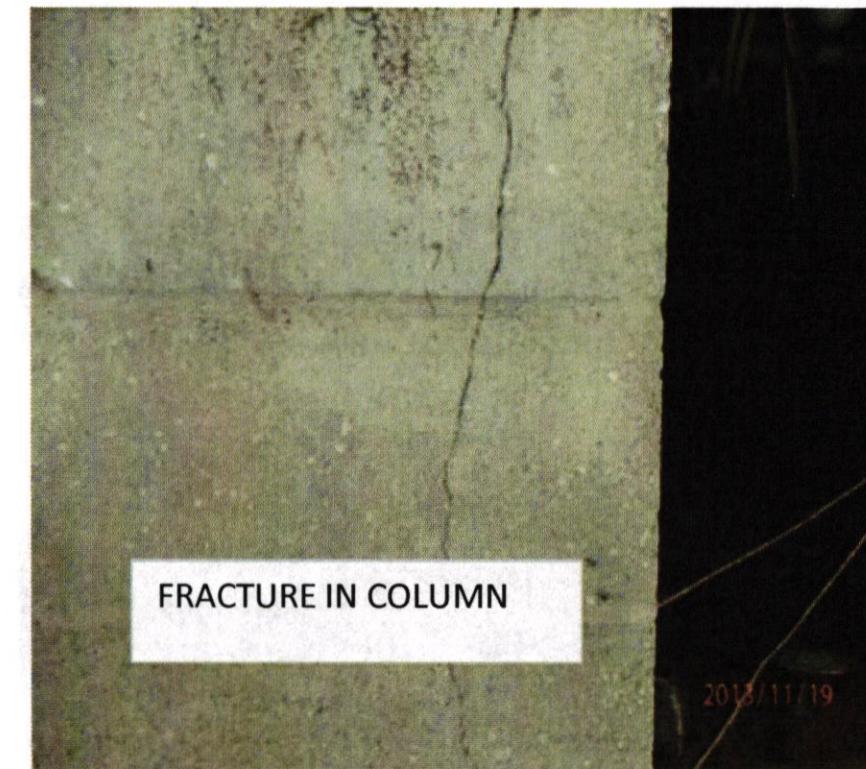
Some of cracking in joints to foundation columns

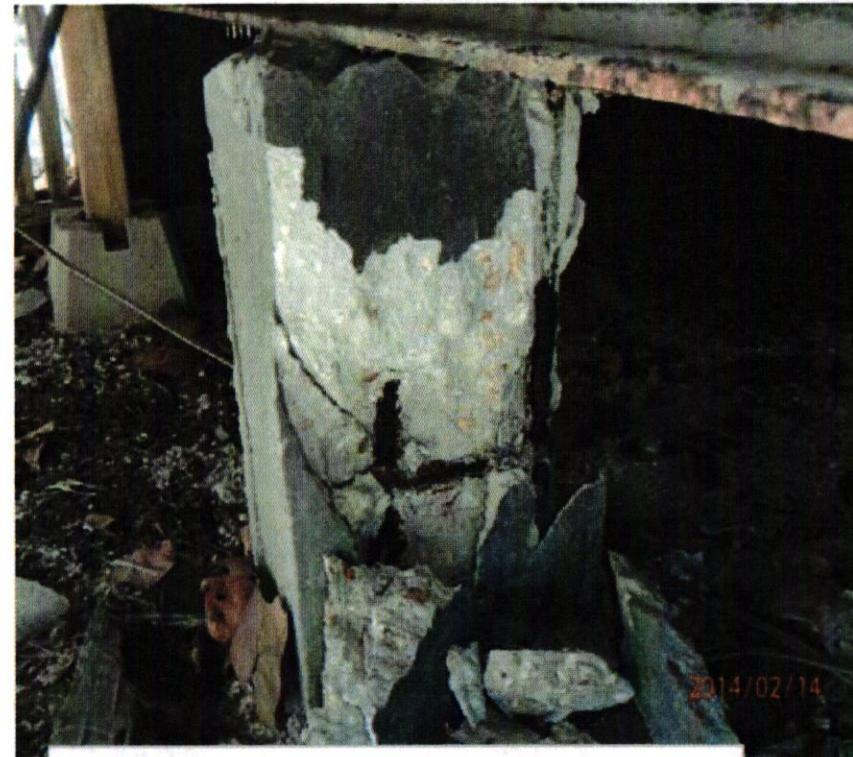
Extensive on approximately 40% of the piers

SPALLED CONCRETE WITH EXPOSED REINFORCEMENT

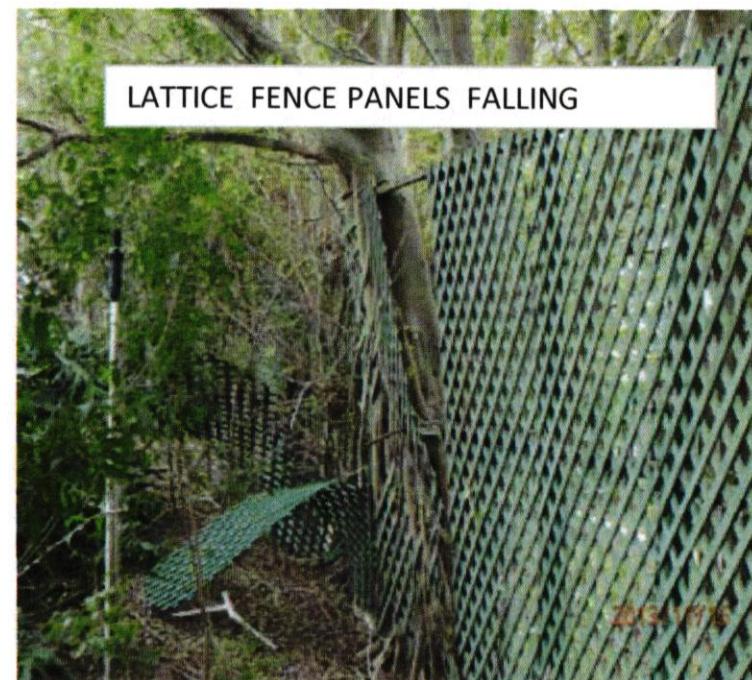
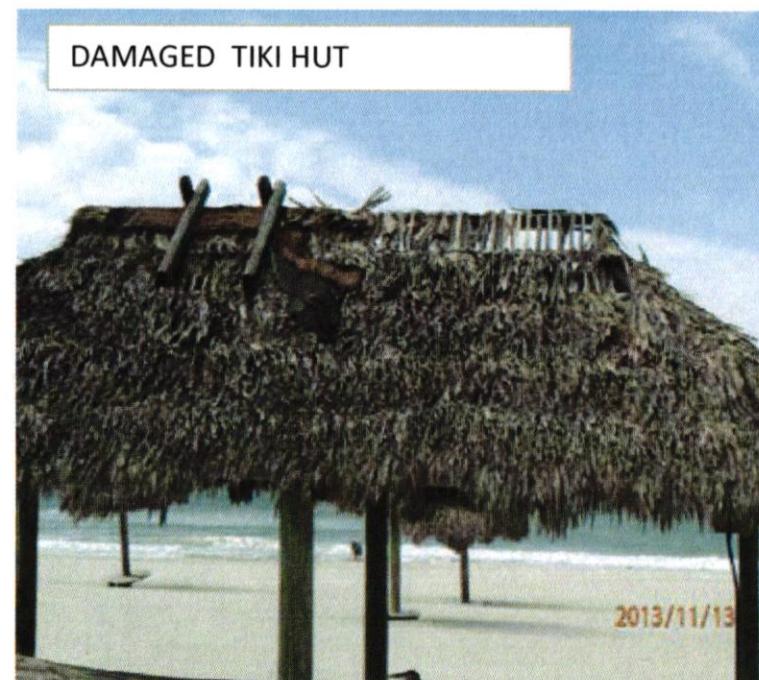
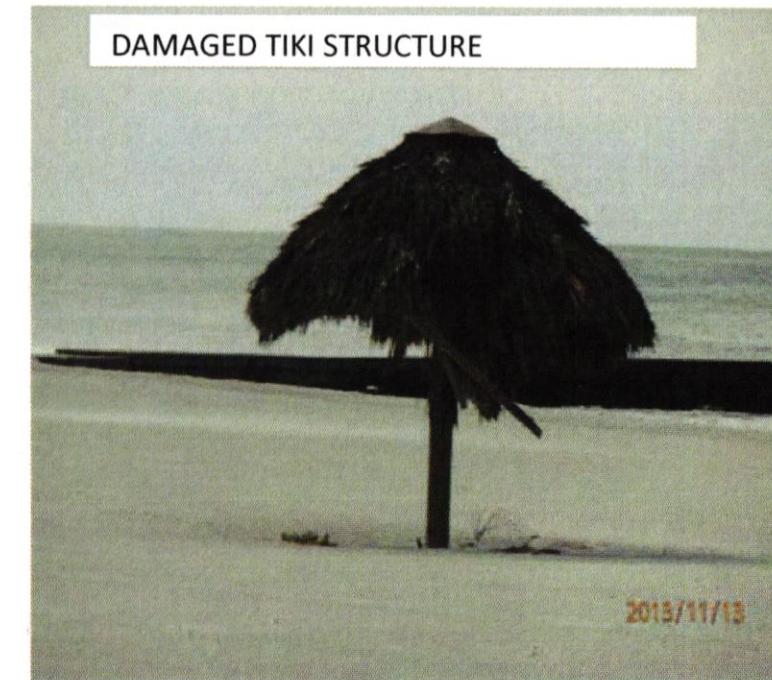
All ground level walkways and ramps have rotted wood, warp deck boards, rotted deck boards, and broken railings

Security fencing incomplete at some building. At first inspection appeared complete until an up close inspection was made. Some locations have had vandalizing requiring repair and or reset.
