September 3, 2010

***RE: Colony Beach and Tennis Resort
KEG File # 10RS-0362
Observations and Project Feasibility***

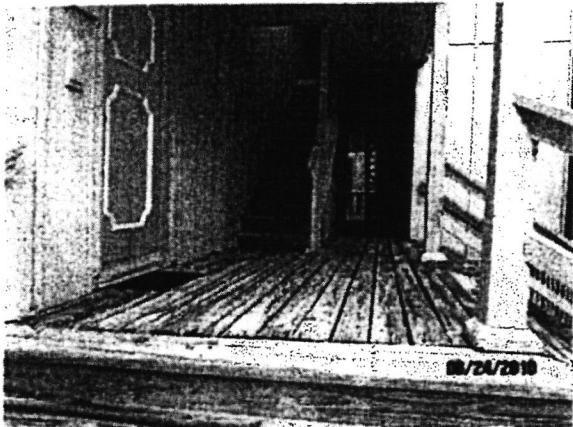
Typical Entry Decking

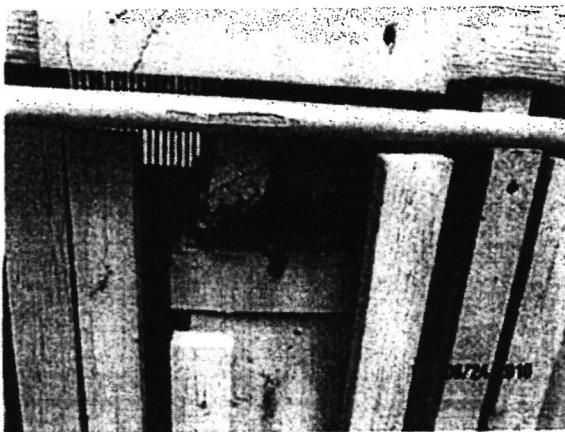
Typical Deteriorated Post Connection

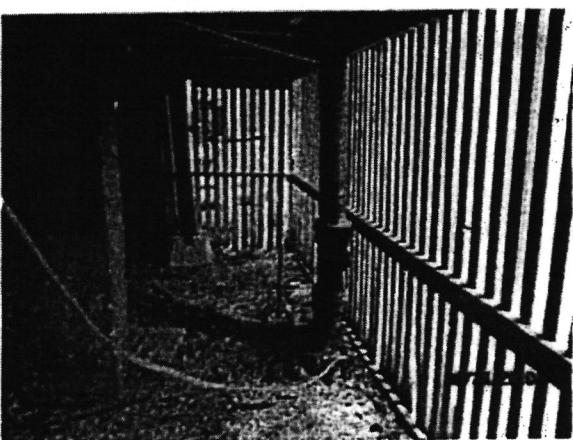
Typical Waste Piping

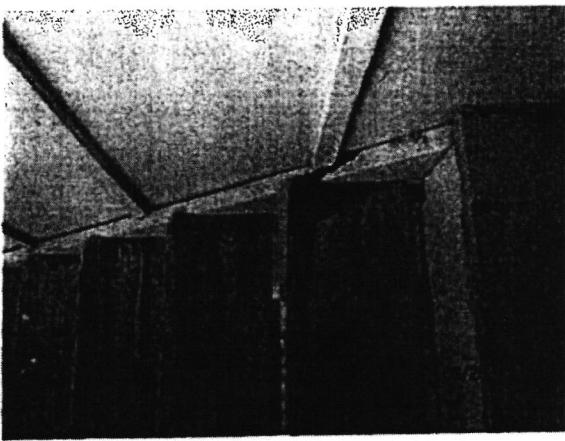
Typical Termite Infestation Evidence

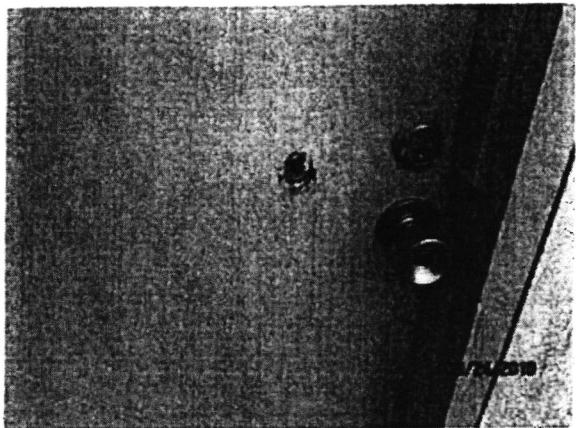
Deterioration at Entry Door

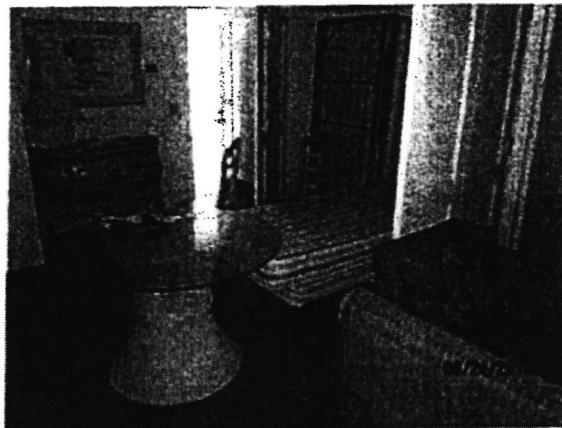
Typical Living Room Furniture

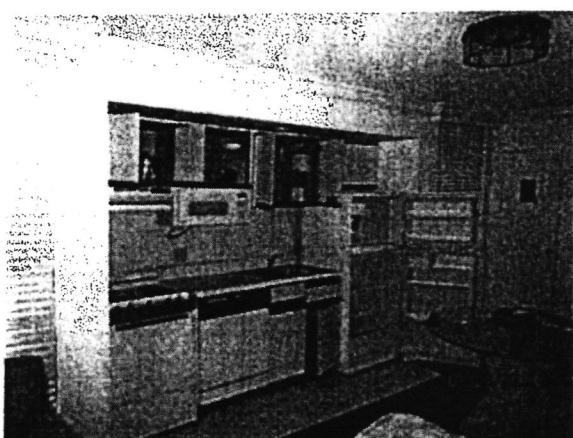
Typical Kitchenette

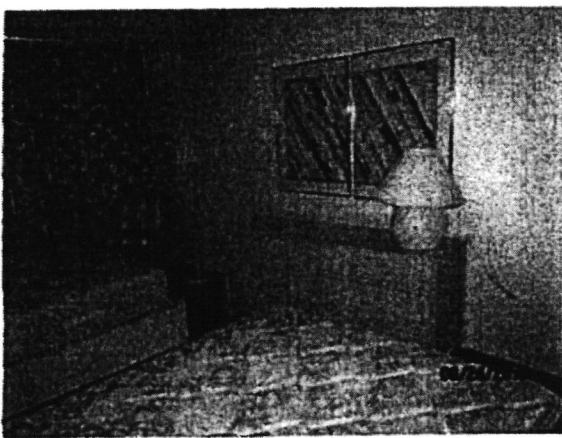
Typical Bedroom Furniture

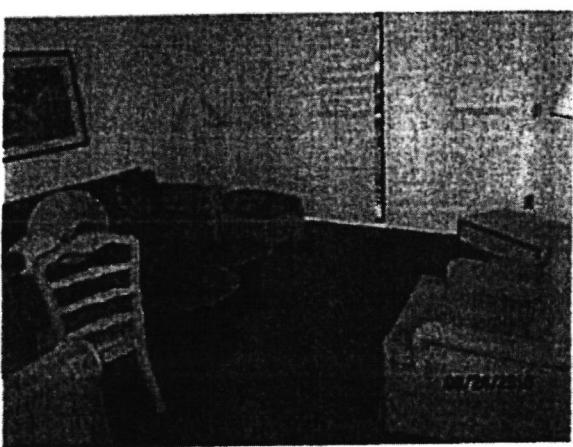
Typical Living Room Furniture

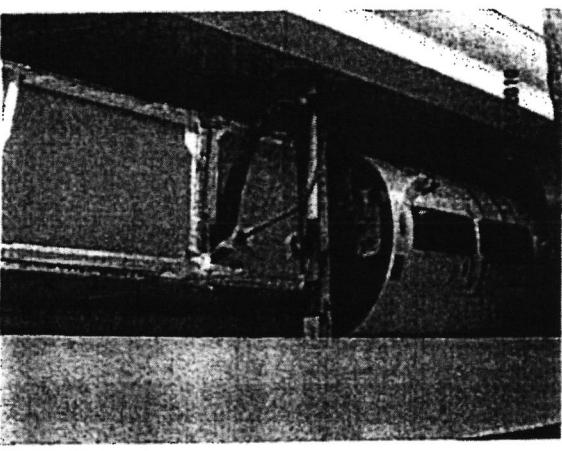
Typical Mechanical Closet

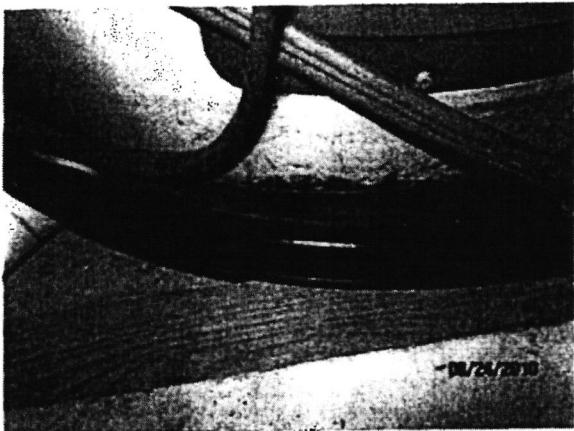
Evidence of Standing Water in WH Pan

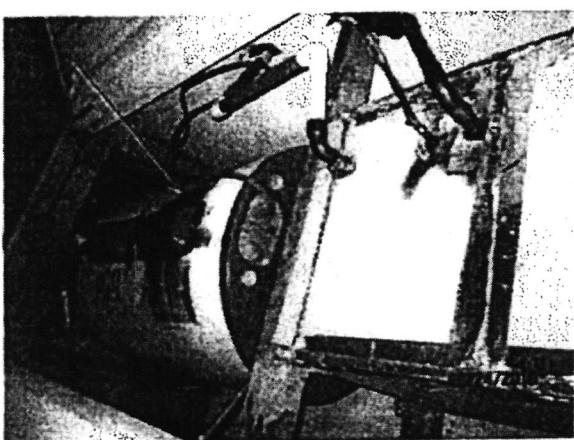
Evidence of Fire at Water Heater
