ENGINEERING INSPECTION REPORT

THE COLONY BEACH and TENNIS RESORT

Longboat Key, Florida

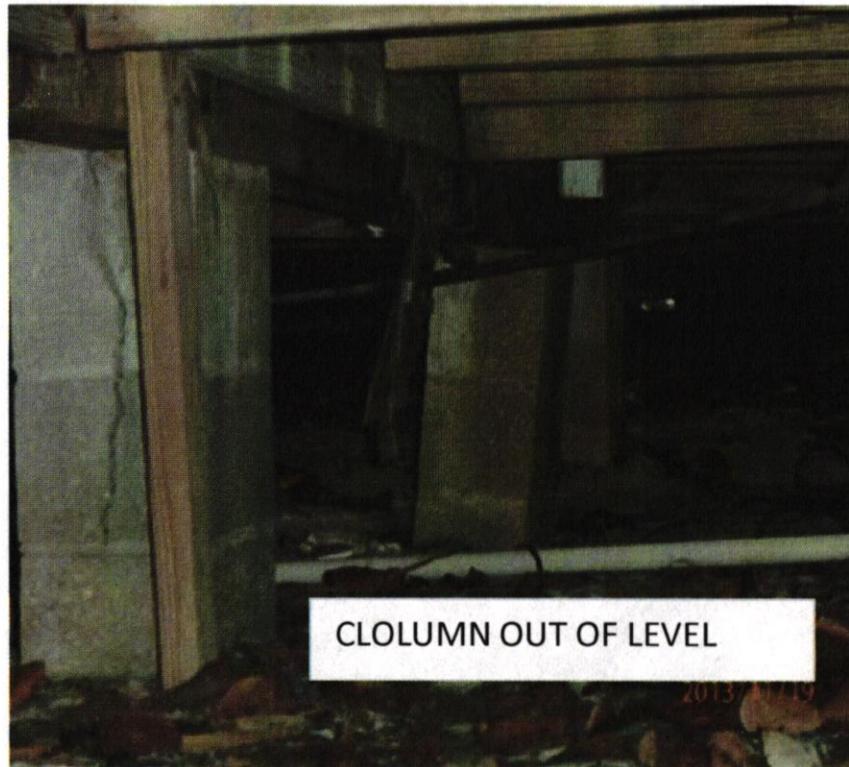
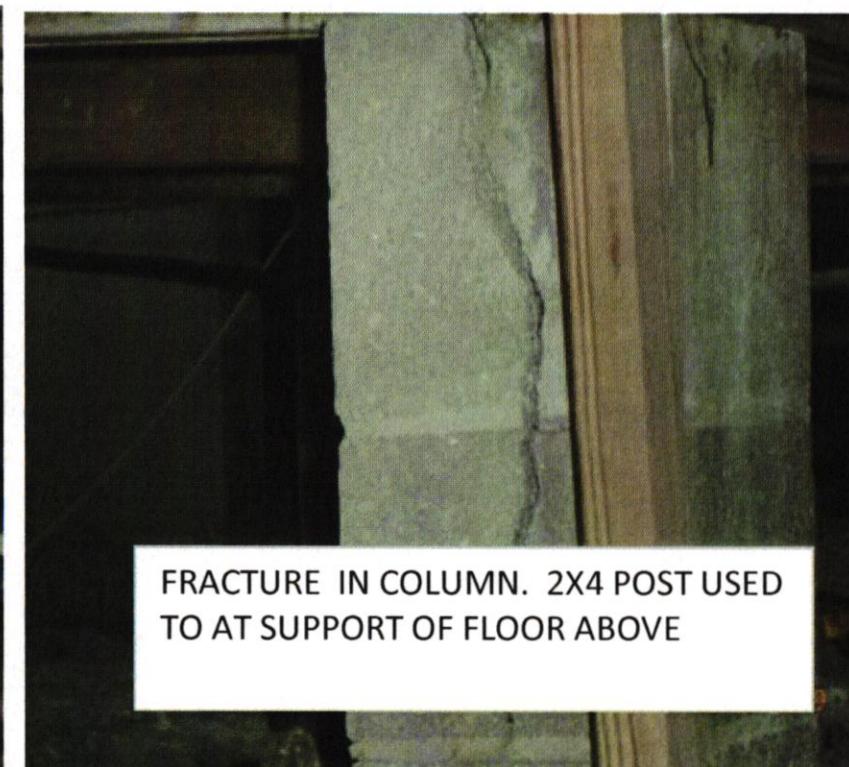
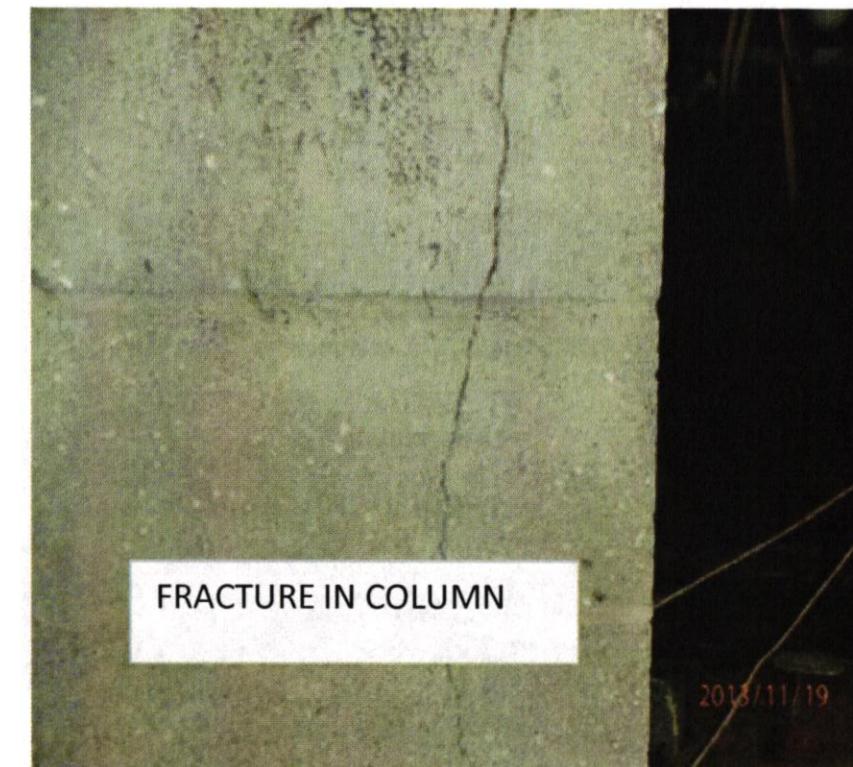
Some of cracking in joints to foundation columns

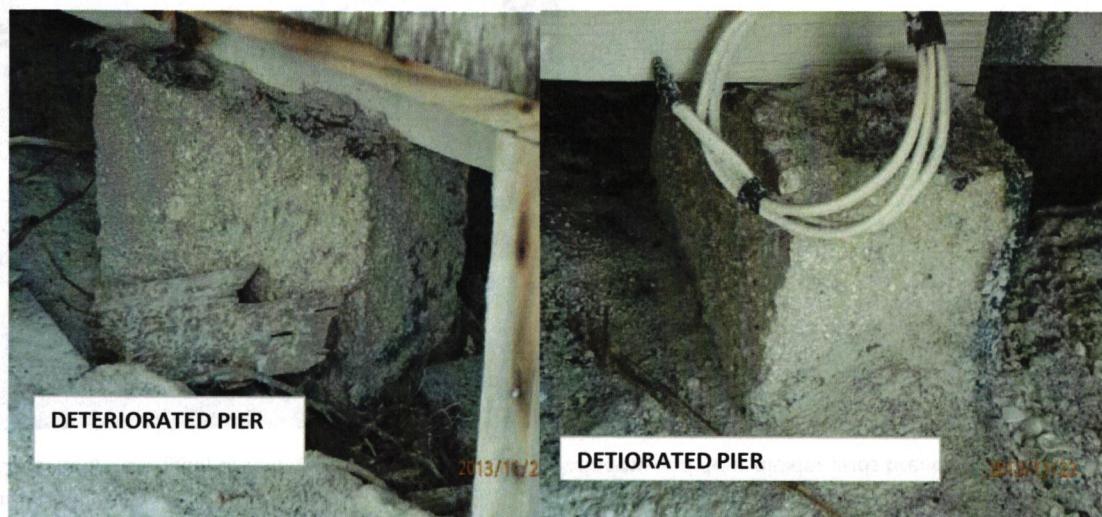
DETERIORATED PIER

Exposed reinforcement

Detached, dislodged, or failing connections

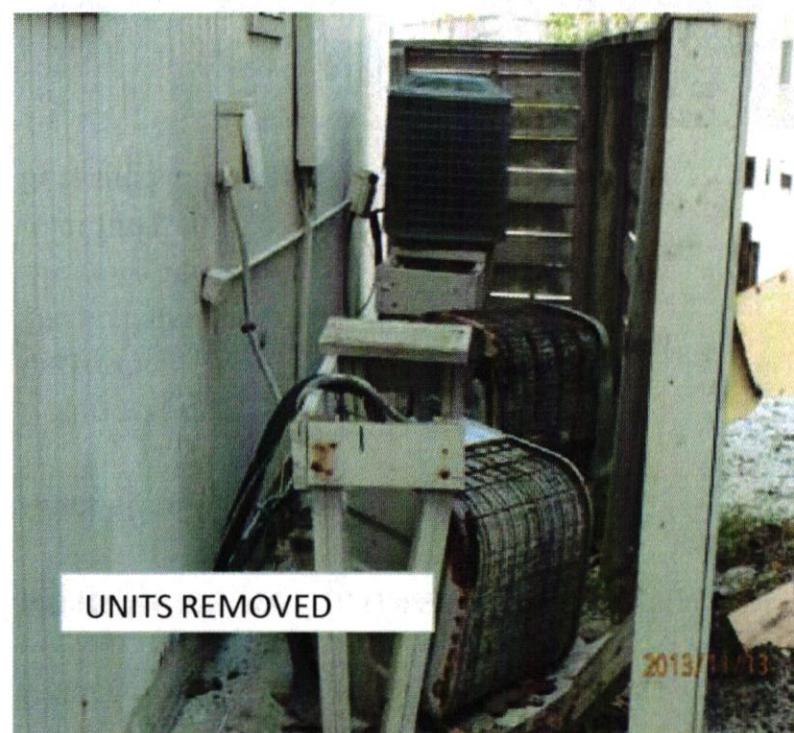
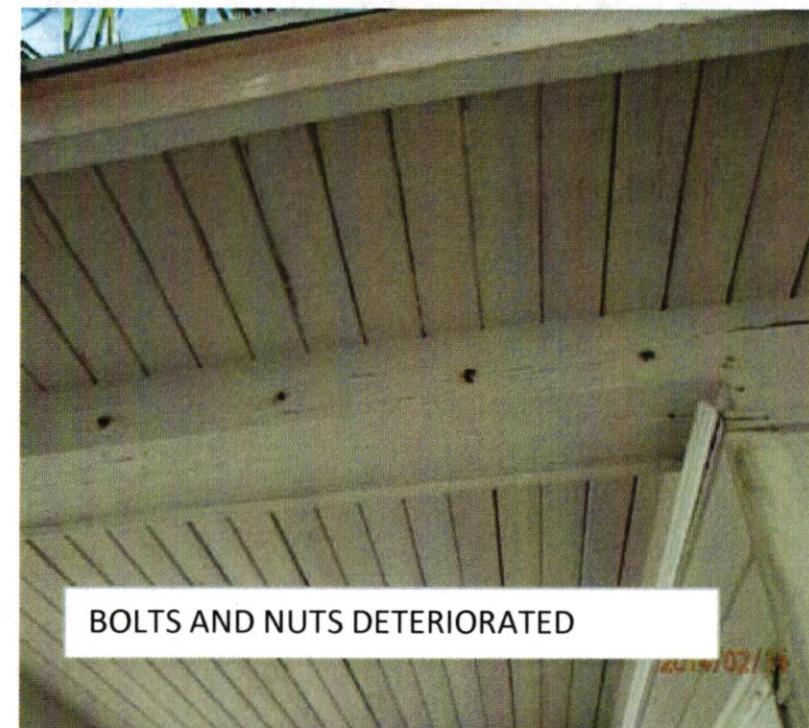
Bottom of air conditioning units

Corroded joints to awnings.

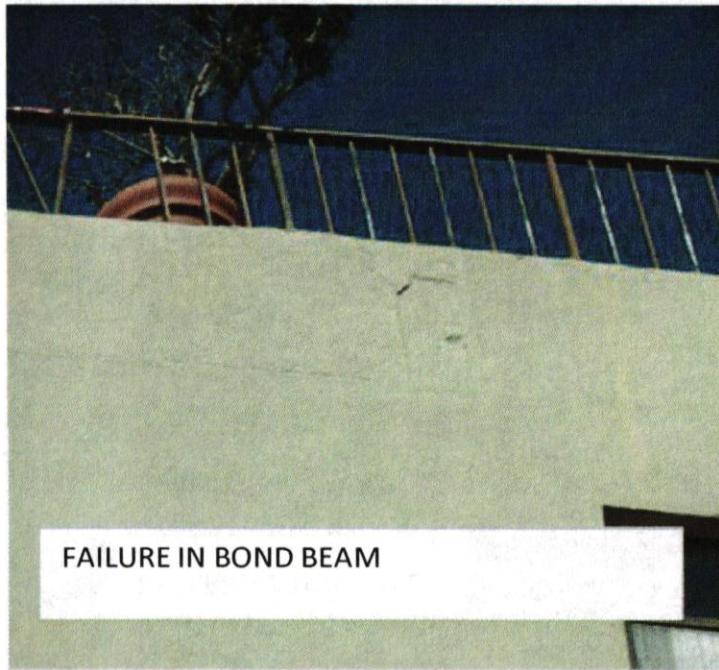
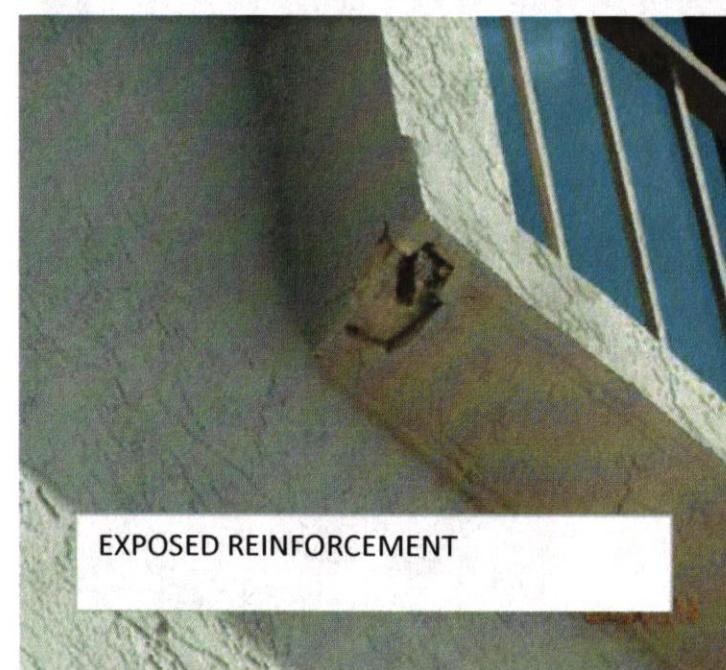
Parapet walls
North west corner, parapet walls
Around window buttresses
breaks of plaster and mortar at window buttresses

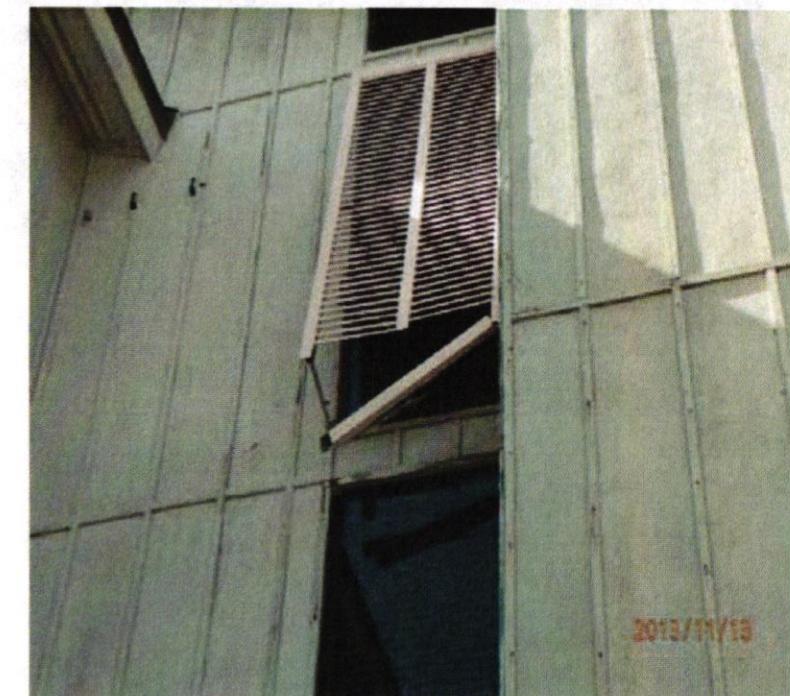
Deterioration
Corrosion
Elastic deformation
Ultimate deformation
Joint fatigue
Detached, dislodged, or failing connections.

Shutter supports

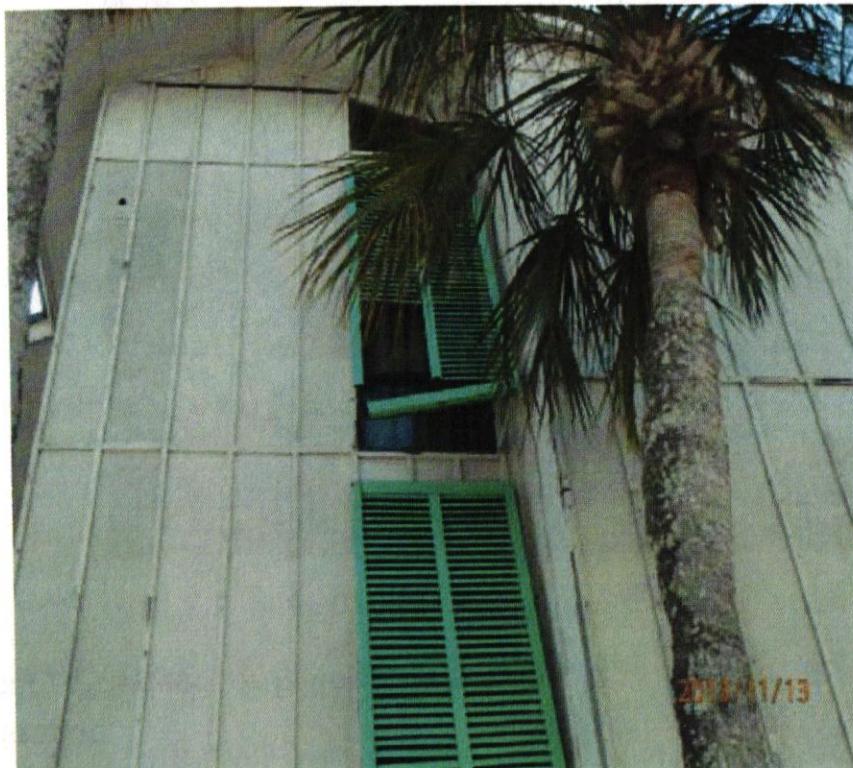
Detached, dislodged, or failing connections.

Connection poles to shutters.

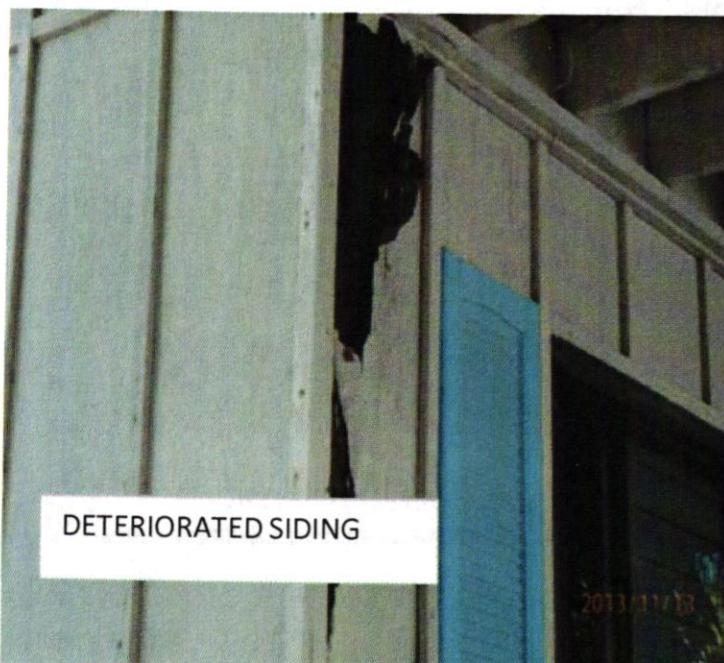
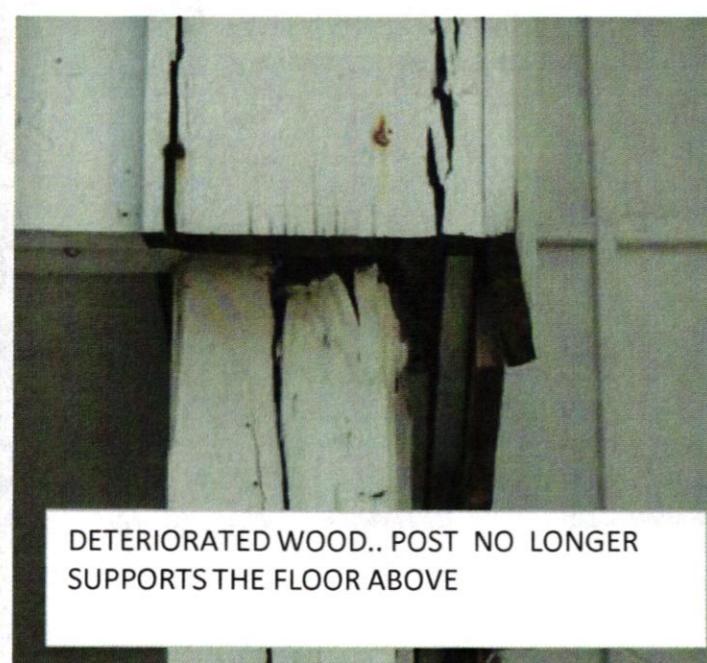
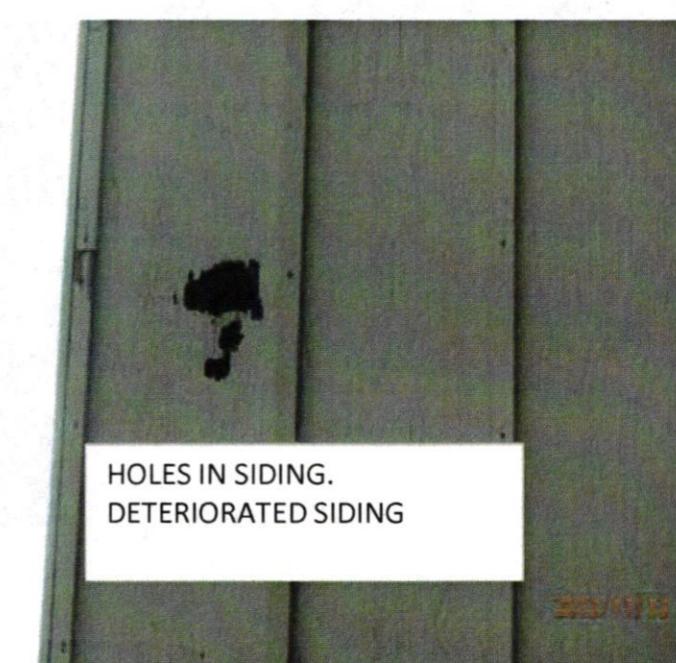
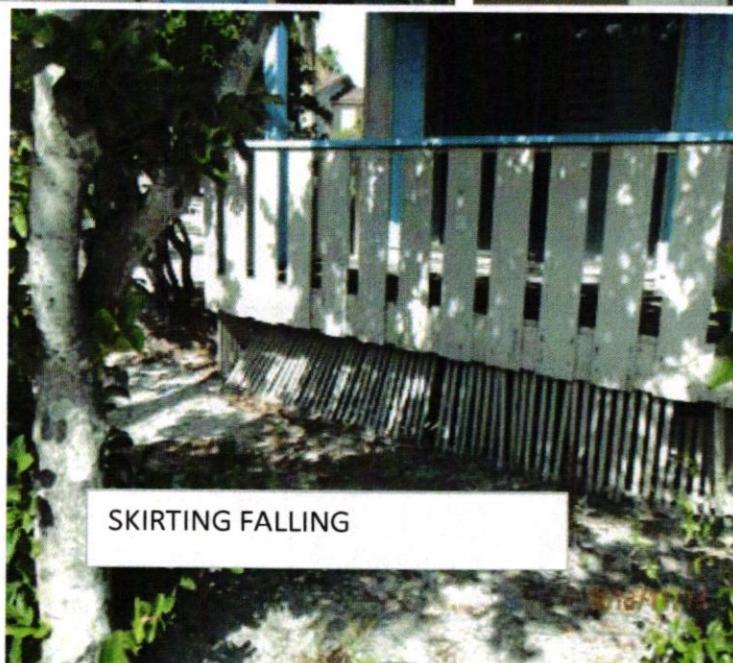
Siding, trims, floor framing, wood shutters, fascia and soffits. The entry stairs and lower walkway show signs of failing to support. Railings pulling from walls. Railing missing balusters.

Excessive cutting and notching

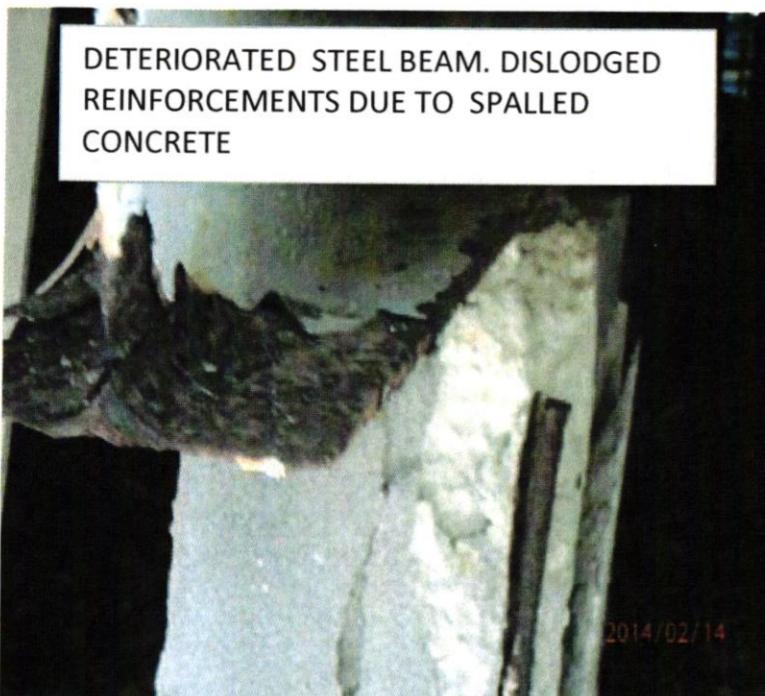
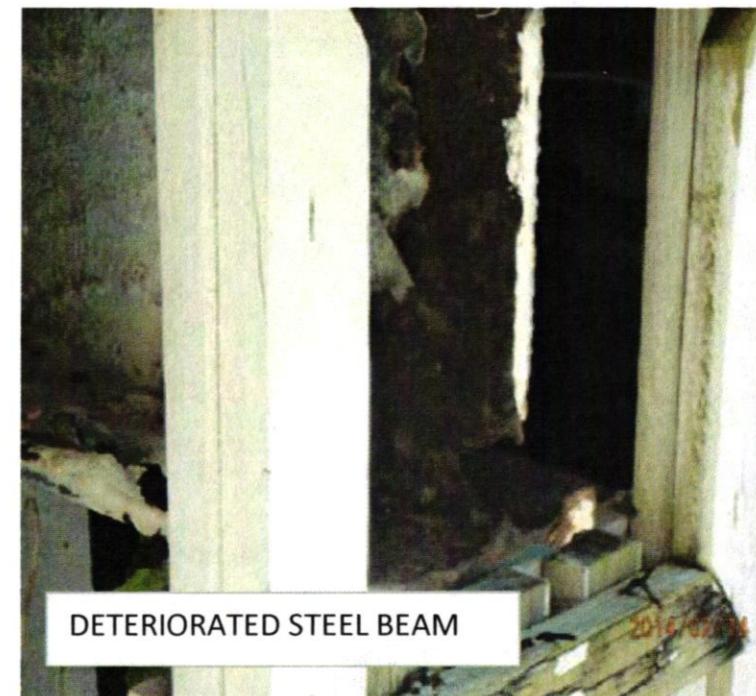
Detached, dislodged, or failing connections

A/C units at the bottom

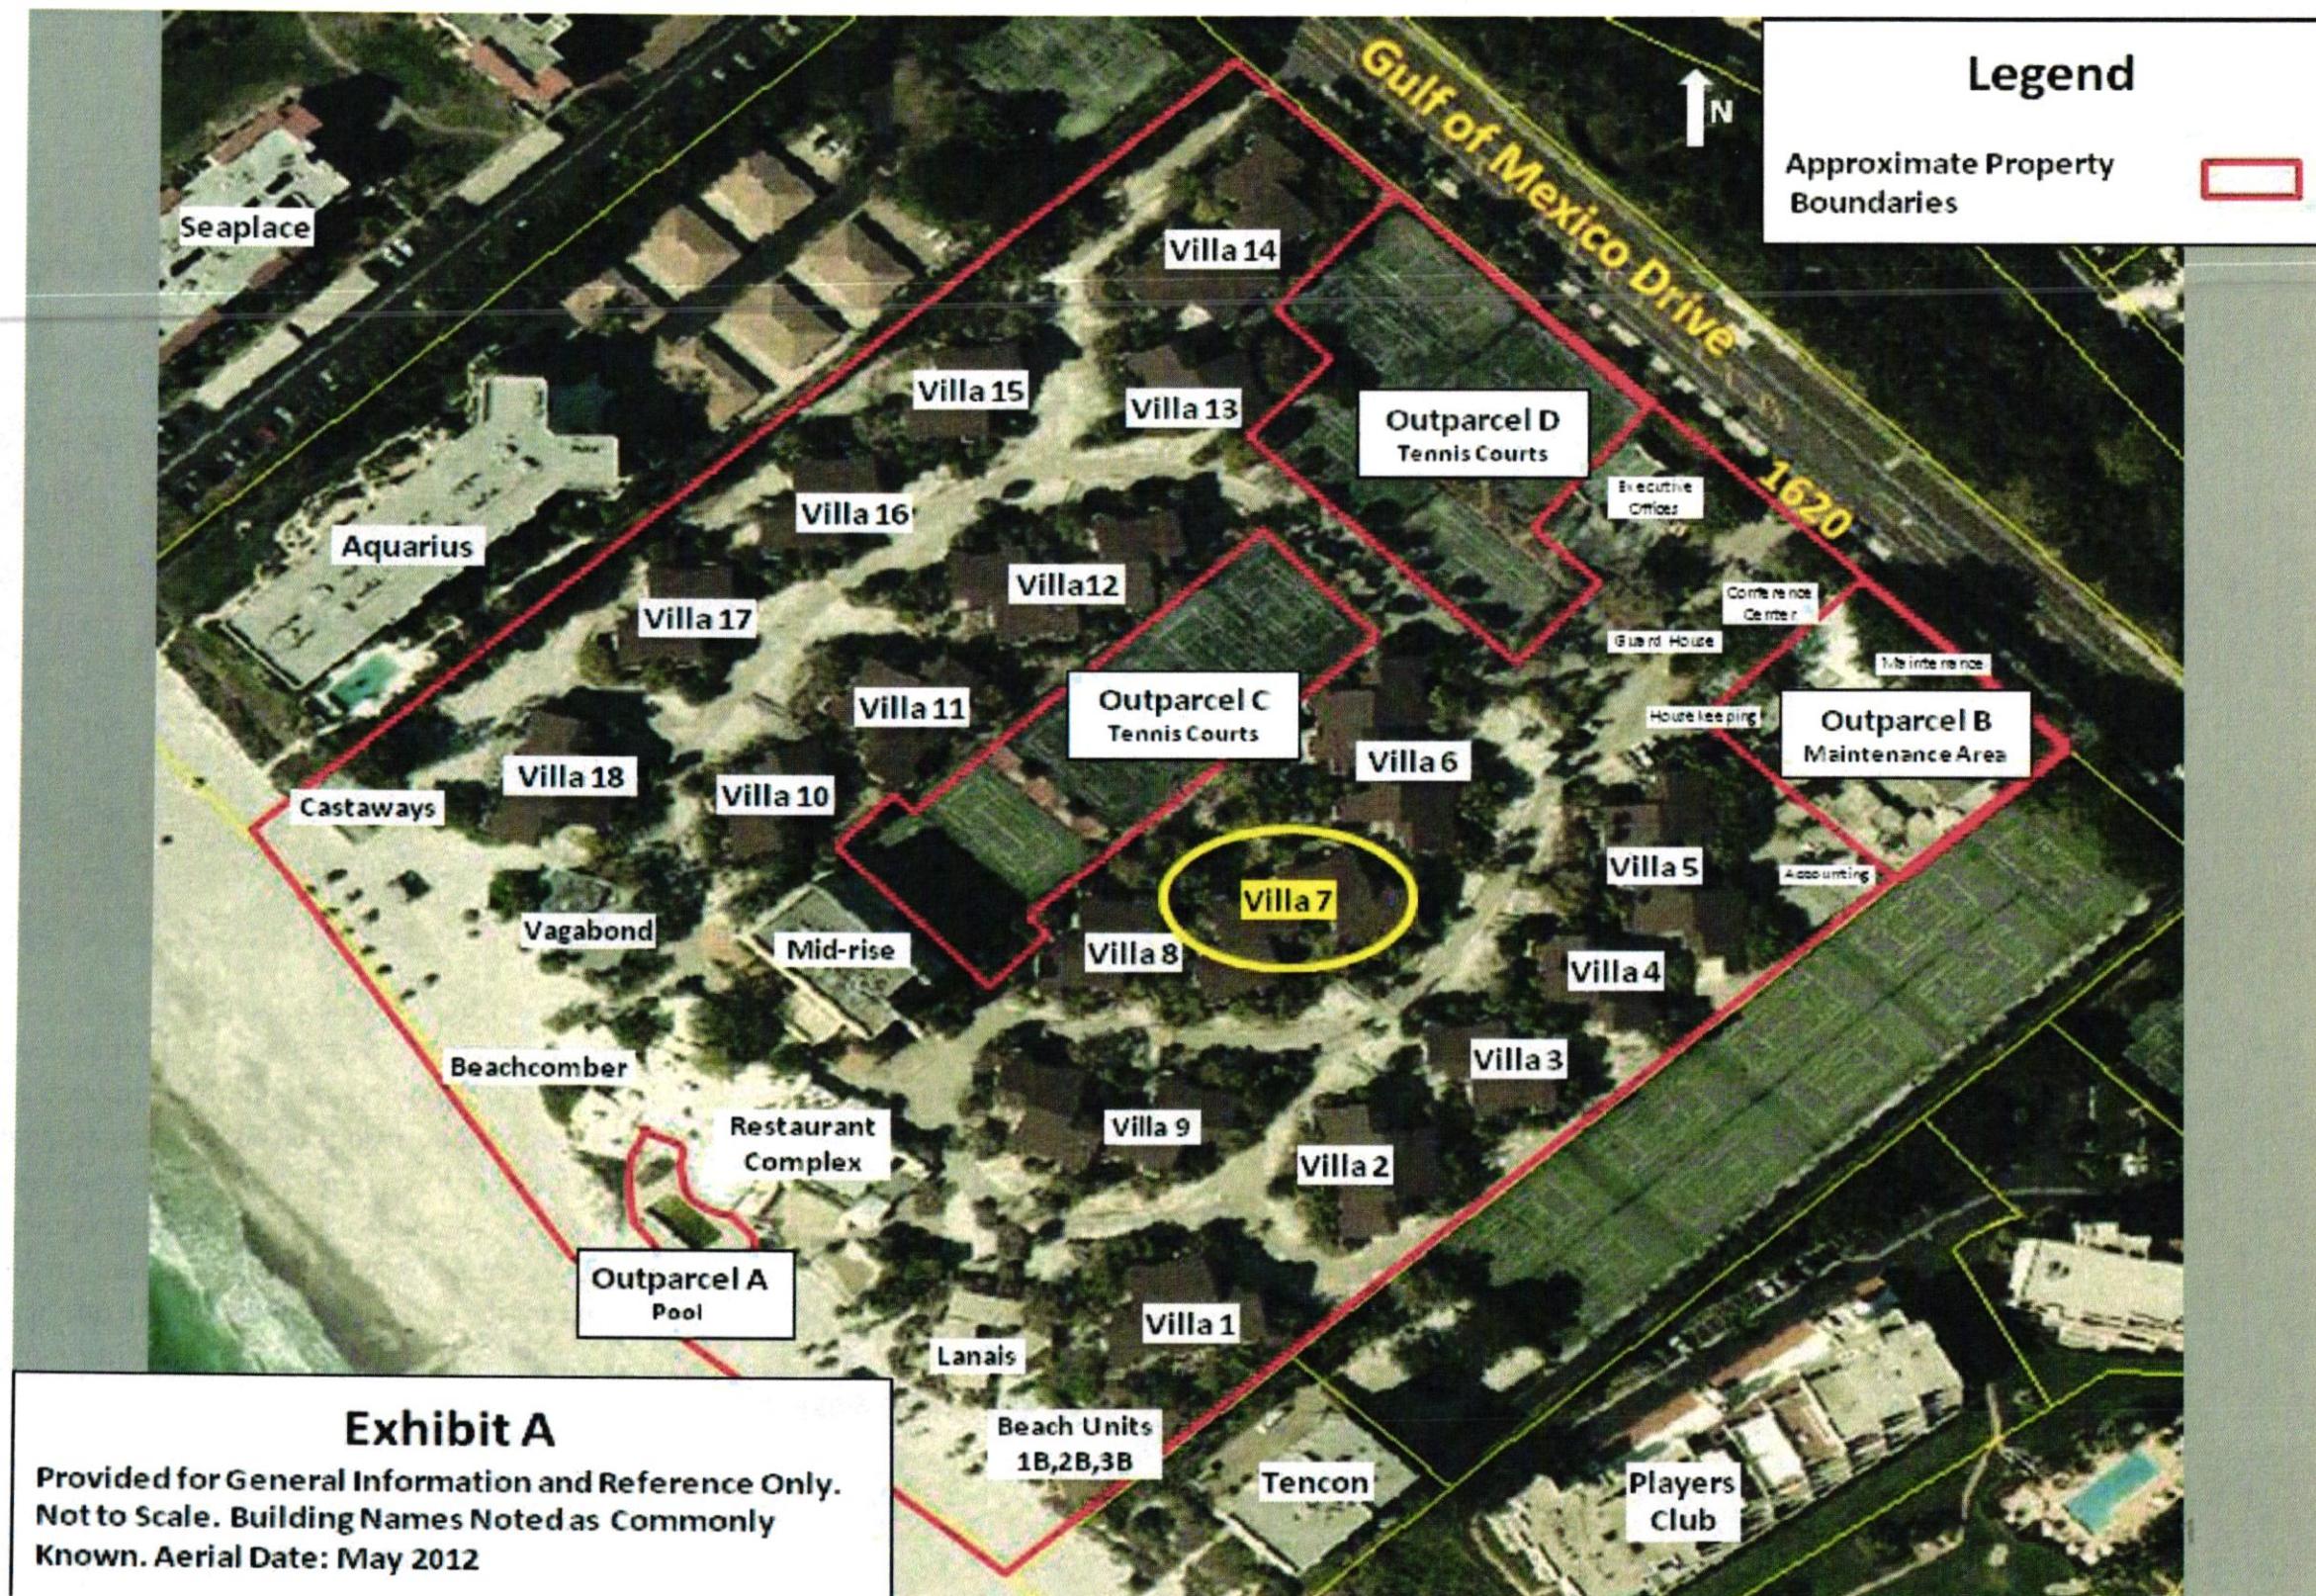
Cast iron building drains corroded and broken
Un-attended furniture/items on patios
Abandoned ac units under building.
Boarded up windows and doors due to vandalizing.
Security fencing does not provide for complete restricti
Air conditioning unit are beginning to fail. A/C unit may fall and have potential to have electrical issues as well as possible leaking for the refrigerant.
Removed soffit material due to having bee infestation.
Lattice skirting falling from position.

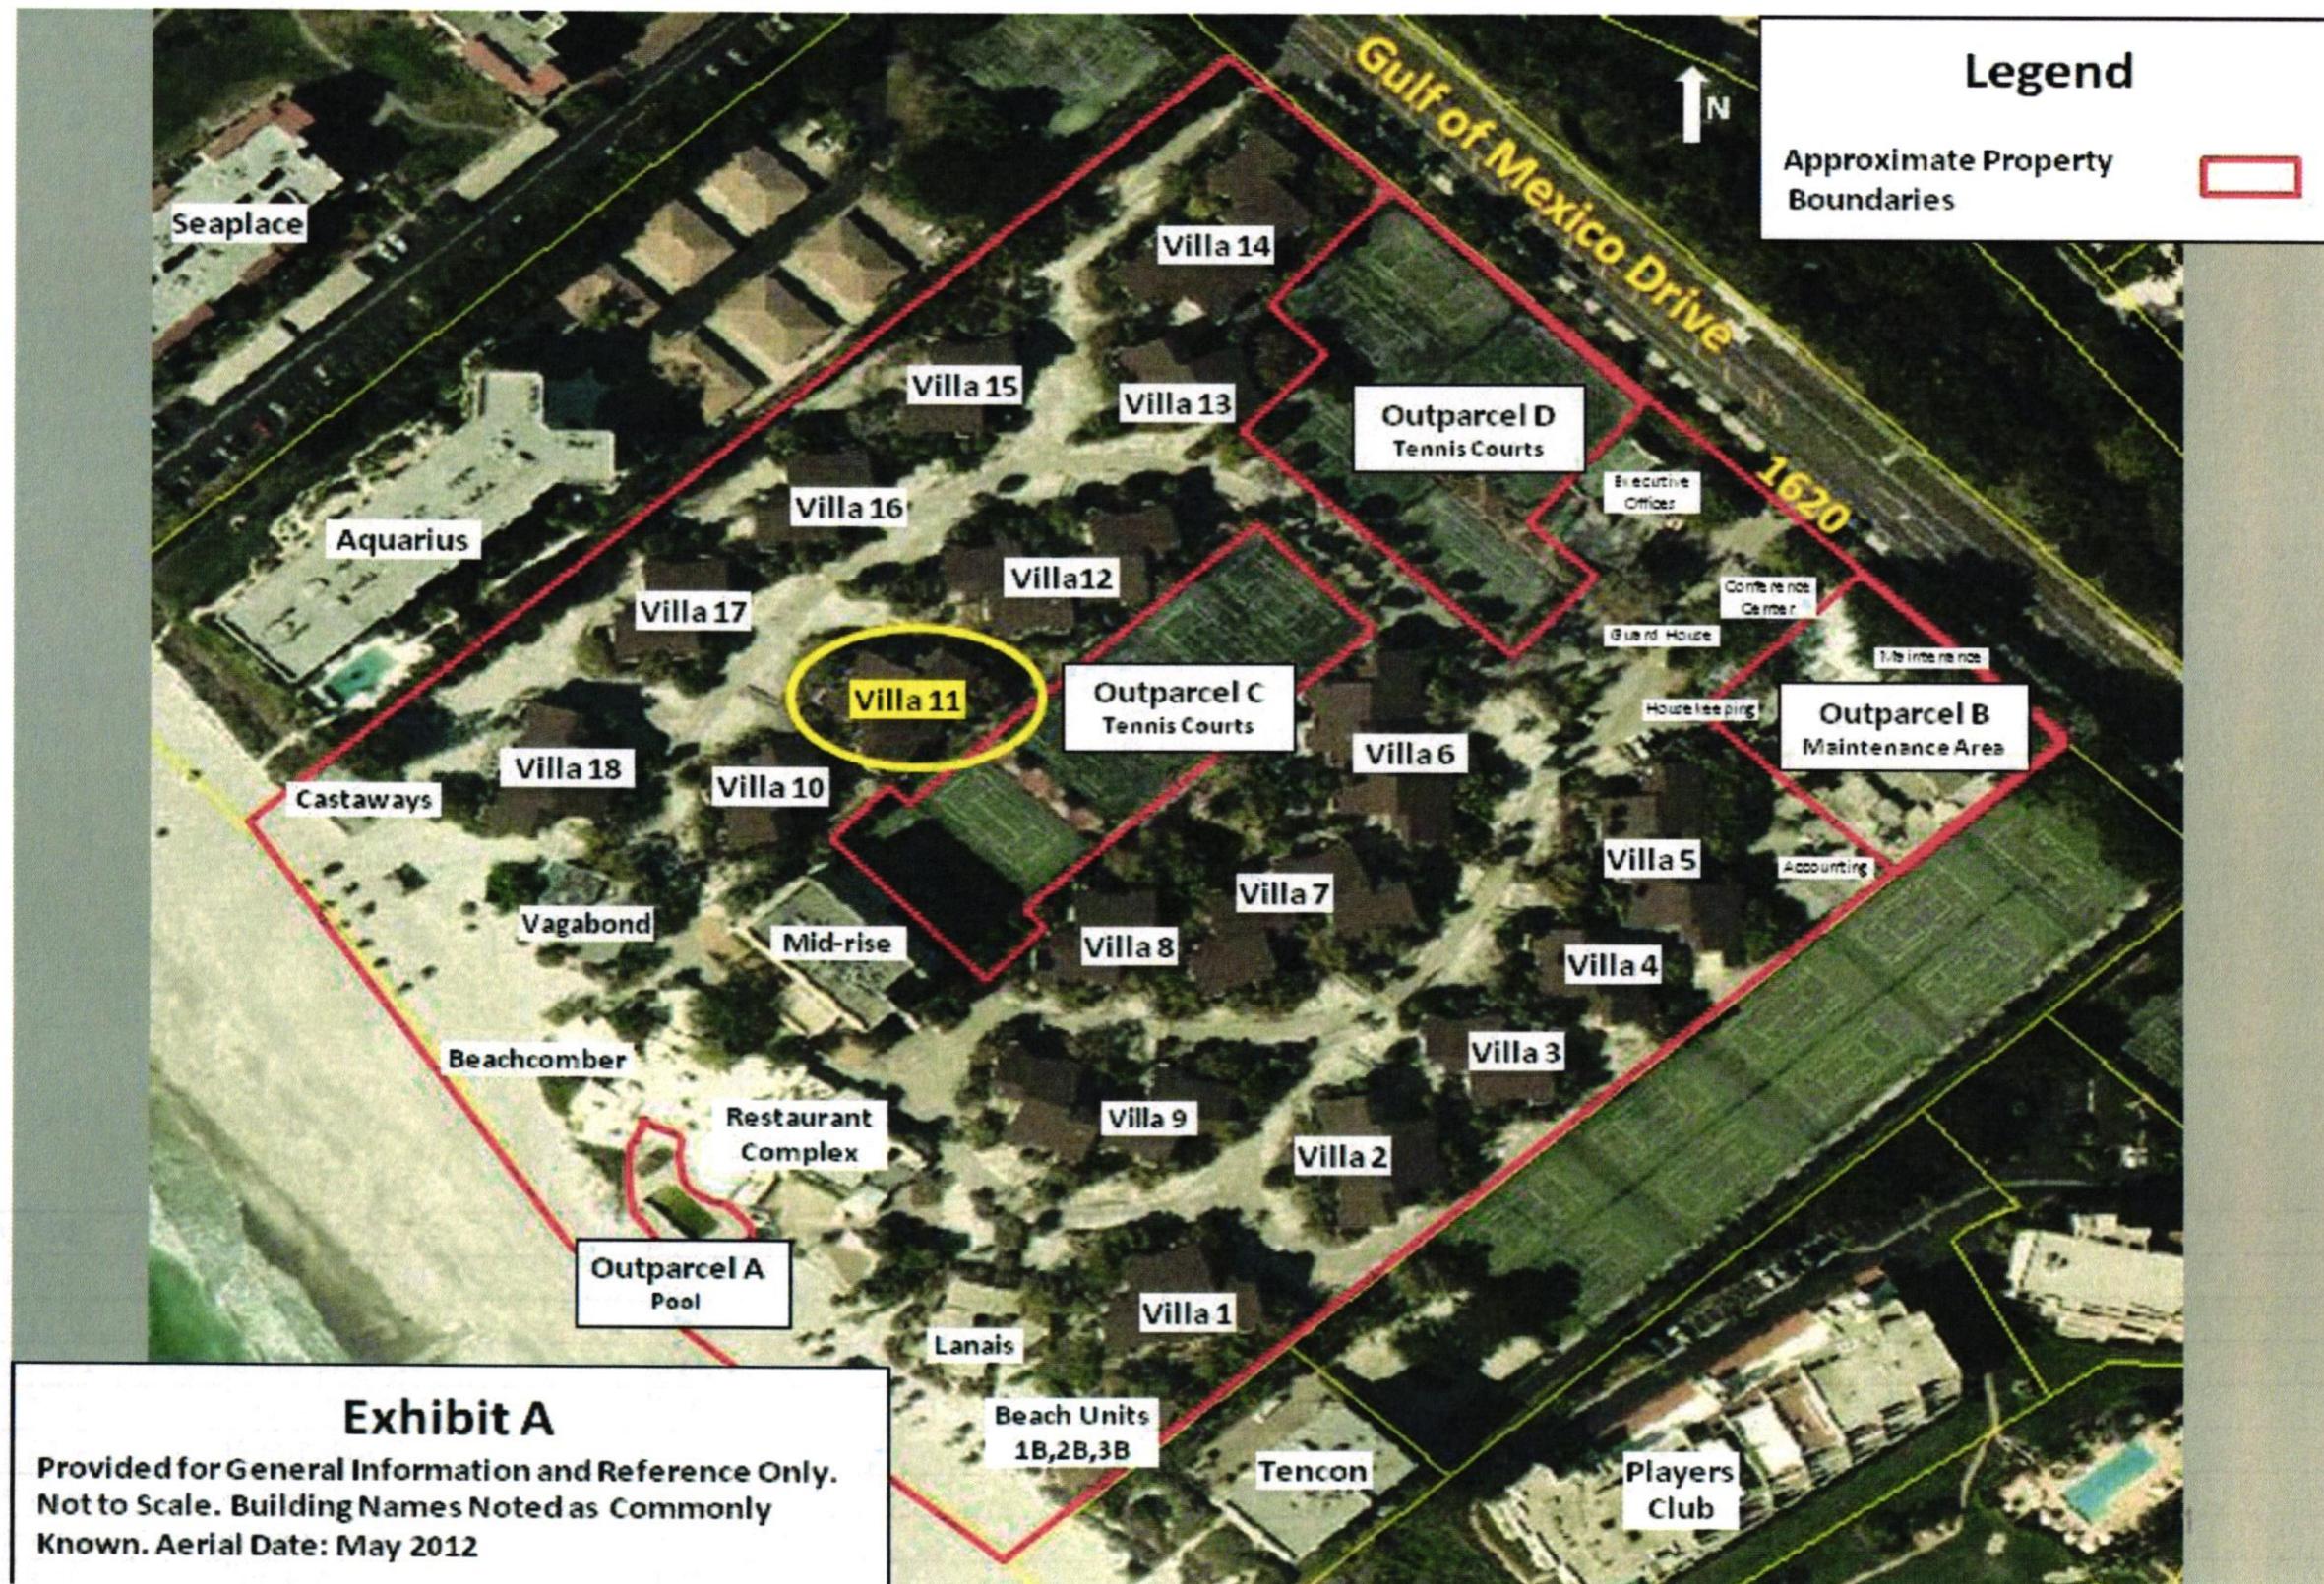
Boarded up windows and doors due to vandalizing.

Air conditioning unit are beginning to fail. A/C unit may fall and have potential to have electrical issues as well as possible leaking for the refrigerant. One unit has fallen from the stand. One Lattice skirting falling from position.

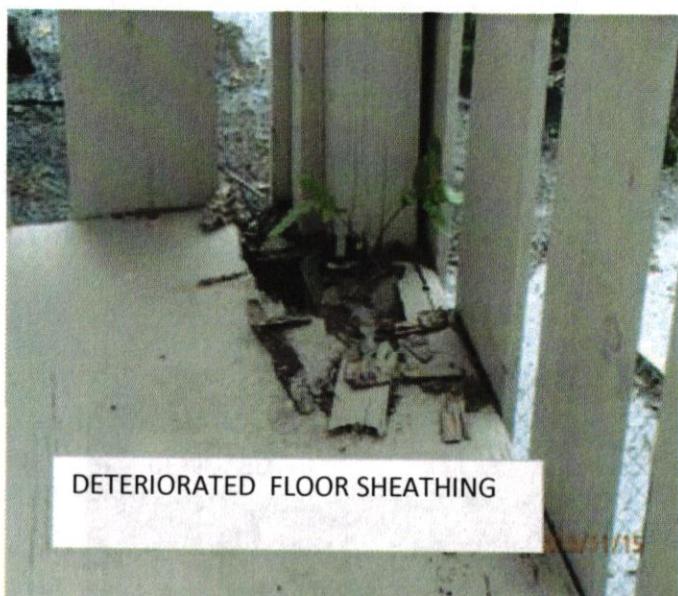
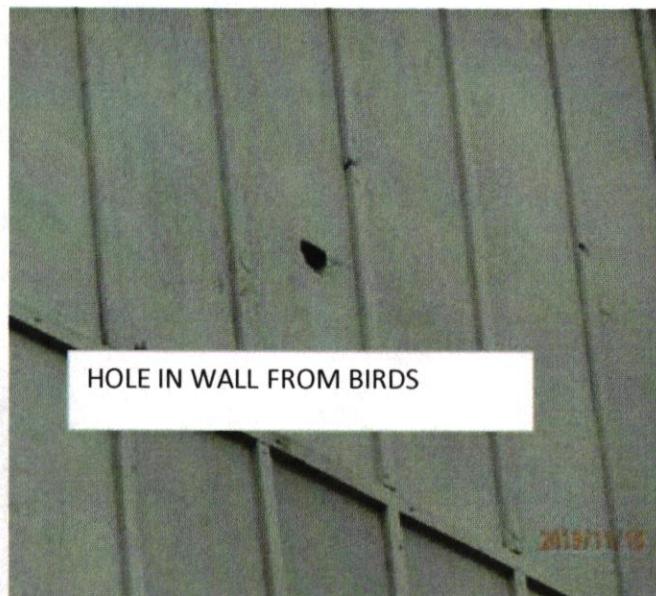
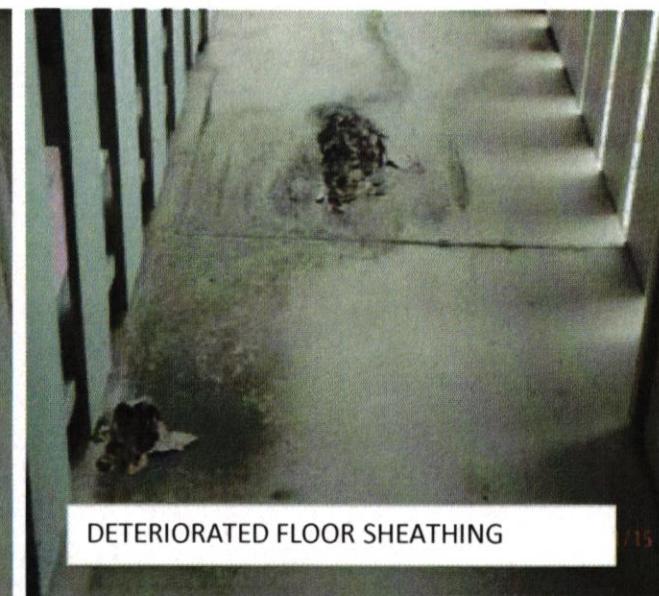
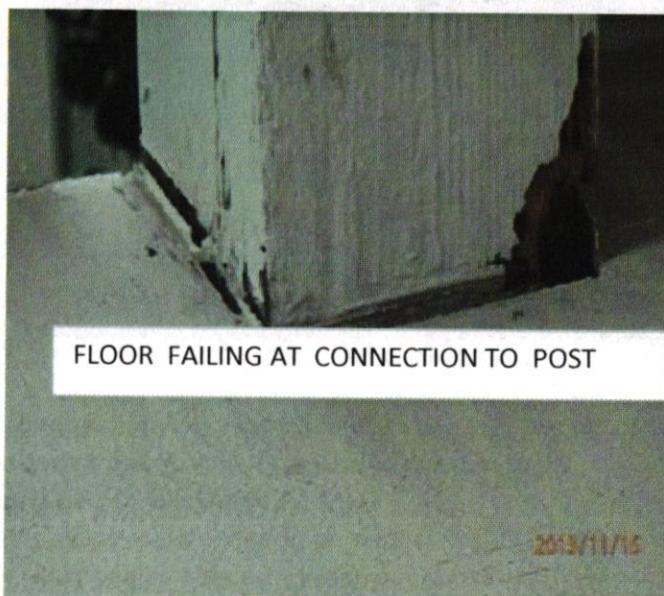
Siding, trims, floor framing, wood shutters, fascia and soffits. The entry stairs and lower walkway show signs of failing to support. Railings pulling from walls. Railing missing balusters.

Excessive cutting and notching

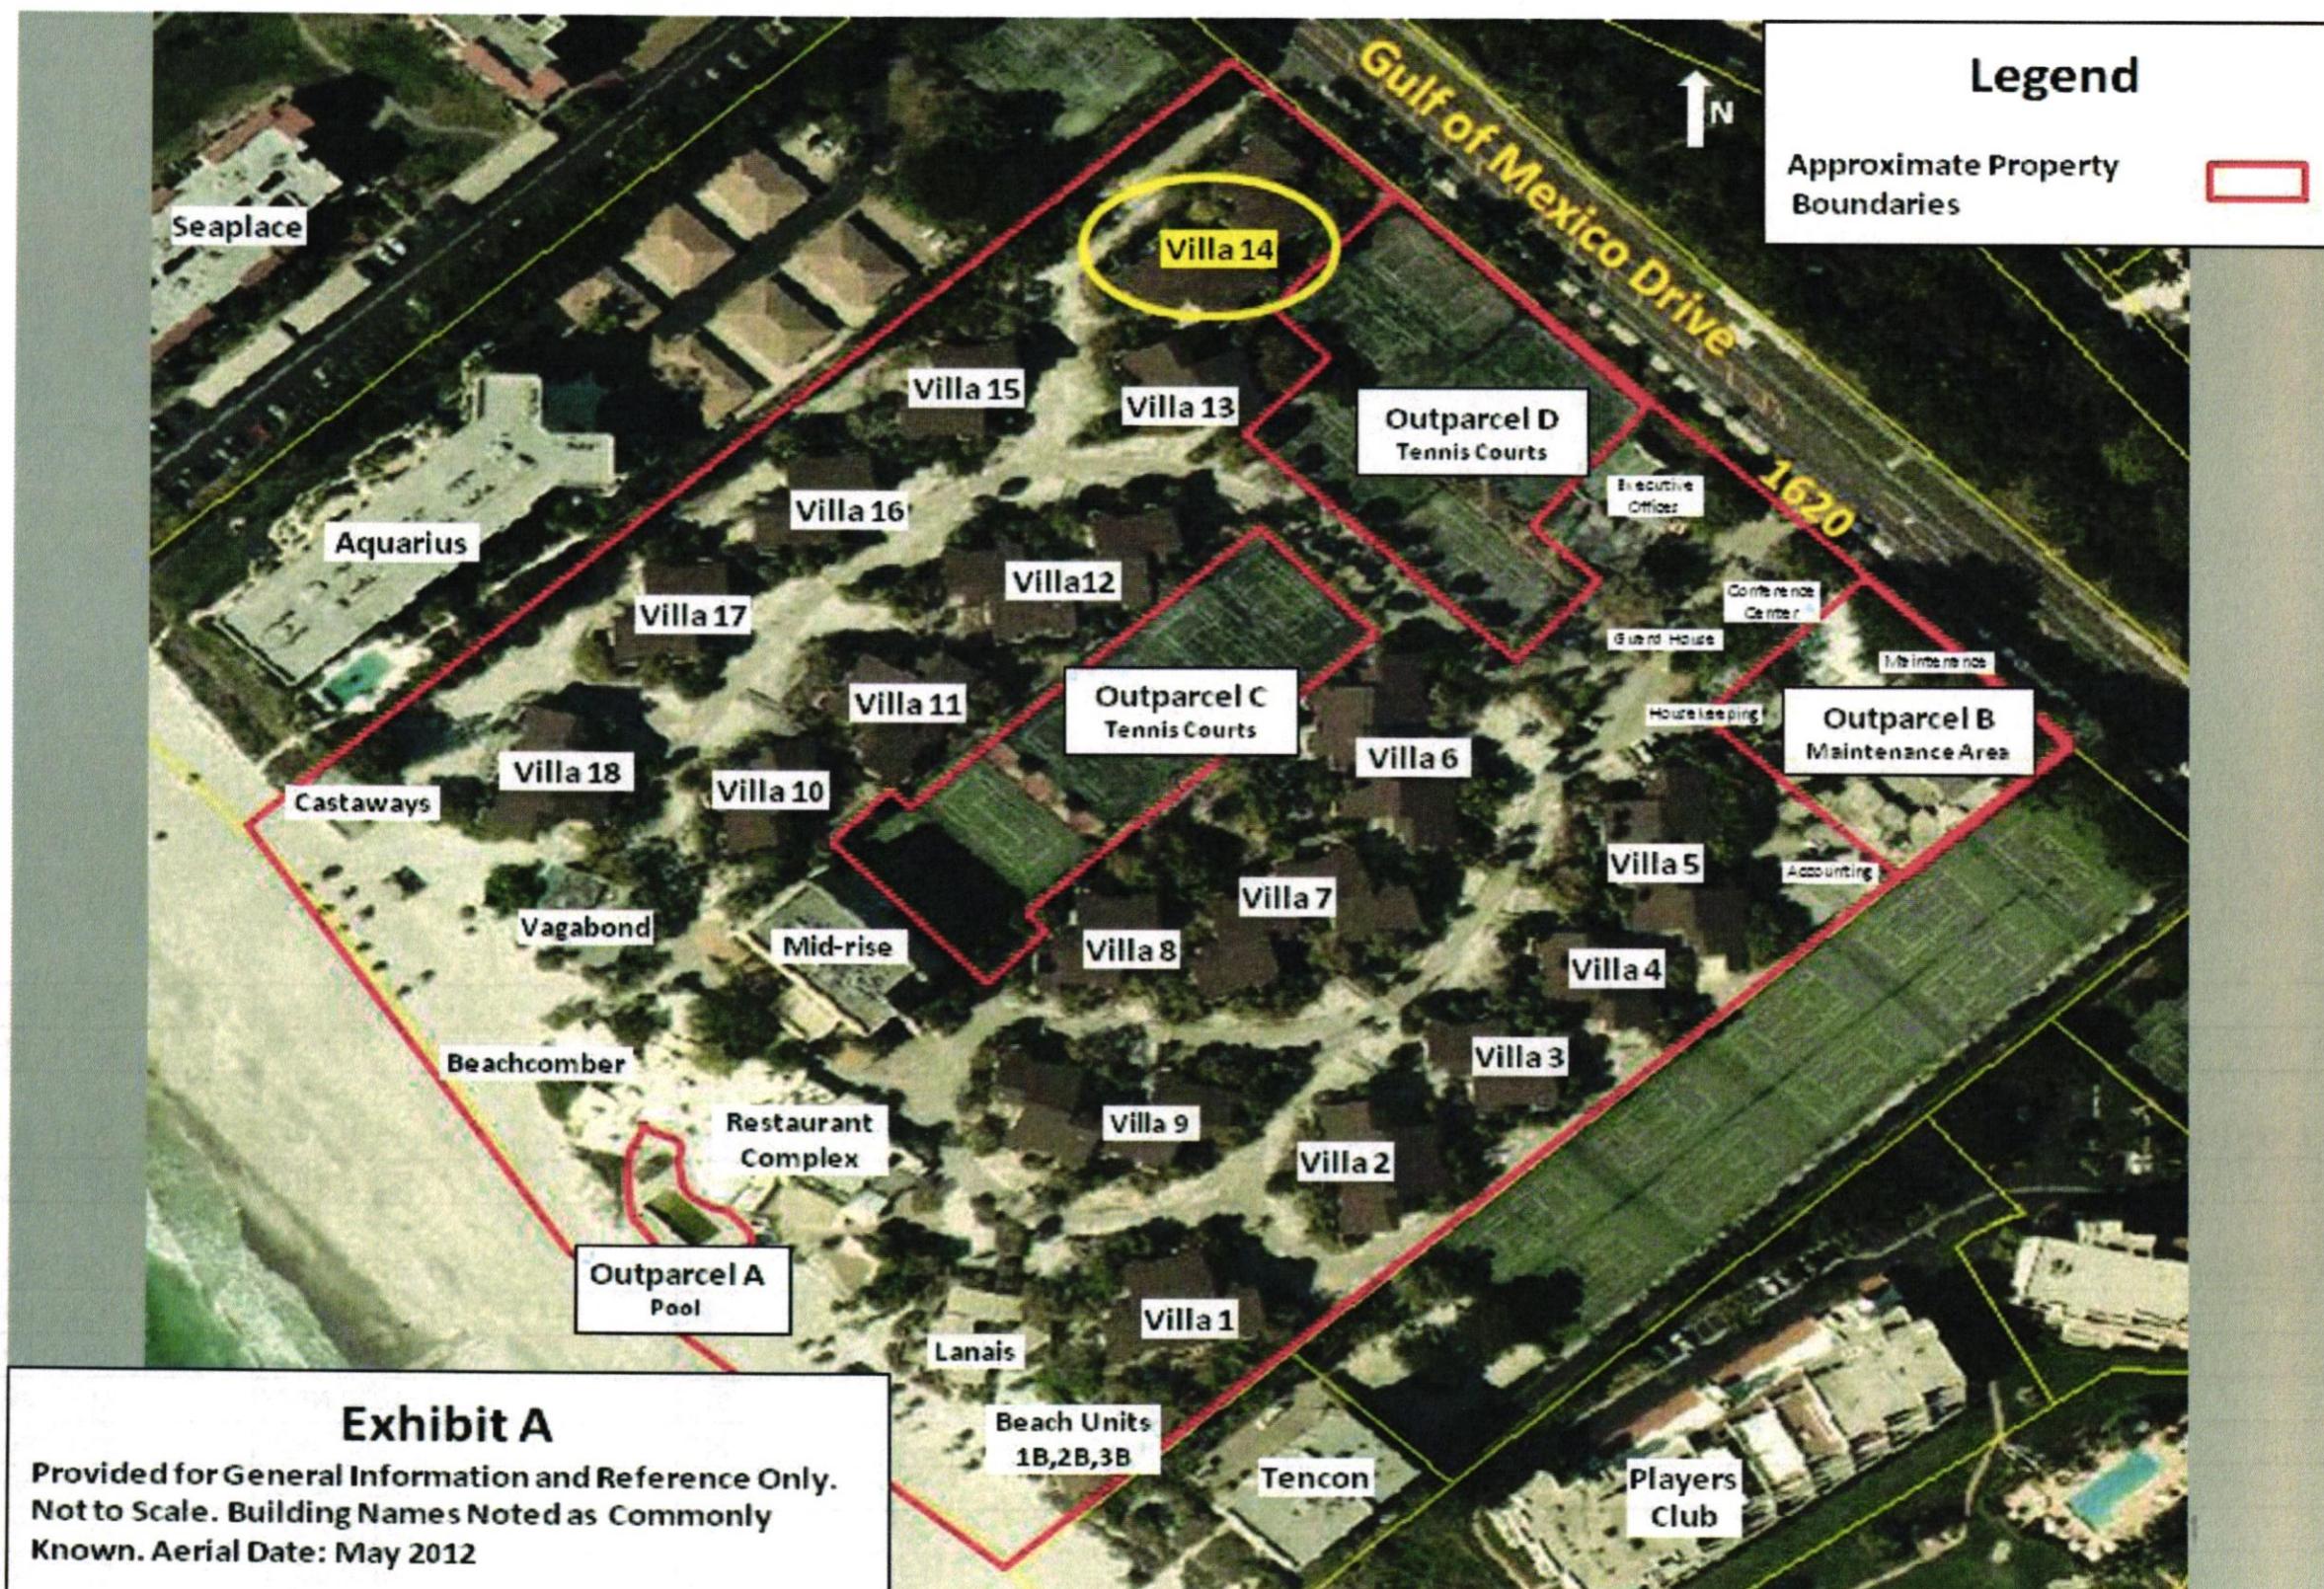
Cast iron building drains corroded and broken
Un-attended furniture/items on patios
Abandoned ac units under building.
Boarded up windows and doors due to vandalizing.
Air conditioning unit are beginning to fail. A/C unit may fall and have potential to have electrical issues as well as possible leaking of the refrigerant.
