ENGINEERING INSPECTION REPORT

THE COLONY BEACH and TENNIS RESORT

Longboat Key, Florida

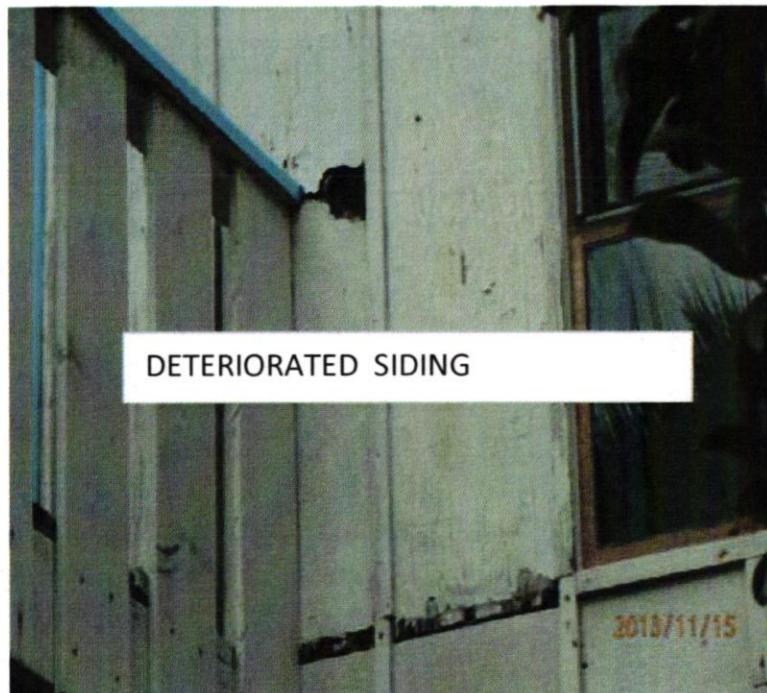
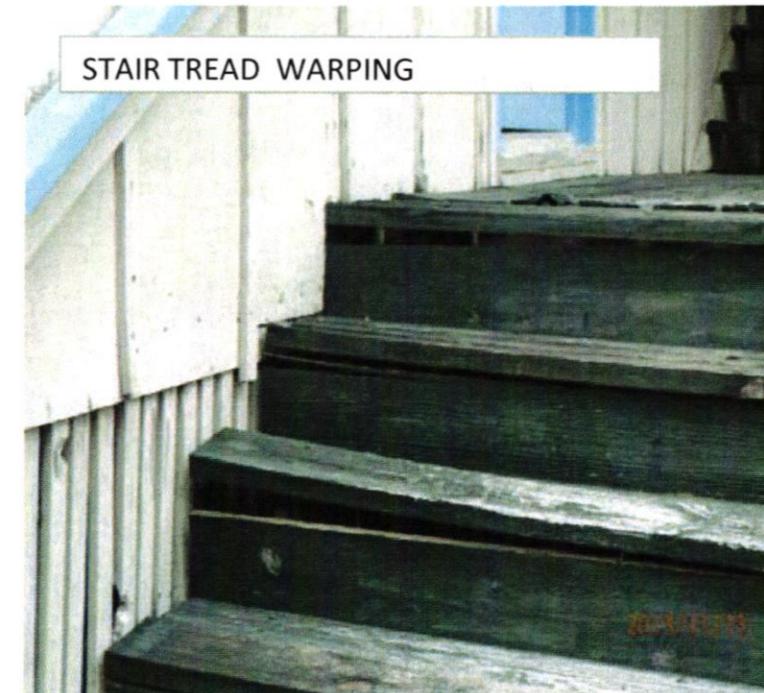
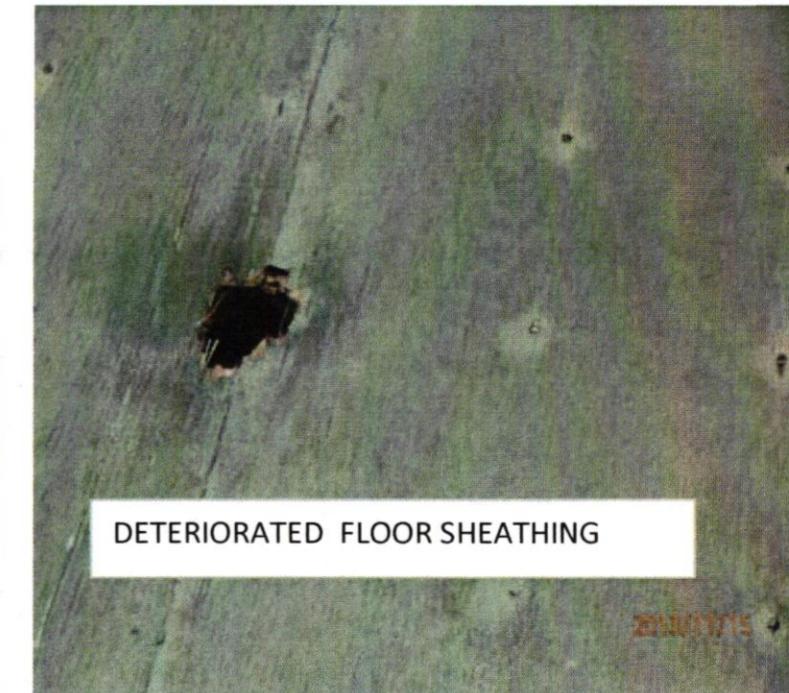
A/C unit stands.

Siding, trims, floor framing, wood shutters, fascia and soffits. The entry stairs and lower walkway show signs of failing to support. Railings pulling from walls. Railing missing balusters.

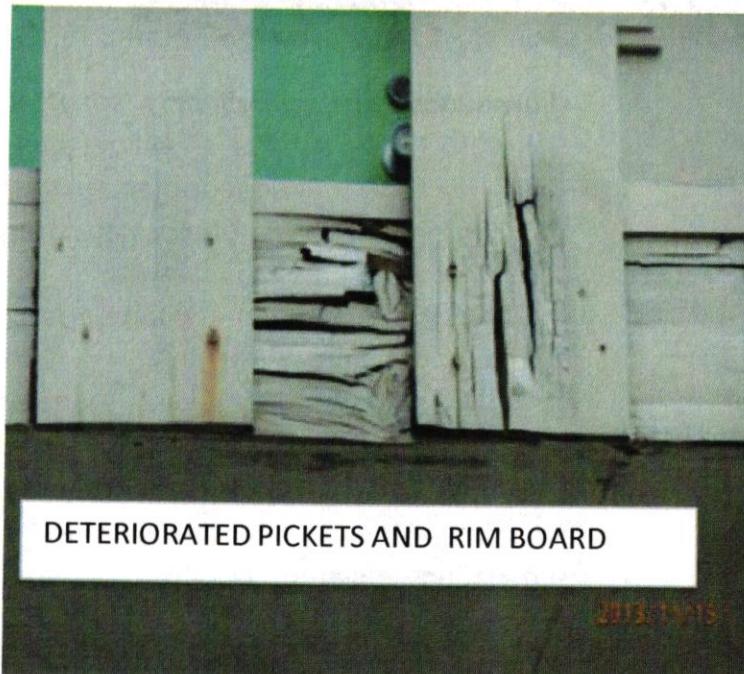
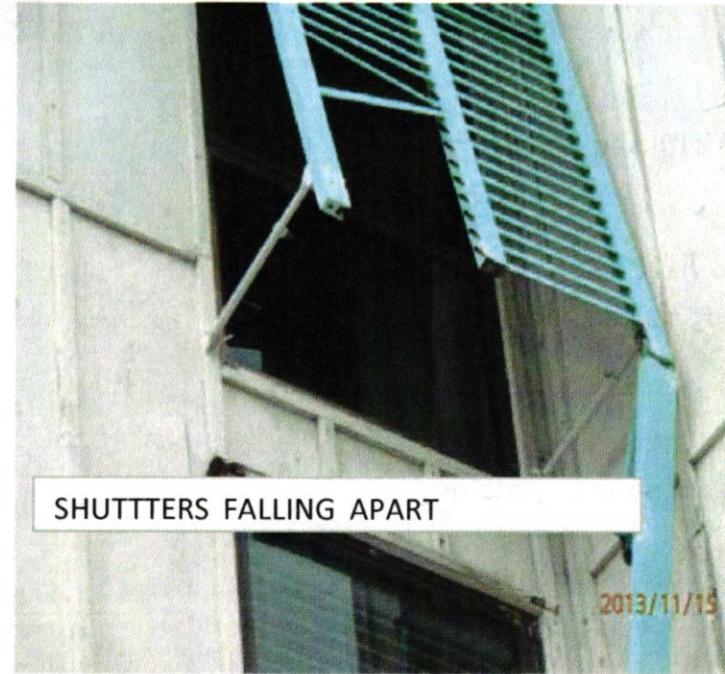
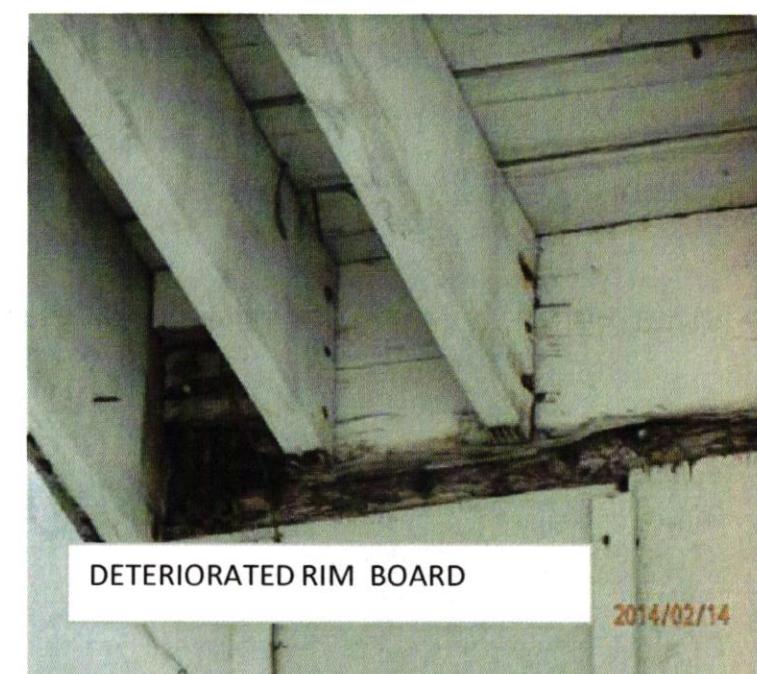
Siding, trims, floor framing, wood shutters, fascia and soffits. The entry stairs and lower walkway show signs of failing to support. Railings pulling from walls. Railing missing balusters.

Excessive cutting and notching

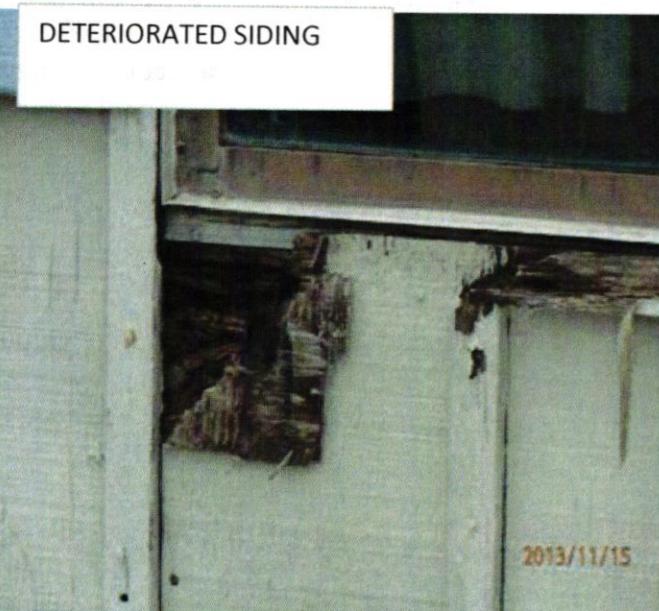
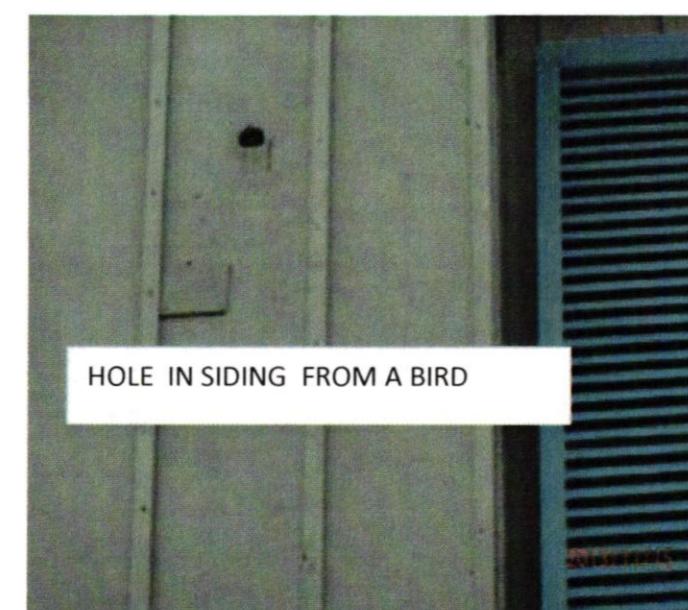
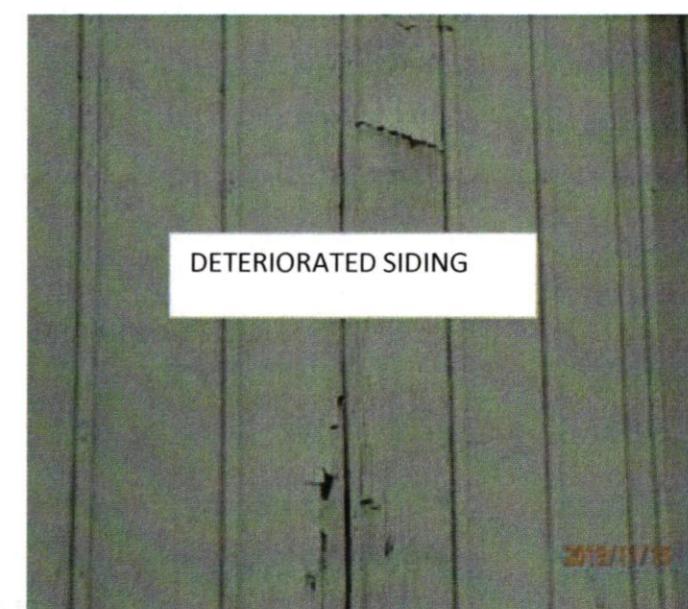
Post appears to not be supporting upper walkway. A/C unit stands

Siding, trims, floor framing, wood shutters, fascia and soffits. The entry stairs and lower walkway show signs of failing to support. Railings pulling from walls. Railing missing balusters.

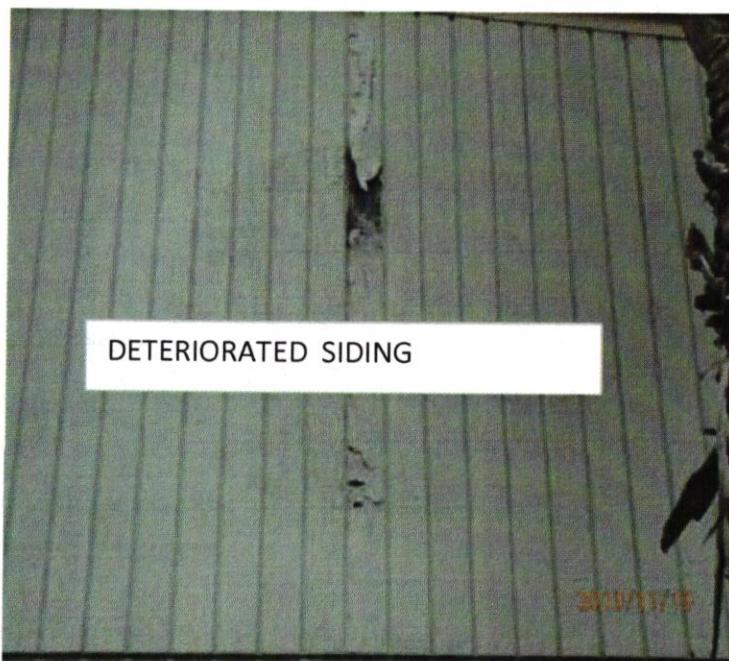
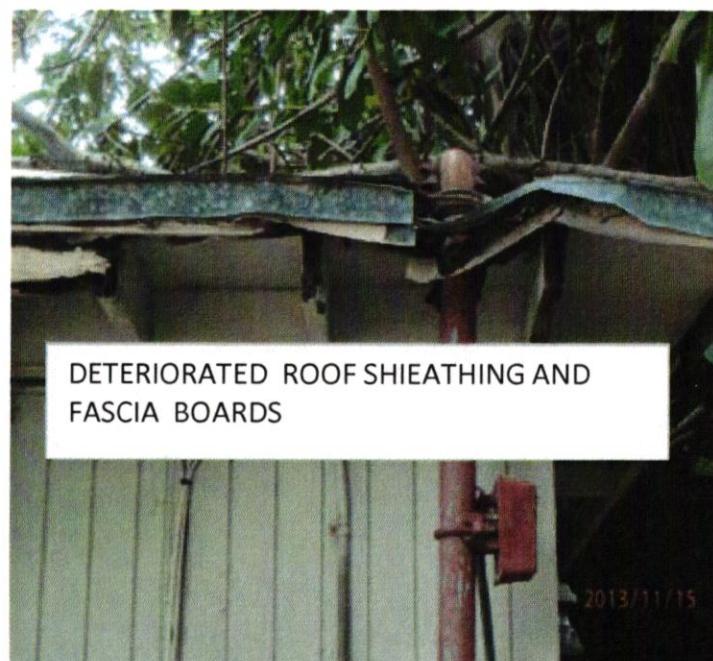
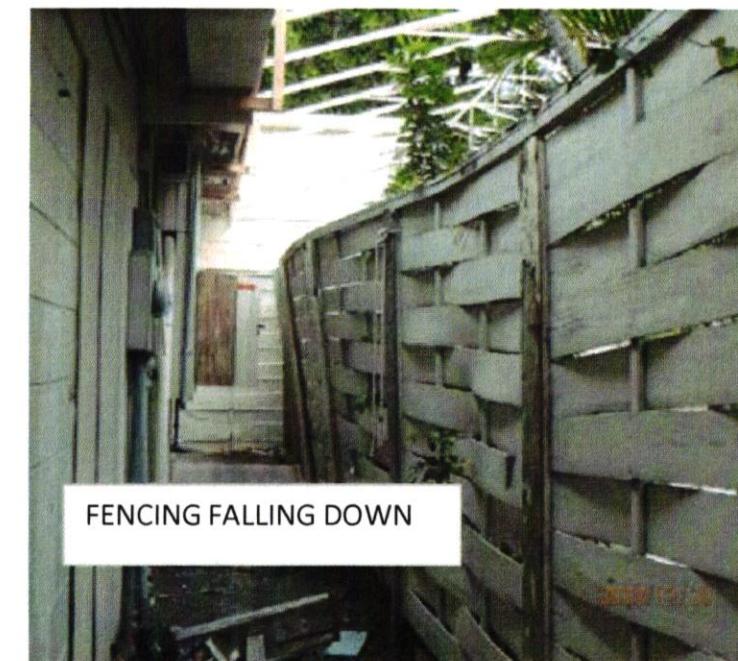
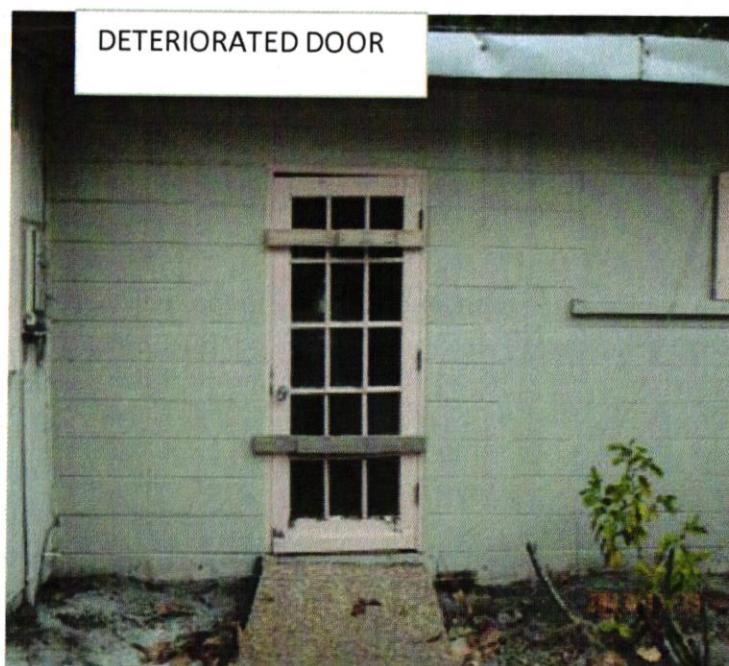
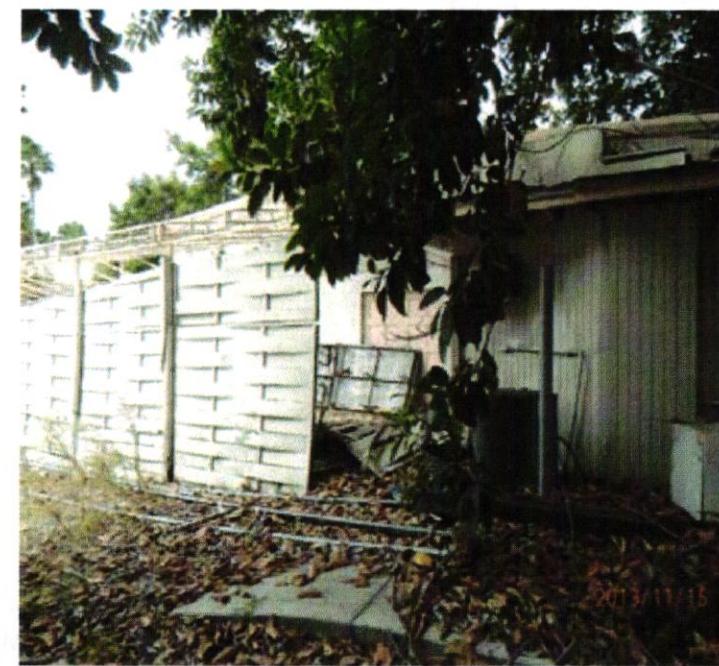
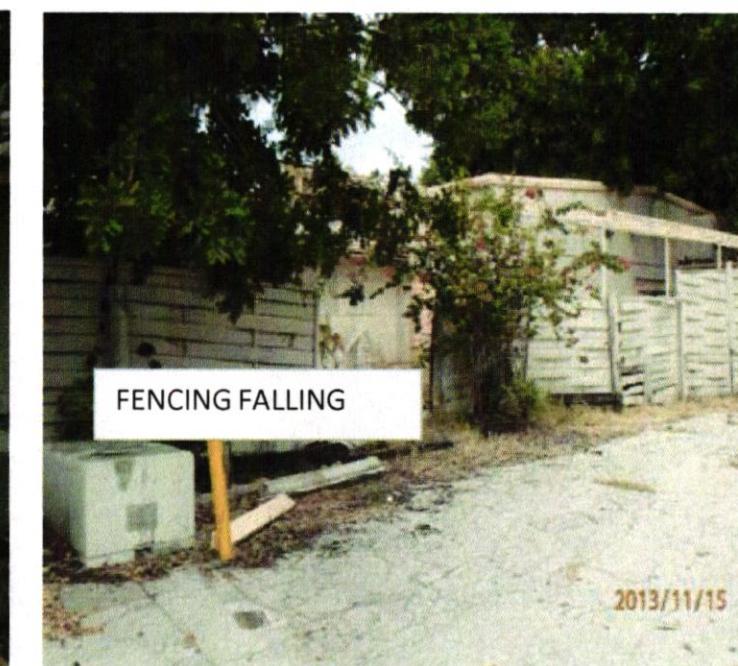
Roof sheathing. Siding, fascia boards, trims, doors, windows.

Signs of termite damage

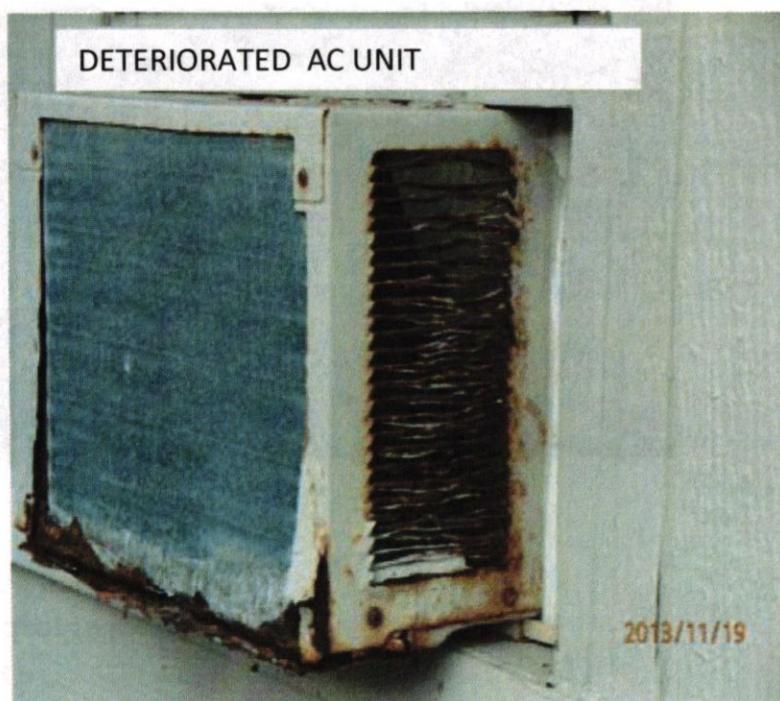
Air conditioner unit corroded beyond usefulness

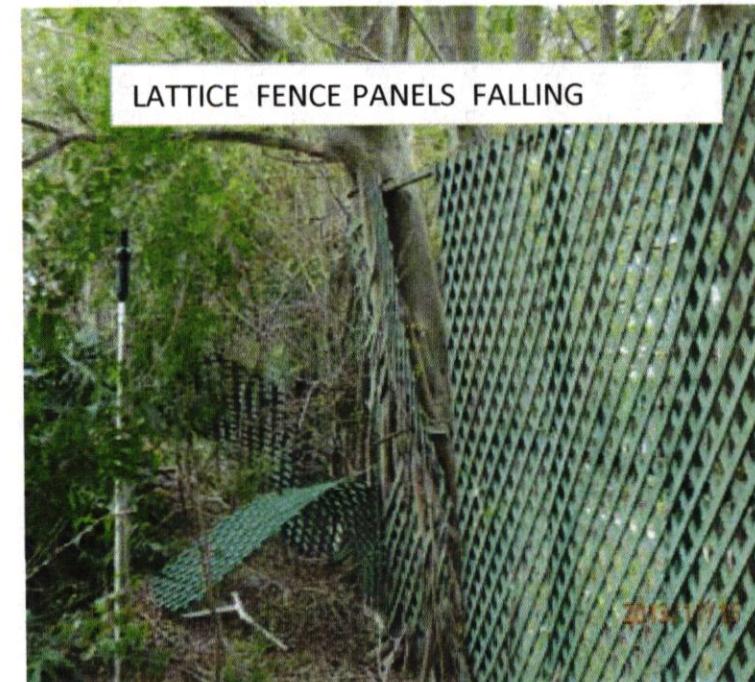
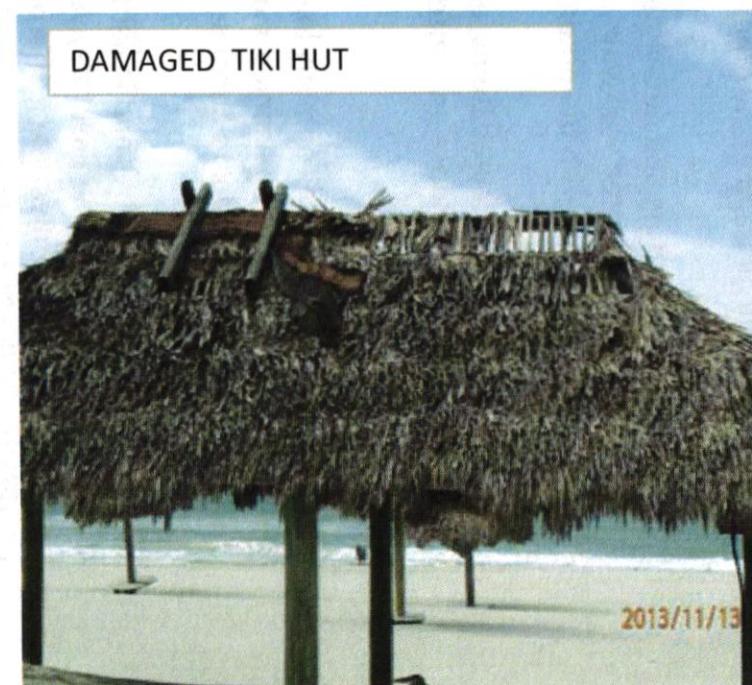
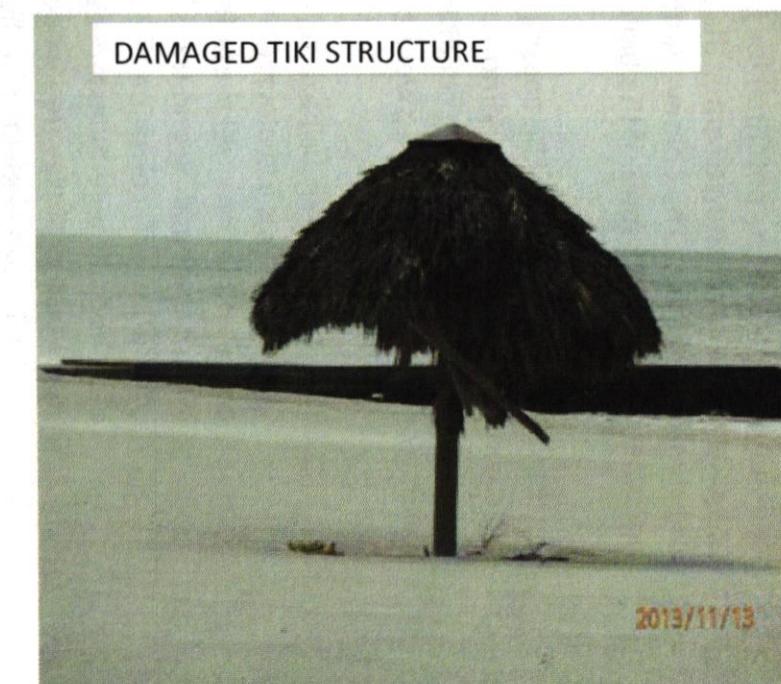
All ground level walkways and ramps have rotted wood, warp deck boards, rotted deck boards, and broken railings

Security fencing incomplete at some building. At first inspection appeared complete until an up close inspection was made. Some locations have had vandalizing requiring repair and or reset.
