S U M M A R Y R E P O R T

Date: May 07, 2012

SUBJECT: The Colony

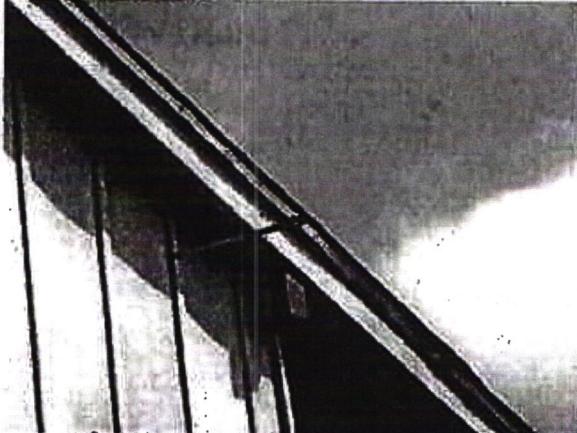
001 – Original roof flashing bent and mis-applied

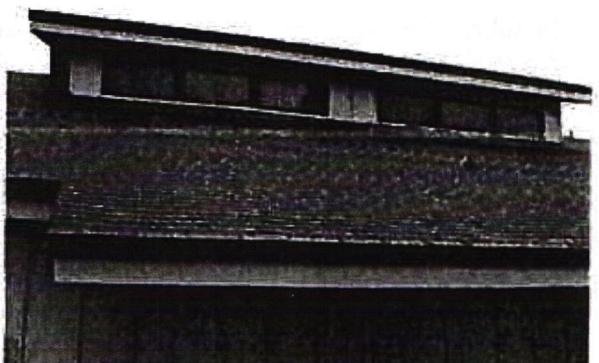
004 – Visible valleys in underlayment between joists @ roof

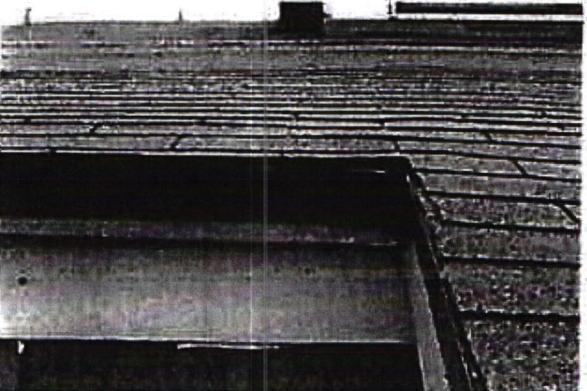
005 – Existing flashing, erratic cut-back @ shingles

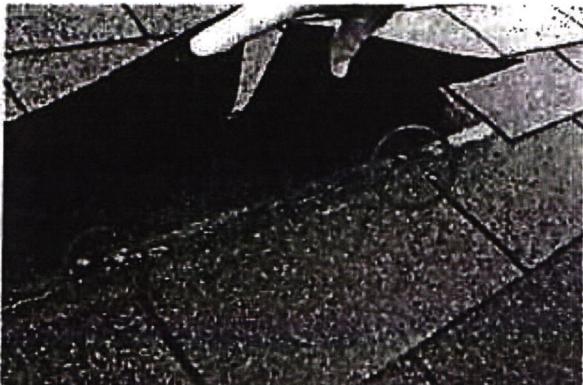
007 – Improper attachment of roof shingle

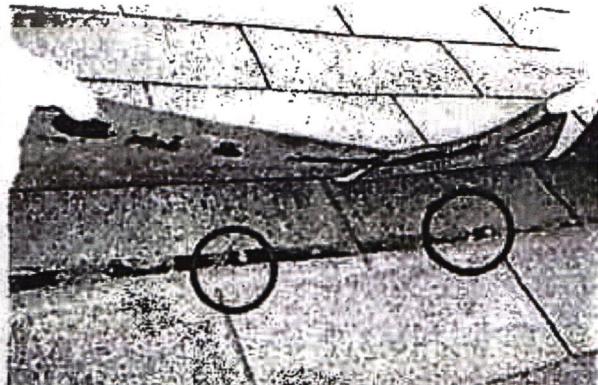
008 – Improper attachment of roof shingle

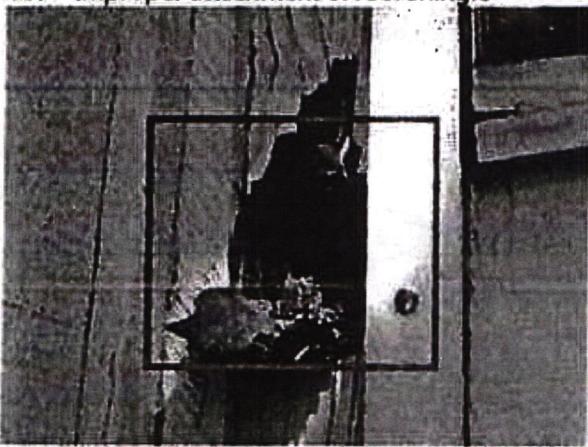
009 – Rotten wood and open hole in exterior siding

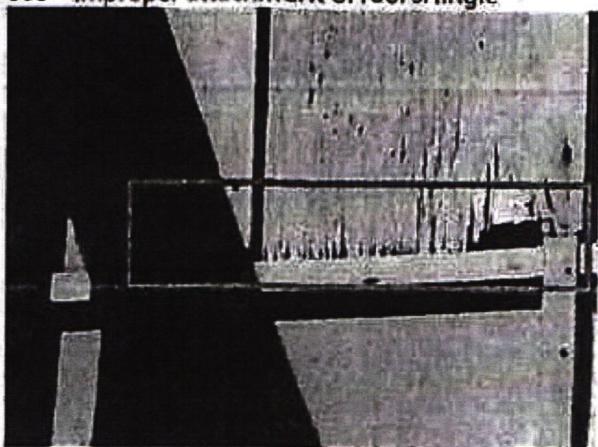
010 – Rotten wood and open hole in exterior siding

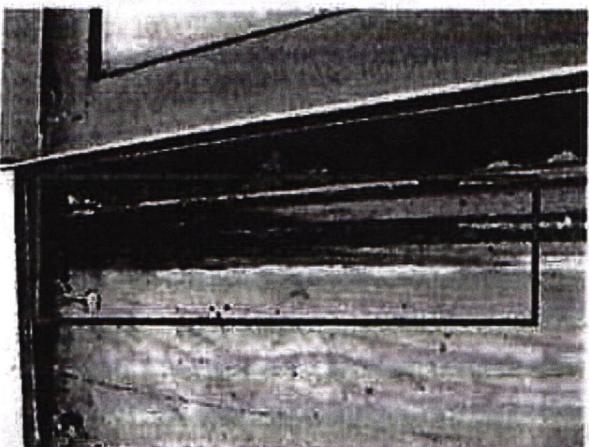
011 – Exposed rotten framing beneath window

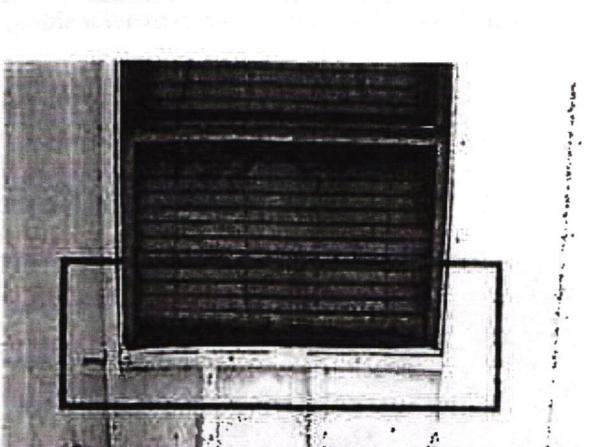
012 – Bowed framing and window caused by settling of framing members

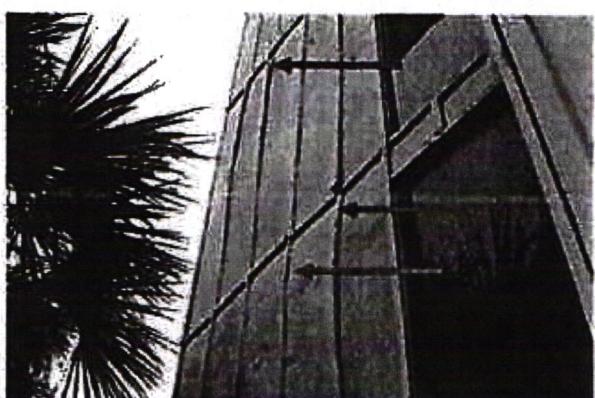
016 – Bowed exterior sheathing and loose battens

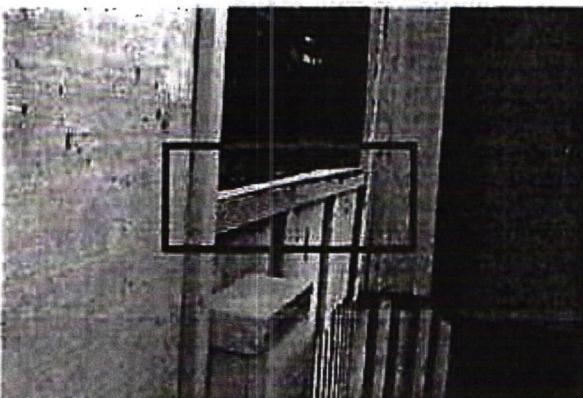
017 – Bowed window sill flashing, no sealant

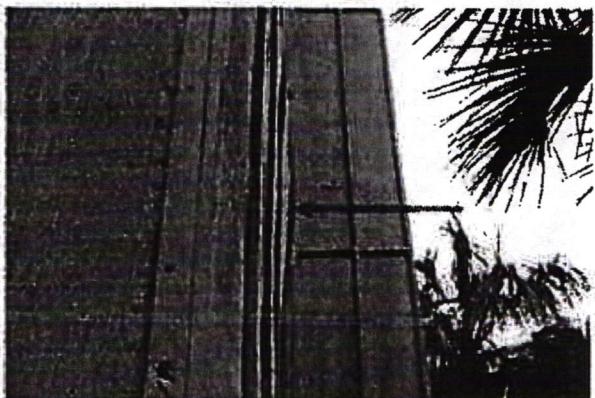
018 – Bowed exterior sheathing and loose battens

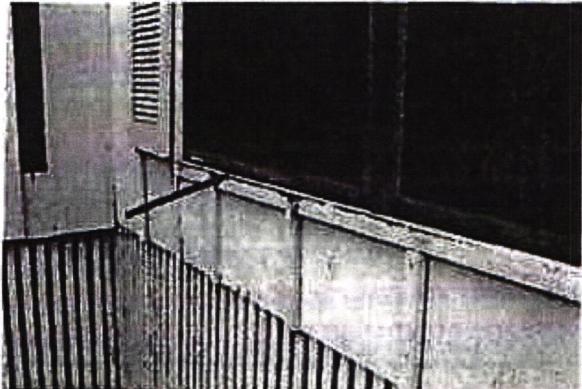
019 - Bowed window sill flashing, no sealant

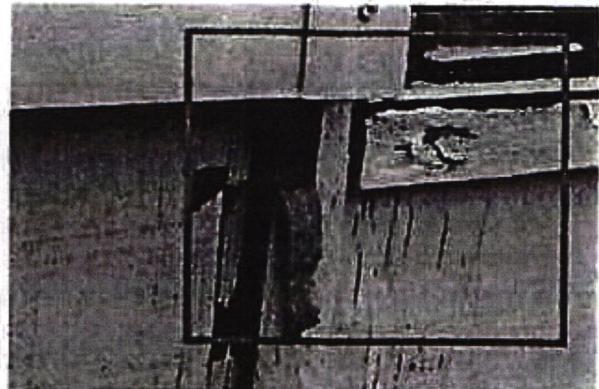
020 - Rotten wood siding beneath window

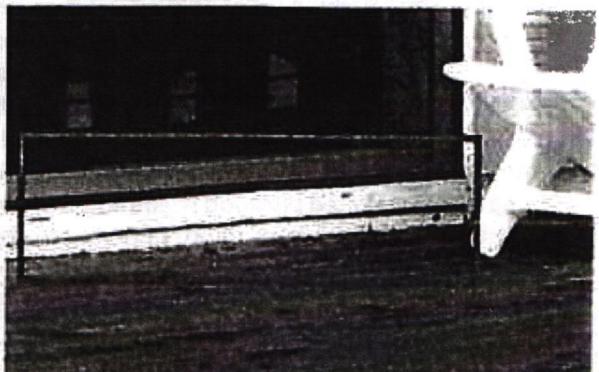
022 - Rusty fasteners and no sealant a sliding glass frame sill

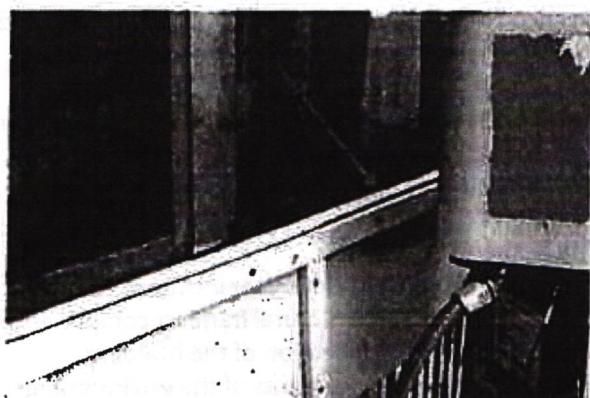
023 - Bowed window sill flashing, no sealant
