TOWN OF LONGBOAT KEY

Re: Town of Longboat Key Consent Order OGC 20-1261
Evaluation Summary

Technical Memorandum

Subject Longboat Key Sewer Leak Consent Order – Draft Evaluation Summary

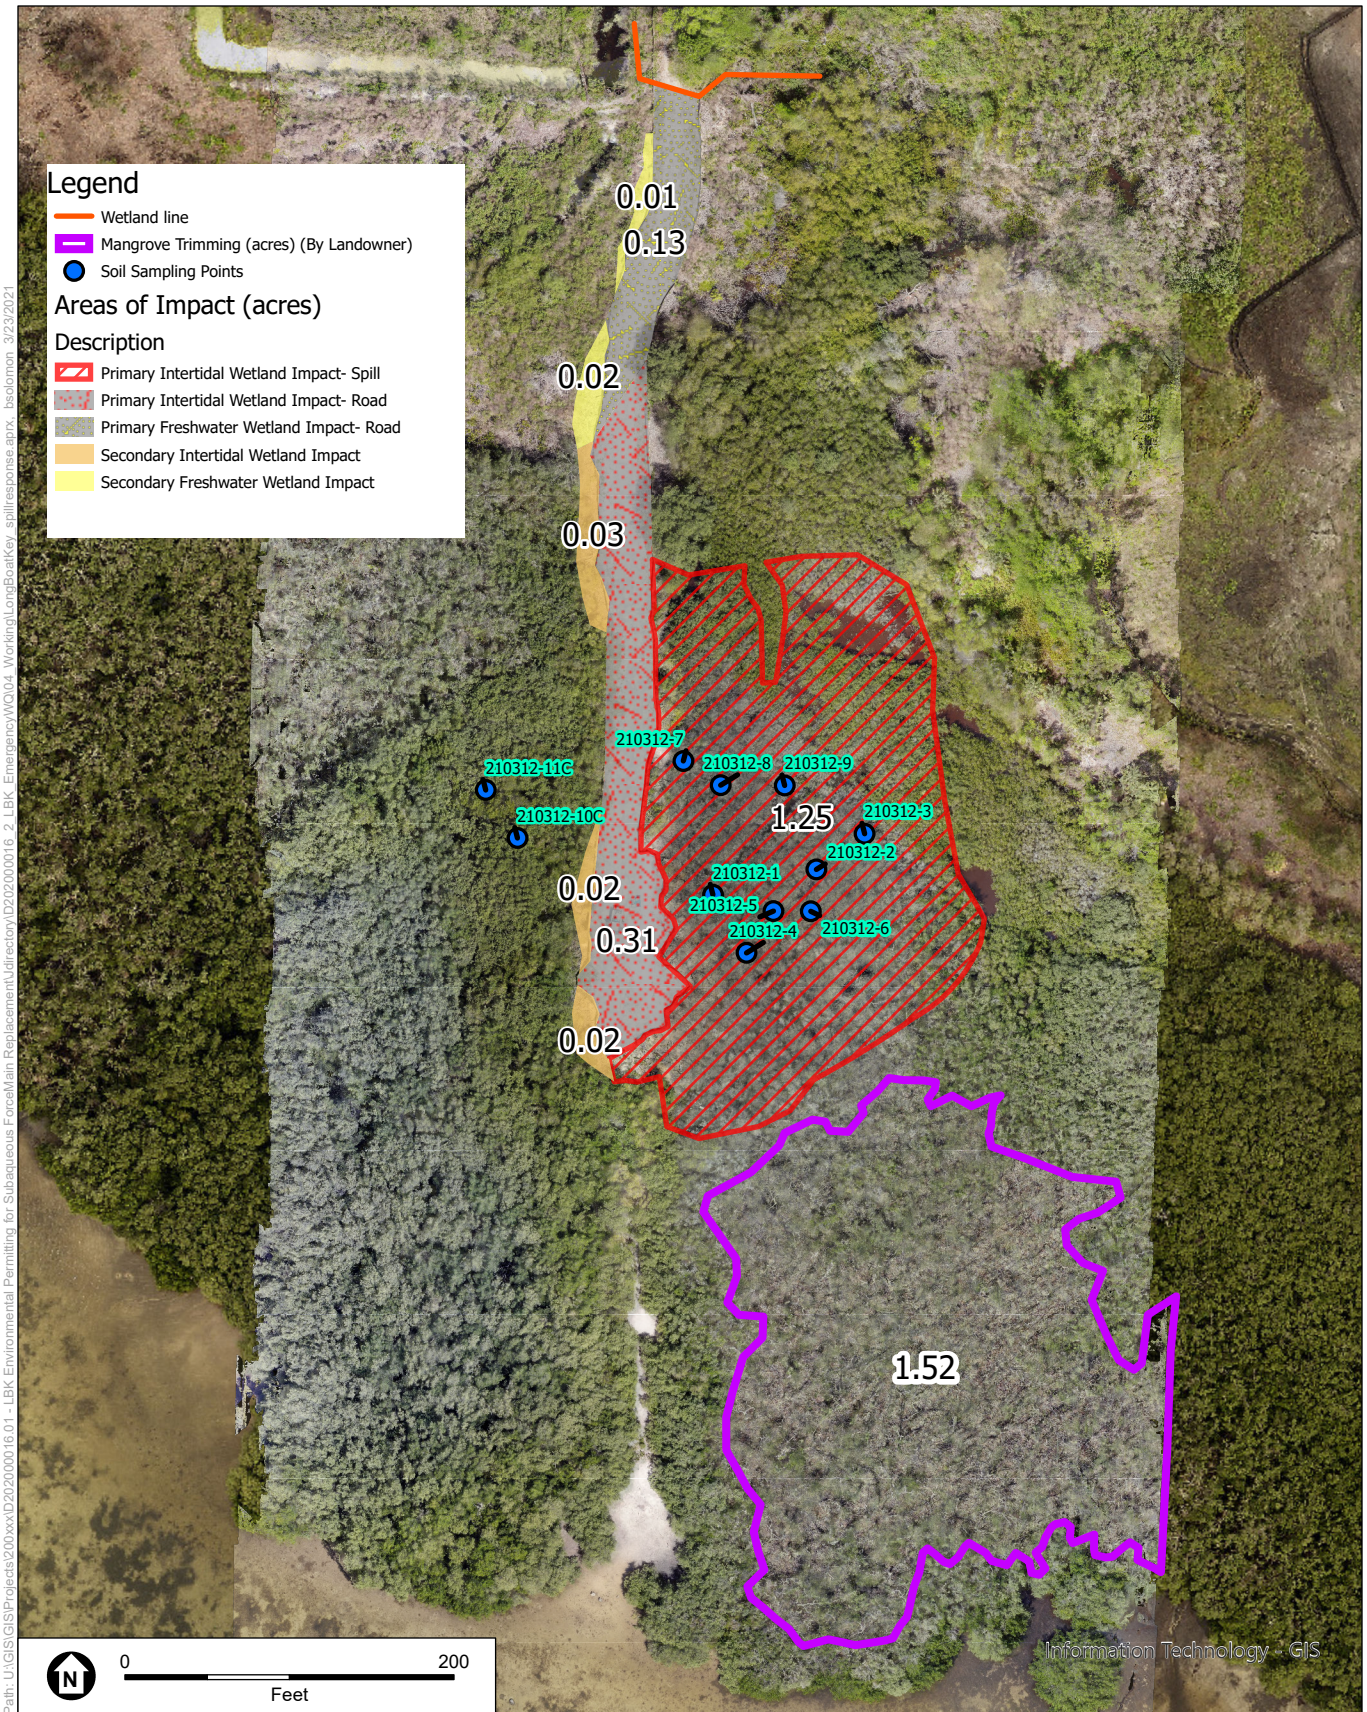
Figure 1 - March 12, 2021 UAV Drone Imagery

photographs were collected using the UAV drone. The signatures of the fill and sewage leak impact areas were clearly observed from the UAV drone's flight elevation. As of this writing the analysis of the topographic and the real-color and thermal signatures were still in process. **Figure 1** shows true color aerial imagery of entire impact area, as recorded on the March 12, 2021 UAV drone flyover.

An anomalous visual signature was observed south and east of the previously delineated sewage leak impact area, and is depicted on **Figure 1**. This area was traversed in the field and quickly determined to be mangrove trees that had been trimmed and/or topped, and not an expansion of the sewage leak impact area. **Figure 2** shows a photograph of trimmed/topped mangroves in this area. The Long Bar Pointe Mitigation Bank Permit issued by FDEP authorizes mangrove trimming in this area, and the observed tree mangrove topping work is presumed to be consistent with this permit.

The ESA field team collected nine (9) surface sediment core samples in the sewage leak impact area; two (2) control samples in adjacent un-impacted mangroves at the same elevation; and one (1) field equipment blank. The locations of where sediments samples were collected are shown in **Figure 1**. Within the sewage leak impact area an attempt was made to collect samples along three west-to-east transects to provide for a stratified-random sample station distribution.

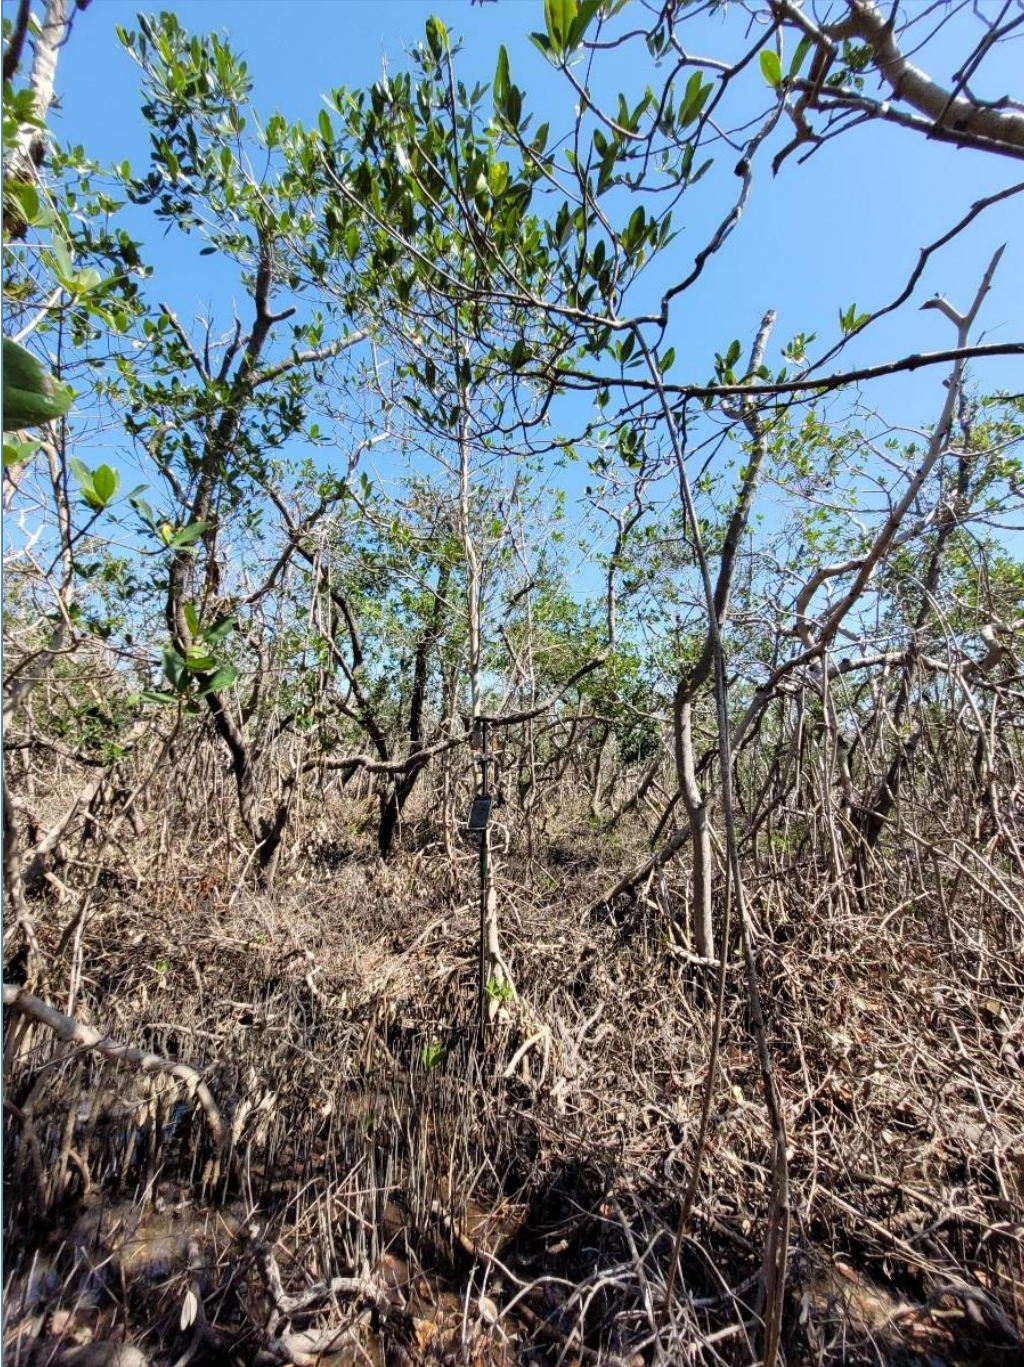
Figure 2 – Mangrove tree trimming/topping area southeast of the sewage leak impact area.

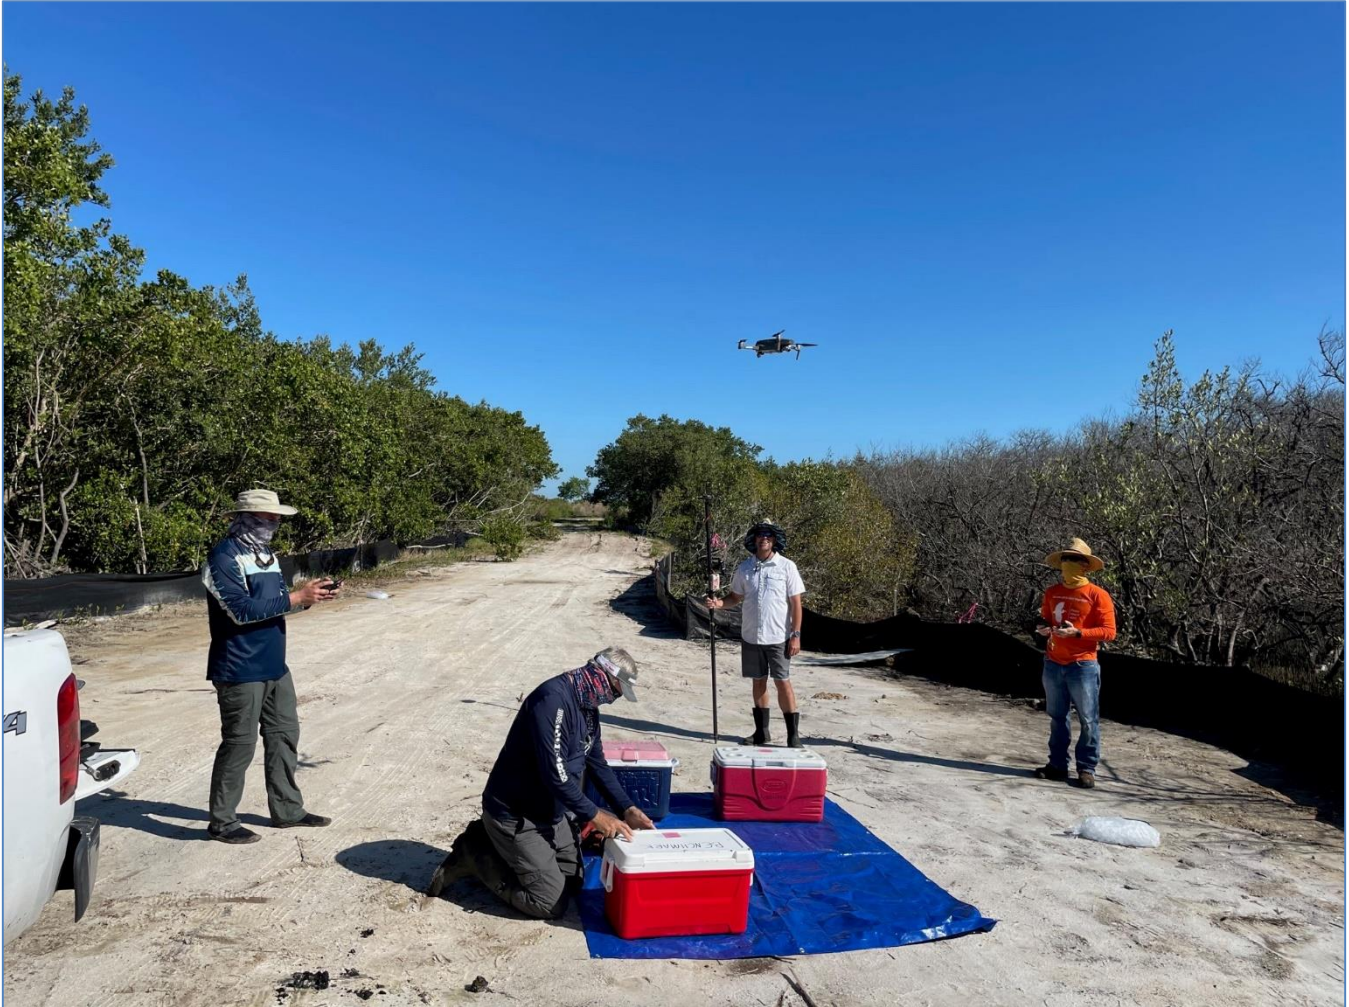
The ESA field team traversed the boundaries of the road fill/clearing and sewage leak impact areas, and tied flagging ribbon to delineate the impact area for later ground surveys of each impact area. Since the sewer force main leak was repaired in July 2020, there has been no additional fill or clearing in this area. The fill road remains open and non-vegetated. Some new mangrove seedlings were observed in portions of the peripheral areas that were cleared but not filled. **Figure 3** shows the fill road, and the ESA field team with the UAV drone in operation.

Figure 3 – ESA field team mobilizing on the access fill road with the UAV drone in flight.

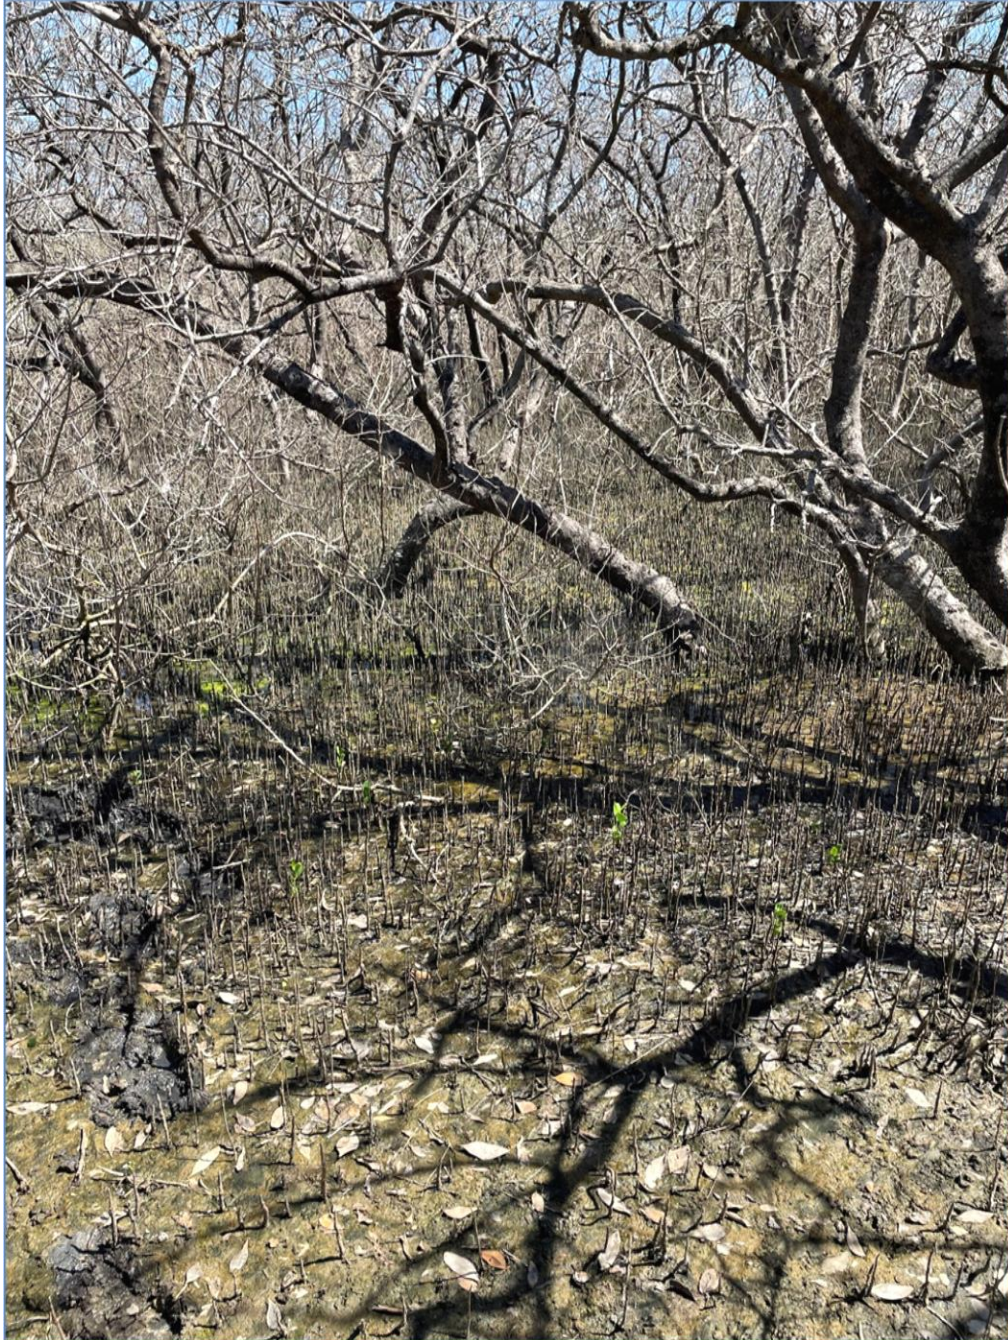
The limits of the sewage leak impact area appeared to be unchanged from that observed in September 2020 when ESA conducted the initial impact assessment. While traversing the sewage leak impact area, a Sulphur-like odor was detected, and portions of this area had a thin algal mat on the sediment surface. Virtually all mangrove trees within the center of the sewage leak impact area were dead or fully defoliated, and there was no indication of tree recovery, no recruitment of new mangrove seedlings, and no viable mangrove propagules in the majority of this area (**Figure 4**). There was also no growth or recruitment of halophytic herbaceous plant species (which often occurs in treefall or canopy loss gaps in mangrove forests) in the sewage leak impact area.

Based on the activities and observations described above, ESA concludes that there has been no expansion of the sewage leak mangrove impact area since the initial assessment was conducted in September 2020. However, there has also been little or no natural recovery of this area. It is not clear if natural recovery is being stalled by poor hydrology (lack of efficient tidal circulation and flushing), contaminated sediments, or a combination of both factors.

The sewage leak impact area appears to be a slightly lower, semi-isolated depression within a larger black mangrove forest basin. A portion of the dead mangrove area was shrub black mangroves adjacent to a small open water pool. This pool and the larger sewage leak impact area does not appear to have frequent or efficient tidal circulation or flushing. Evidence for this is the filamentous algal mat on the sediment surface, and the lack of mangrove propagules in this area.

Figure 4 – Sewage leak mangrove impact area.

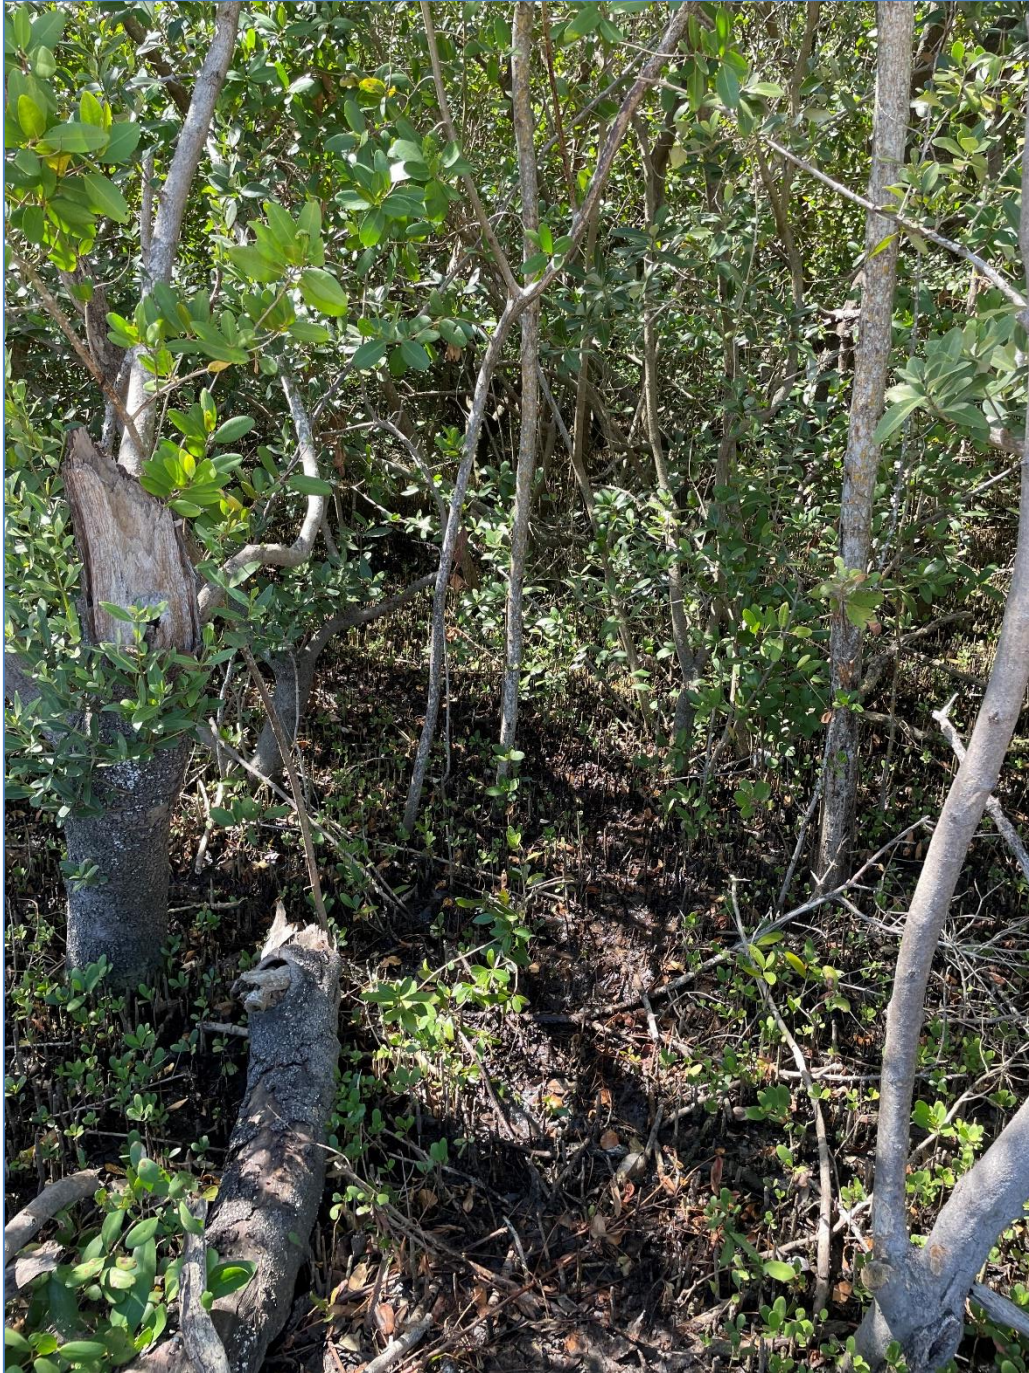
Compared to the un-impacted mangroves immediately west of the fill road (**Figure 5**), the sewage leak impact area was completely defoliated with no canopy cover and few or no healthy pneumatophores. Some smaller mangrove trees on the periphery of the sewage leak impact area, mostly on slightly elevated hummocks, did appear to be recovering with new leaves observed (**Figure 6**). The boundary between the sewage leak impact area and adjacent live mangroves could be clearly seen, both on the aerial imagery and on the ground (**Figure 7**).

Figure 5 – Un-impacted mangrove control area.

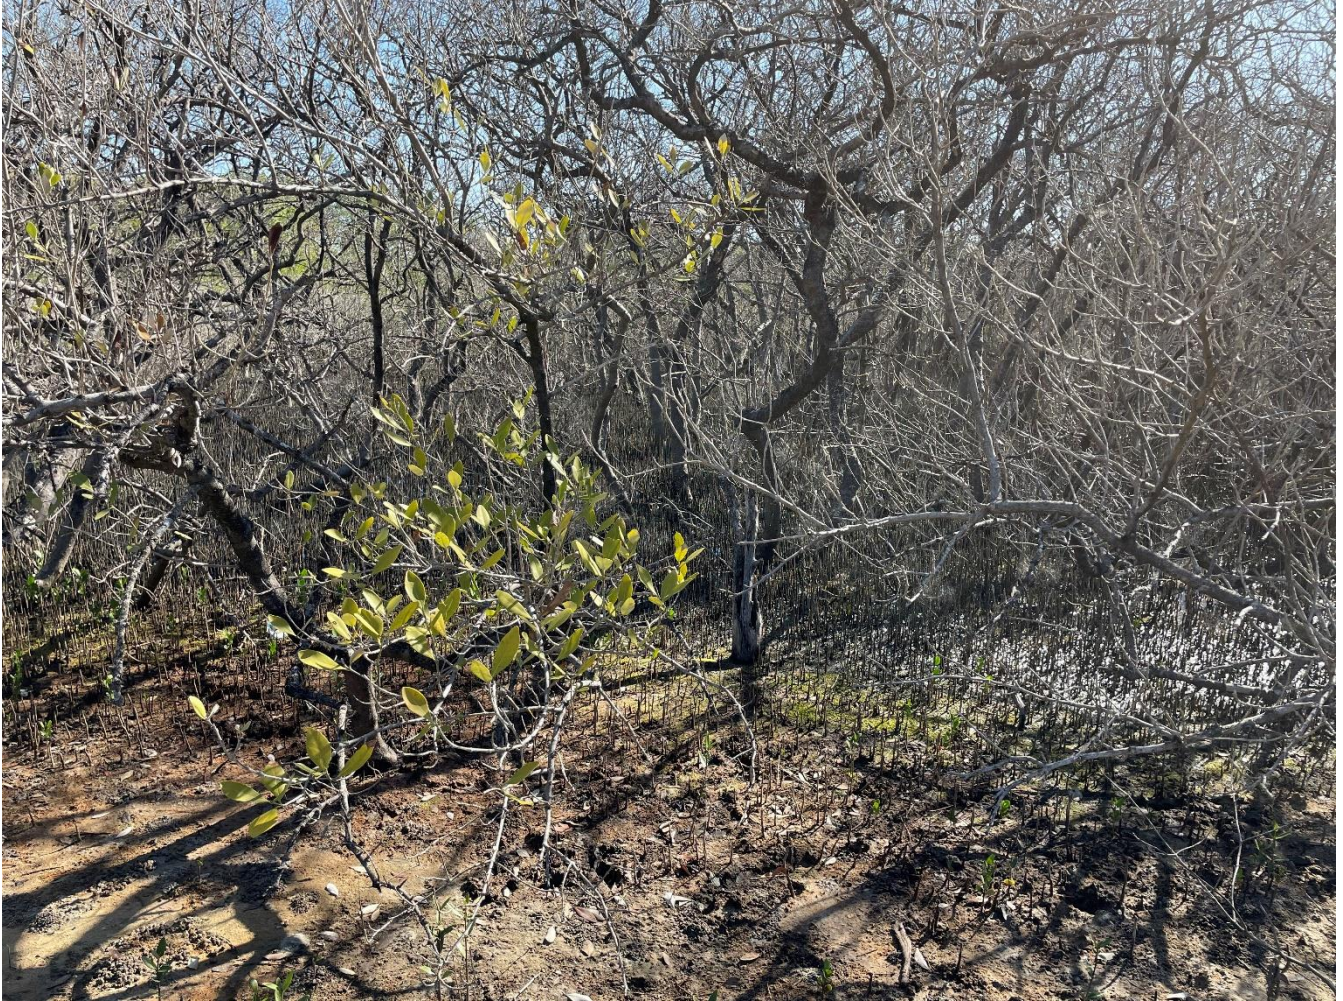
Figure 6 – Recovering mangrove is sewage leak impact area.

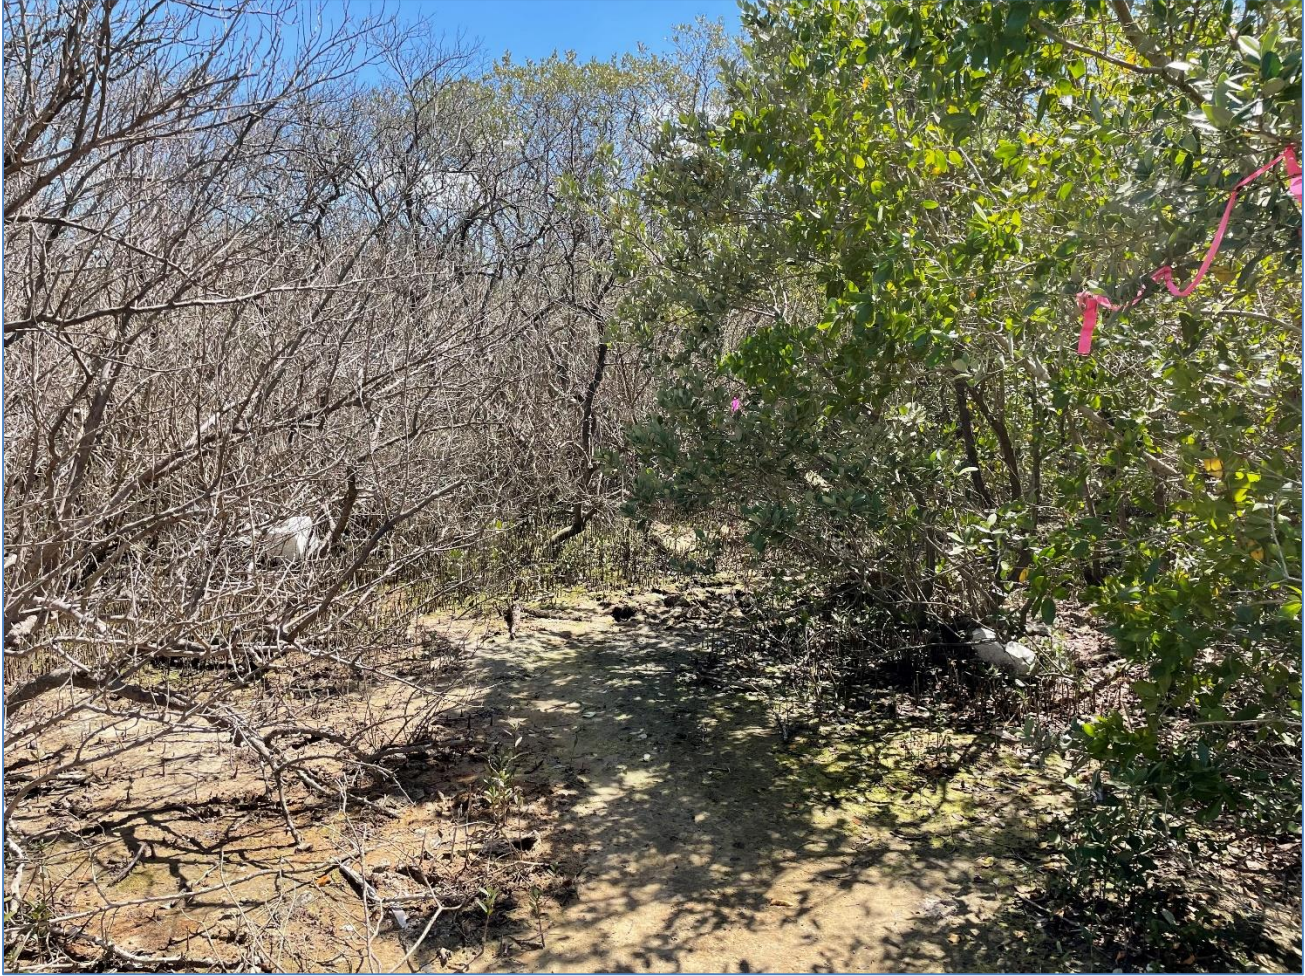
Figure 7 – Boundary of sewage leak impact area and un-impacted mangroves.

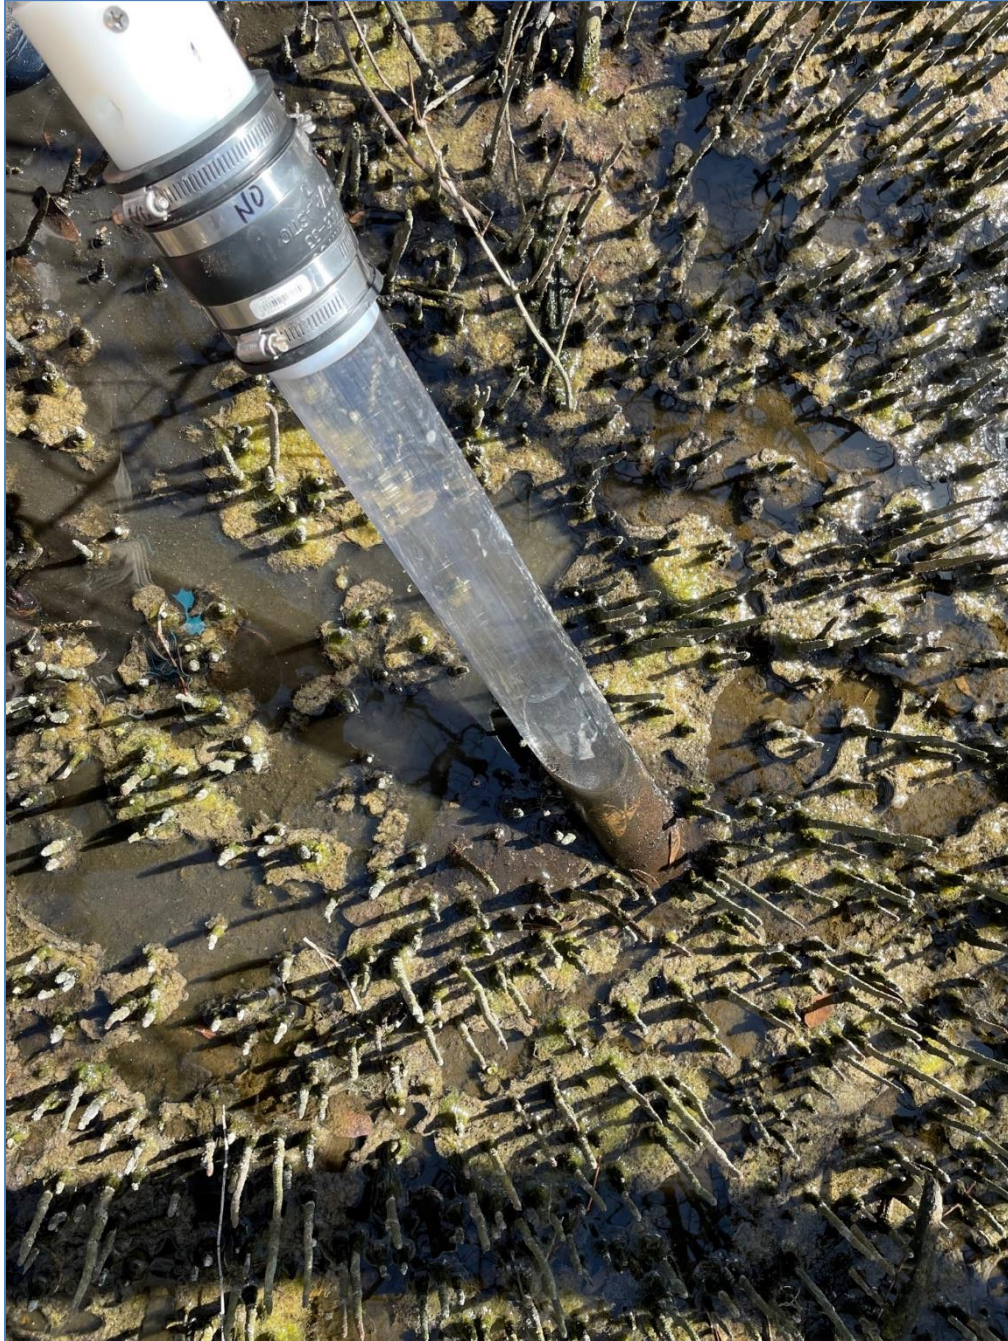
Sediment samples were collected using a 3-inch diameter polycarbonate suction sediment corer, as shown in **Figure 8**. The coring device was pushed into the surface sediments, between mangrove pneumatophores where feasible, until resistance was attained. Each sample typically collected the top 6-8 inches of sediments. Each sediment core sample was generally a mixture of: 1) wet black muck; 2) dense dark brown fibrous peat; 3) decomposing mangrove roots and pneumatophores; and 4) larger living and recently dead mangrove roots and pneumatophores. At each sampling location 2-3 core samples were composited and mixed in a clean metal bowl. Sample containers were then filled with the mixed sediment material. The sediment samples were immediately delivered to Benchmark Environmental Analytical Laboratory in Palmetto, Florida, for analysis. The parameters to be analyzed include:

Figure 8 – Sediment corer with sample from sewage leak impact area.
