Re: Bay Isles Parkway Divestiture and Conveyance for the  
Eastbound Rampway to SR 789 Pedestrian Tunnel

*The Proposed Conveyance for the  
Eastbound Rampway to SR 789  
Pedestrian Tunnel and All  
Infrastructure Assets from  
Bay Isles Parkway to the  
Town of Longboat Key*

TO: Commissioners of the Town of Longboat Key  
FROM: Bay Isles Association, Inc.  
SUBJECT: Proposed Conveyance for the Eastbound Rampway to SR 789  
Pedestrian Tunnel and All Infrastructure Assets

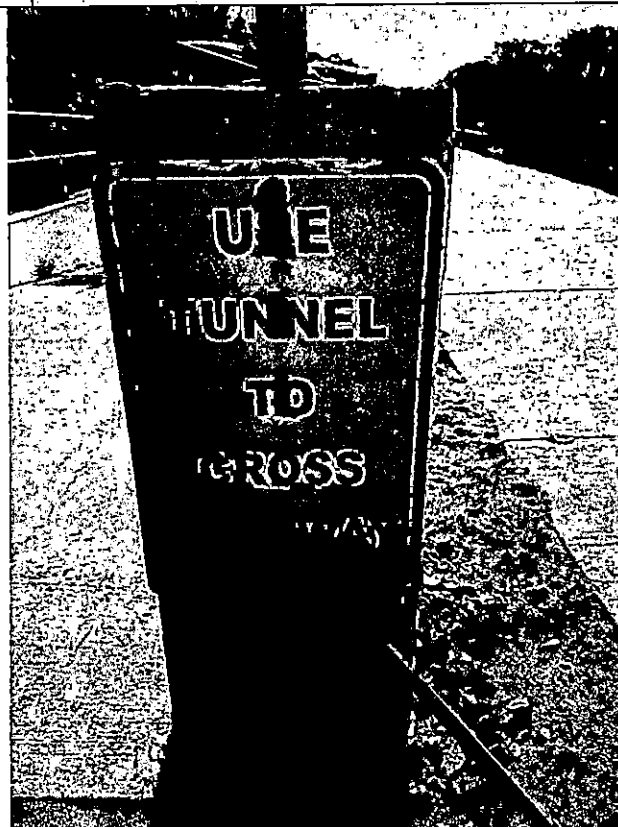
PHOTO 14	DESCRIPTION	NORTHEAST PEDESTRIAN CROSSING SIGN. CORRODED BOLT AT THE TOP. MISSING BOLT AT THE BOTTOM
----------	-------------	---

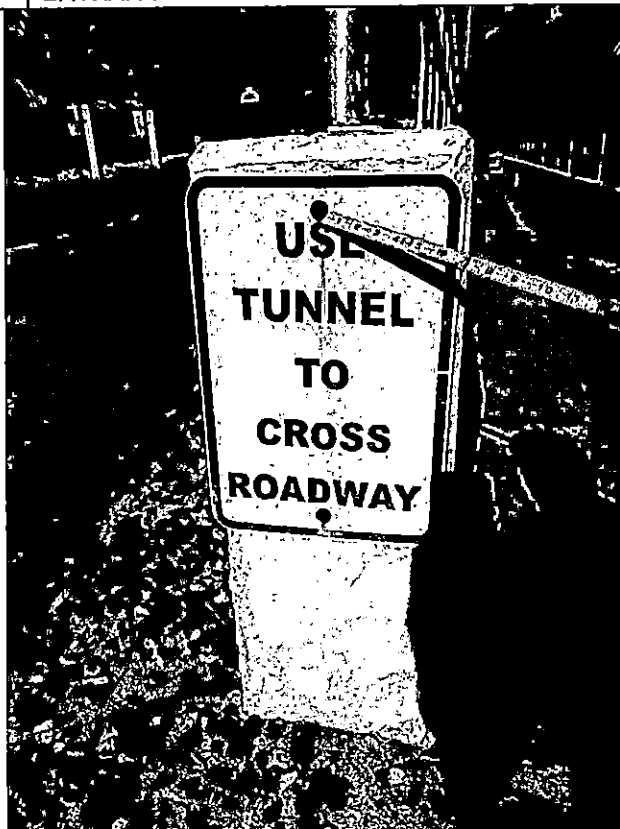
PHOTO 18

SOUTHEAST PEDESTRIAN CROSSING SIGN. CORRODED BOLTS TOP & BOTTOM

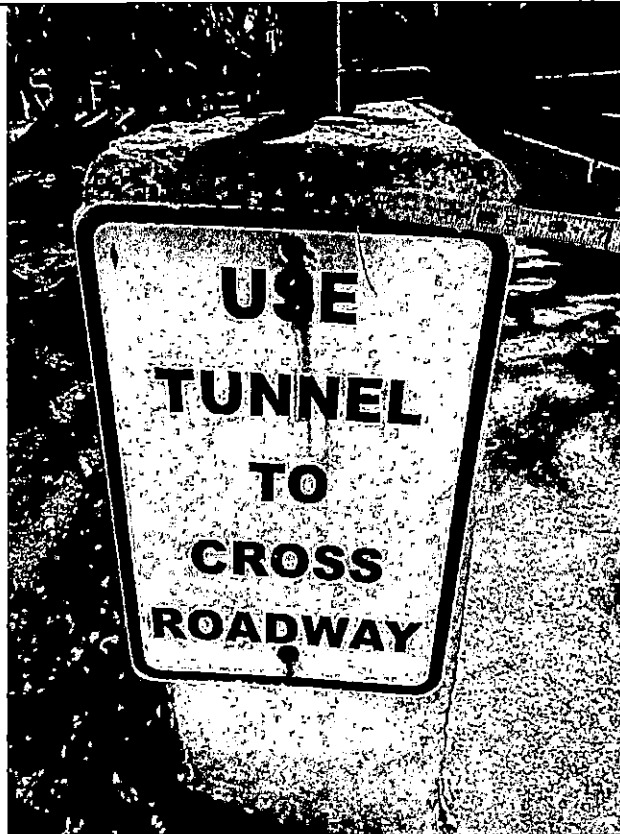
PHOTO 37	DESCRIPTION	TUNNEL ENTRANCE SIGN AT NORTHWEST ENTRANCE CORRODED BOLTS
----------	-------------	---

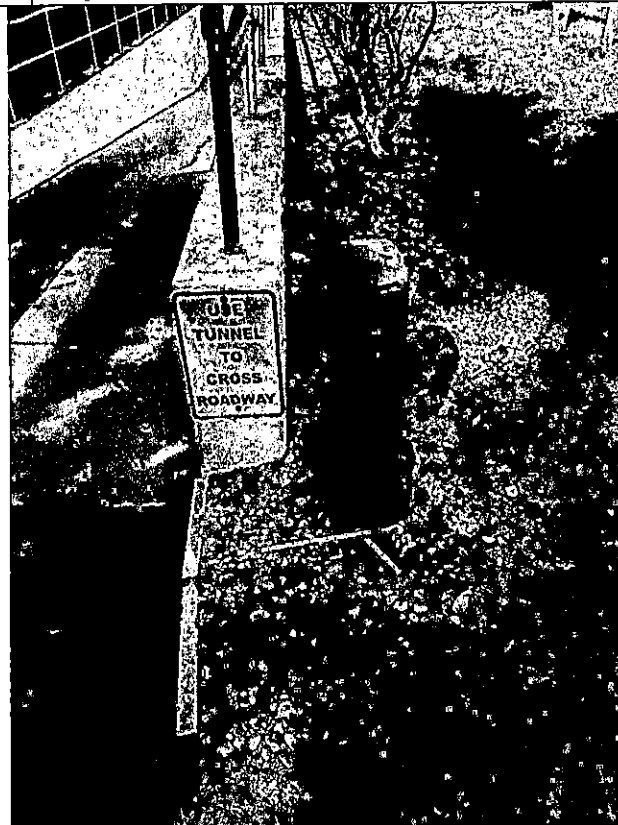
PHOTO 42	DESCRIPTION	SOUTHWEST - PEDESTRIAN TUNNEL SIGN. CORRODED BOLTS. UTILITIES
----------	-------------	---

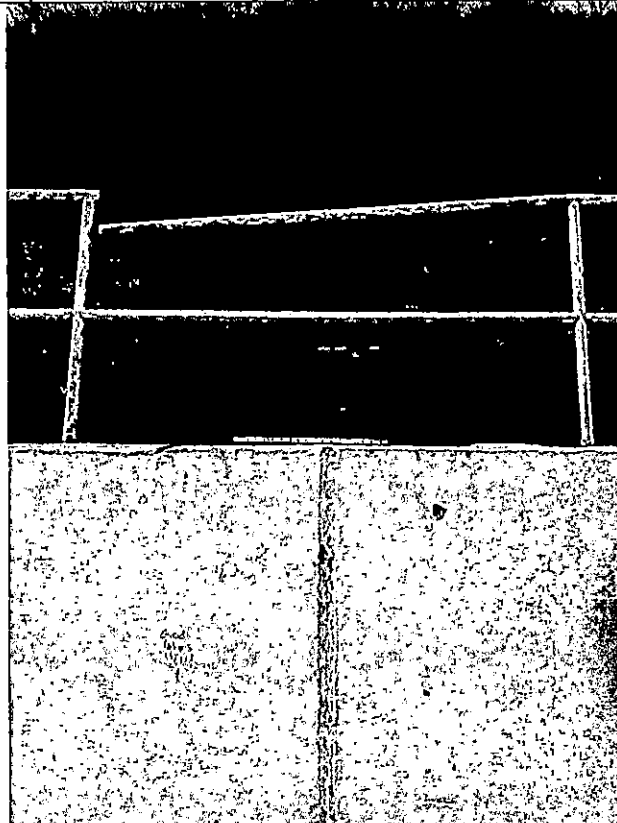
PHOTO 46

Pedestrian railings are also present on adjacent retaining walls, of which five horizontal rails were damaged on the west retaining wall (Photo 46).

WEST ELEVATION - RAIL DAMAGE AT RETAINING WALL

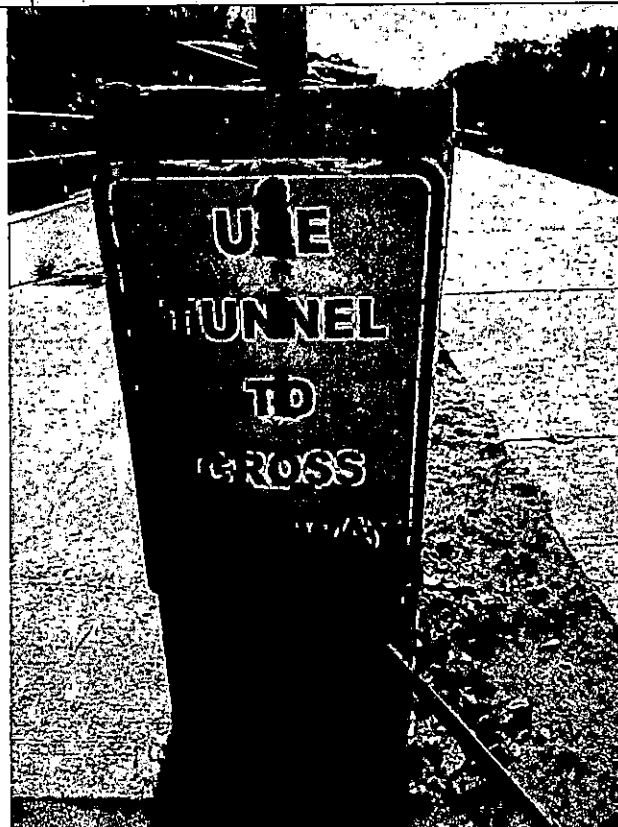
PHOTO 14	DESCRIPTION	NORTHEAST PEDESTRIAN CROSSING SIGN. CORRODED BOLT AT THE TOP. MISSING BOLT AT THE BOTTOM
----------	-------------	---

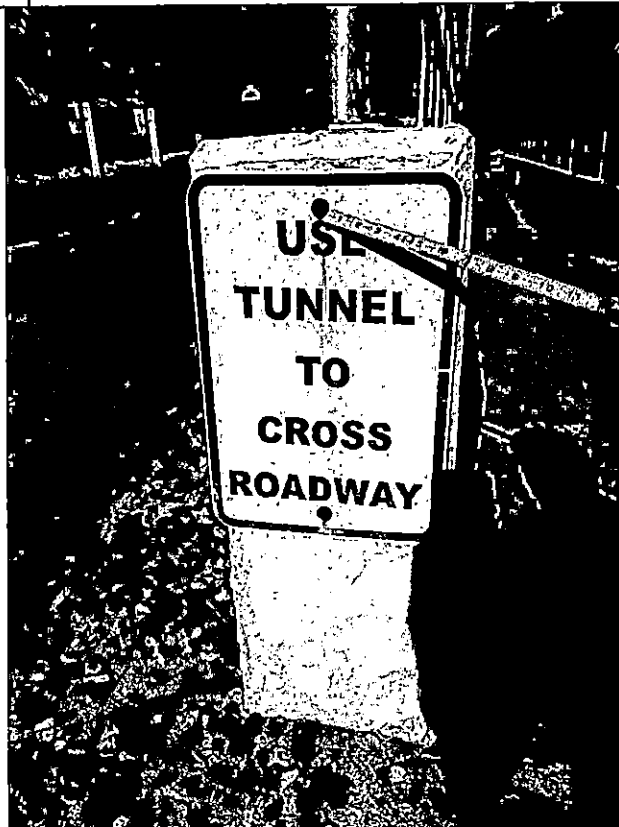
PHOTO 18	DESCRIPTION	SOUTHEAST PEDESTRIAN CROSSING SIGN. CORRODED BOLTS TOP & BOTTOM
----------	-------------	---

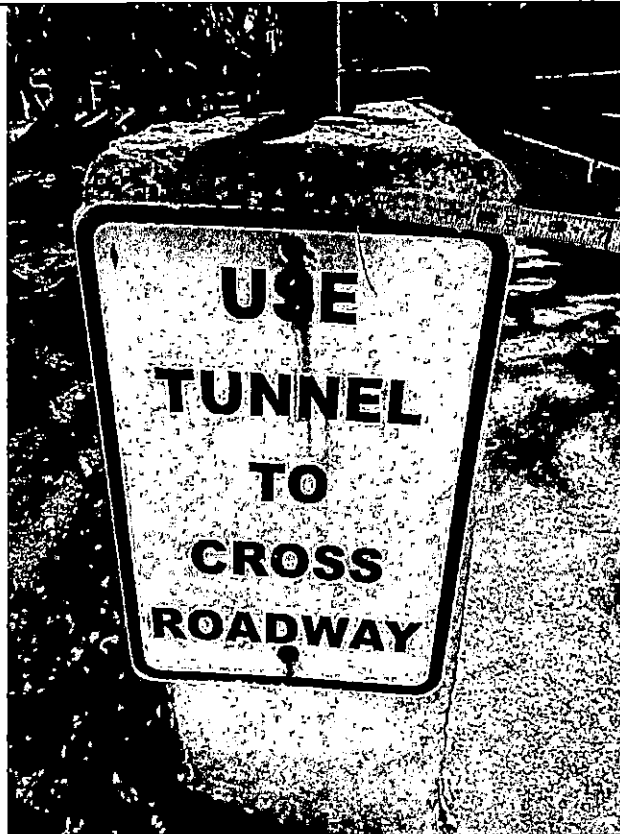
PHOTO 37	DESCRIPTION	TUNNEL ENTRANCE SIGN AT NORTHWEST ENTRANCE CORRODED BOLTS
----------	-------------	---

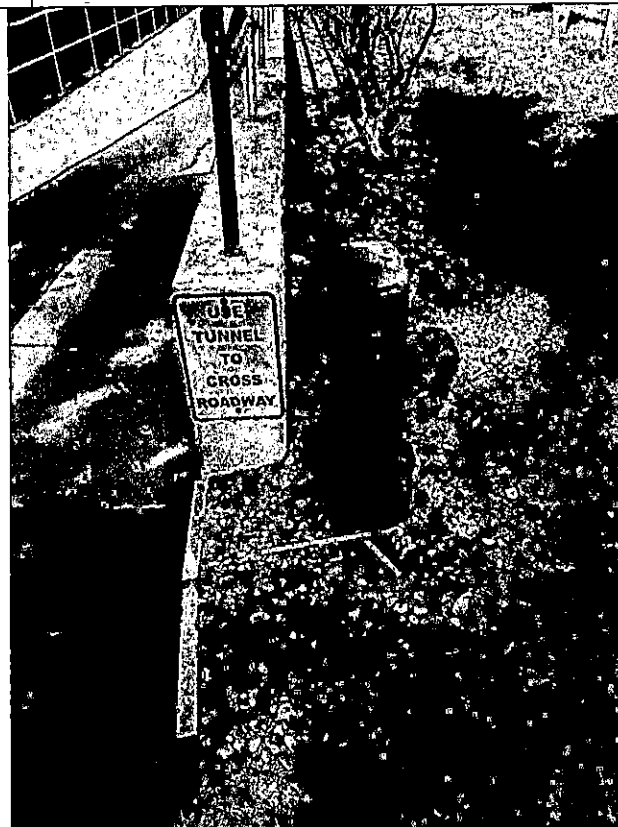
PHOTO 42	DESCRIPTION	SOUTHWEST - PEDESTRIAN TUNNEL SIGN. CORRODED BOLTS. UTILITIES
----------	-------------	---

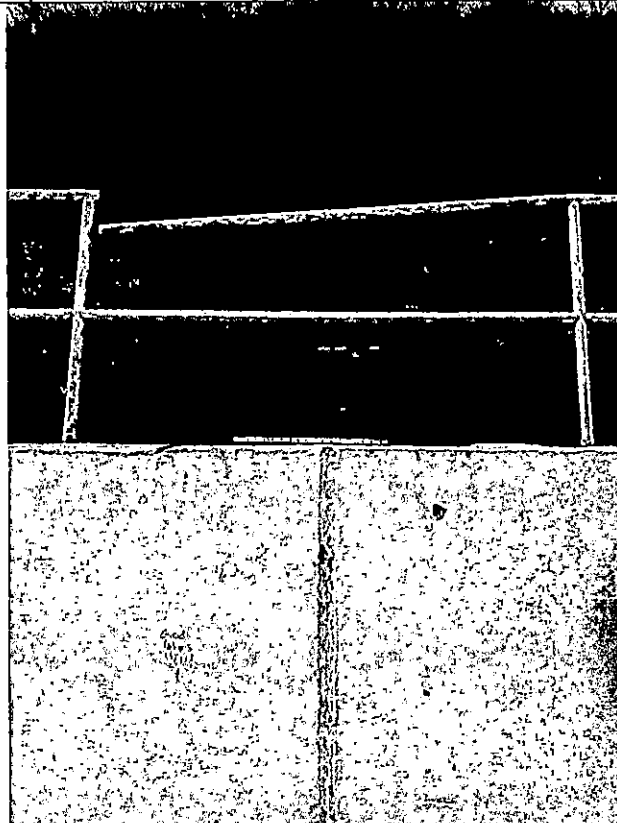
PHOTO 46

WEST ELEVATION - RAIL DAMAGE AT RETAINING WALL
