# Longboat Key Canal Maintenance Program

## Canal Sheets June 2024

Developed by First Line Coastal alongside the Town of  
Longboat Key Public Works Department

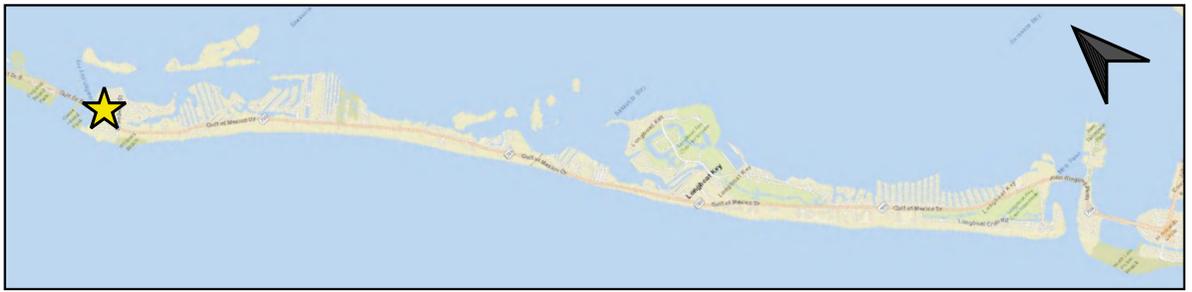
**01**

Noted Damage to Structures: Yes - Bowing Seawalls

Transiting: D - Conditionally Restricted

Meeting/Overtaking: D - Conditionally Restricted

Maneuvering/docking: D - Conditionally Restricted

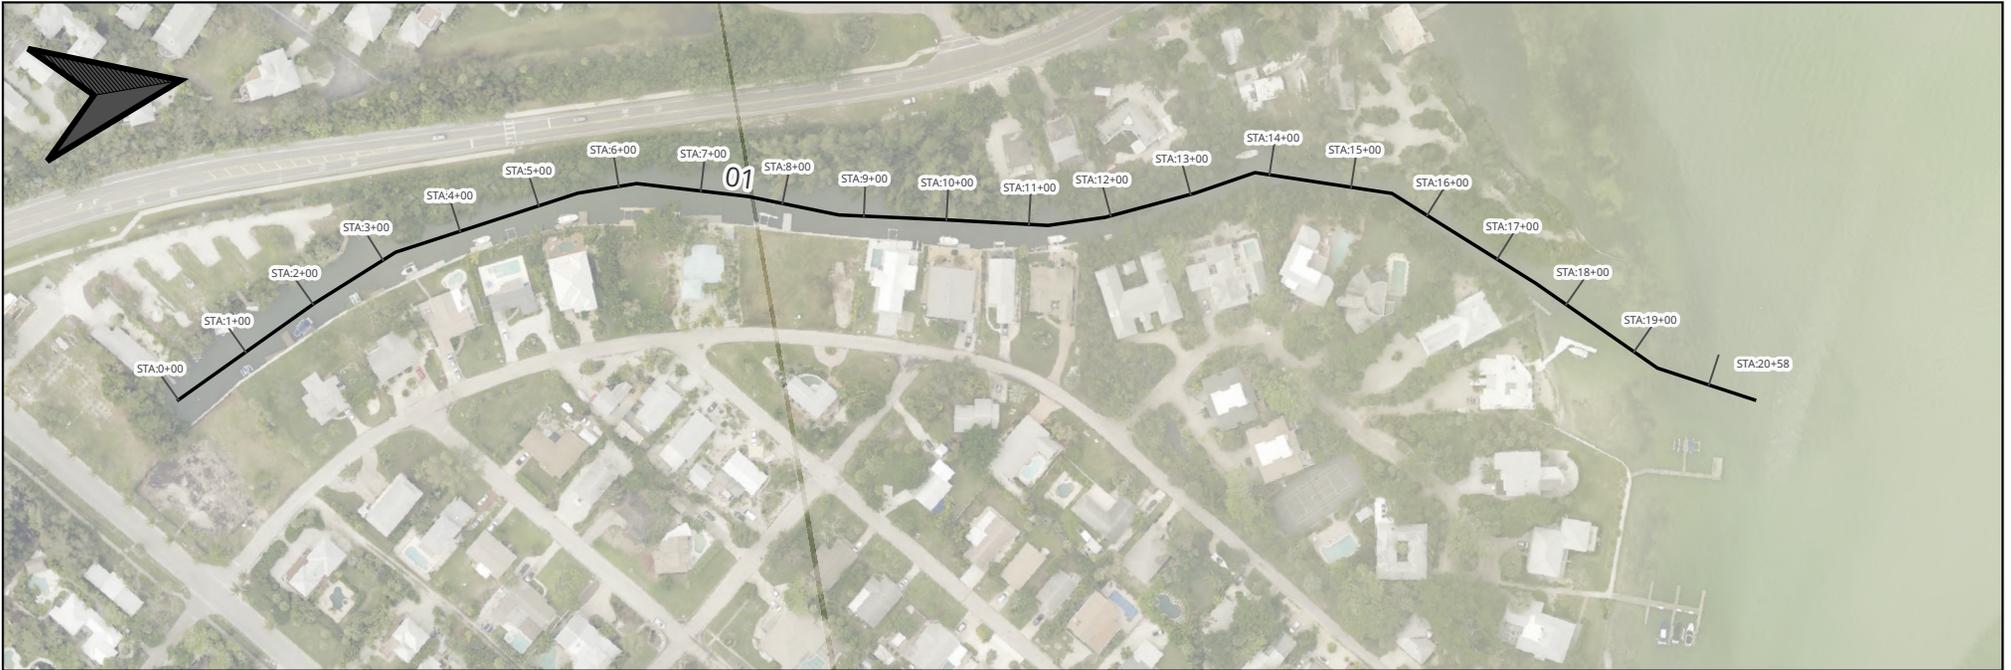
# Canal 01

Limiting Depth at last Survey: -2 ft MLW at STA 16+84

Maintained Width: 20 FT  
 Maintained Depth: -4.00 MLW  
 Monitoring Frequency: 1 year  
 Dredging Required: Yes  
 Min Dredge Target: -3.75 MLW  
 Number of Segments: Determine during future project  
 Dredge Length: Determine during future project  
 Additional Work: Mangrove trimming, consider advanced maintenance at mouth in the future

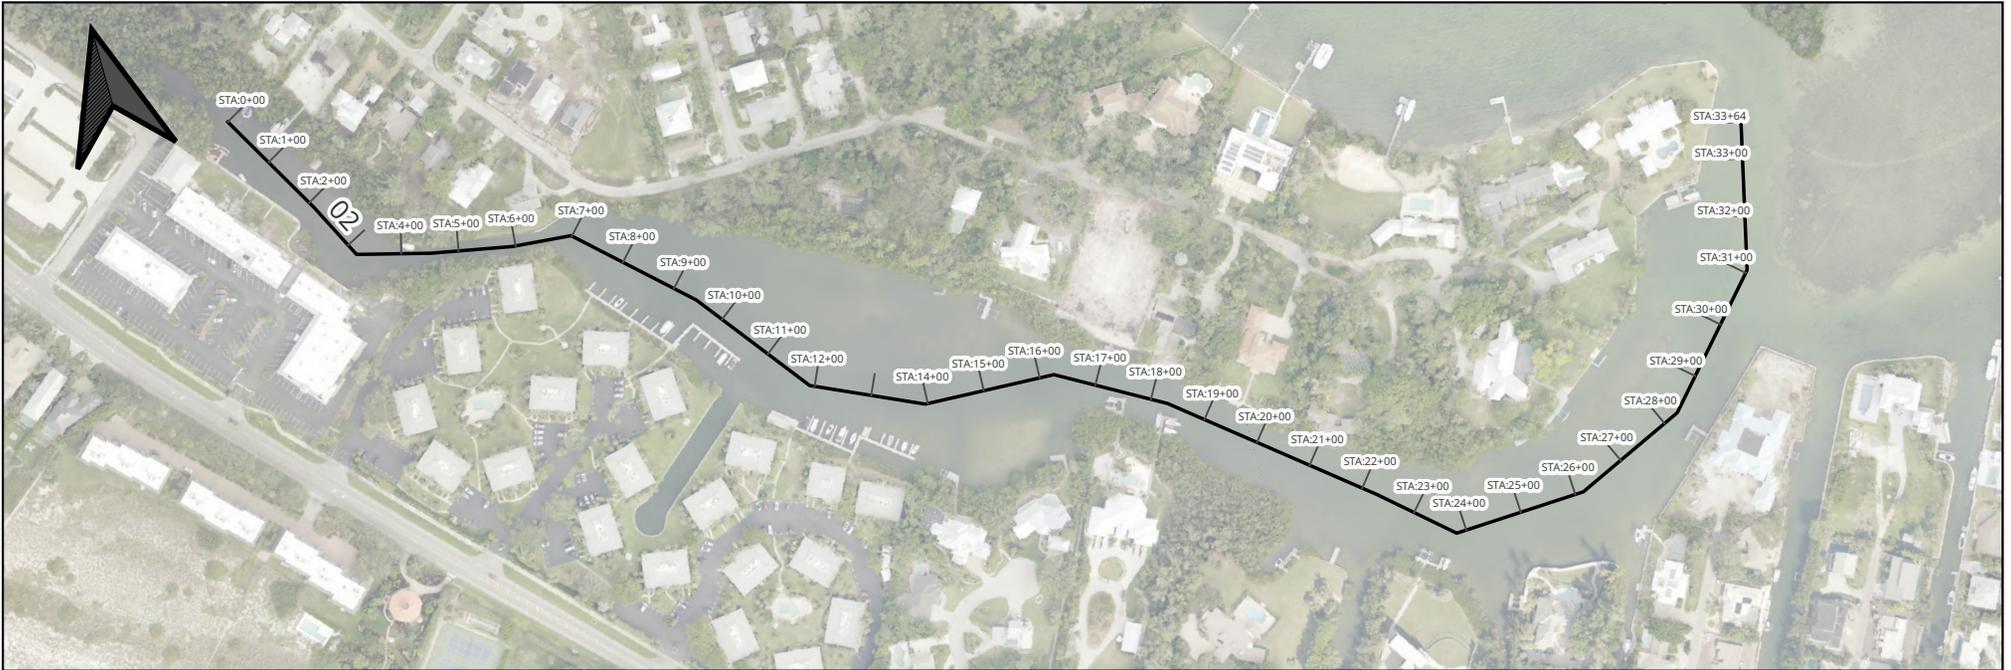
# Canal 02

Notes: Green Marker 7 missing

Maintained Width: 20 FT  
 Maintained Depth: -5.00 MLW  
 Monitoring Frequency: 1 year  
 Dredging Required: Yes  
 Min Dredge Target: -4.75 MLW  
 Number of Segments: Determine during future project  
 Dredge Length: Determine during future project  
 Additional Work: Mangrove trimming, consider additional ATONS in the future

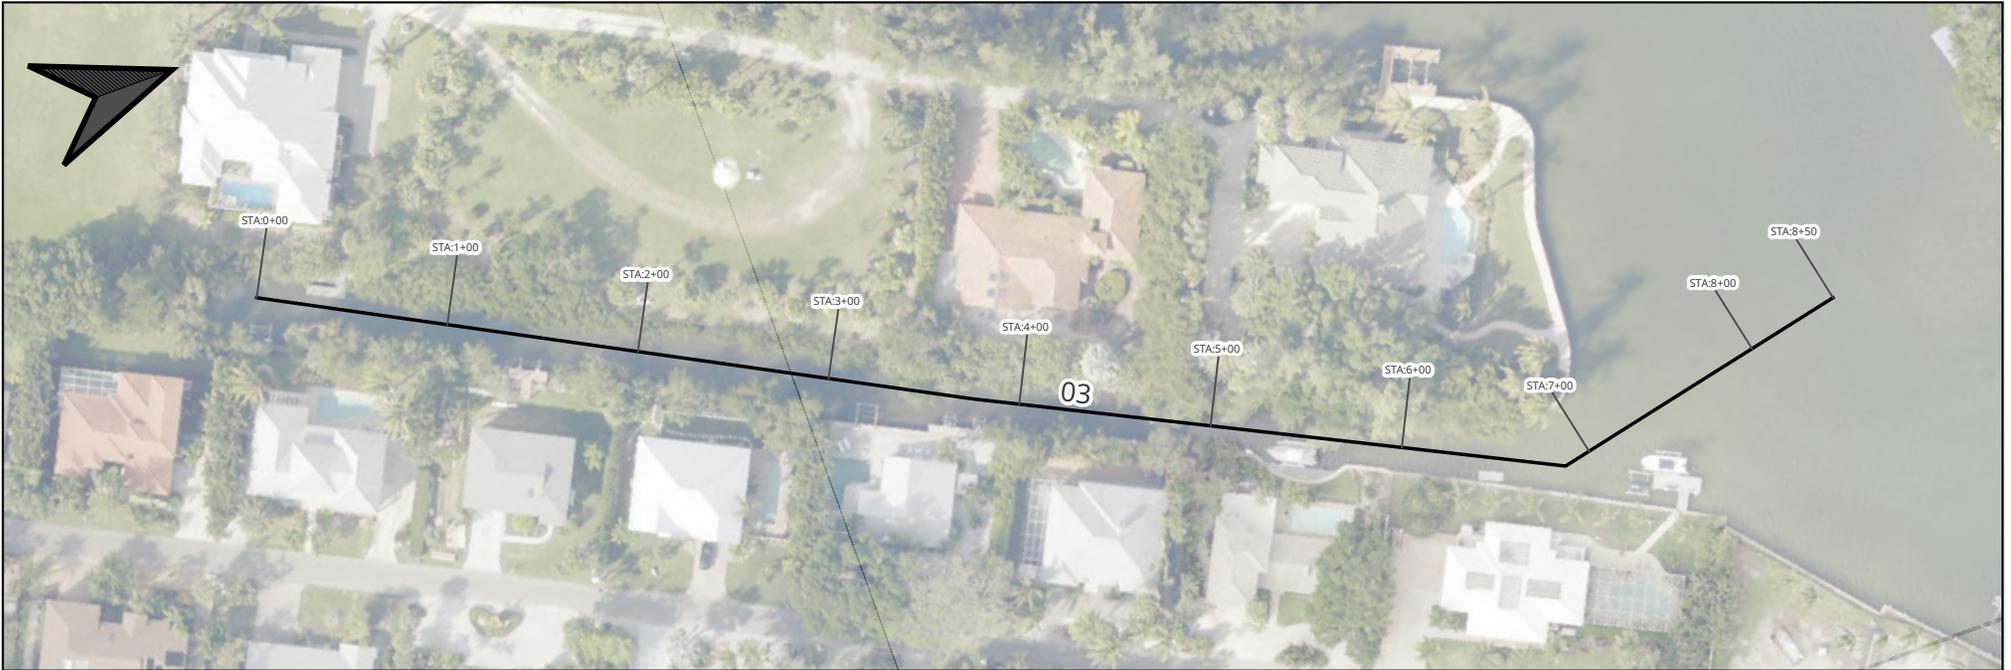
# Canal 03

Maneuvering  
 D - Conditionally Restricted

Maintained Width: 15 FT  
 Maintained Depth: -4.00 MLW  
 Monitoring Frequency: 1 year  
 Dredging Required: Yes  
 Min Dredge Target: -3.75 MLW  
 Number of Segments: Determine during future project  
 Dredge Length: Determine during future project  
 Additional Work:

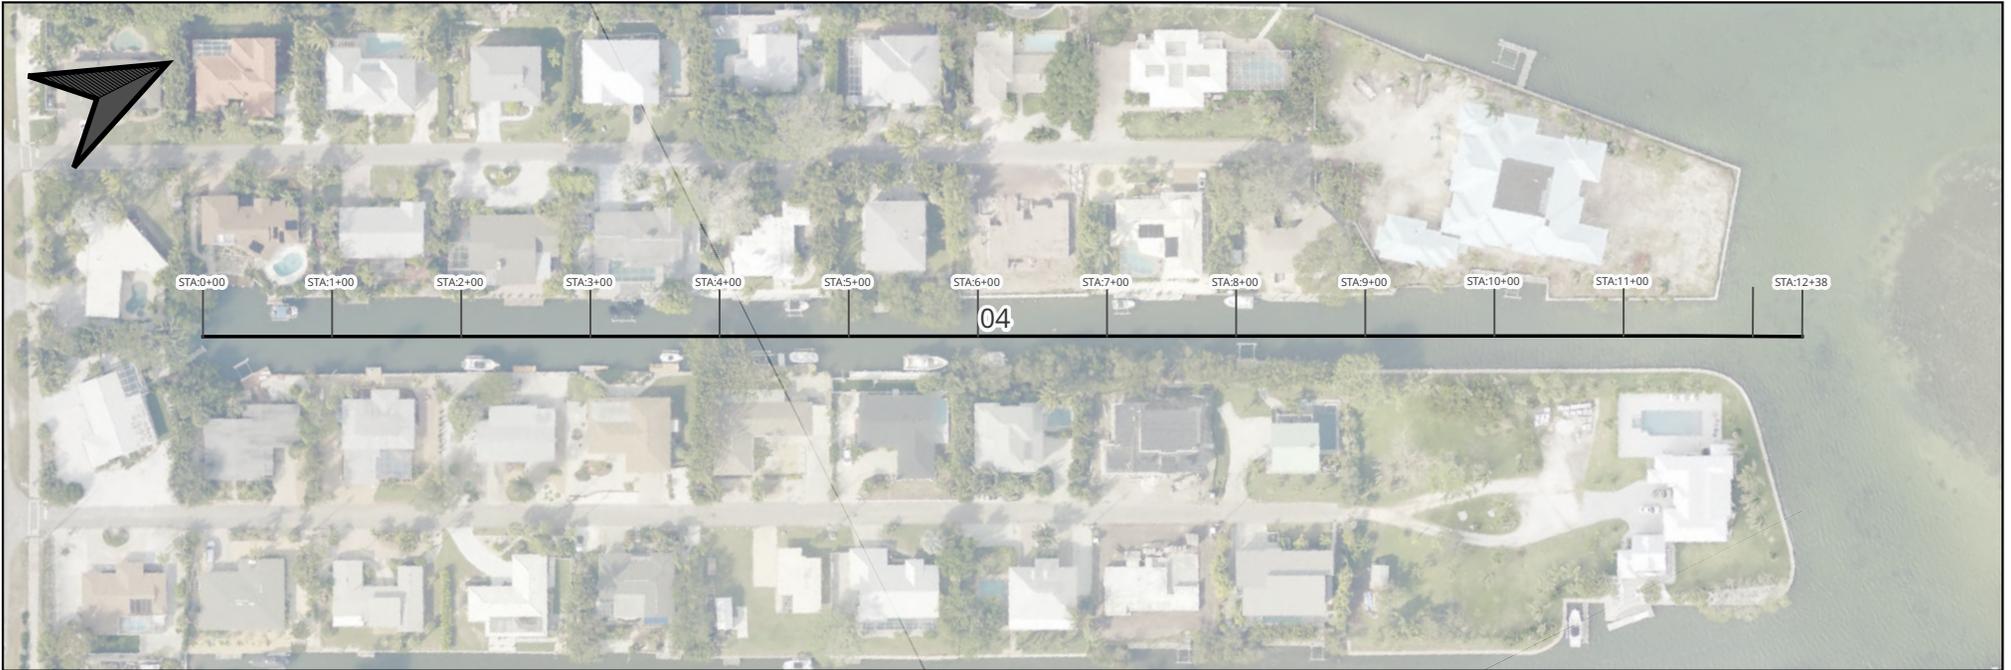
# Canal 04

Maneuvering/docking: D - Conditionally Restricted

Maintained Width: 20 FT  
 Maintained Depth: -5.00 MLW  
 Monitoring Frequency: 1 year  
 Dredging Required: Yes  
 Min Dredge Target: -4.75 MLW  
 Number of Segments: Determine during future project  
 Dredge Length: Determine during future project  
 Additional Work:

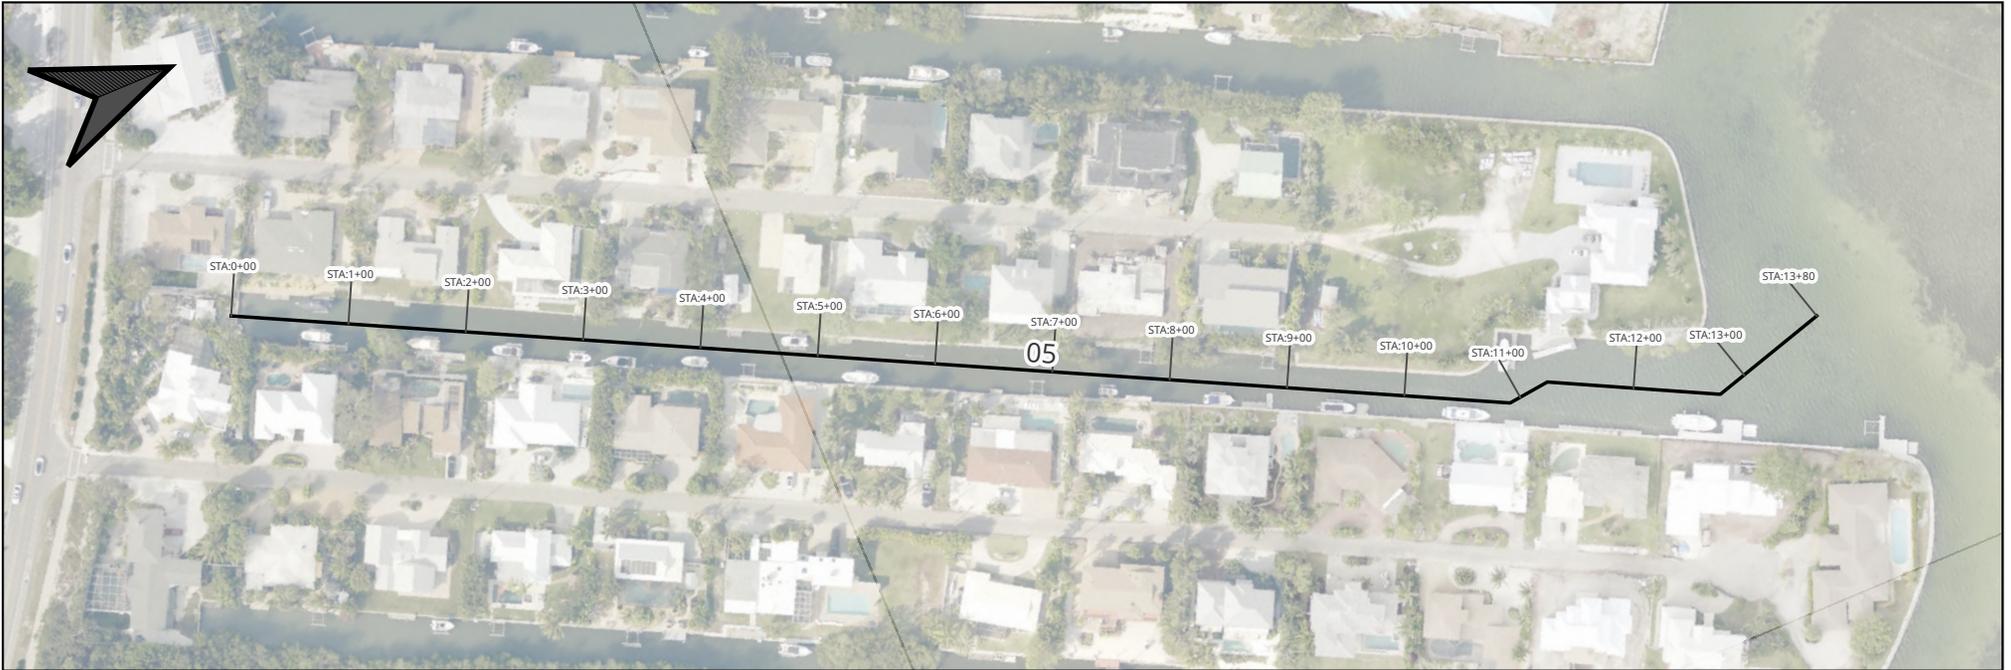
# Canal 05

Transiting: D - Conditionally Restricted

Meeting/Overtaking: D - Conditionally Restricted

Maneuvering/docking: D - Conditionally Restricted

Maintained Width: 20 FT  
 Maintained Depth: -5.00 MLW  
 Monitoring Frequency: 1 year  
 Dredging Required: Yes  
 Min Dredge Target: -4.75 MLW  
 Number of Segments: Determine during future project  
 Dredge Length: Determine during future project  
 Additional Work:

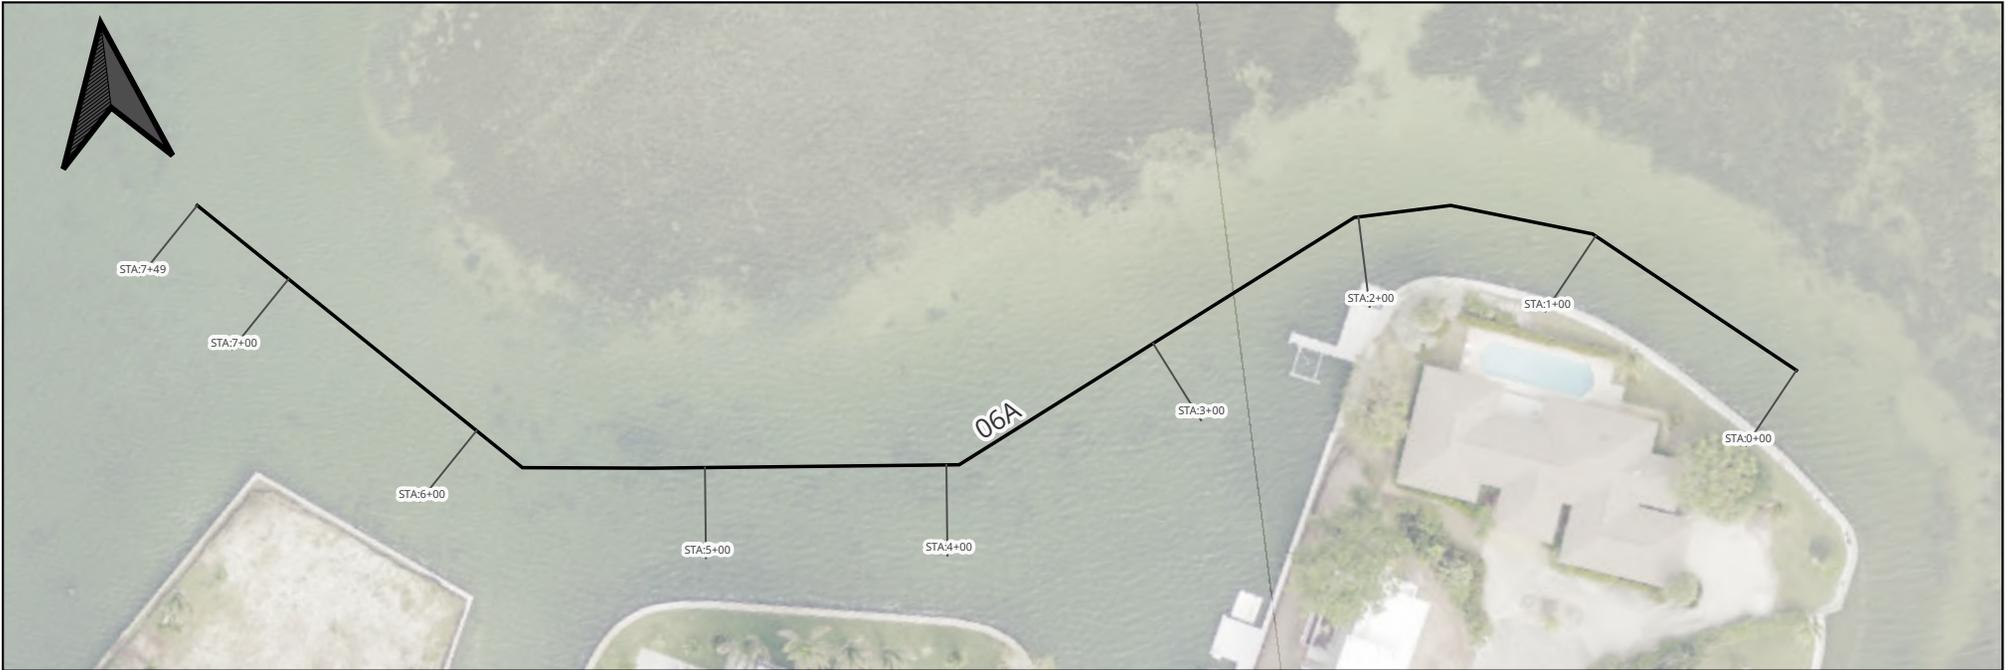
# Canal 06A

Maneuvering/docking: D - Conditionally Restricted

Maintained Width: 20 FT  
 Maintained Depth: -5.00 MLW  
 Monitoring Frequency: 1 year  
 Dredging Required: Yes  
 Min Dredge Target: -4.75 MLW  
 Number of Segments: Determine during future project  
 Dredge Length: Determine during future project  
 Additional Work:

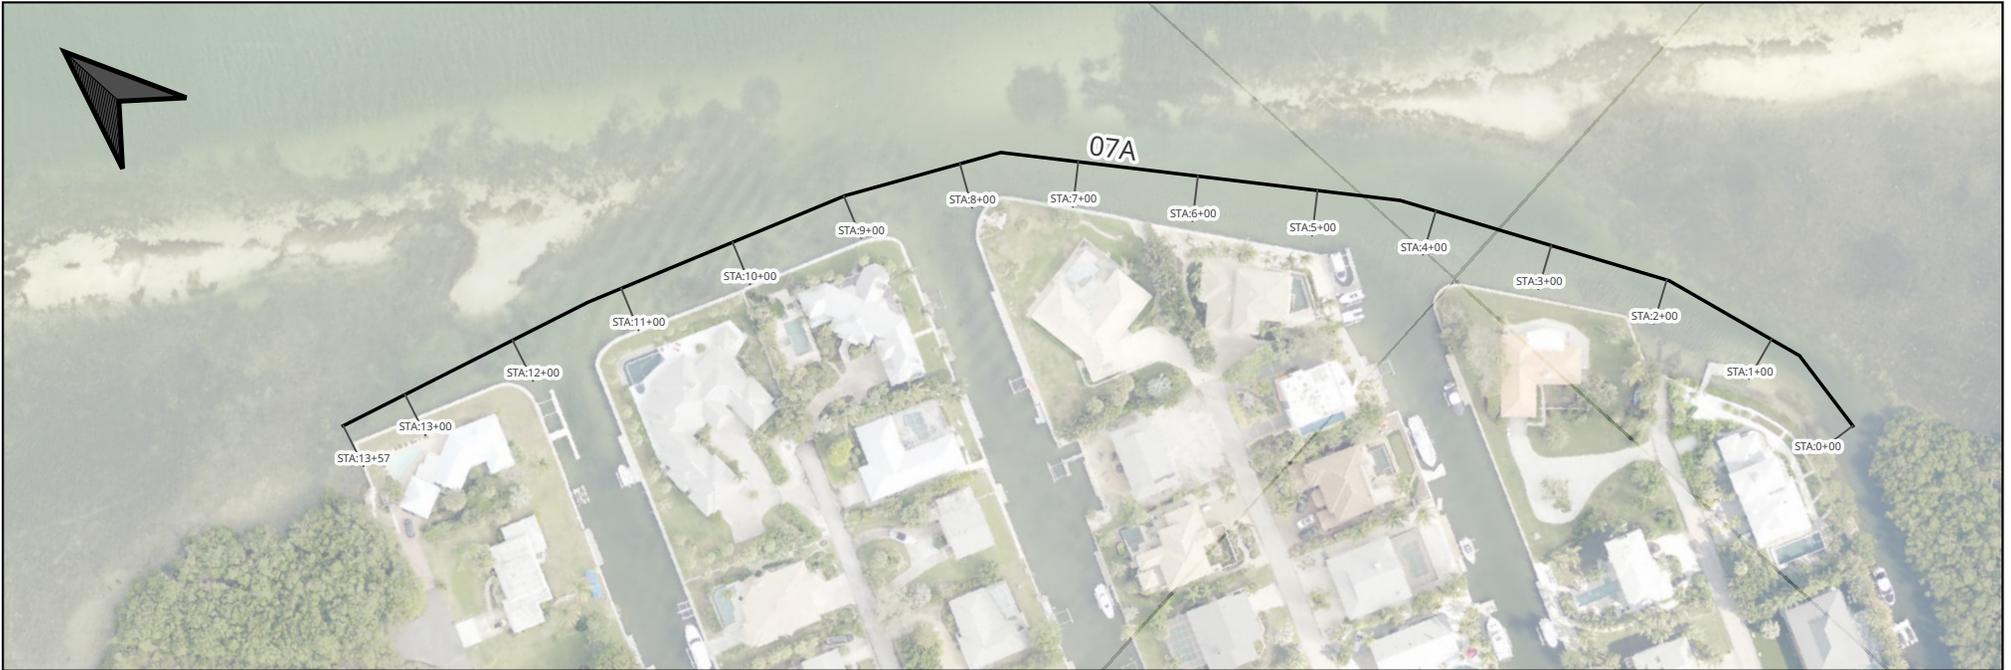
# Canal 07A

Maneuvering/docking: D - Conditionally Restricted

Maintained Width: 20 FT  
 Maintained Depth: -5.00 MLW  
 Monitoring Frequency: 1 year  
 Dredging Required: Yes  
 Min Dredge Target: -4.75 MLW  
 Number of Segments: Determine during future project  
 Dredge Length: Determine during future project  
 Additional Work: Channel re-aligned 6/5/2024.

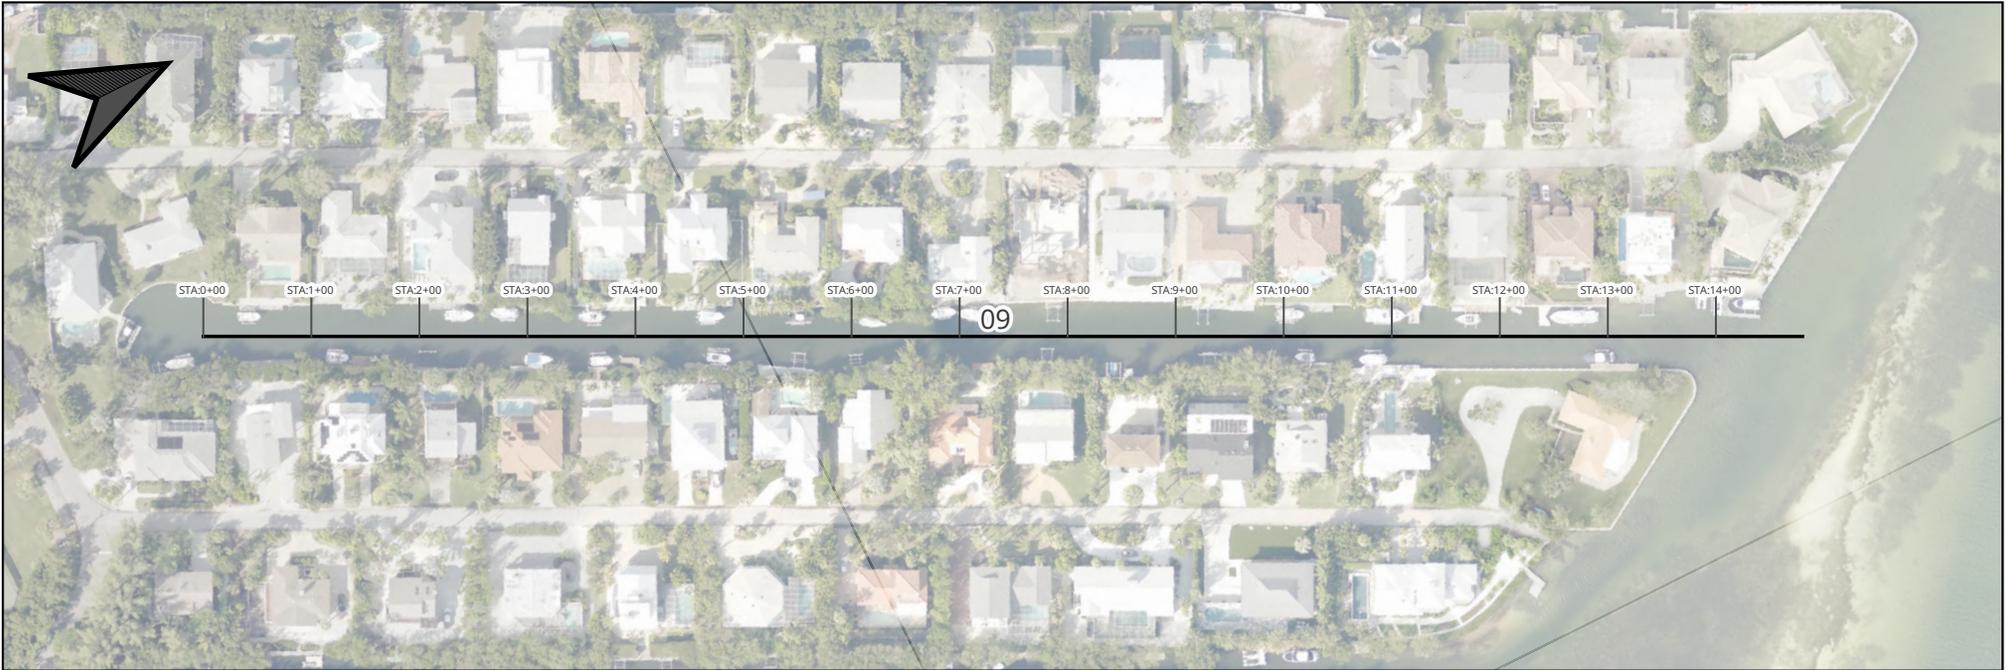
# Canal 09

Transiting: D - Conditionally Restricted

Meeting/Overtaking: D - Conditionally Restricted

Maintained Width: 20 FT  
 Maintained Depth: -5.00 MLW  
 Monitoring Frequency: 1 year  
 Dredging Required: None  
 Min Dredge Target: -4.75 MLW  
 Number of Segments: 0  
 Dredge Length: 0 FT  
 Additional Work:

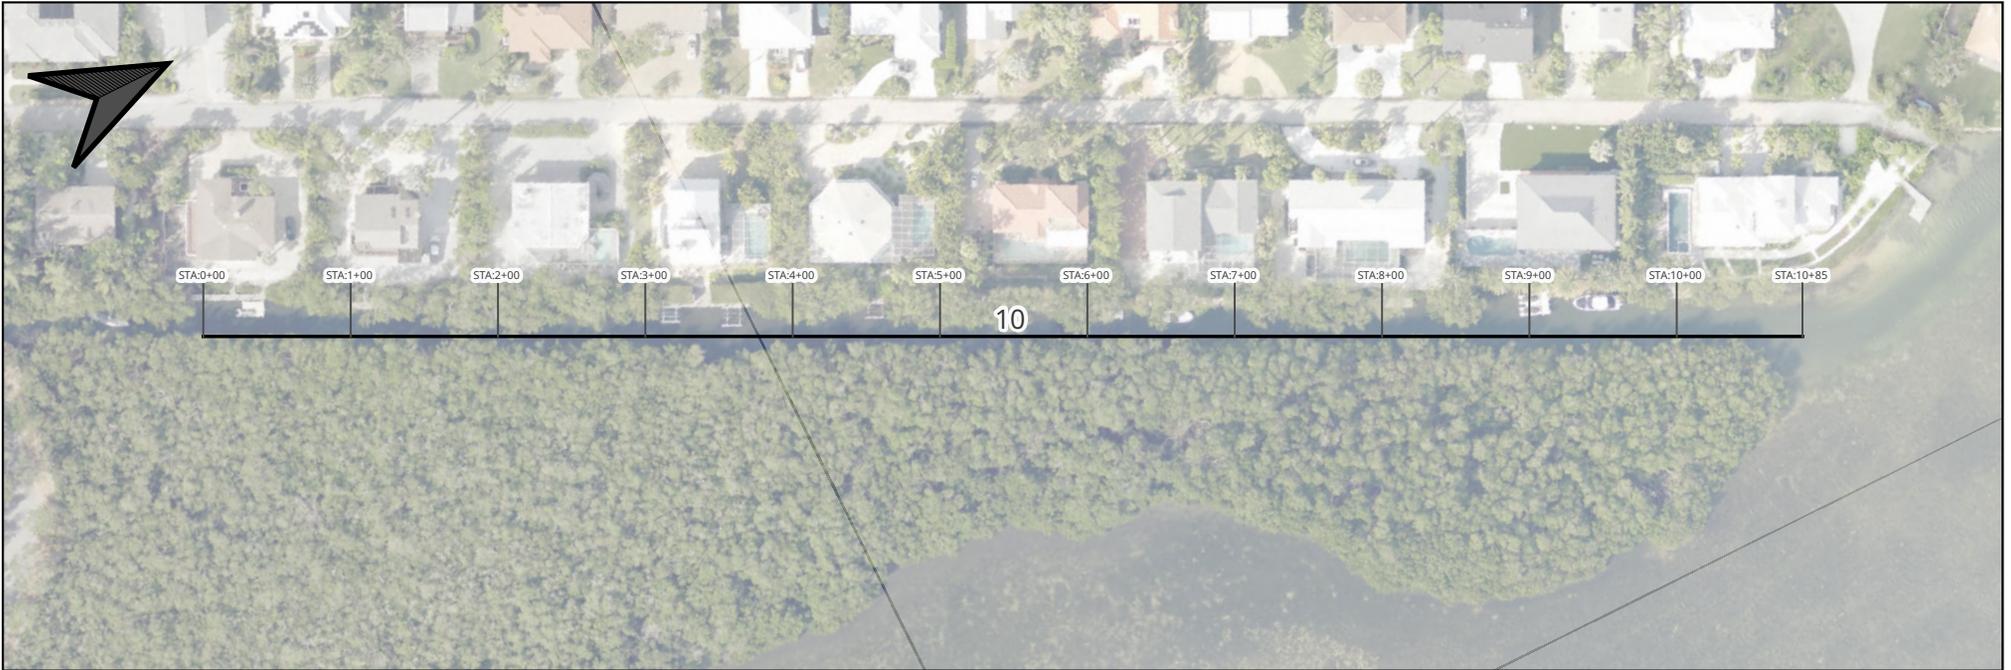
# Canal 10

Maneuvering/docking: D - Conditionally Restricted

Maintained Width: 15 FT  
 Maintained Depth: -5.00 MLW  
 Monitoring Frequency: 1 year  
 Dredging Required: Yes  
 Min Dredge Target: -4.75 MLW  
 Number of Segments: Determine during future project  
 Dredge Length: Determine during future project  
 Additional Work: Channel re-alignment 6/5/2024

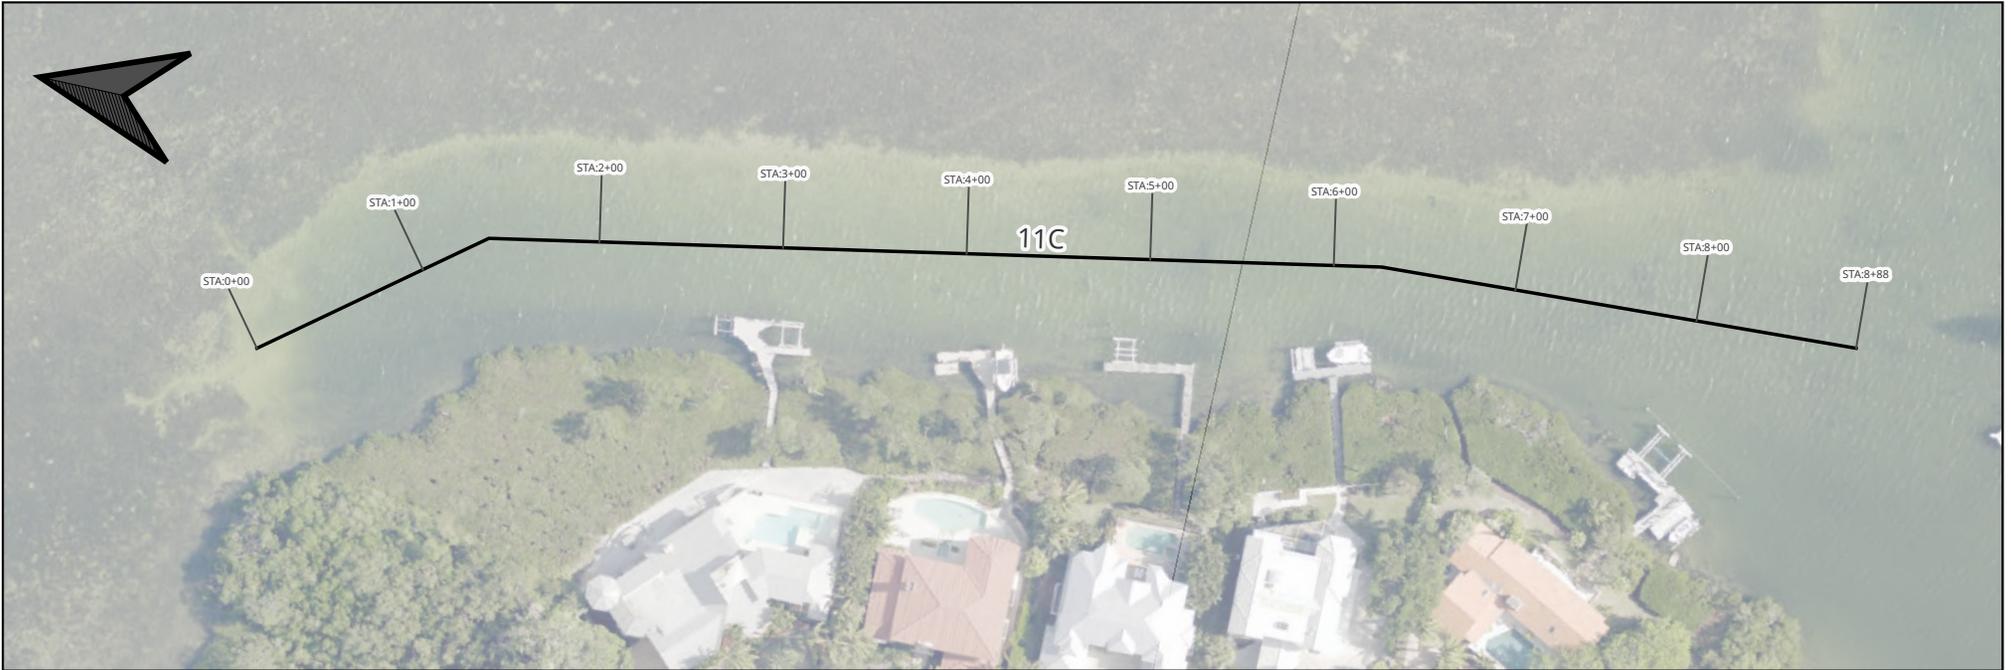
# Canal 11C

Primary Usage: Mooring/Dockage                      Avg Vessel Beam: 7 - 10 ft  
 Density of Water Access: 60%                      Avg Vessel Draft: 2 - 4 ft  
 Noted Damage to Structures: No                      Mapped Seagrass: None  
 Notable Exposures: Waves, Wind                      Mapped  
 Impediments: None

Maintained Width: 20 FT  
 Maintained Depth: -5.00 MLW  
 Monitoring Frequency: 2 years  
 Dredging Required: None  
 Min Dredge Target: -4.75 MLW  
 Number of Segments: 0  
 Dredge Length: 0 FT  
 Additional Work: Channel between 0+00 and 2+00 should not be maintained

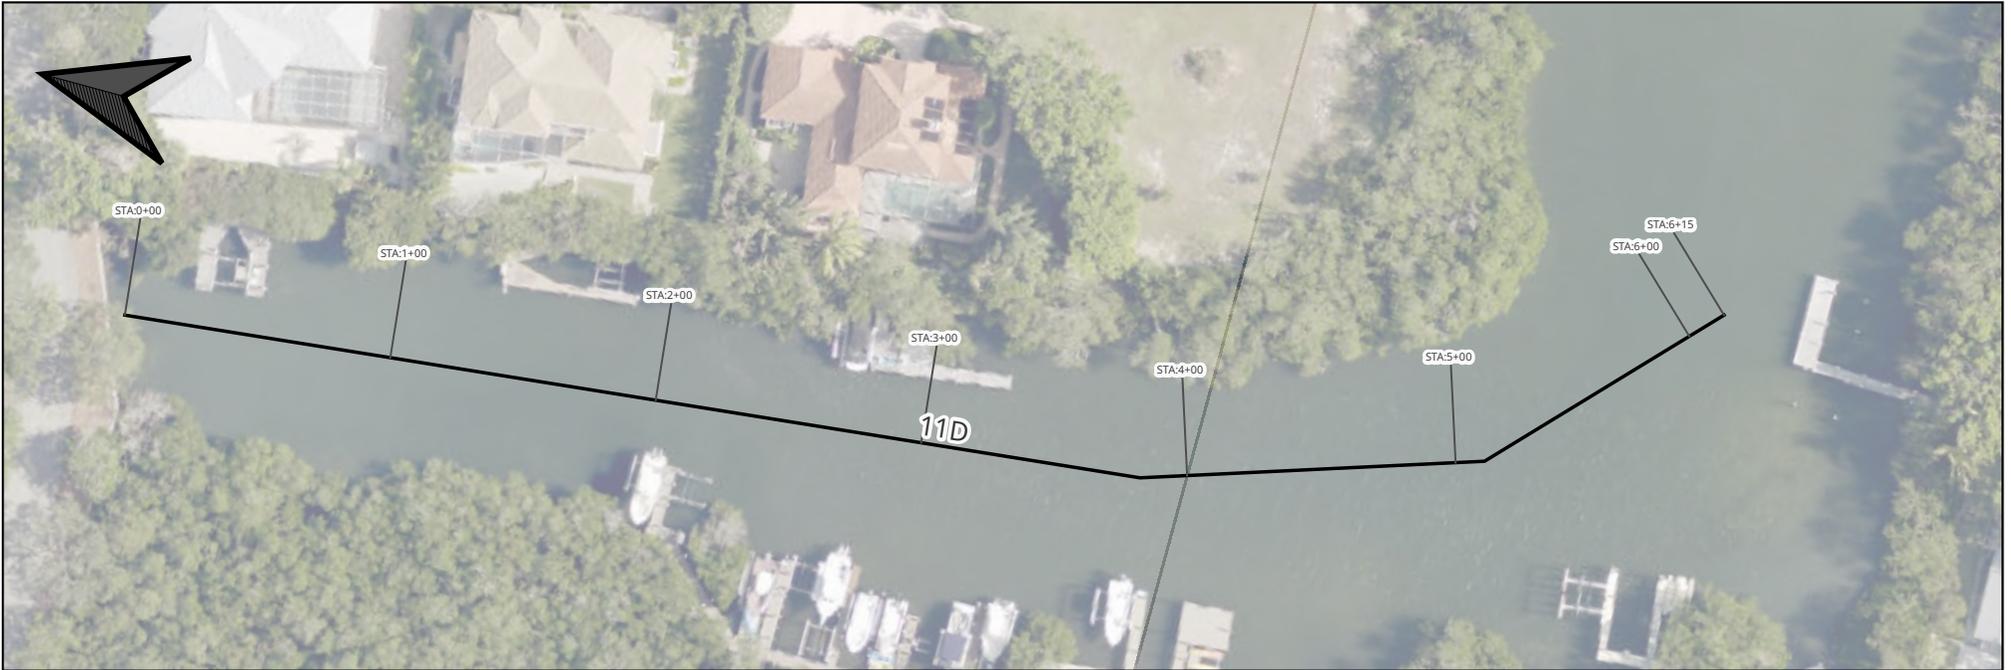
# Canal 11D

Limiting Depth at last Survey: -4.5 ft MLW at STA 0+13

Maintained Width: 20 FT  
 Maintained Depth: -5.00 MLW  
 Monitoring Frequency: 2 years  
 Dredging Required: None  
 Min Dredge Target: -4.75 MLW  
 Number of Segments: 0  
 Dredge Length: 0 FT  
 Additional Work:

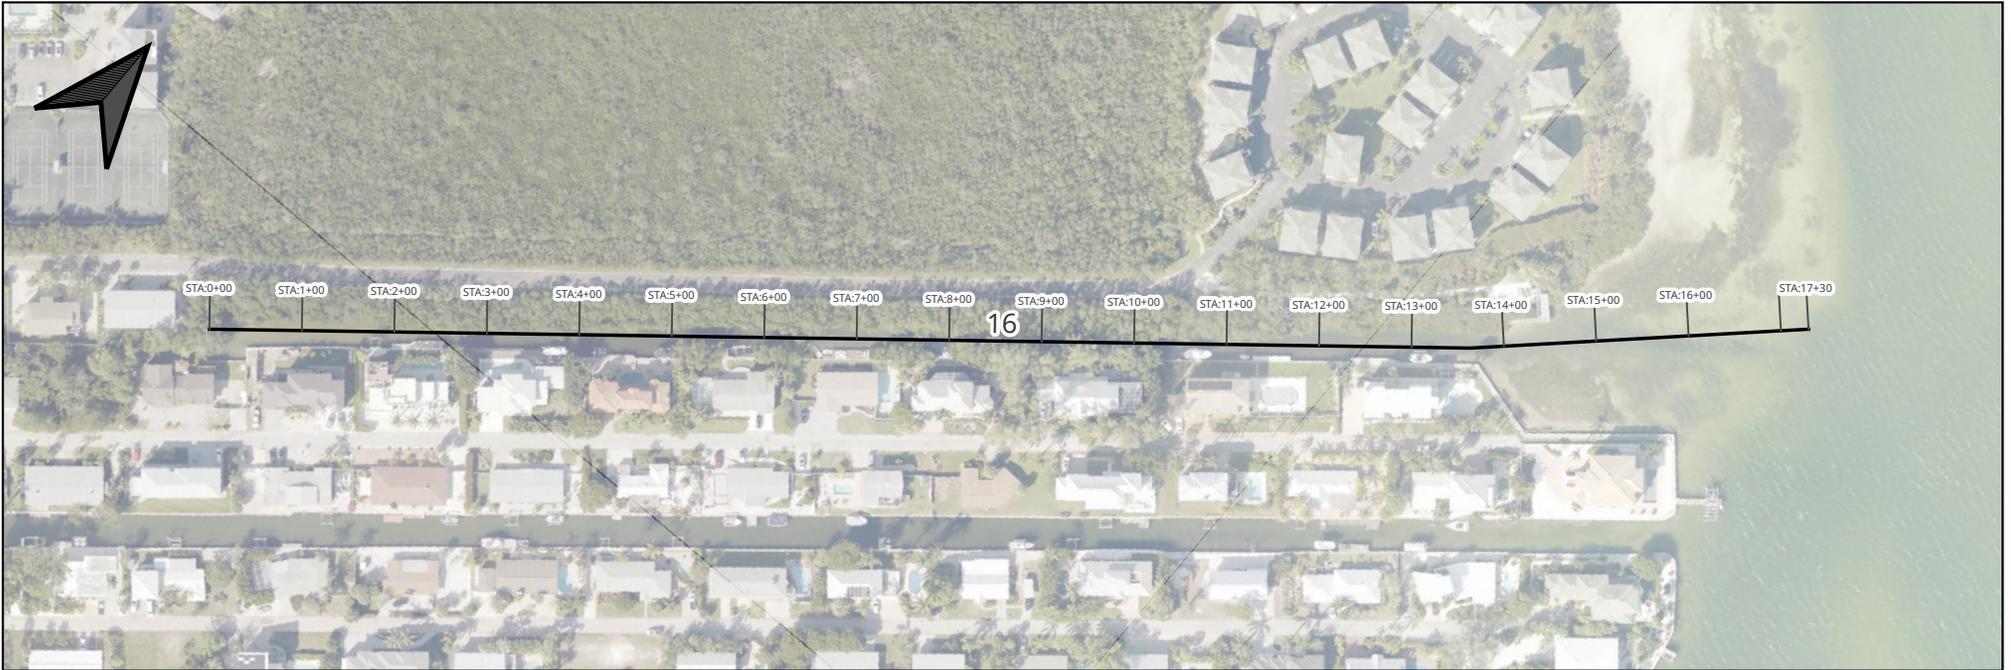
# Canal 16

<u>Vessel</u>	<u>Transiting</u>
Length: 24 ft	A - Unrestricted
Beam: 9 ft	
Draft: 3.5 ft	
	<u>Meeting</u>
	B - As expected
	<u>Maneuvering</u>
	D - Conditionally Restricted

Maintained Width: V cut  
 Maintained Depth: -5.00 MLW  
 Monitoring Frequency: 1 year  
 Dredging Required: Yes  
 Min Dredge Target: -4.75 MLW  
 Number of Segments: Determine during future project  
 Dredge Length: Determine during future project  
 Additional Work: Mangrove trimming required for adequate survey data collection, recommend increasing maintained width for improved level of service

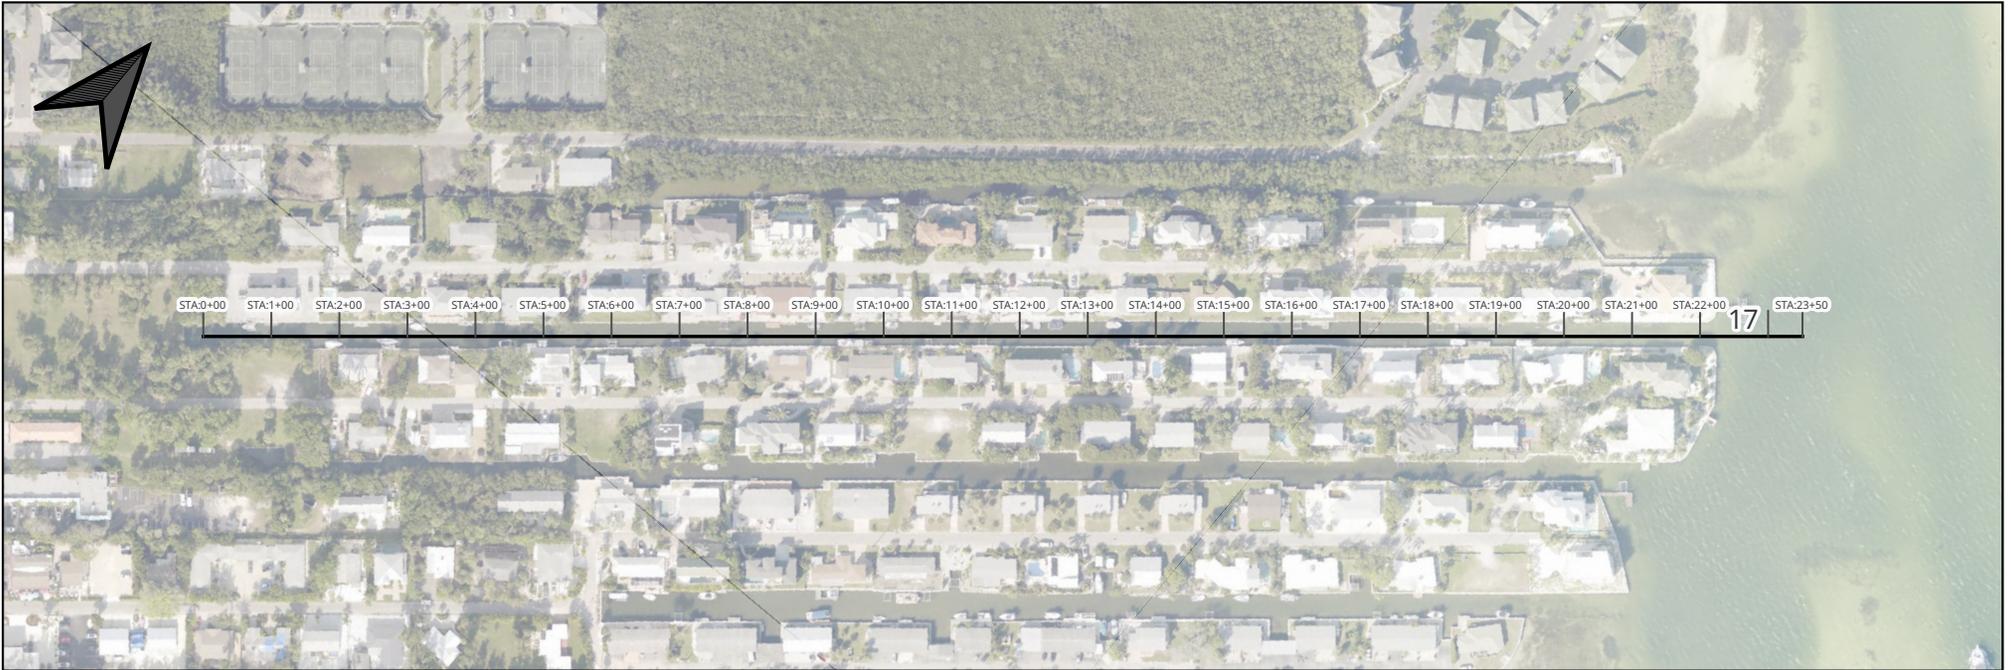
# Canal 17

Meeting  
 D - Conditionally Restricted

Noted Damage to Structures: Yes - Bowing Seawalls

Maintained Width: 10 FT  
 Maintained Depth: -3.00 MLW  
 Monitoring Frequency: 1 year  
 Dredging Required: None  
 Min Dredge Target: -2.75 MLW  
 Number of Segments: 0  
 Dredge Length: 0 FT  
 Additional Work: Recommend expanding to 4 ft depth during future projects

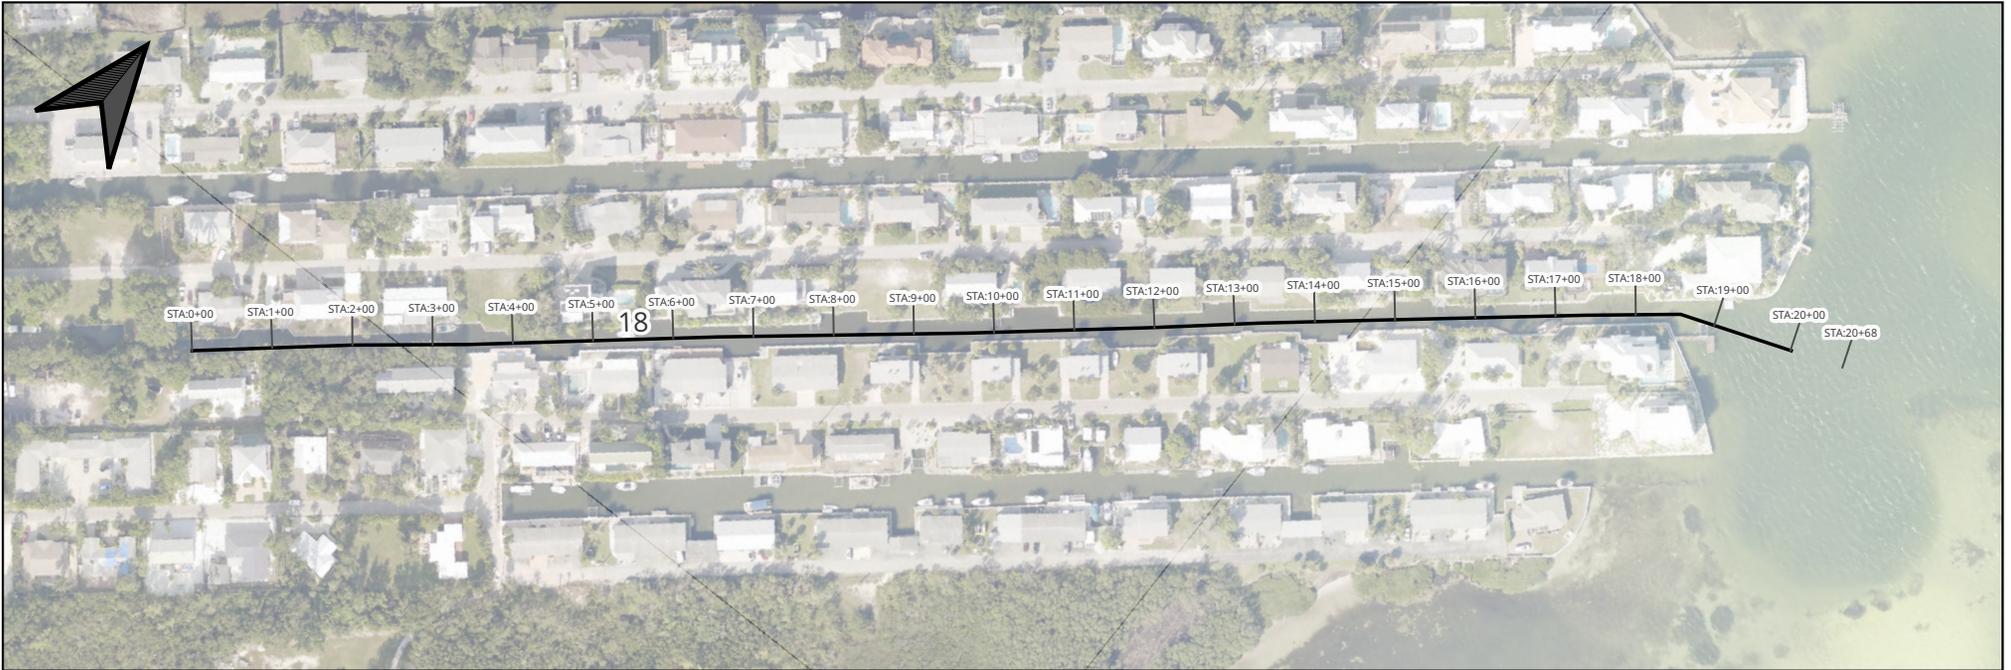
# Canal 18

<u>Vessel</u>	<u>Transiting</u>
Length: 24 ft	B - As expected
Beam: 9 ft	
Draft: 3.5 ft	
	<u>Meeting</u>
	D - Conditionally Restricted
	<u>Maneuvering</u>
	F - Not Navigable

Transiting: D - Conditionally Restricted

Maintained Width: 10 FT  
 Maintained Depth: -3.00 MLW  
 Monitoring Frequency: 1 year  
 Dredging Required: Yes  
 Min Dredge Target: -2.75 MLW  
 Number of Segments: Determine during future project  
 Dredge Length: Determine during future project  
 Additional Work: Recommend expanding maintained width at "basins" to improve meeting and docking ability

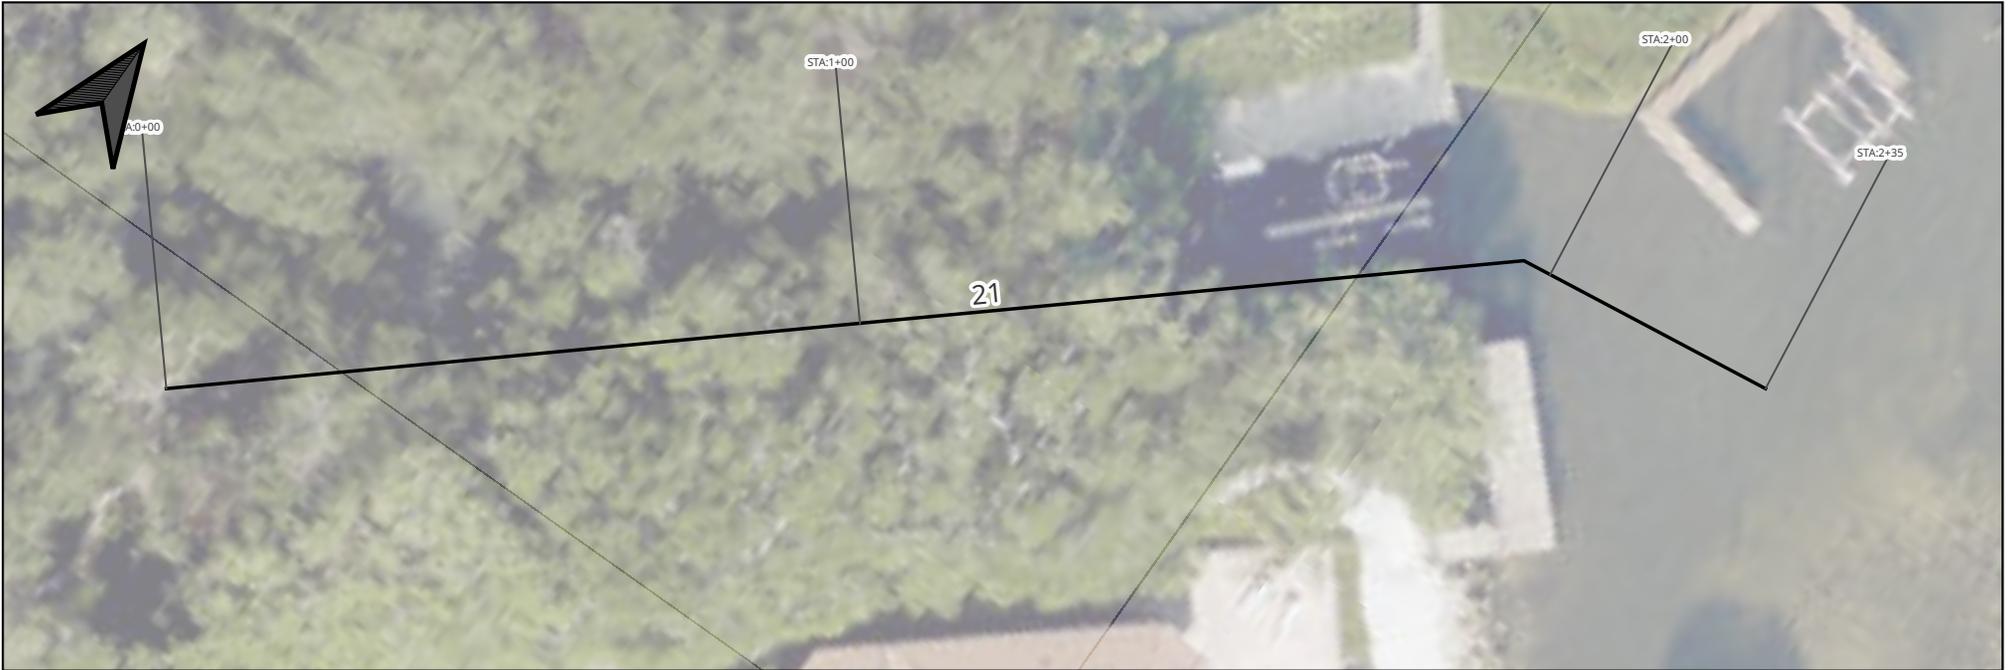
# Canal 21

Limiting Depth at last Survey: -1.2 ft MLW at STA 1+90

Maintained Width: N/A  
 Maintained Depth: N/A  
 Monitoring Frequency: N/A  
 Dredging Required: N/A  
 Min Dredge Target: N/A  
 Number of Segments: N/A  
 Dredge Length: N/A  
 Additional Work: Removed from the program
