# Longboat Key Canal Maintenance Program

## Canal Sheets June 2024

Developed by First Line Coastal alongside the Town of  
Longboat Key Public Works Department

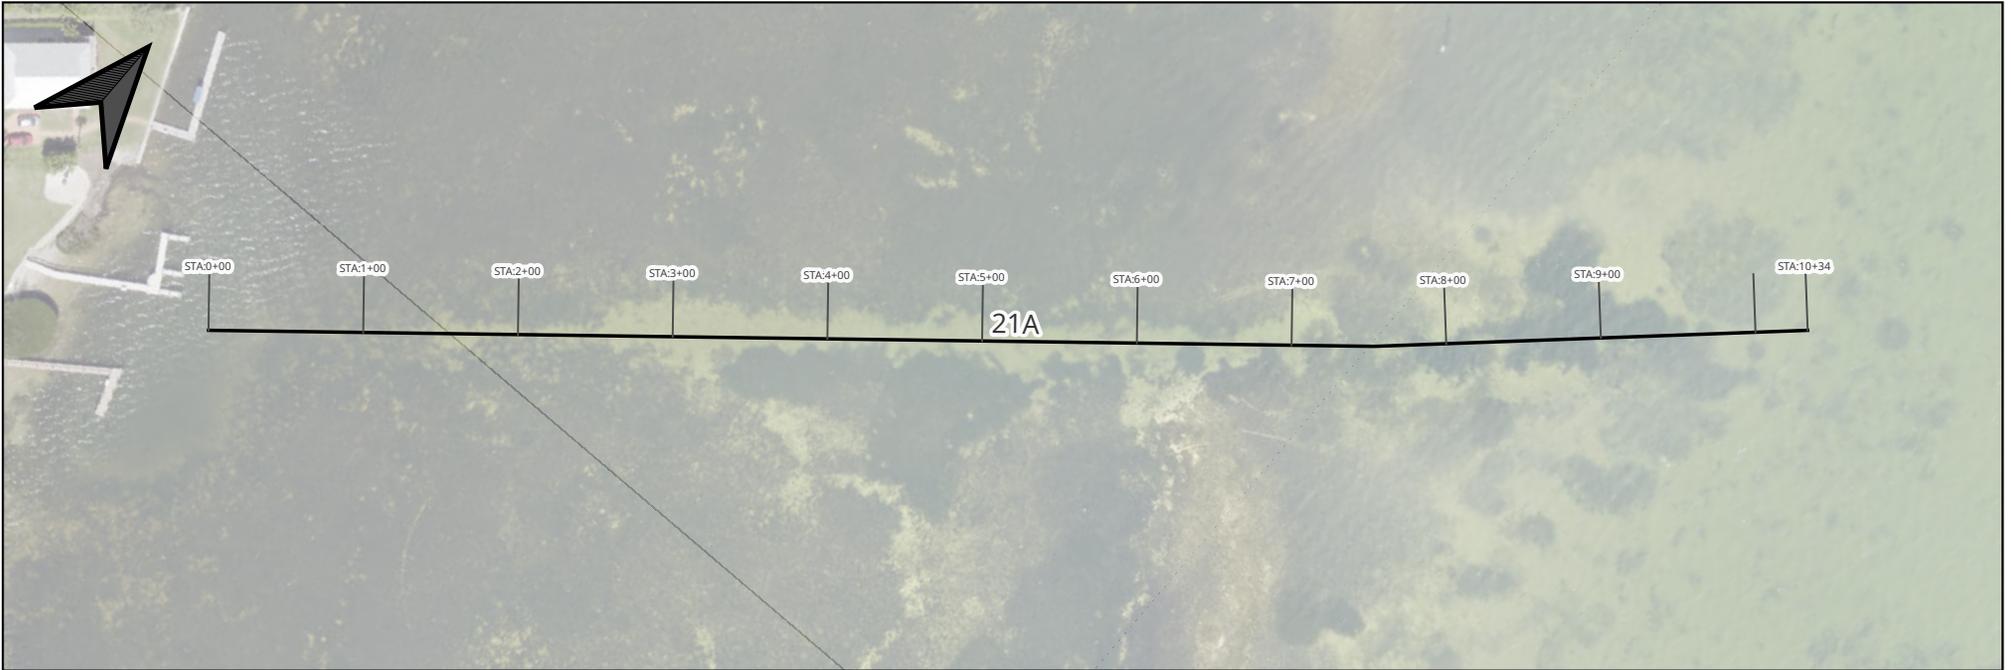
# Canal 21A

Limiting Depth at last Survey: -3.2 ft MLW at STA 1+30

Maintained Width: 20 FT  
 Maintained Depth: -5.00 MLW  
 Monitoring Frequency: 1 year  
 Dredging Required: Yes  
 Min Dredge Target: -4.75 MLW  
 Number of Segments: Determine during future project  
 Dredge Length: Determine during future project  
 Additional Work: Consider offsetting level of service with 22A

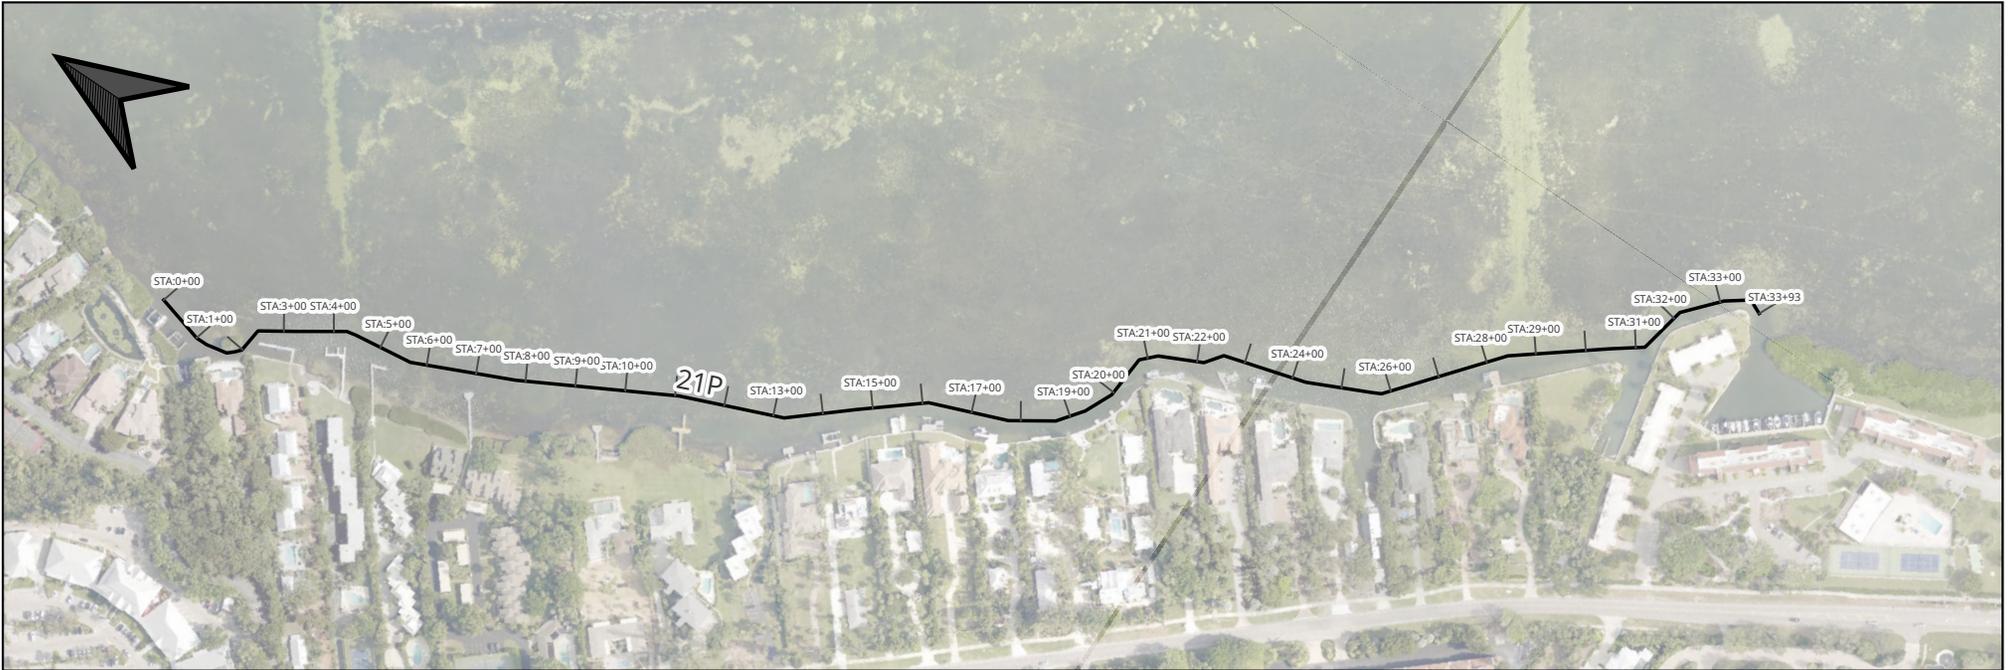
# Canal 21P

Limiting Depth at last Survey: -1.1 ft MLW at STA 22+50

Maintained Width: 20 FT  
 Maintained Depth: -5.00 MLW  
 Monitoring Frequency: 1 year  
 Dredging Required: Yes  
 Min Dredge Target: -4.75 MLW  
 Number of Segments: Determine during future project  
 Dredge Length: Determine during future project  
 Additional Work: Evaluate alignment shift in the future with additional survey. Consider basin at north end to accommodate 21

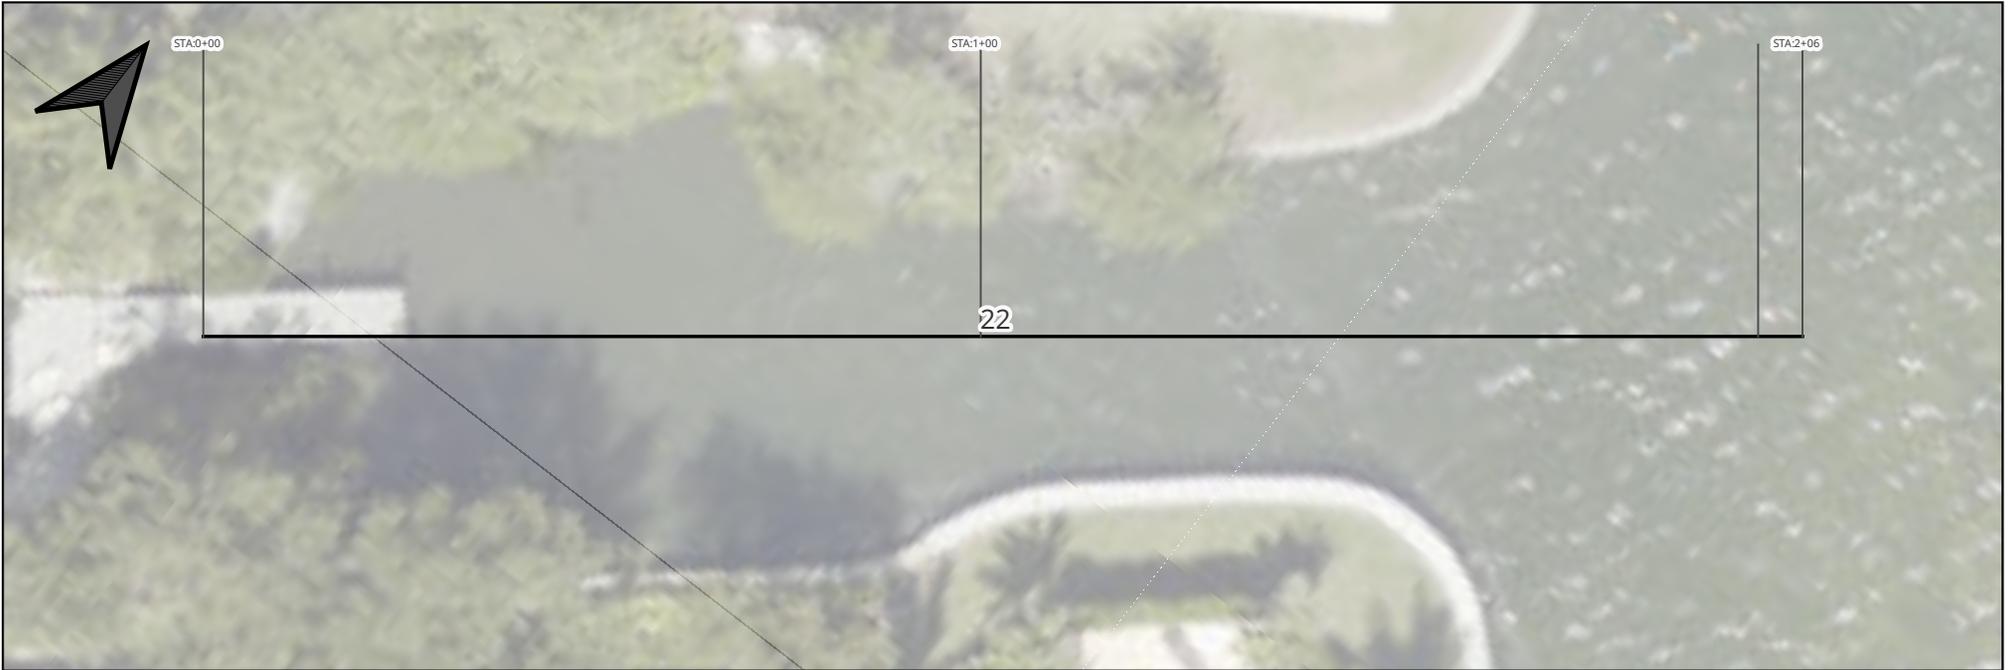
# Canal 22

Notes: Marker sign missing. Shallow at low tide. Dense seagrass

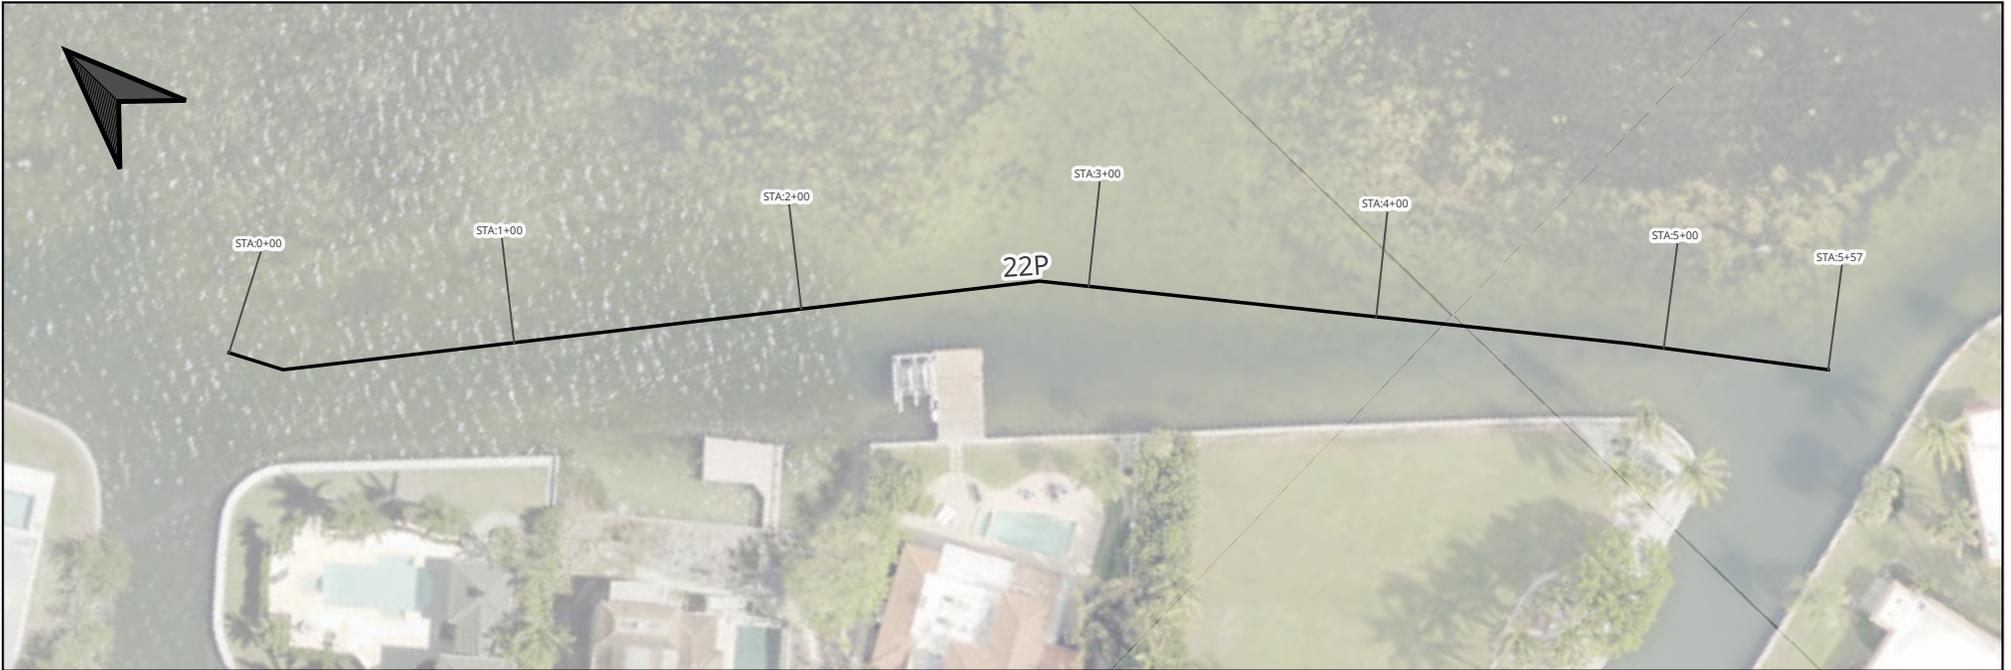
# Canal 22P

Limiting Depth at last Survey: -4 ft MLW at STA 2+70

Maintained Width: N/A  
 Maintained Depth: N/A  
 Monitoring Frequency: N/A  
 Dredging Required: N/A  
 Min Dredge Target: N/A  
 Number of Segments: N/A  
 Dredge Length: N/A  
 Additional Work: Added to 21P

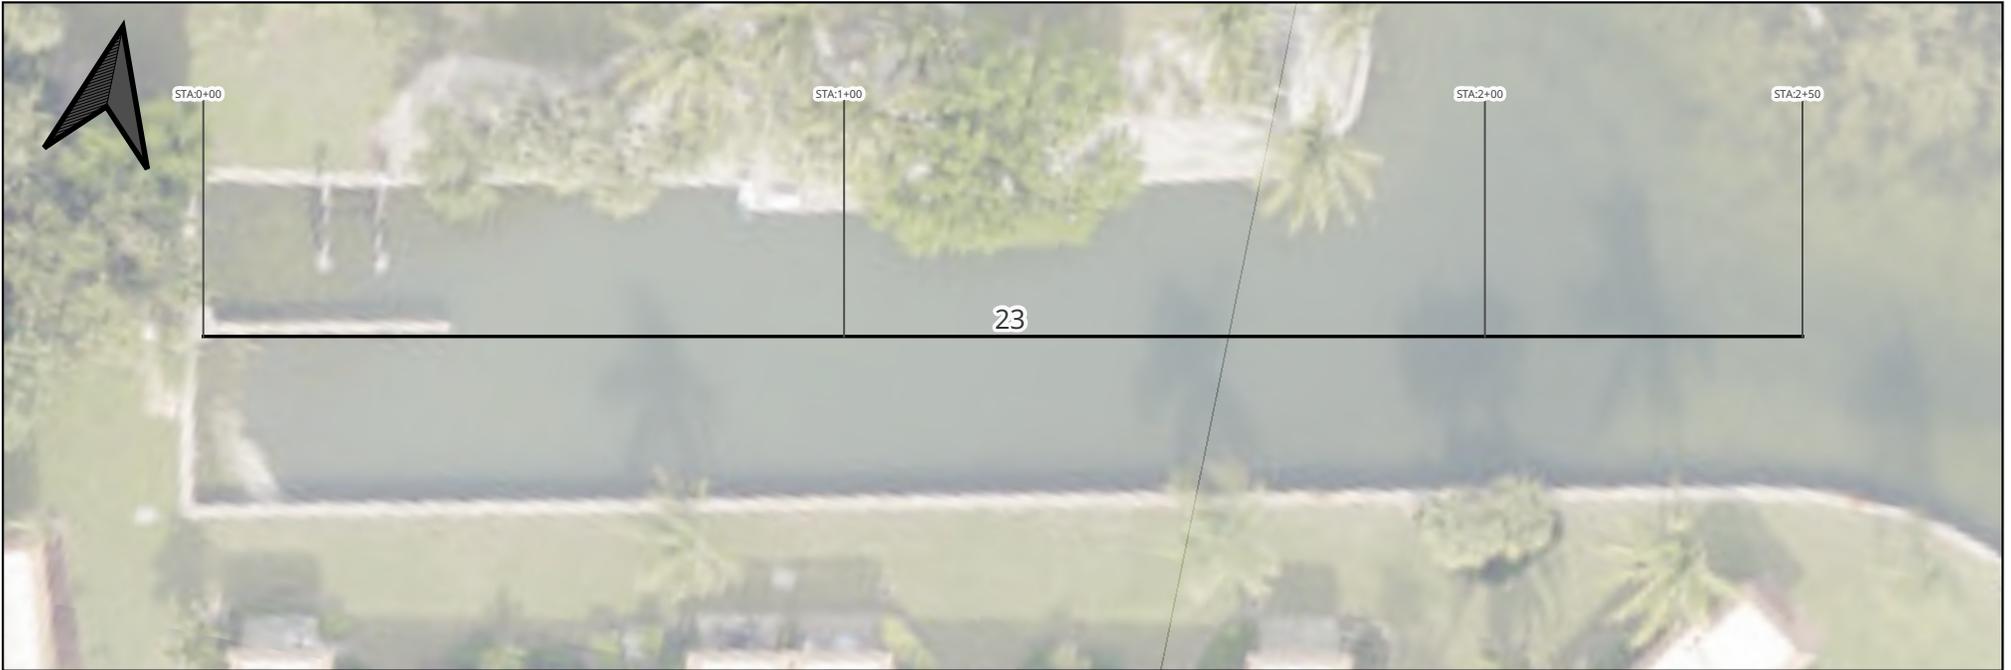
# Canal 23

Limiting Depth at last Survey: -3.4 ft MLW at STA 0+40

Maintained Width: 20 FT  
 Maintained Depth: -5.00 MLW  
 Monitoring Frequency: 2 years  
 Dredging Required: None  
 Min Dredge Target: -4.75 MLW  
 Number of Segments: 0  
 Dredge Length: 0 FT  
 Additional Work: Stations 0+00 to 0+55 not maintained by the Town

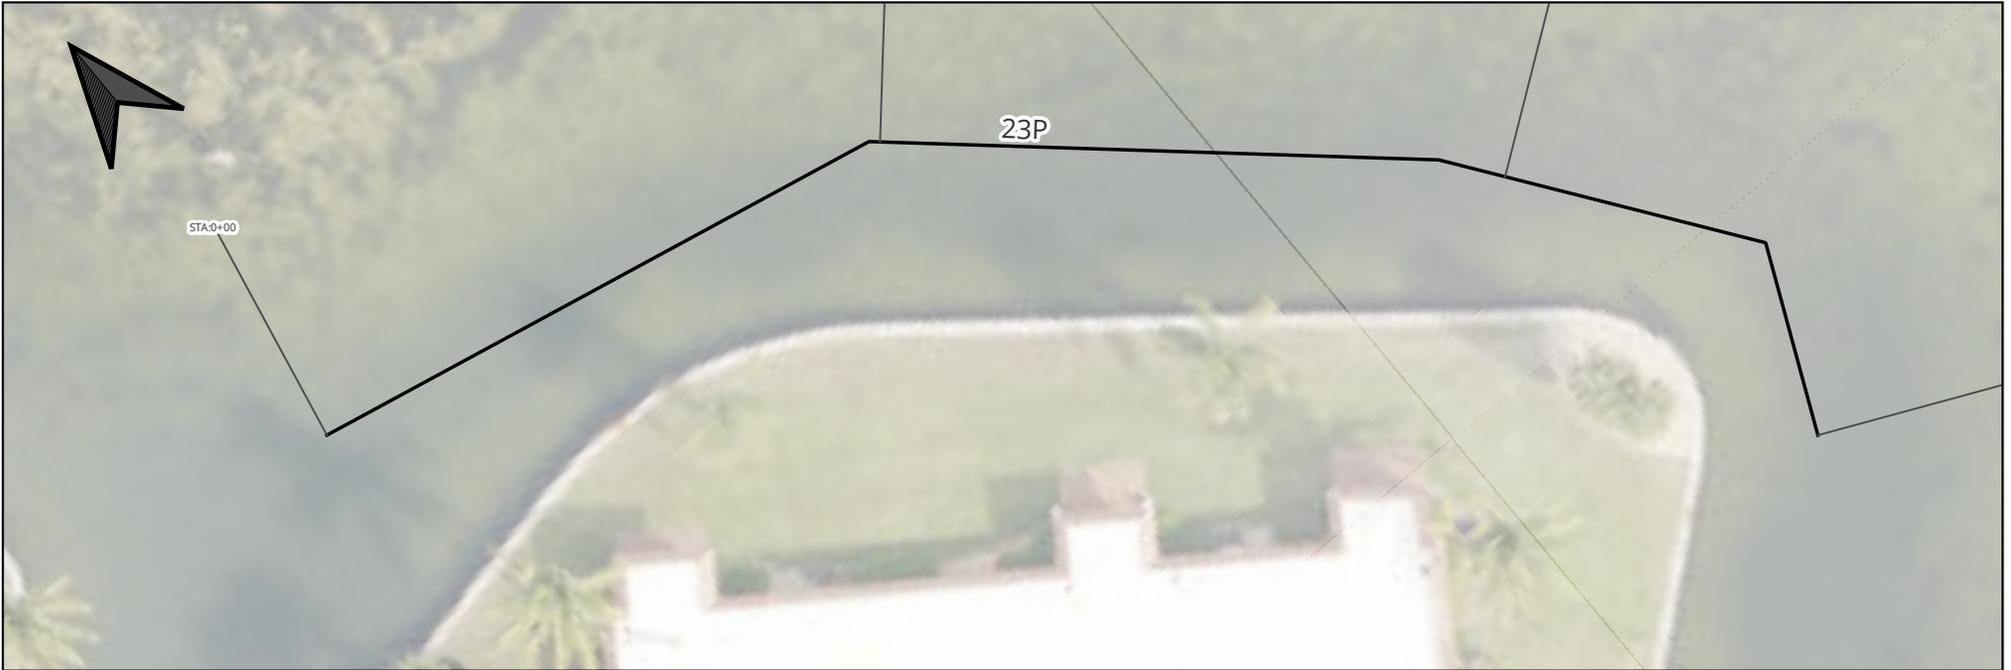
# Canal 23P

Limiting Depth at last Survey: -3.4 ft MLW at STA 2+75

Maintained Width: N/A  
 Maintained Depth: N/A  
 Monitoring Frequency: N/A  
 Dredging Required: N/A  
 Min Dredge Target: N/A  
 Number of Segments: N/A  
 Dredge Length: N/A  
 Additional Work: Added to 21P

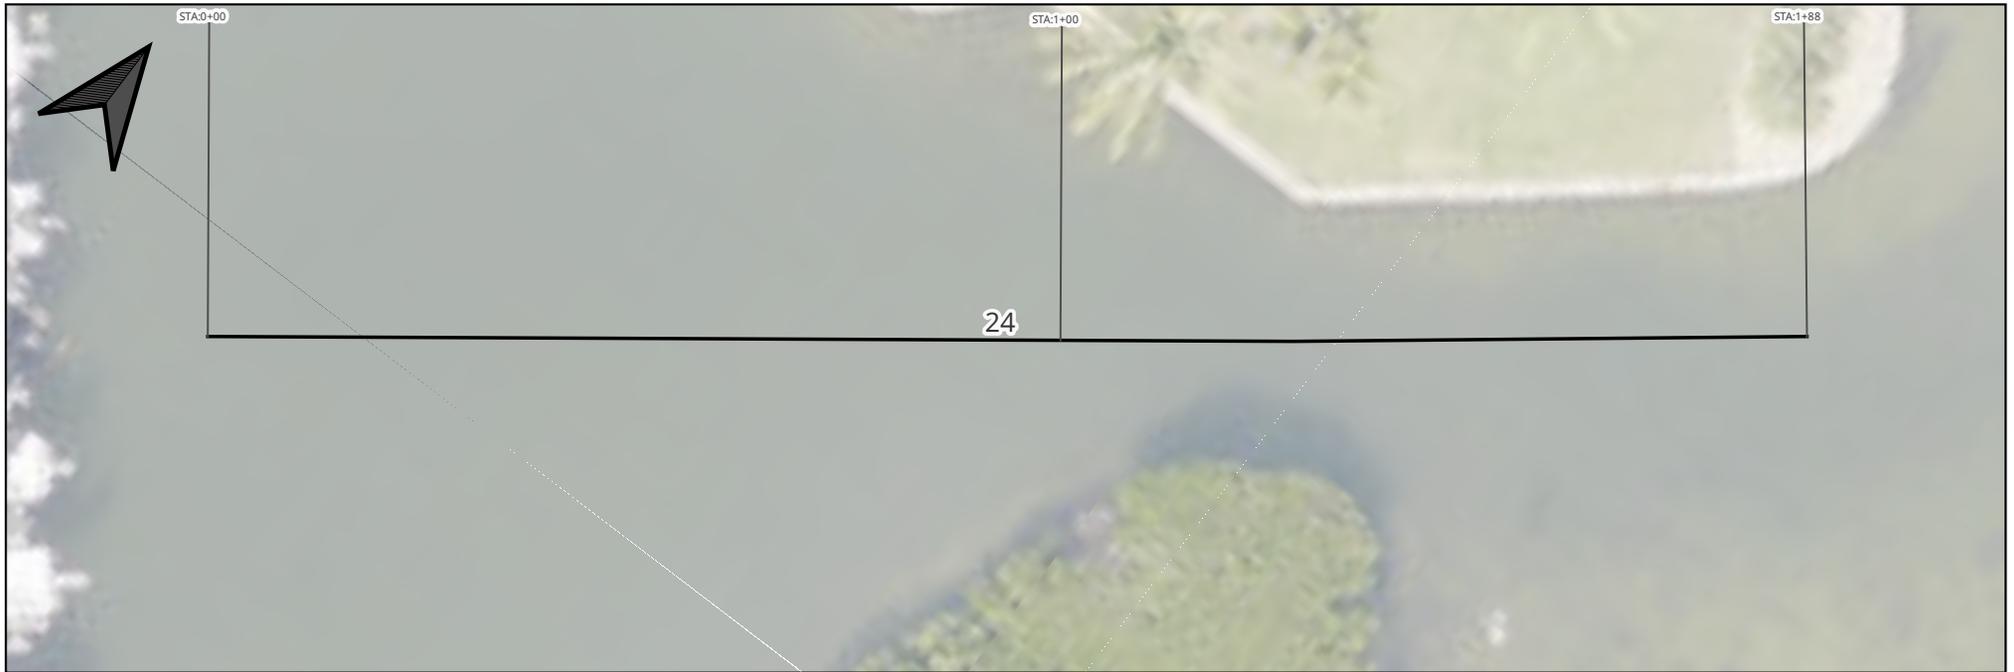
# Canal 24

Limiting Depth at last Survey: -3.4 ft MLW at STA 1+88

Maintained Width: 20 FT  
 Maintained Depth: -4.00 MLW  
 Monitoring Frequency: 2 year  
 Dredging Required: None  
 Min Dredge Target: -3.75 MLW  
 Number of Segments: 0  
 Dredge Length: 0 FT  
 Additional Work: Consider adding T for improved level of service

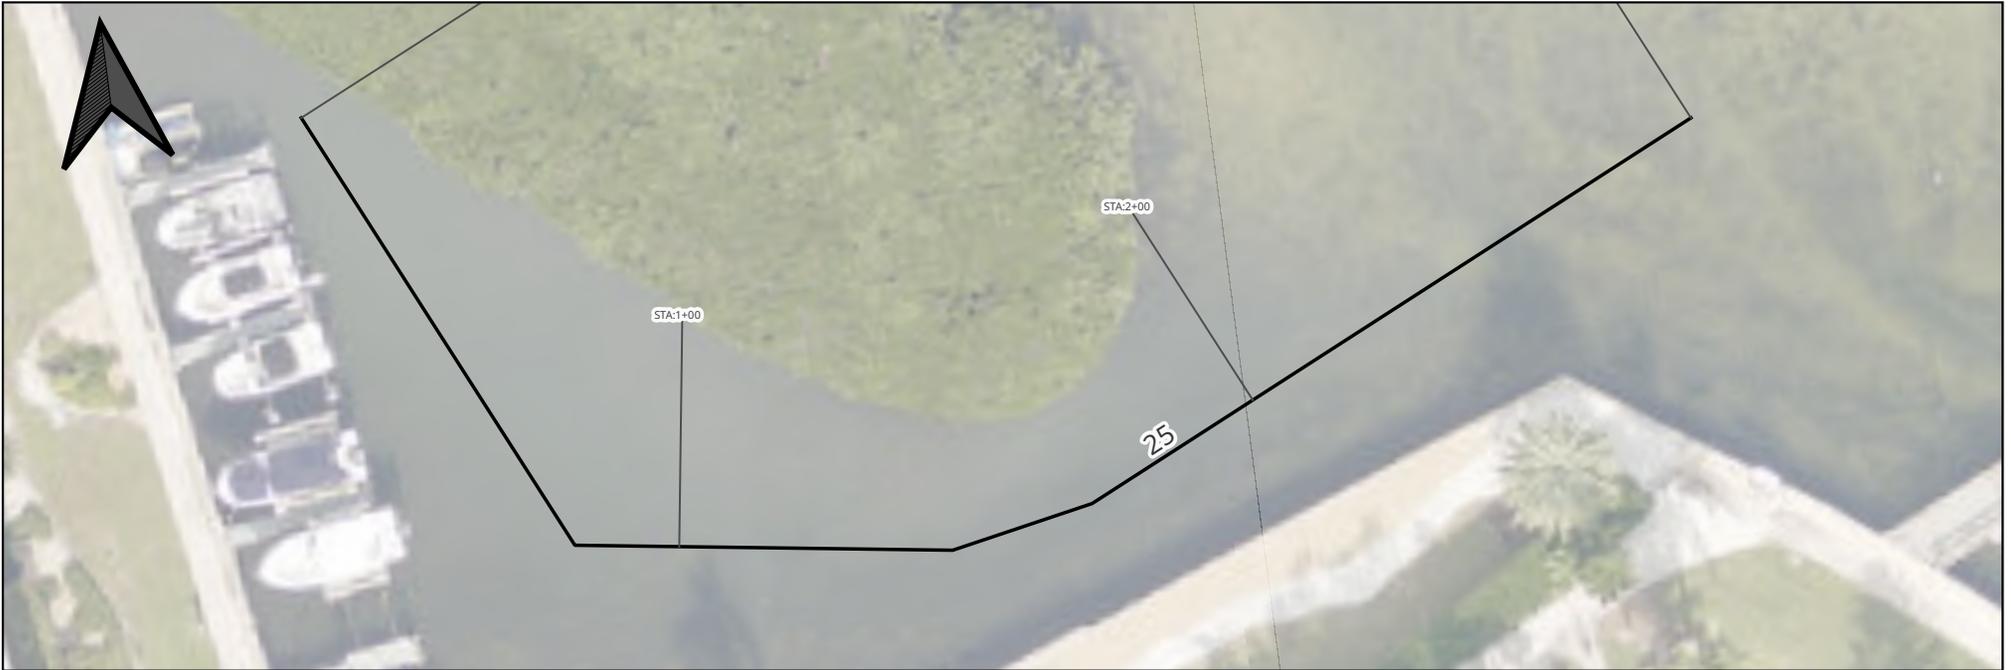
# Canal 25

Limiting Depth at last Survey: -3.1 ft MLW at STA 2+85

Maintained Width: 20 FT  
 Maintained Depth: -4.00 MLW  
 Monitoring Frequency: 1 year  
 Dredging Required: None  
 Min Dredge Target: -3.75 MLW  
 Number of Segments: 0  
 Dredge Length: 0 FT  
 Additional Work: Add seagrass/shoal marker

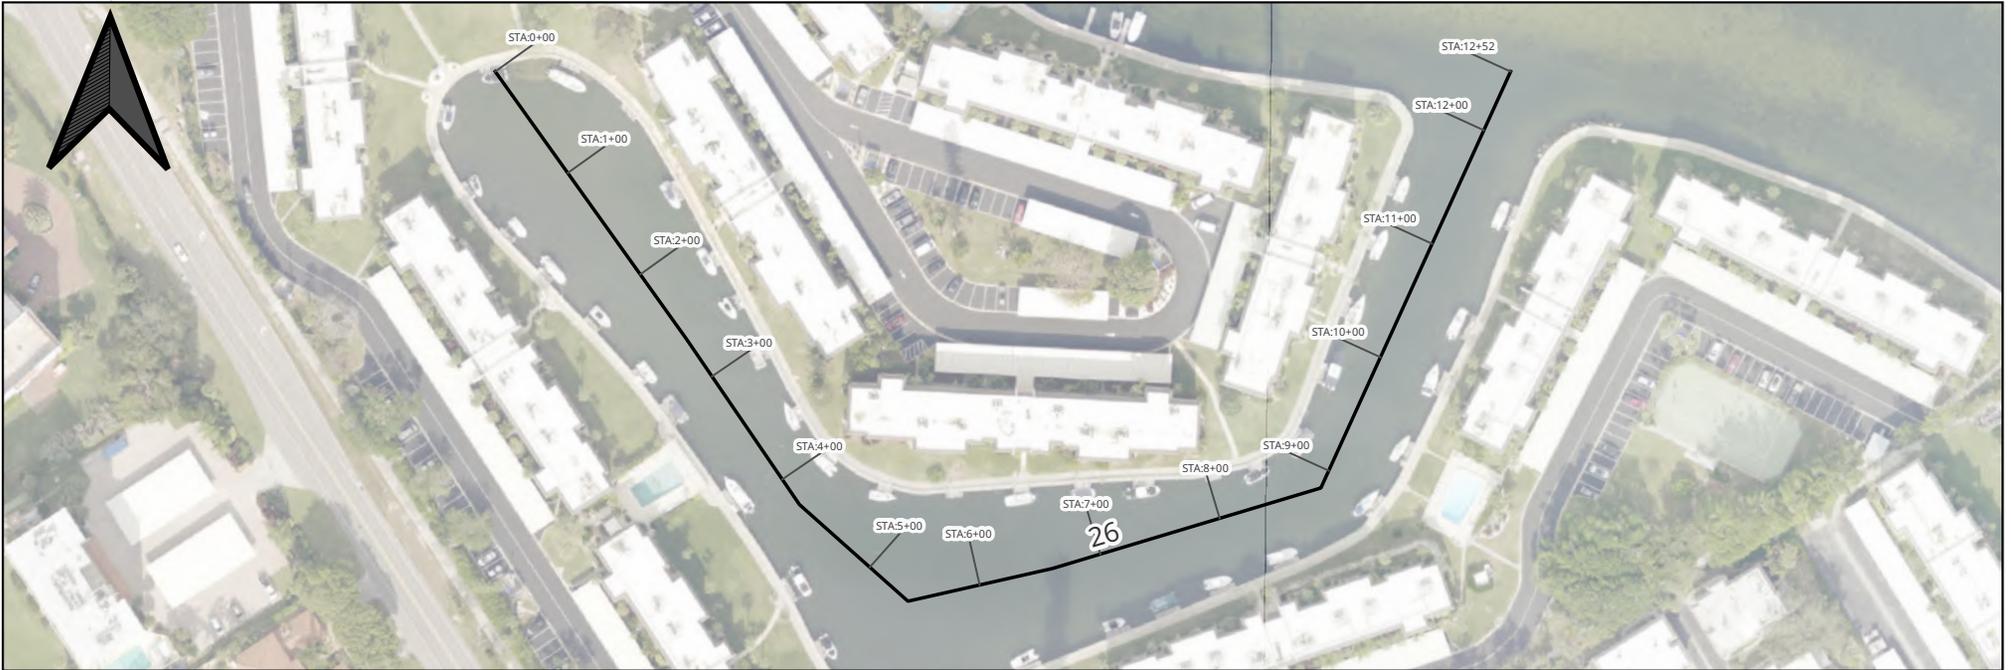
# Canal 26

Notes: Markers low to waterline. Marker pilings are old and damaged. Adjust south end alignment

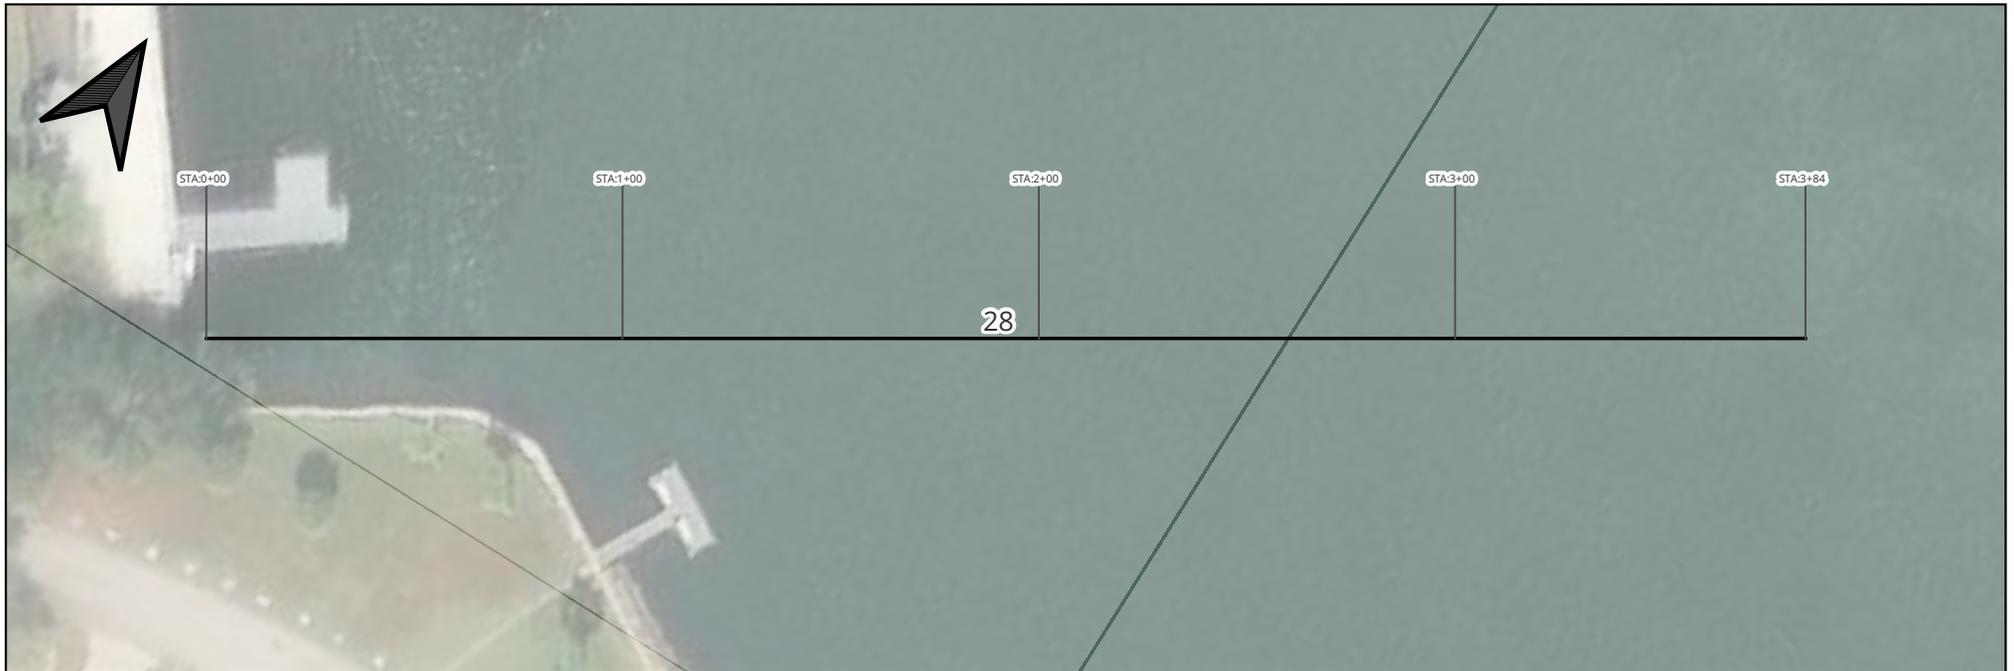
# Canal 28

Limiting Depth at last Survey: -2.3 ft MLW at STA 0+10

Maintained Width: N/A  
 Maintained Depth: N/A  
 Monitoring Frequency: N/A  
 Dredging Required: N/A  
 Min Dredge Target: N/A  
 Number of Segments: N/A  
 Dredge Length: N/A  
 Additional Work: Removed from the program

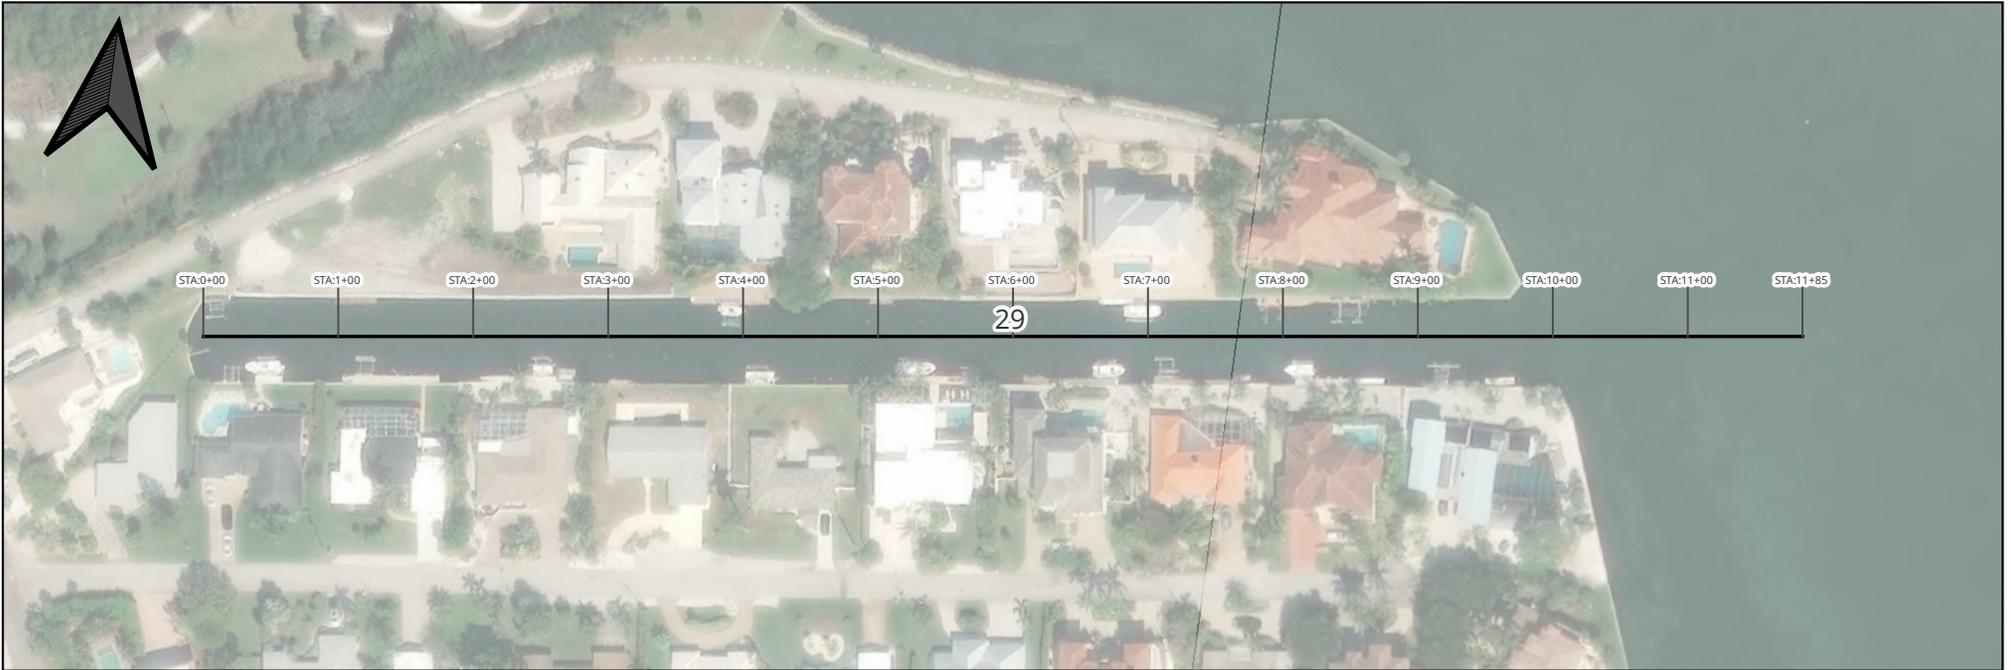
# Canal 29

Limiting Depth at last Survey: -4.2 ft MLW at STA 8+90

Maintained Width: 20 FT  
 Maintained Depth: -5.00 MLW  
 Monitoring Frequency: 2 years  
 Dredging Required: None  
 Min Dredge Target: -4.75 MLW  
 Number of Segments: 0  
 Dredge Length: 0 FT  
 Additional Work:

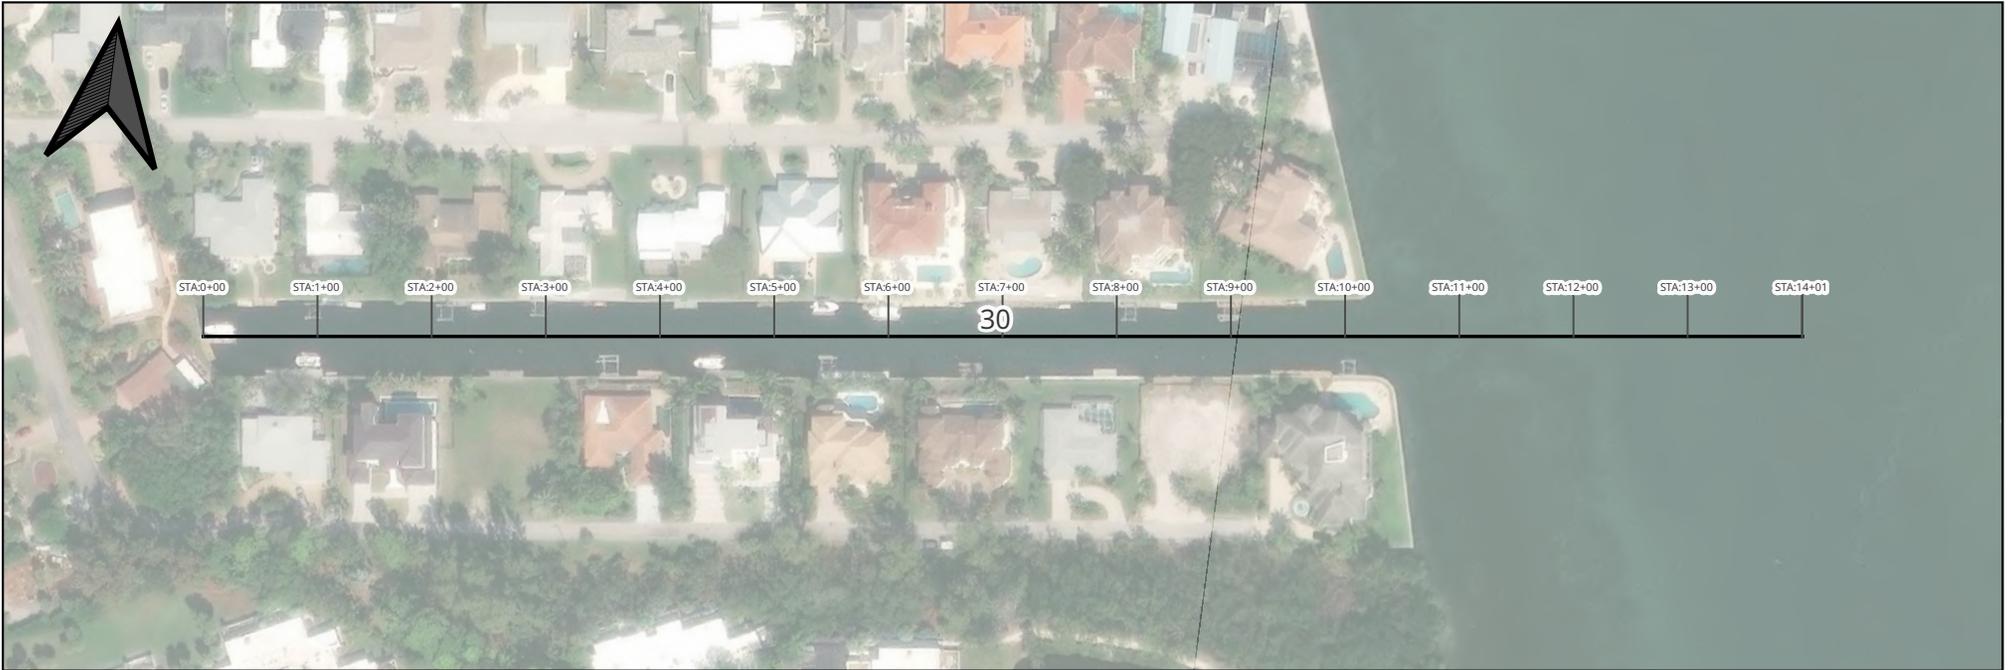
# Canal 30

Limiting Depth at last Survey: -4.6 ft MLW at STA 11+35

Maintained Width: 20 FT  
 Maintained Depth: -5.00 MLW  
 Monitoring Frequency: 2 years  
 Dredging Required: None  
 Min Dredge Target: -4.75 MLW  
 Number of Segments: 0  
 Dredge Length: 0 FT  
 Additional Work:

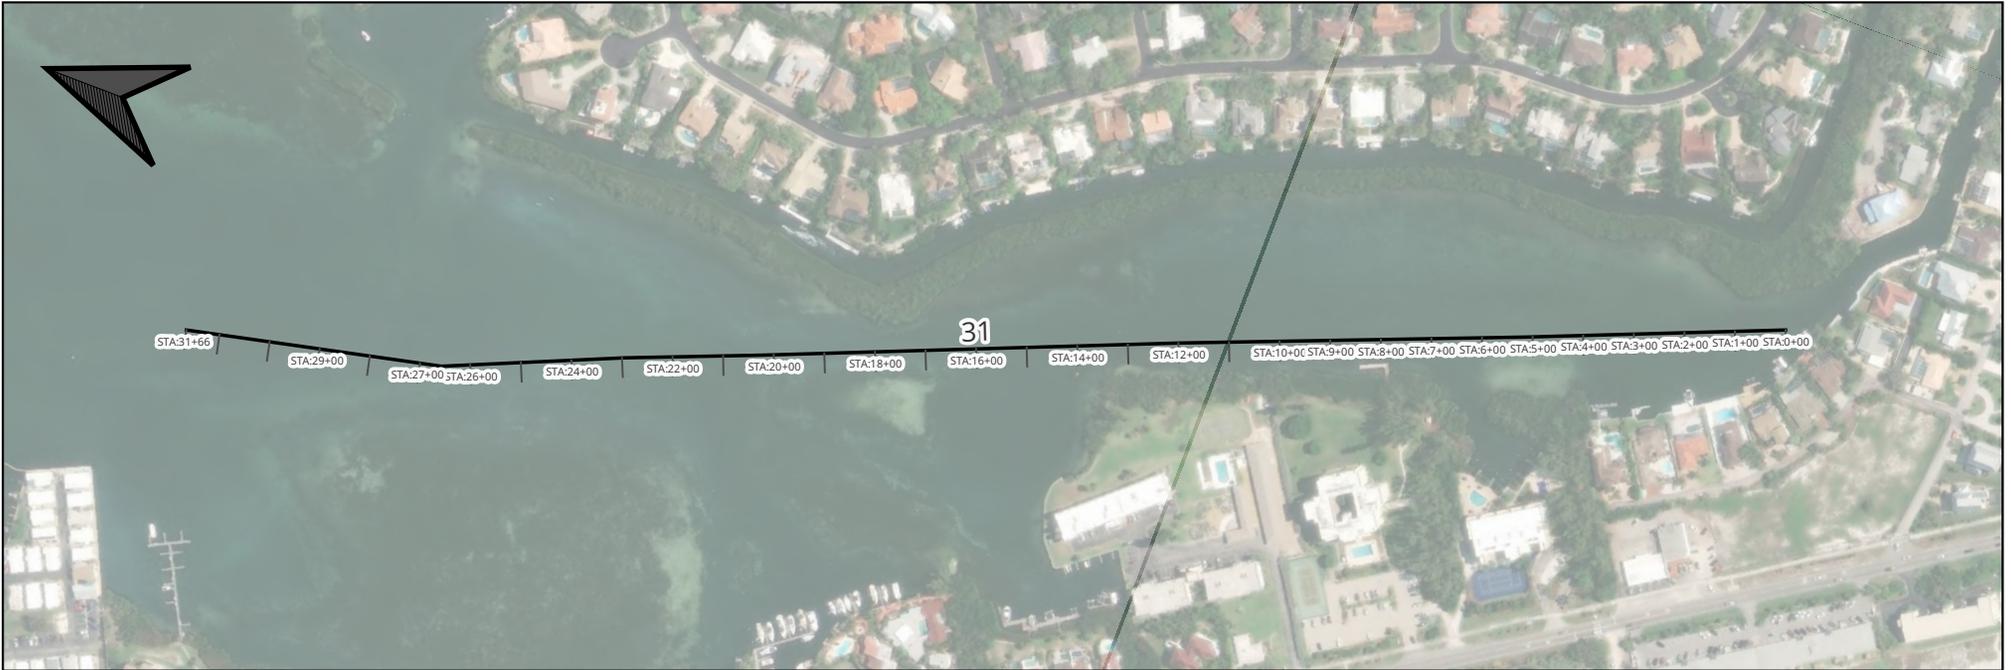
# Canal 31

Limiting Depth at last Survey: -5.4 ft MLW at STA 18+45

Maintained Width: 20 FT  
 Maintained Depth: -5.00 MLW  
 Monitoring Frequency: 2 years  
 Dredging Required: None  
 Min Dredge Target: -4.75 MLW  
 Number of Segments: 0  
 Dredge Length: 0 FT  
 Additional Work:

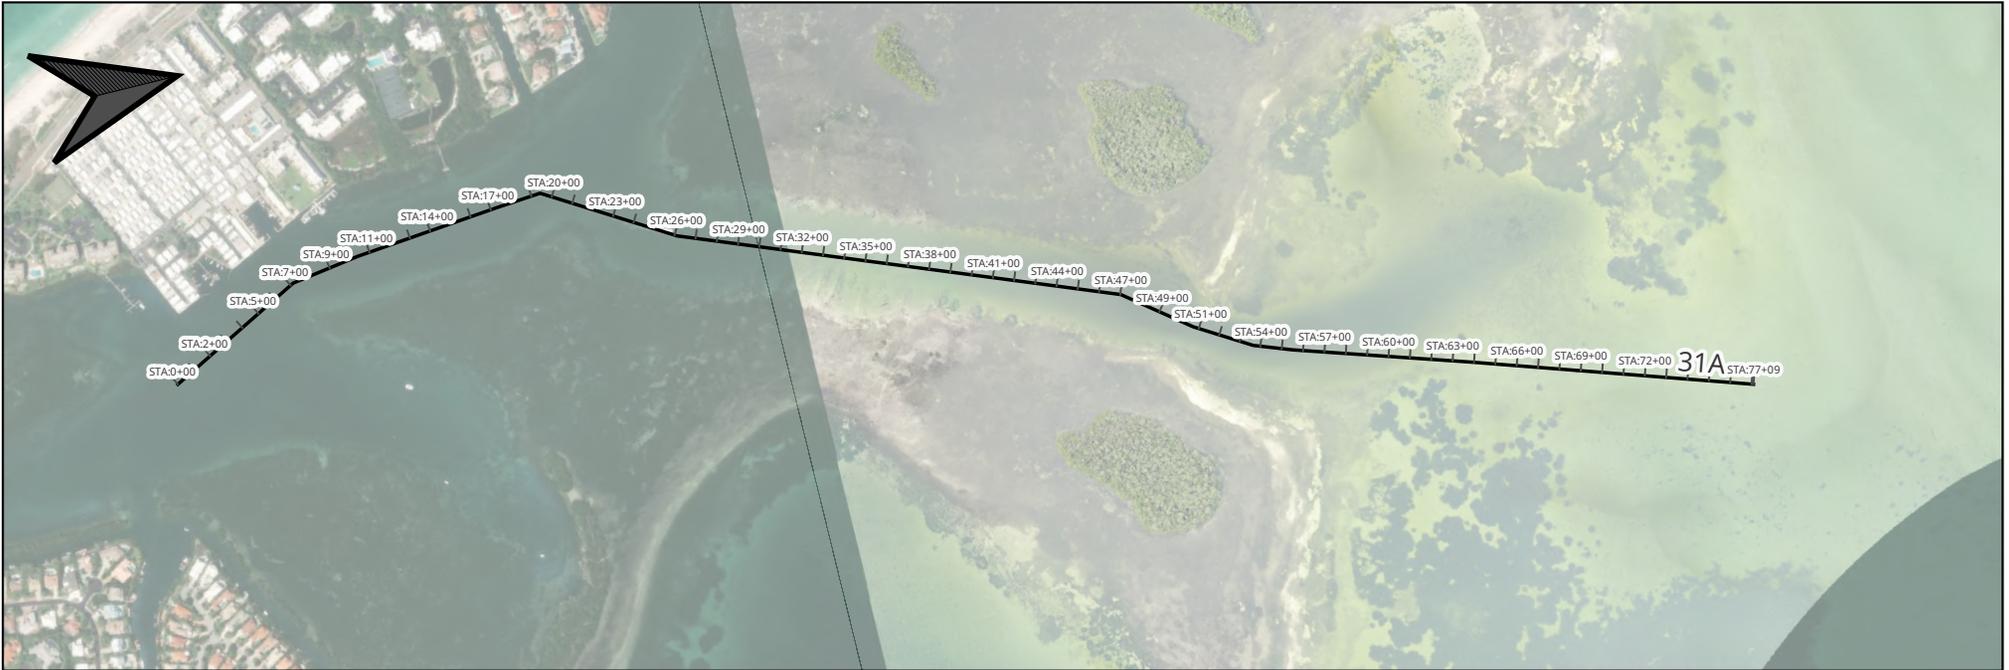
# Canal 31A

<u>Vessel</u>	<u>Transiting</u>
Length: 35 ft	B - As expected
Beam: 14 ft	
Draft: 5.5 ft	
	<u>Meeting</u>
	C - local knowledge
	<u>Maneuvering</u>
	D - Conditionally Restricted

Maintained Width: 40 FT  
 Maintained Depth: -5.00 MLW  
 Monitoring Frequency: 2 years  
 Dredging Required: None  
 Min Dredge Target: -4.75 MLW  
 Number of Segments: 0  
 Dredge Length: 0 FT  
 Additional Work: Recommend increasing channel width and depth in the future. Consider re-marking channel

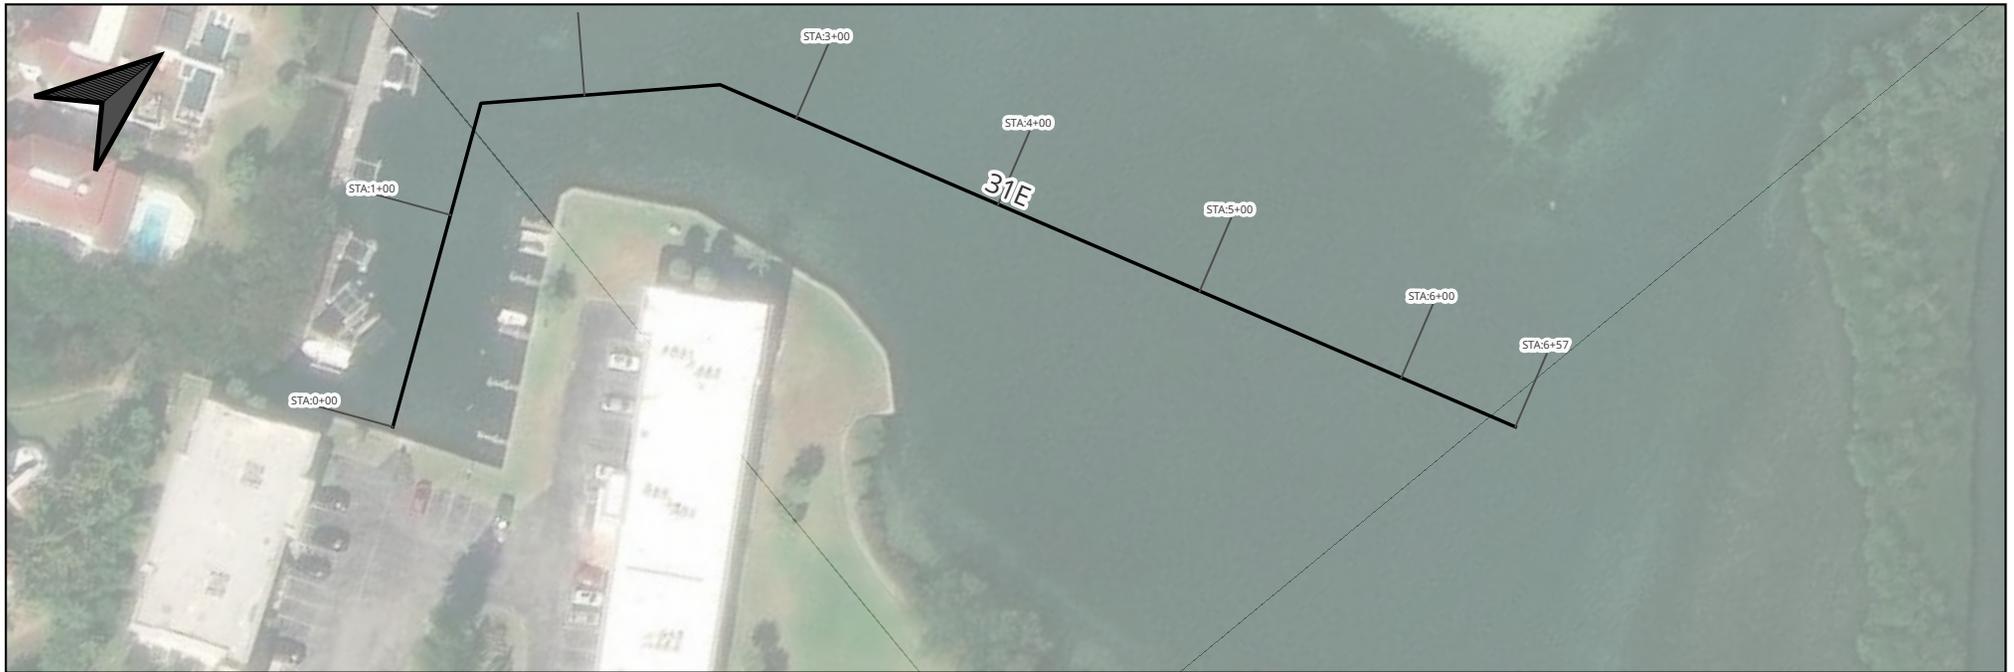
# Canal 31E

Primary Usage: Mooring/Dockage, Transit                      Avg Vessel Beam: 7 - 10 ft  
 Density of Water Access: 30%                      Avg Vessel Draft: 2 - 4 ft  
 Noted Damage to Structures: No                      Mapped Seagrass: None  
 Notable Exposures: Wind                      Mapped  
 Impediments: None

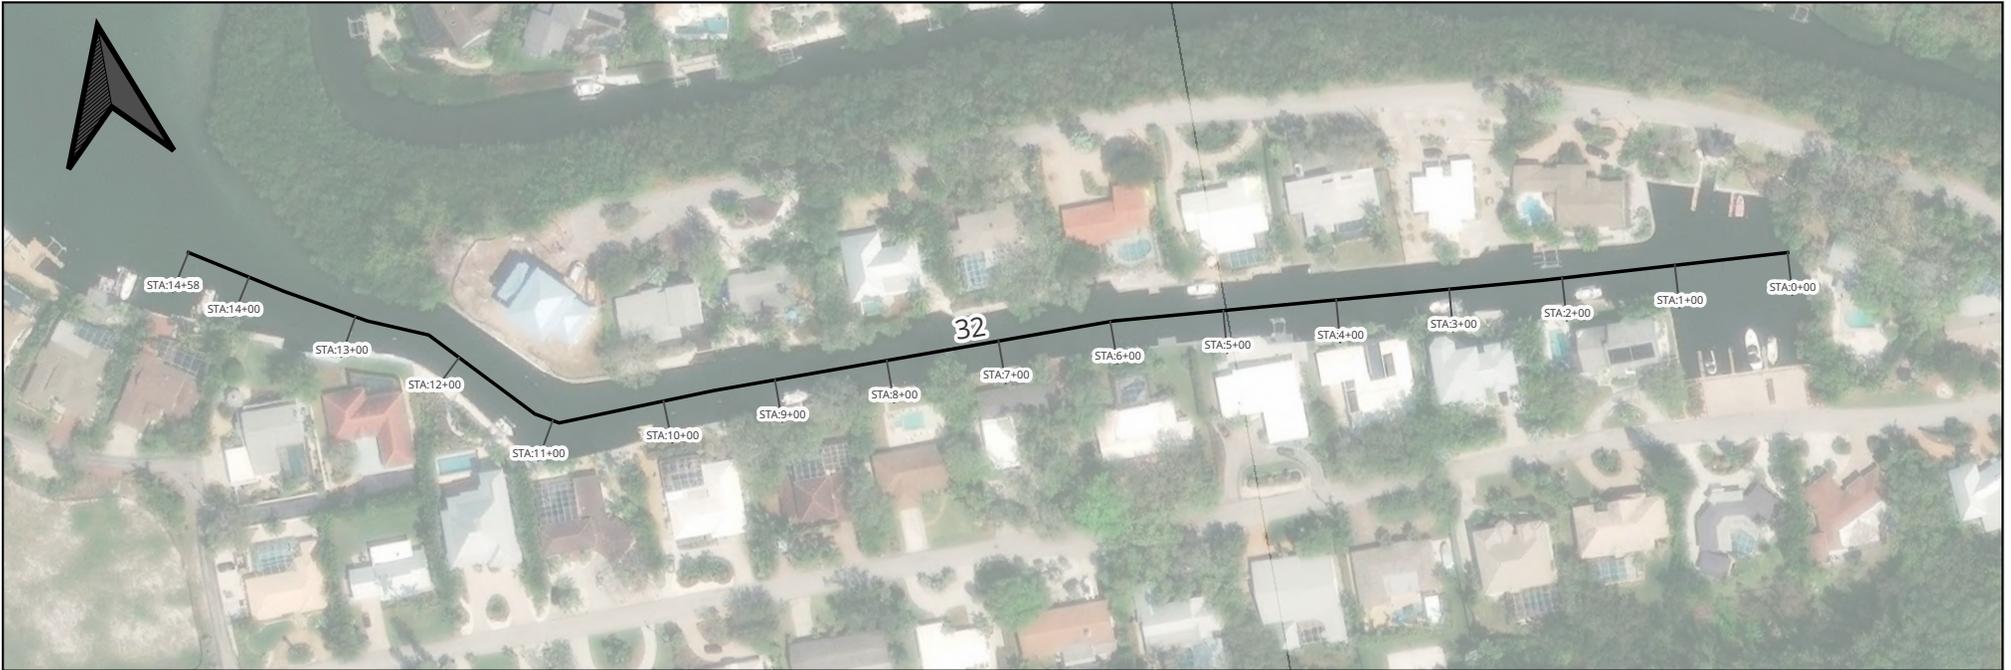
# Canal 32

Limiting Depth at last Survey: -3.6 ft MLW at STA 7+33

Maintained Width: 20 FT  
 Maintained Depth: -5.00 MLW  
 Monitoring Frequency: 1 year  
 Dredging Required: Yes  
 Min Dredge Target: -4.75 MLW  
 Number of Segments: Determine during future project  
 Dredge Length: Determine during future project  
 Additional Work:
