# Longboat Key Canal Maintenance Program

## Canal Sheets June 2024

Developed by First Line Coastal alongside the Town of  
Longboat Key Public Works Department

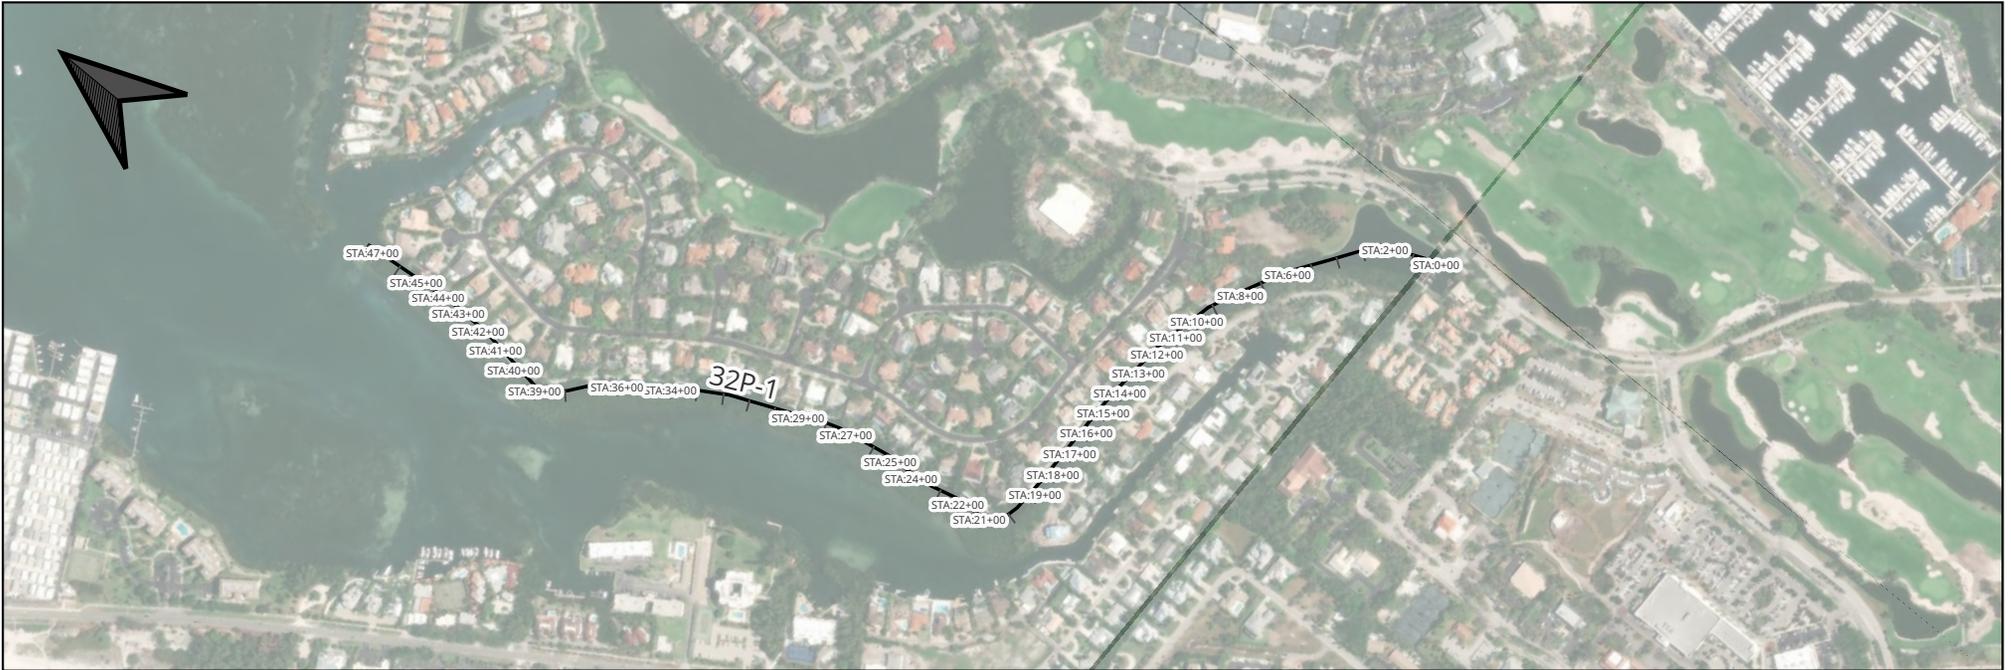
# Canal 32P-1

Limiting Depth at last Survey: -3.3 ft MLW at STA 43+00

Maintained Width: 20 FT  
 Maintained Depth: -5.00 MLW  
 Monitoring Frequency: 1 year  
 Dredging Required: Yes  
 Min Dredge Target: -4.75 MLW  
 Number of Segments: Determine during future project  
 Dredge Length: Determine during future project  
 Additional Work: Dredging required in north stretch only

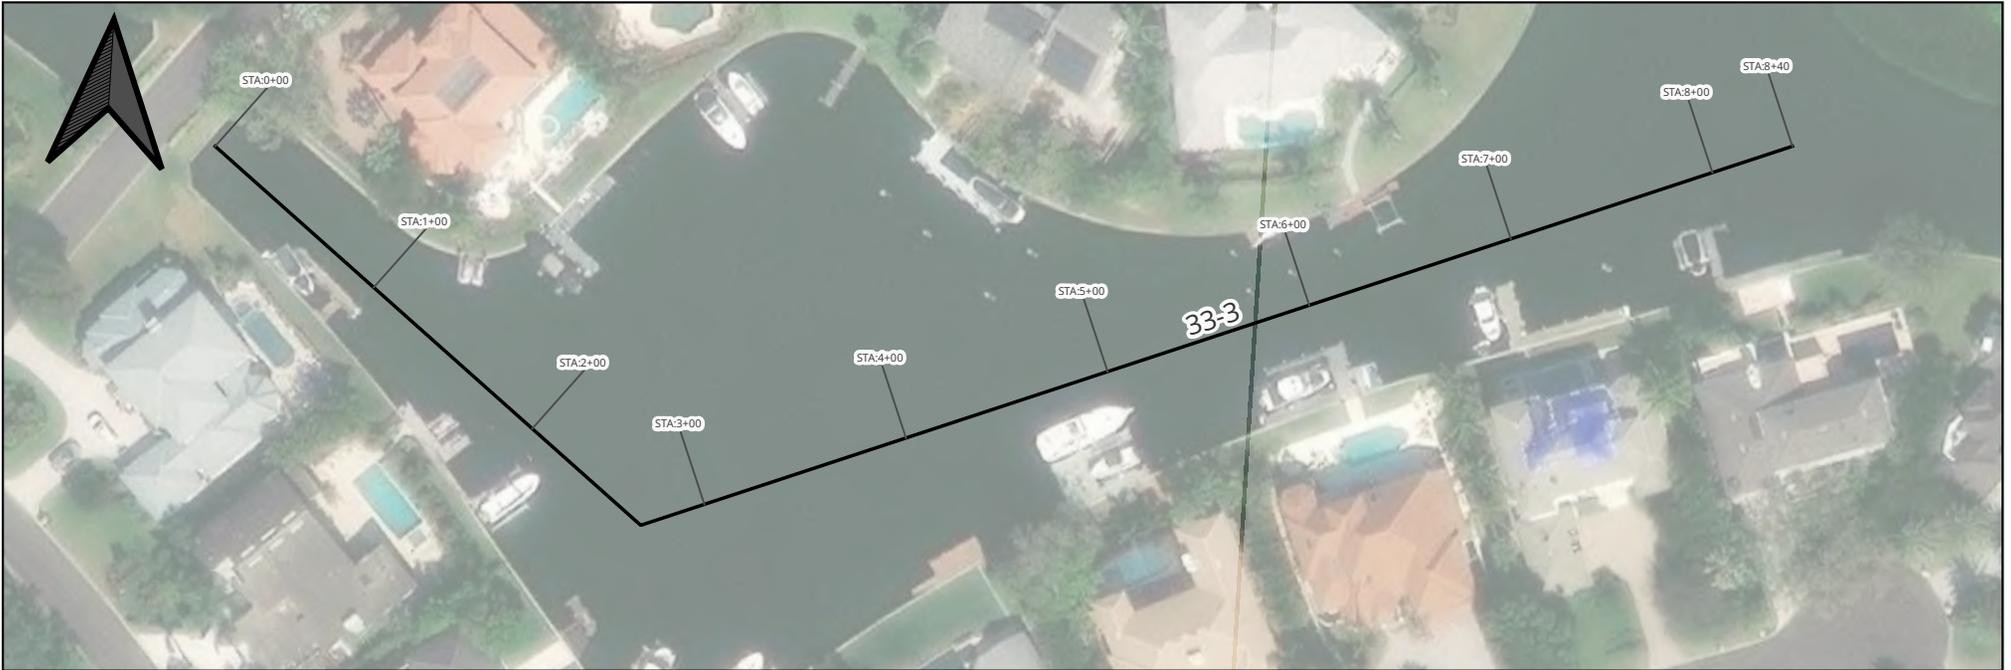
# Canal 33-3

Limiting Depth at last Survey: -4.8 ft MLW at STA 1+00

Maintained Width: 20 FT  
 Maintained Depth: -5.00 MLW  
 Monitoring Frequency: 2 years  
 Dredging Required: None  
 Min Dredge Target: -4.75 MLW  
 Number of Segments: 0  
 Dredge Length: 0 FT  
 Additional Work: Could maintain as a basin

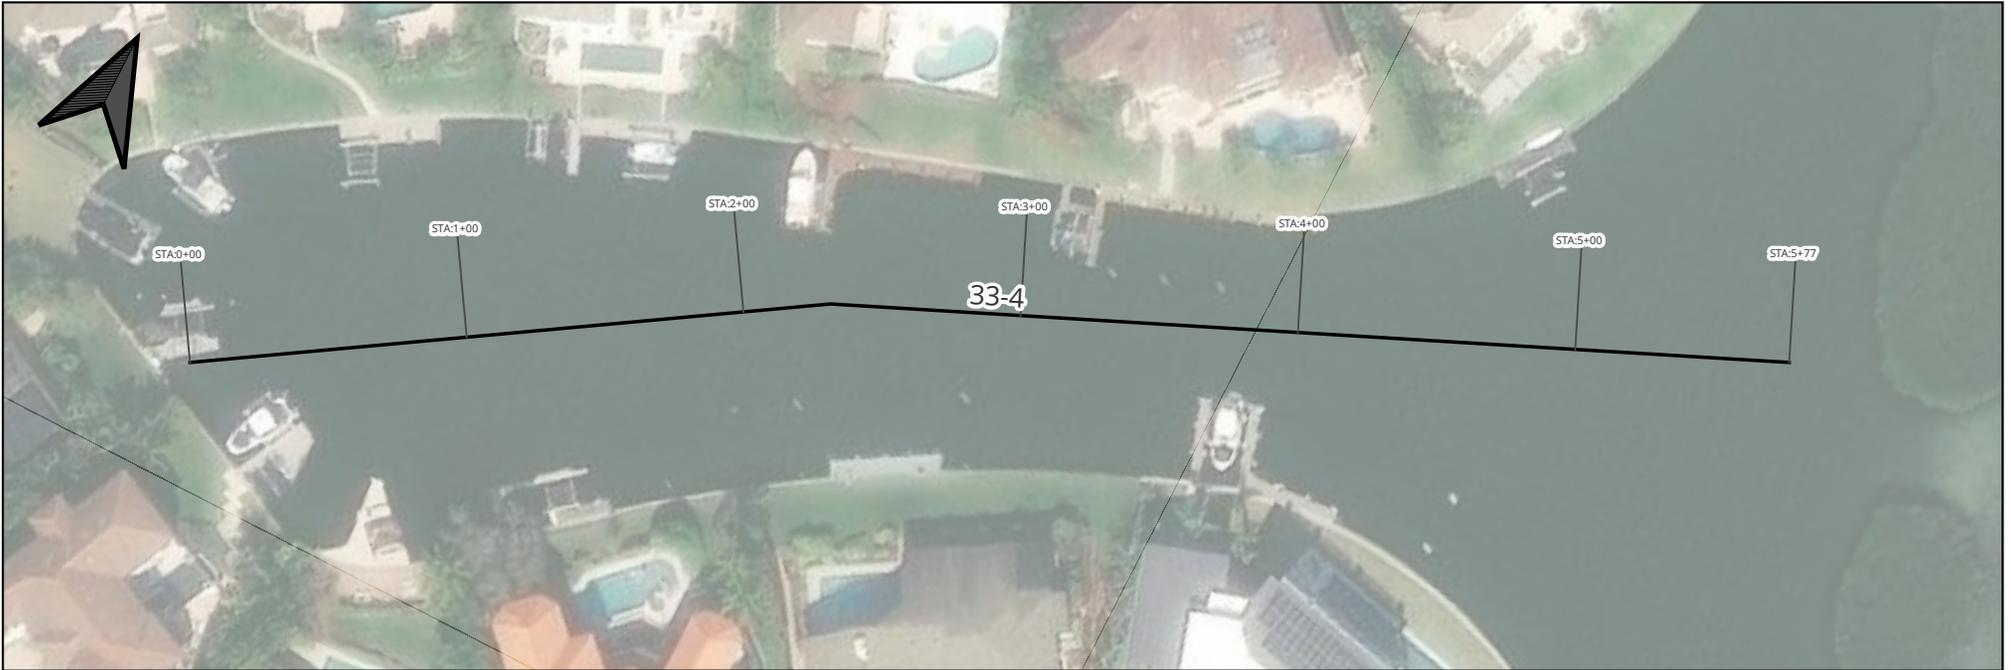
# Canal 33-4

Limiting Depth at last Survey: -7.7 ft MLW at STA 4+75

Maintained Width: 20 FT  
 Maintained Depth: -5.00 MLW  
 Monitoring Frequency: 2 years  
 Dredging Required: None  
 Min Dredge Target: -4.75 MLW  
 Number of Segments: 0  
 Dredge Length: 0 FT  
 Additional Work:

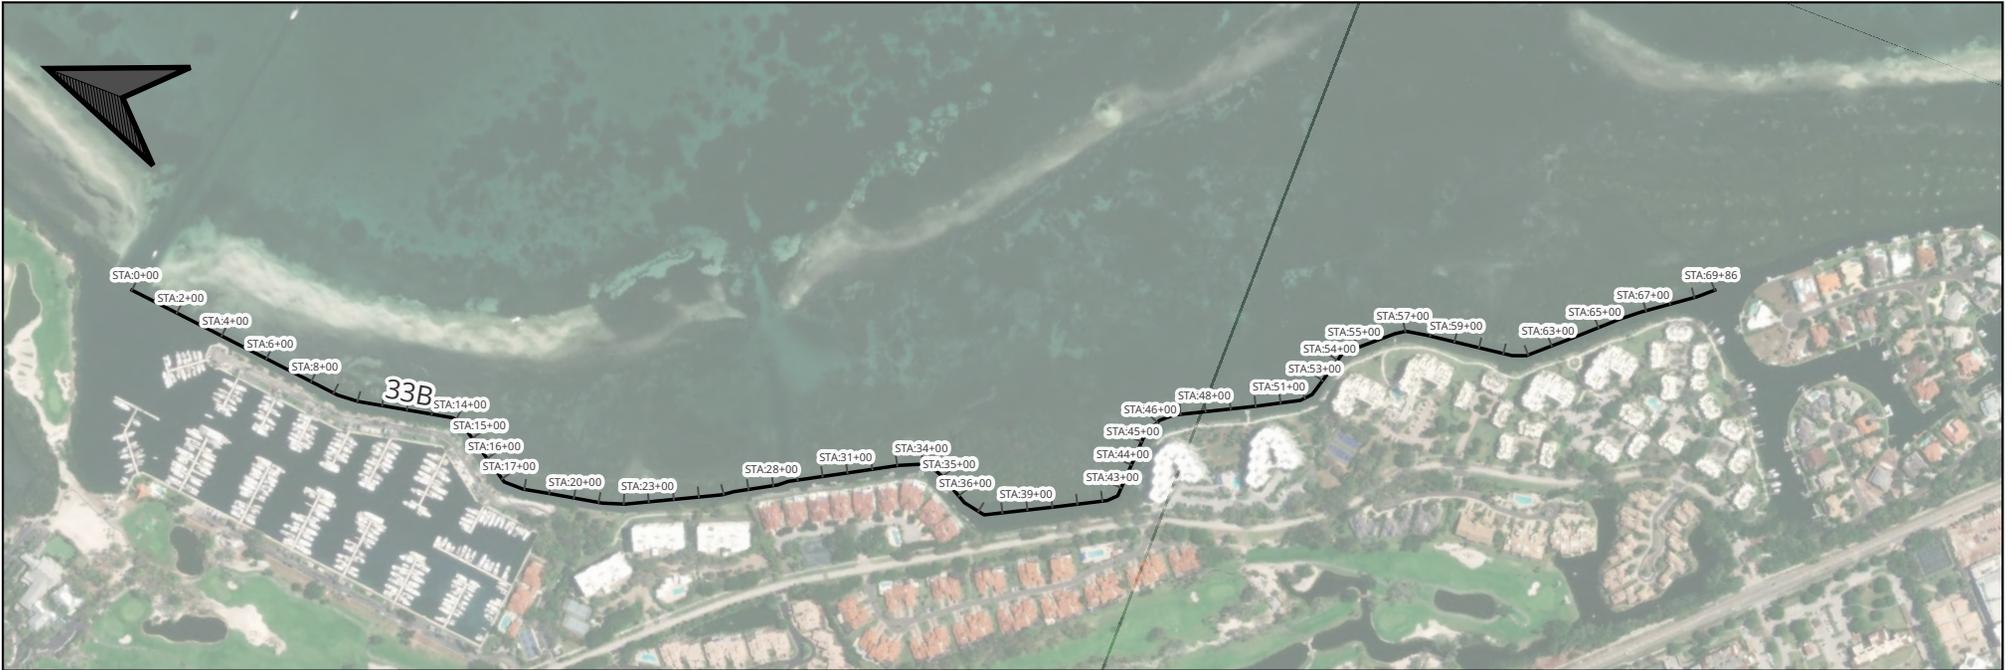
# Canal 33B

Limiting Depth at last Survey: -3.5 ft MLW at STA 14+00

Maintained Width: 20 FT  
 Maintained Depth: -5.00 MLW  
 Monitoring Frequency: 1 year  
 Dredging Required: Yes  
 Min Dredge Target: -4.75 MLW  
 Number of Segments: Determine during future project  
 Dredge Length: Determine during future project  
 Additional Work: Spot dredging

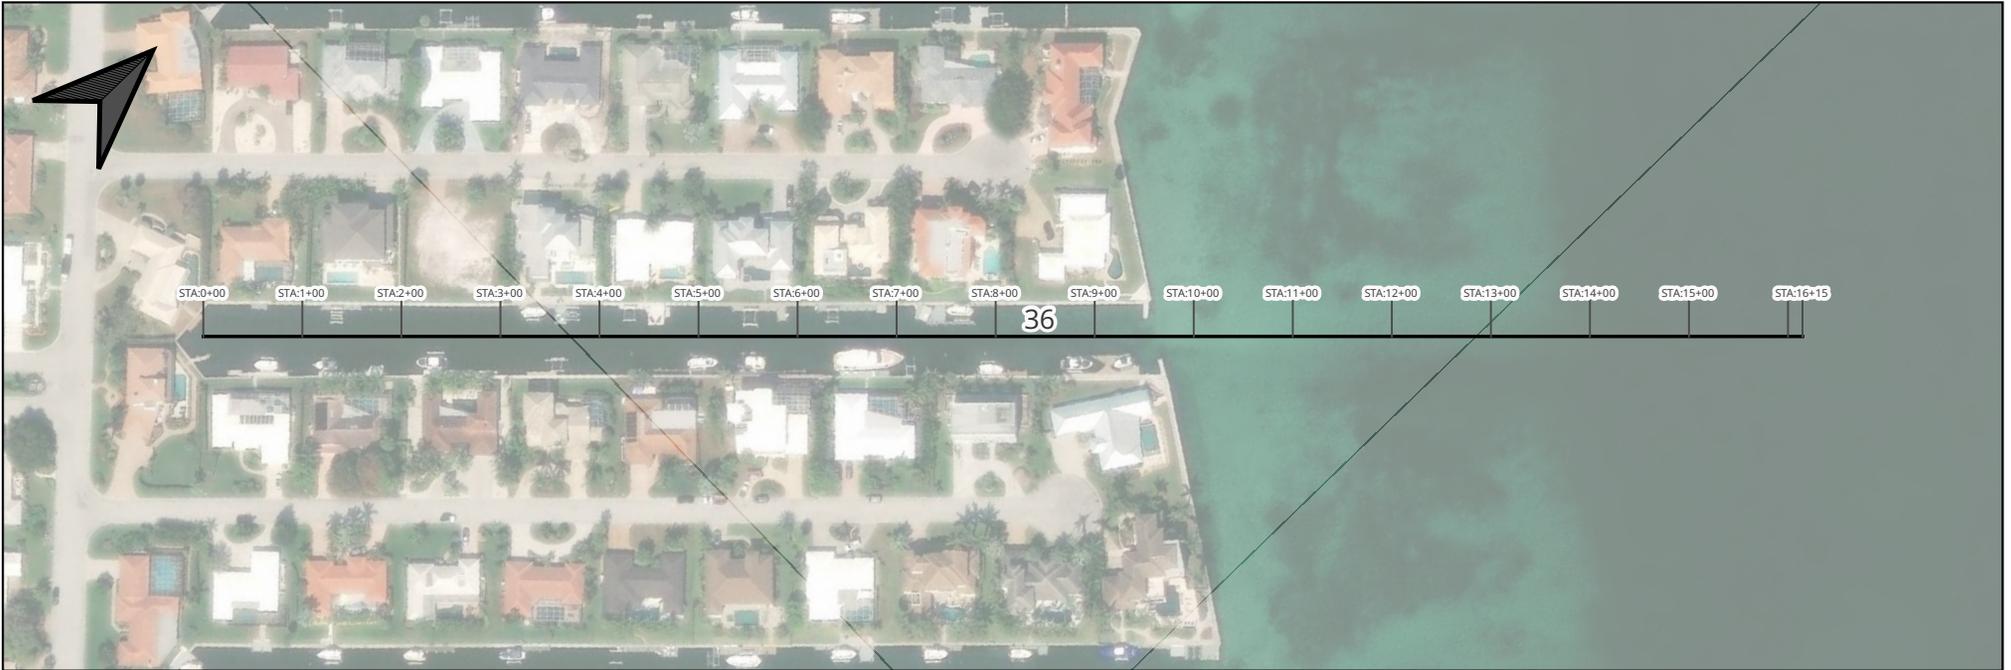
# Canal 36

Limiting Depth at last Survey: -3.6 ft MLW at STA 9+80

Maintained Width: 20 FT  
 Maintained Depth: -5.00 MLW  
 Monitoring Frequency: 1 year  
 Dredging Required: Yes  
 Min Dredge Target: -4.75 MLW  
 Number of Segments: Determine during future project  
 Dredge Length: Determine during future project  
 Additional Work: Maintain mouth to 6ft, interior to 5 ft

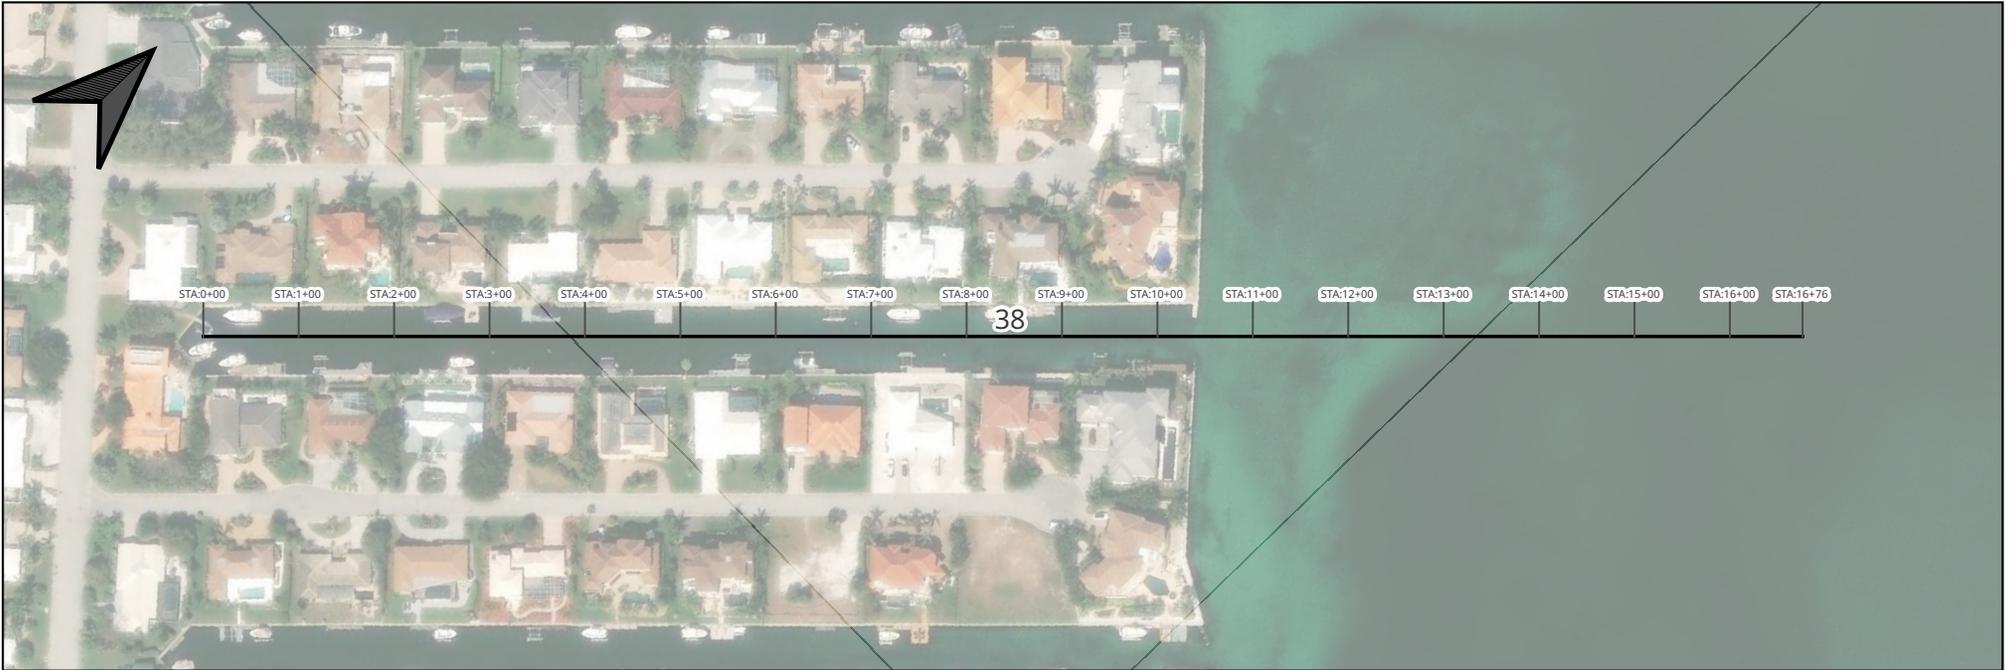
# Canal 38

Limiting Depth at last Survey: -4.1 ft MLW at STA 10+35

Maintained Width: 20 FT  
 Maintained Depth: -5.00 MLW  
 Monitoring Frequency: 1 year  
 Dredging Required: Yes  
 Min Dredge Target: -4.75 MLW  
 Number of Segments: Determine during future project  
 Dredge Length: Determine during future project  
 Additional Work: Maintain mouth to 6ft, interior to 5 ft

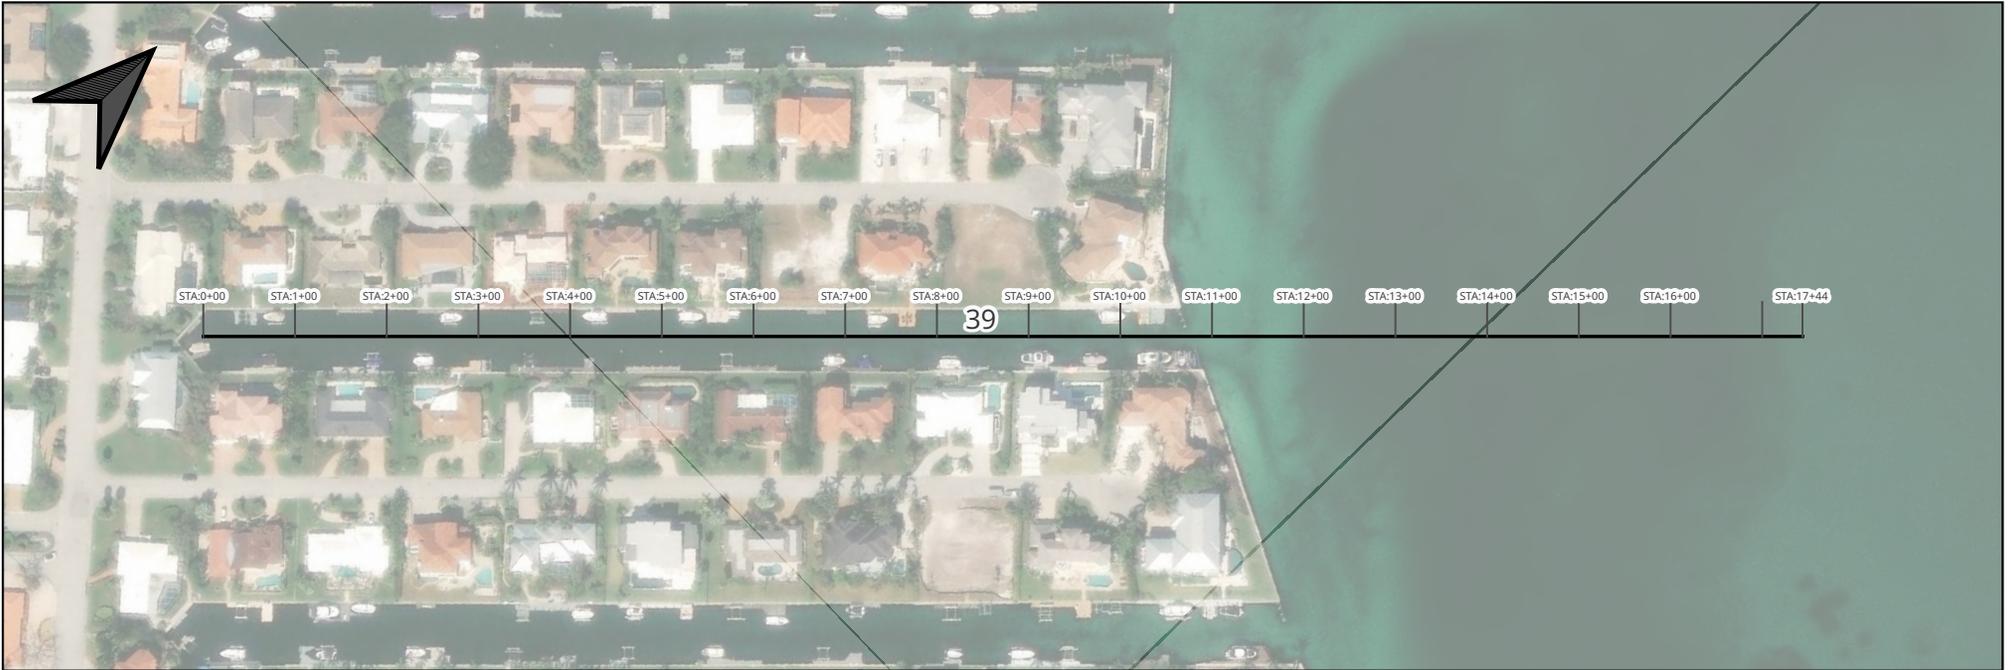
# Canal 39

Limiting Depth at last Survey: -3.9 ft MLW at STA 10+50

Maintained Width: 20 FT  
 Maintained Depth: -5.00 MLW  
 Monitoring Frequency: 1 year  
 Dredging Required: None  
 Min Dredge Target: -4.75 MLW  
 Number of Segments: 0  
 Dredge Length: 0 FT  
 Additional Work:

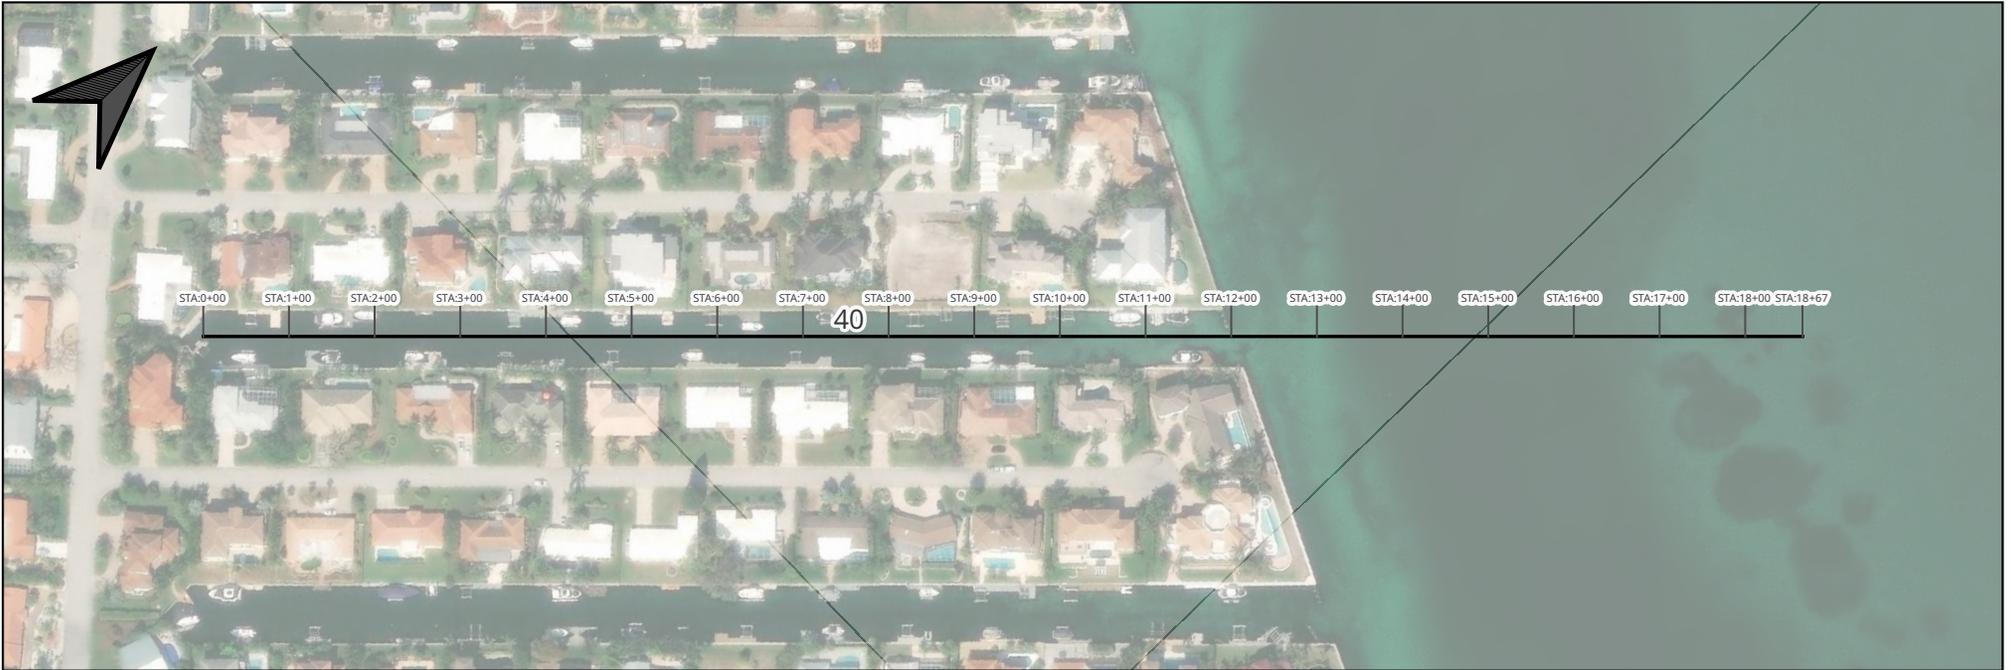
# Canal 40

Limiting Depth at last Survey: -3.7 ft MLW at STA 11+40

Maintained Width: 20 FT  
 Maintained Depth: -5.00 MLW  
 Monitoring Frequency: 1 year  
 Dredging Required: None  
 Min Dredge Target: -4.75 MLW  
 Number of Segments: 0  
 Dredge Length: 0 FT  
 Additional Work:

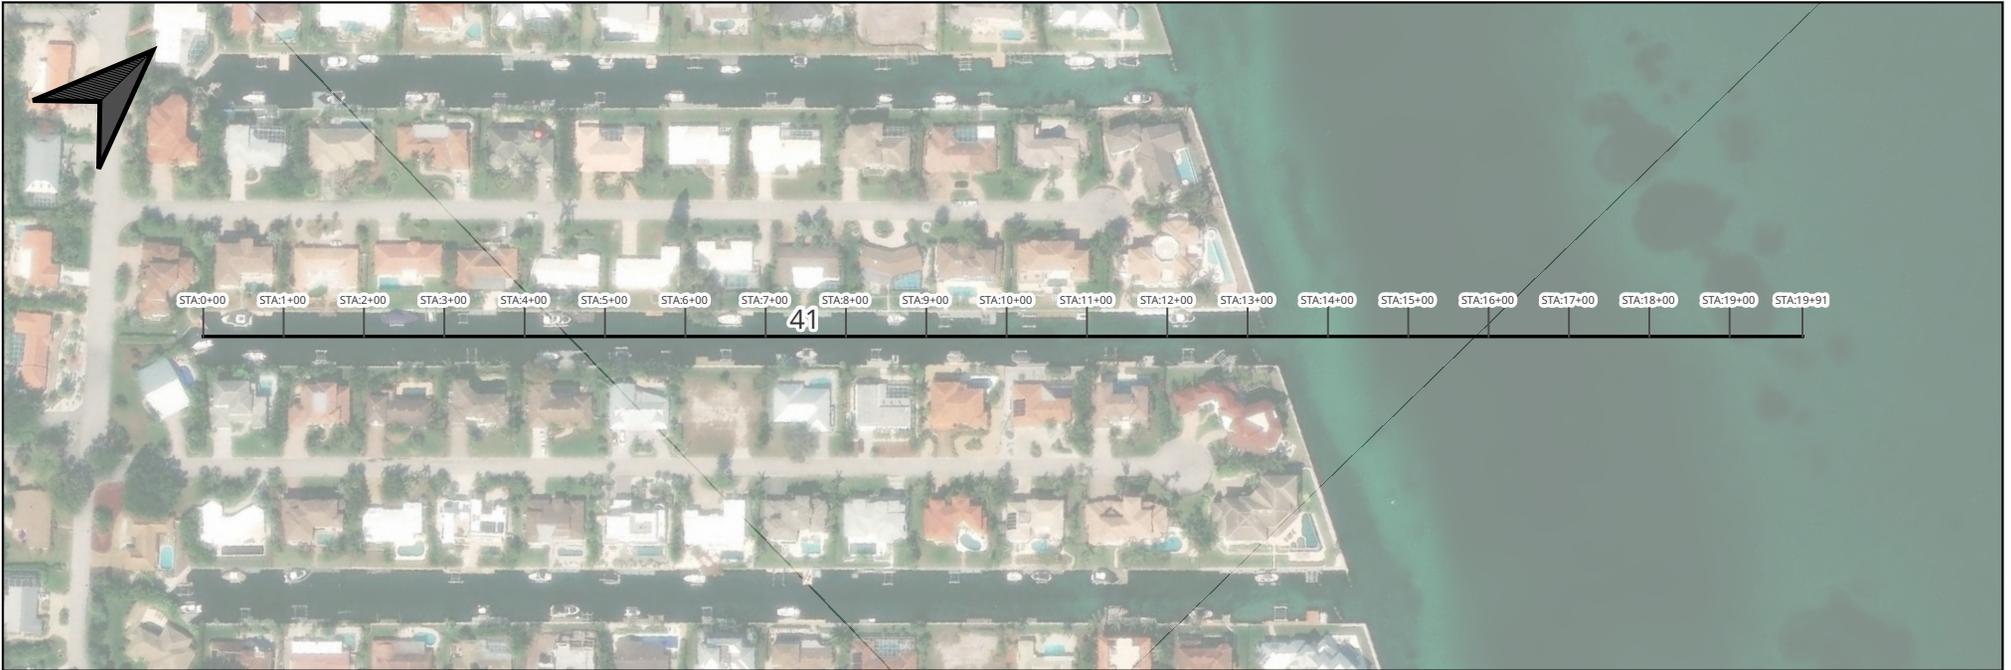
# Canal 41

Limiting Depth at last Survey: -4.1 ft MLW at STA 12+58

Maintained Width: 20 FT  
 Maintained Depth: -5.00 MLW  
 Monitoring Frequency: 1 year  
 Dredging Required: None  
 Min Dredge Target: -4.75 MLW  
 Number of Segments: 0  
 Dredge Length: 0 FT  
 Additional Work:

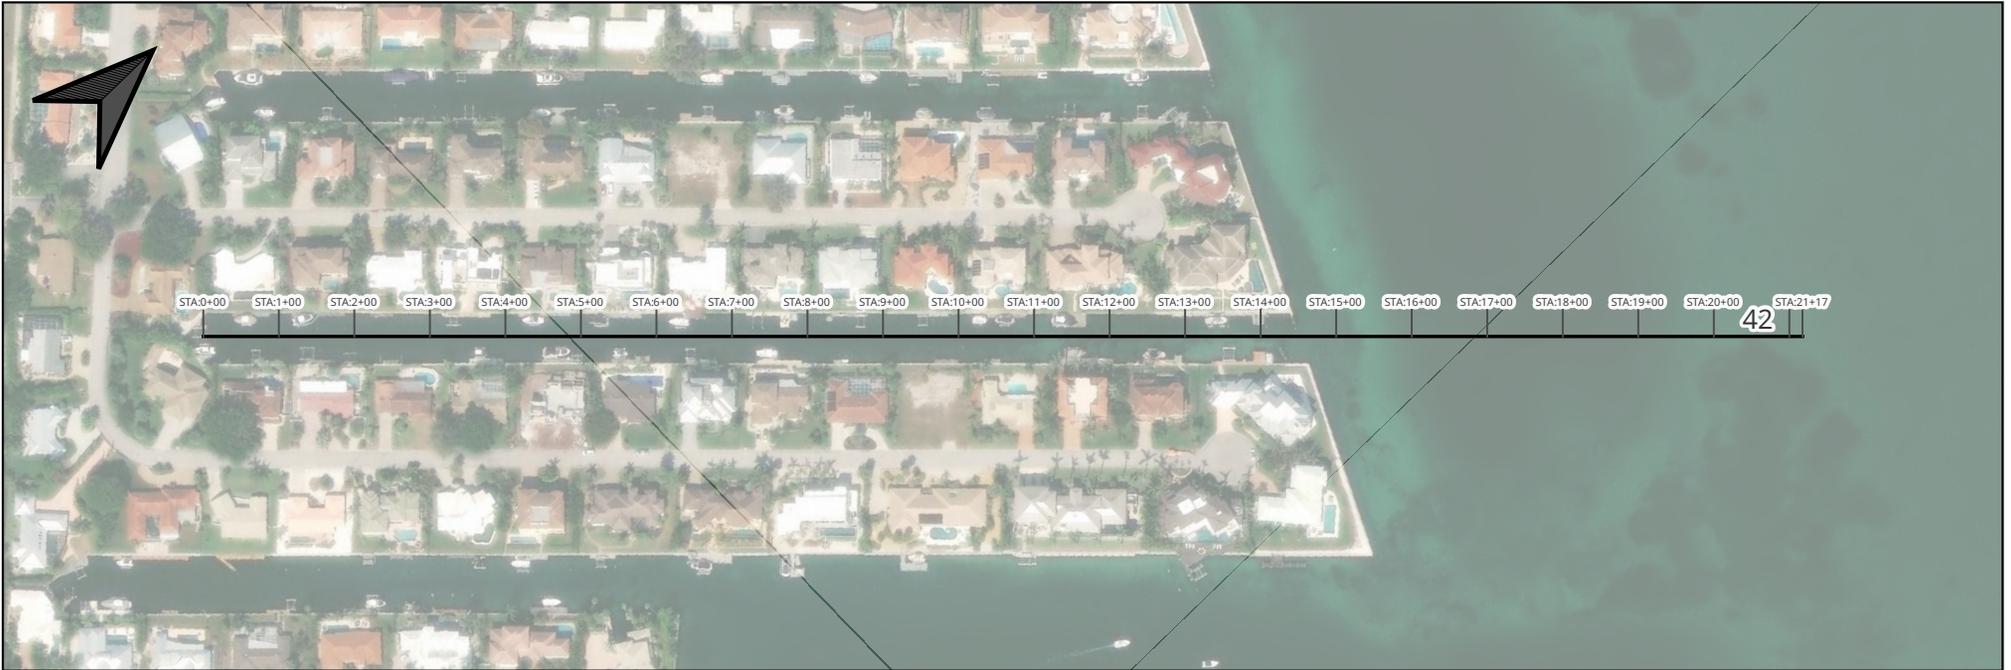
# Canal 42

Limiting Depth at last Survey: -3.8 ft MLW at STA 13+48

Maintained Width: 20 FT  
 Maintained Depth: -5.00 MLW  
 Monitoring Frequency: 1 year  
 Dredging Required: None  
 Min Dredge Target: -4.75 MLW  
 Number of Segments: 0  
 Dredge Length: 0 FT  
 Additional Work:

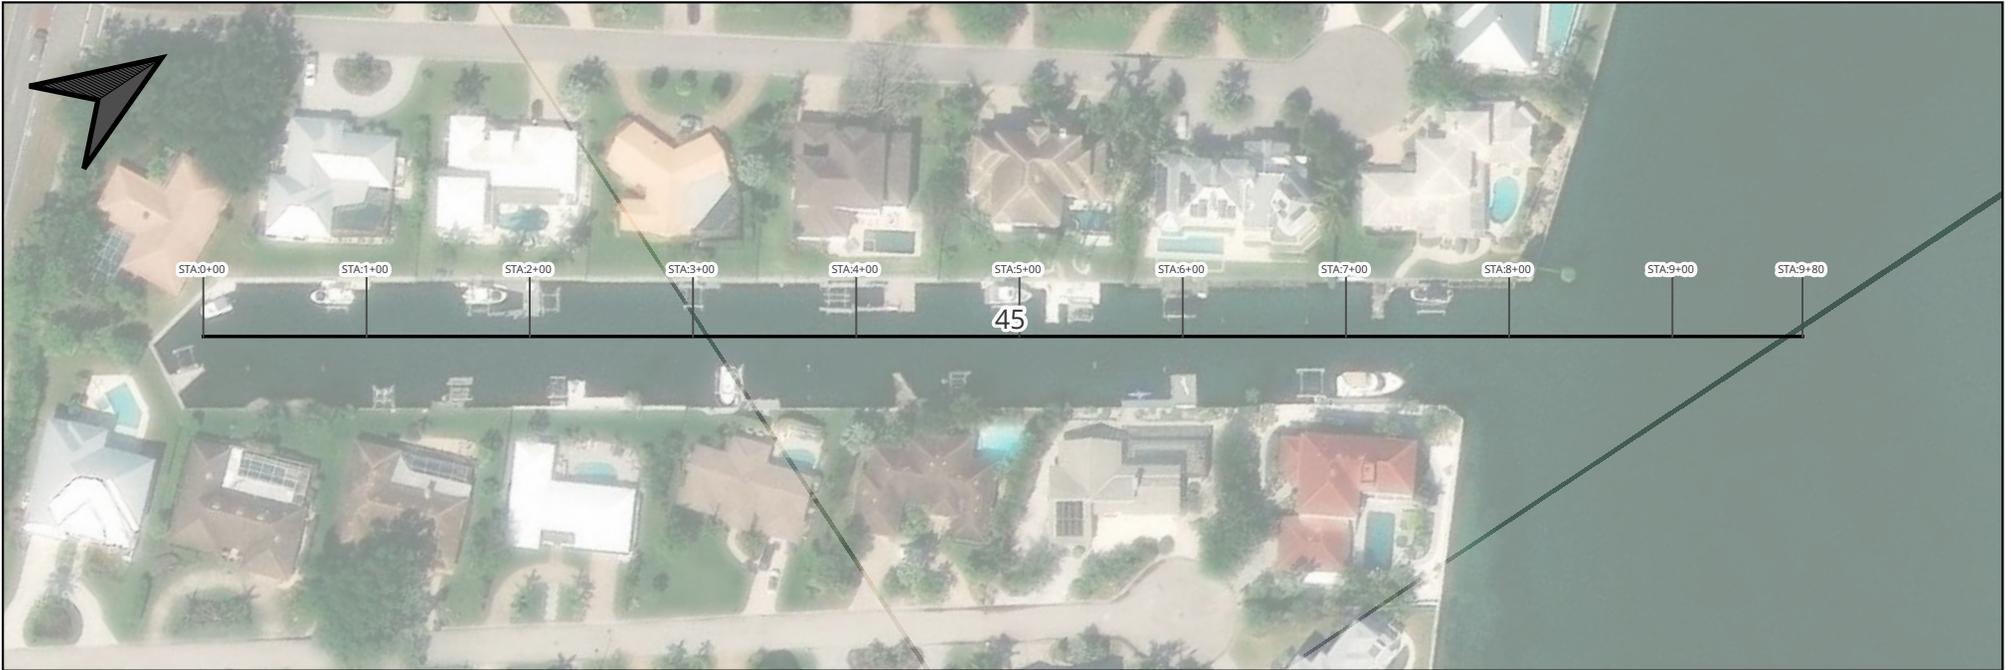
# Canal 45

Limiting Depth at last Survey: -5 ft MLW at STA 7+65

Maintained Width: 20 FT  
 Maintained Depth: -5.00 MLW  
 Monitoring Frequency: 2 years  
 Dredging Required: None  
 Min Dredge Target: -4.75 MLW  
 Number of Segments: 0  
 Dredge Length: 0 FT  
 Additional Work:

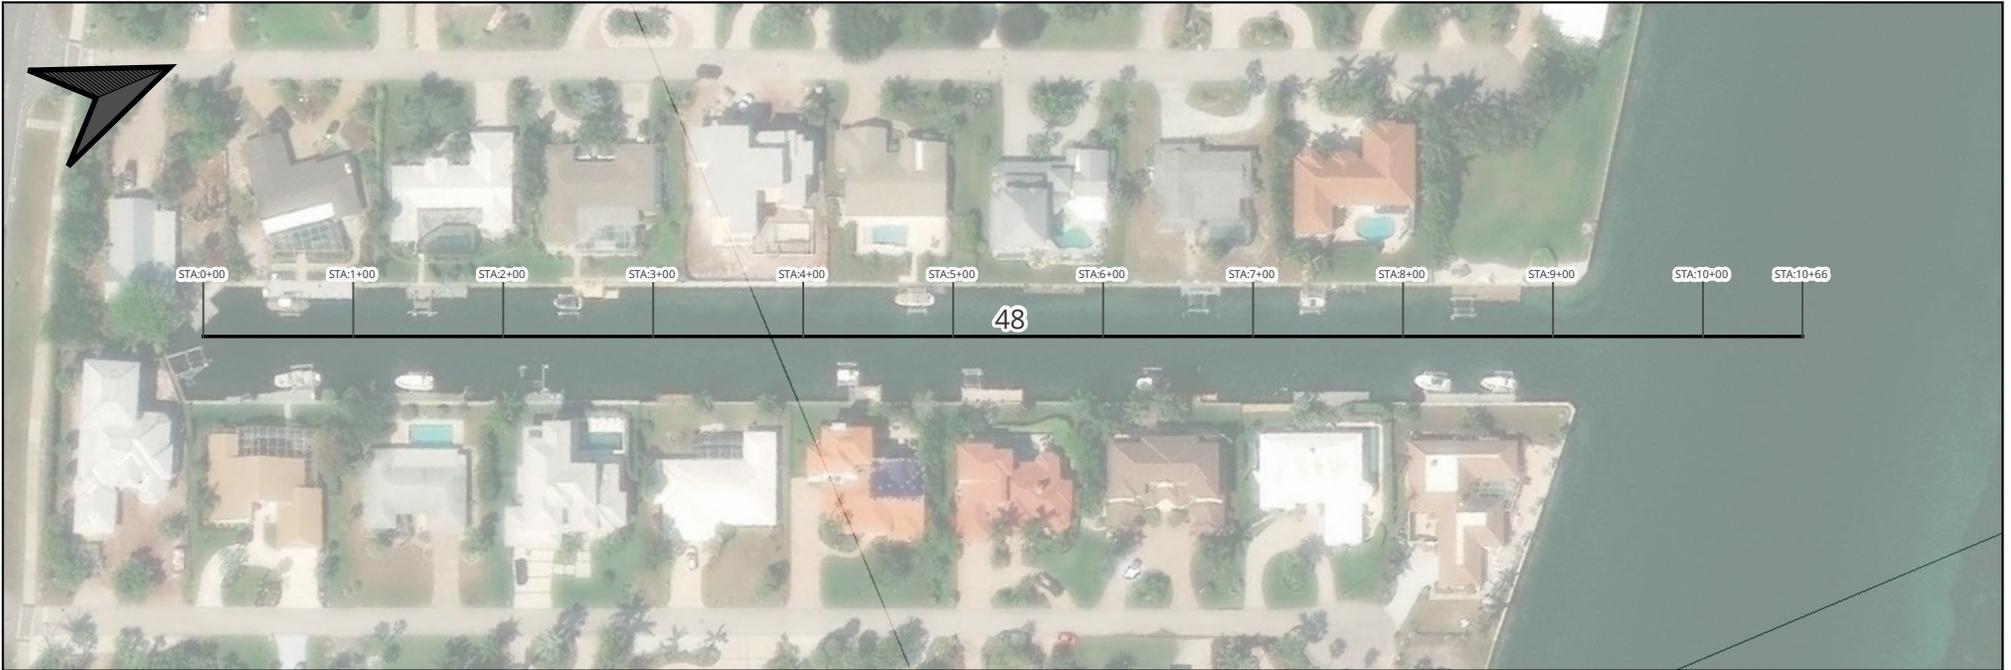
# Canal 48

Limiting Depth at last Survey: -4.1 ft MLW at STA 9+10

Maintained Width: 20 FT  
 Maintained Depth: -5.00 MLW  
 Monitoring Frequency: 2 years  
 Dredging Required: None  
 Min Dredge Target: -4.75 MLW  
 Number of Segments: 0  
 Dredge Length: 0 FT  
 Additional Work:

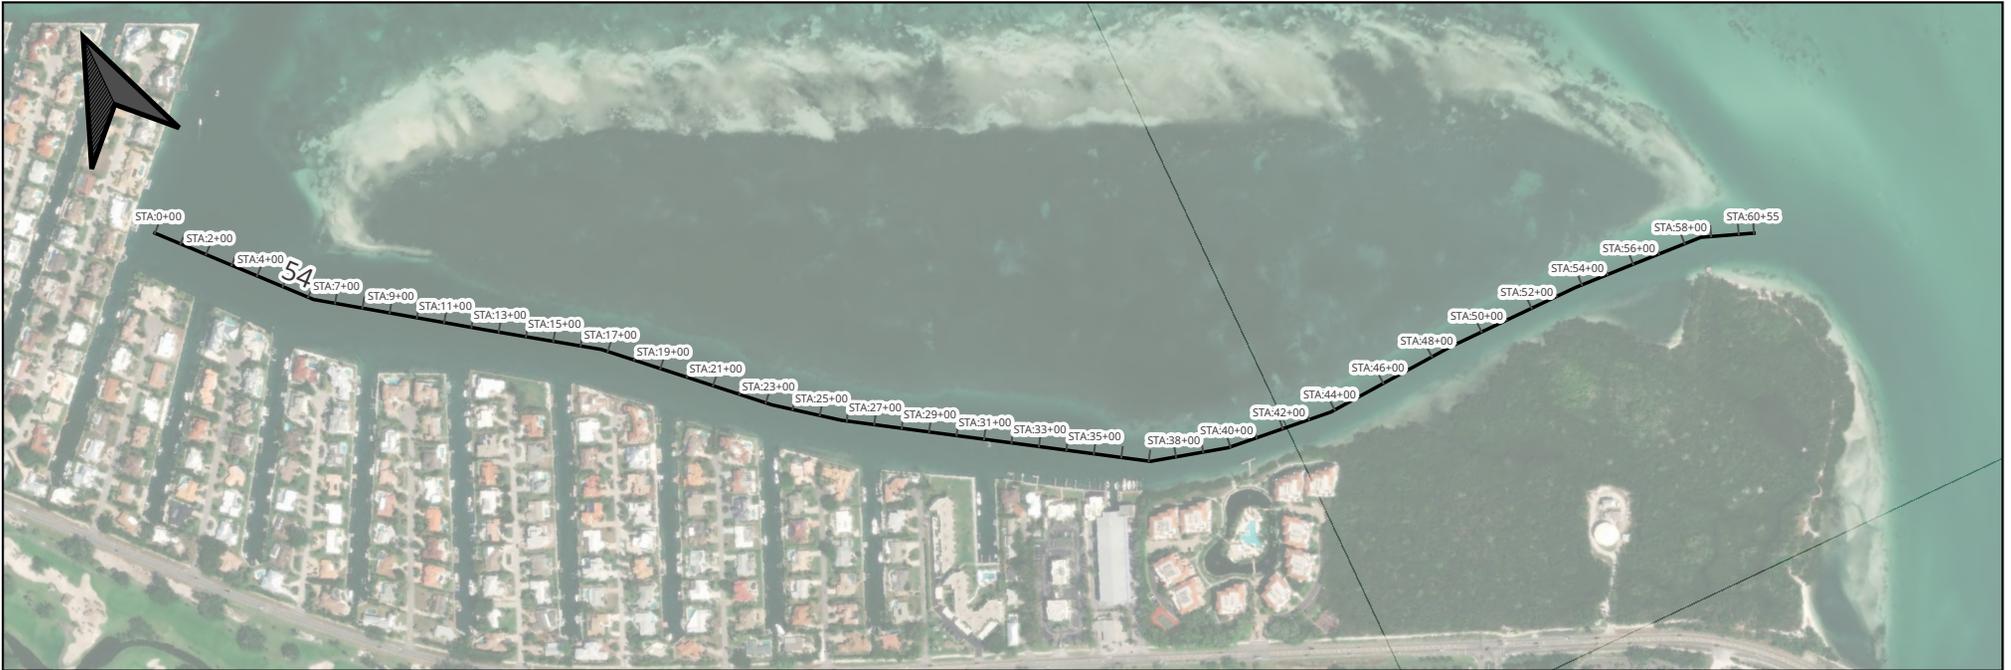
# Canal 54

Limiting Depth at last Survey: -7.6 ft MLW at STA 58+60

Maintained Width: 40 FT  
 Maintained Depth: -6.00 MLW  
 Monitoring Frequency: 2 years  
 Dredging Required: None  
 Min Dredge Target: -5.75 MLW  
 Number of Segments: 0  
 Dredge Length: 0 FT  
 Additional Work: Recommend extending maintained channel 300 ft to the south during future project

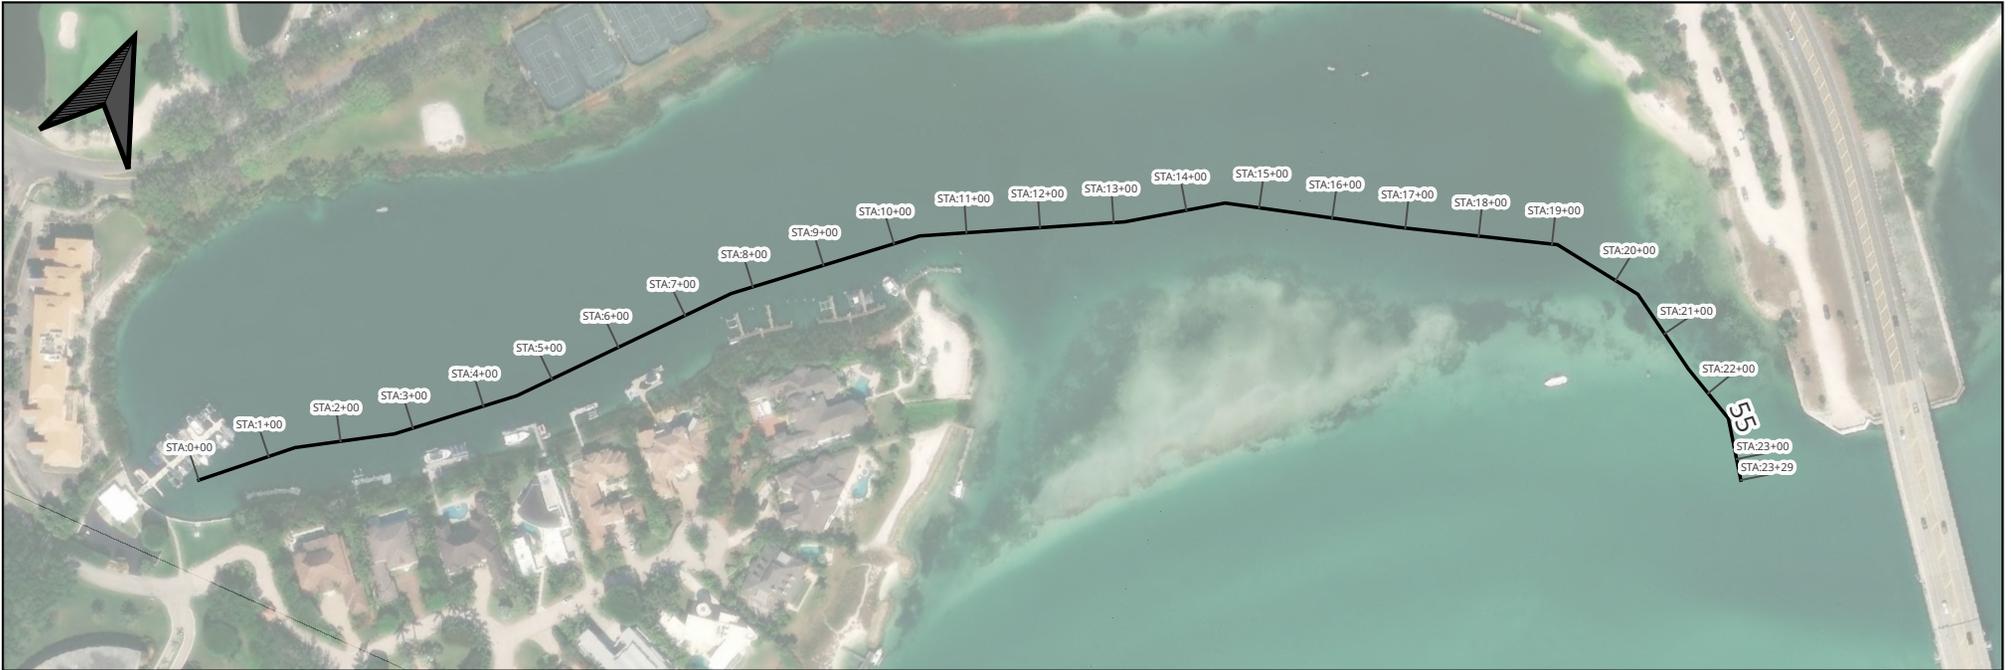
# Canal 55

Notes: Significant seagrass observed

Limiting Depth at last Survey: -2.9 ft MLW at STA 21+34

Maintained Width: 15 FT  
 Maintained Depth: -5.00 MLW  
 Monitoring Frequency: 1 year  
 Dredging Required: Yes  
 Min Dredge Target: -4.75 MLW  
 Number of Segments: Determine during future project  
 Dredge Length: Determine during future project  
 Additional Work: Recommend adding navigational markers

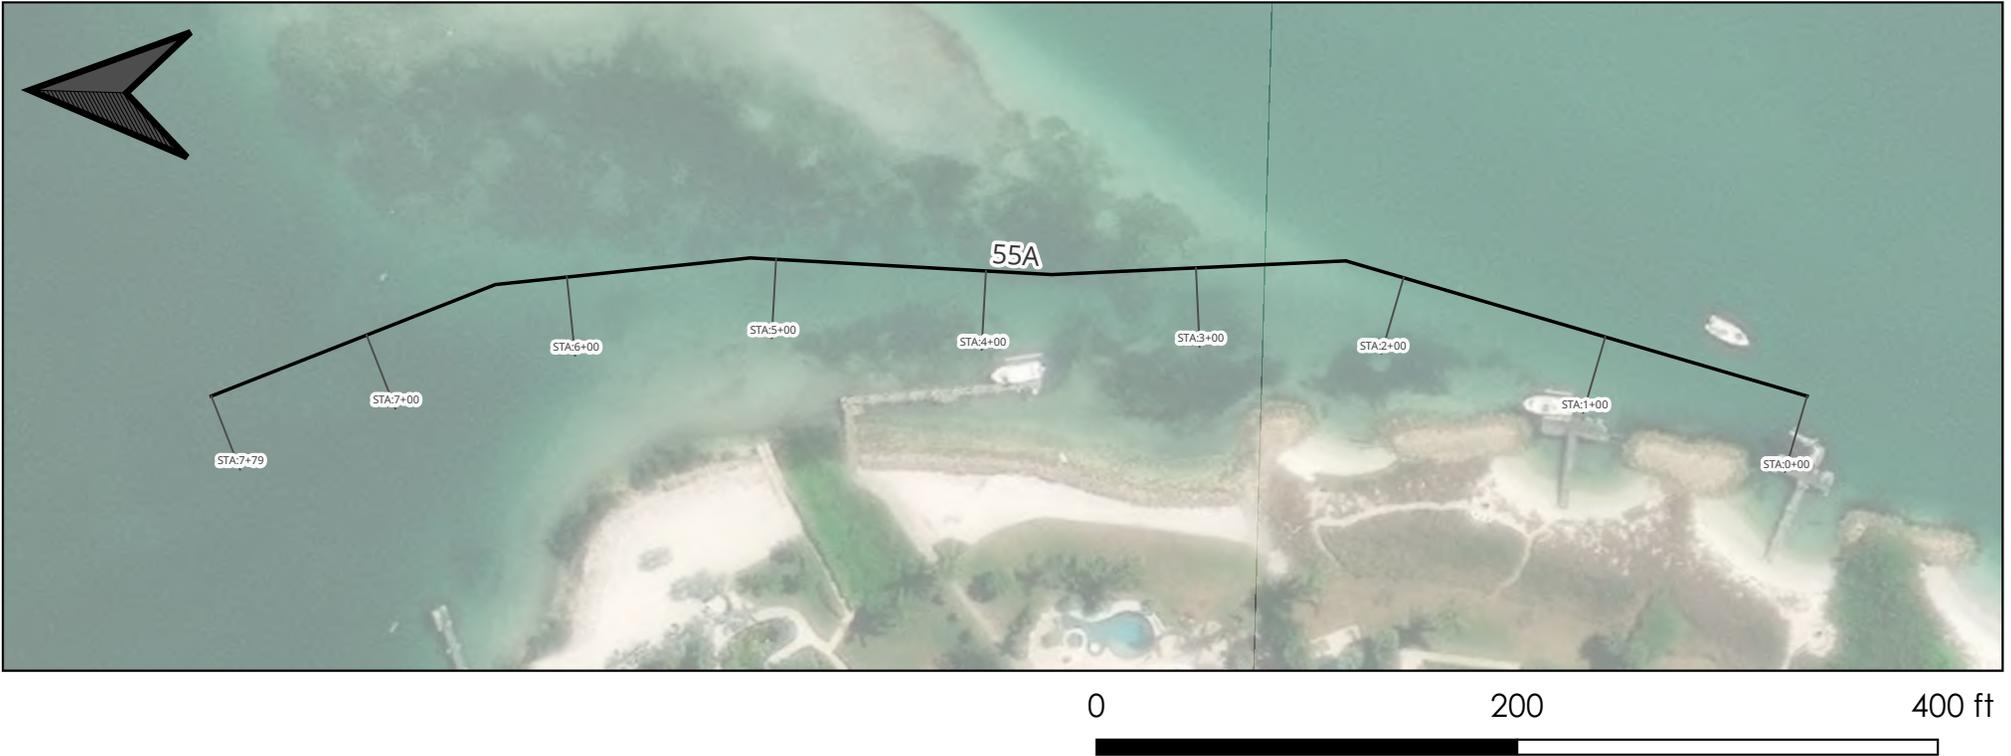
# Canal 55A

Limiting Depth at last Survey: -1.2 ft MLW at STA 3+00

Maintained Width: 2 FT  
 Maintained Depth: -5.00 MLW  
 Monitoring Frequency: 1 year  
 Dredging Required: Yes  
 Min Dredge Target: -4.75 MLW  
 Number of Segments: Determine during future project  
 Dredge Length: Determine during future project  
 Additional Work: Look at alignment in the future, possible widening
