CULTURAL RESOURCE ASSESSMENT SURVEY

LONGBOAT KEY - NORTON STREET DRAINAGE IMPROVEMENTS MANATEE COUNTY, FLORIDA

September 2024

**Archaeological Consultants, Inc.
8110 Blaikie Court, Suite A
Sarasota, Florida 34240**

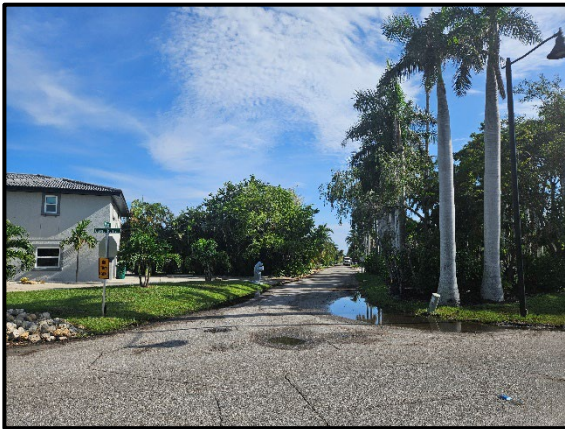
Photo 2.1. General conditions of Norton Street at intersection with General Harris Street, facing northeast.

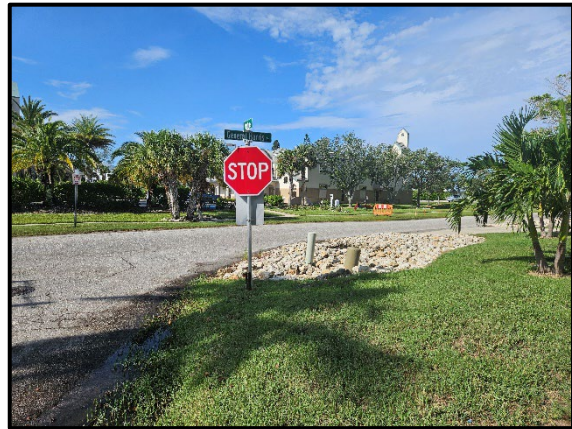
Photo 2.2. View of utilities at intersection of Norton Street and General Harris Street, facing west-southwest.

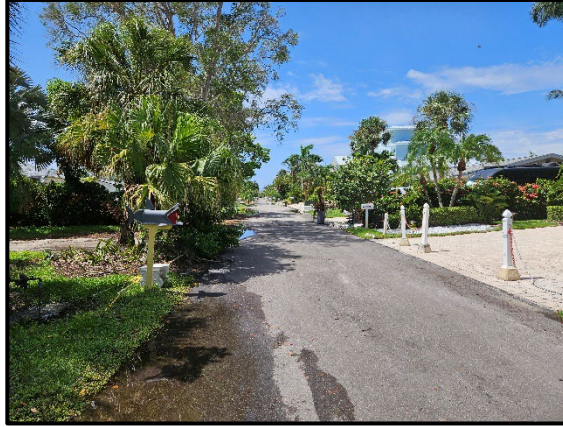
Photo 2.9. View of conditions along Norton Street from end of the project, facing southwest.

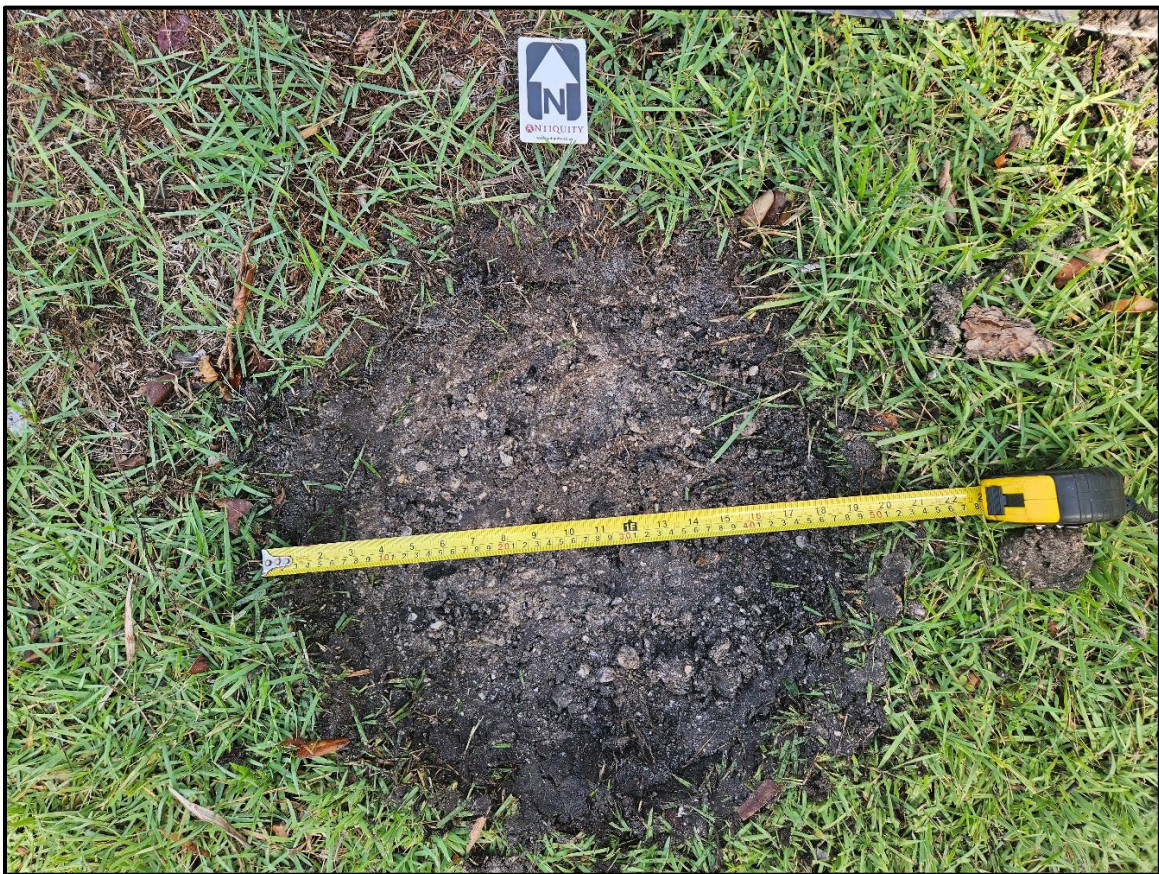
- **Southwest end of Norton Street:** 0-15 centimeters below surface (cmbs) dark brown shelly sand, 15-20 cmbs gray shelly sand with concretions, potential utilities below (**Photo 5.1**)
- **Center of Norton Street:** 0-20 cmbs dark gray brow sand, 20-25 cmbs gray-light gray fill sand some shell with dark brown fill center, possible utilities at bottom (**Photo 5.2**)

Photo 5.1. Stratigraphy at southwest end of Norton Street, facing north, terminated due to fill concretion and utilities below.

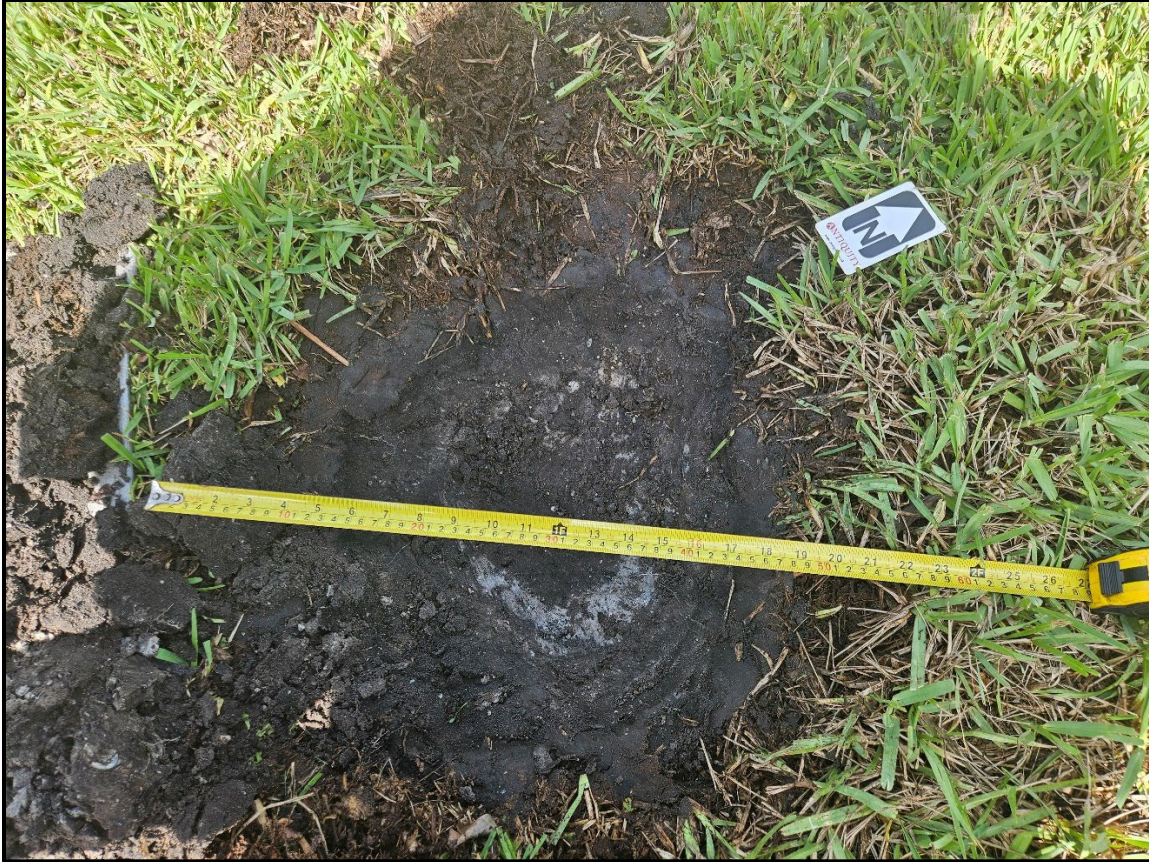
Photo 5.2. Stratigraphy at the center of Norton Street, facing northwest, terminated due to fill concretion and utilities below.

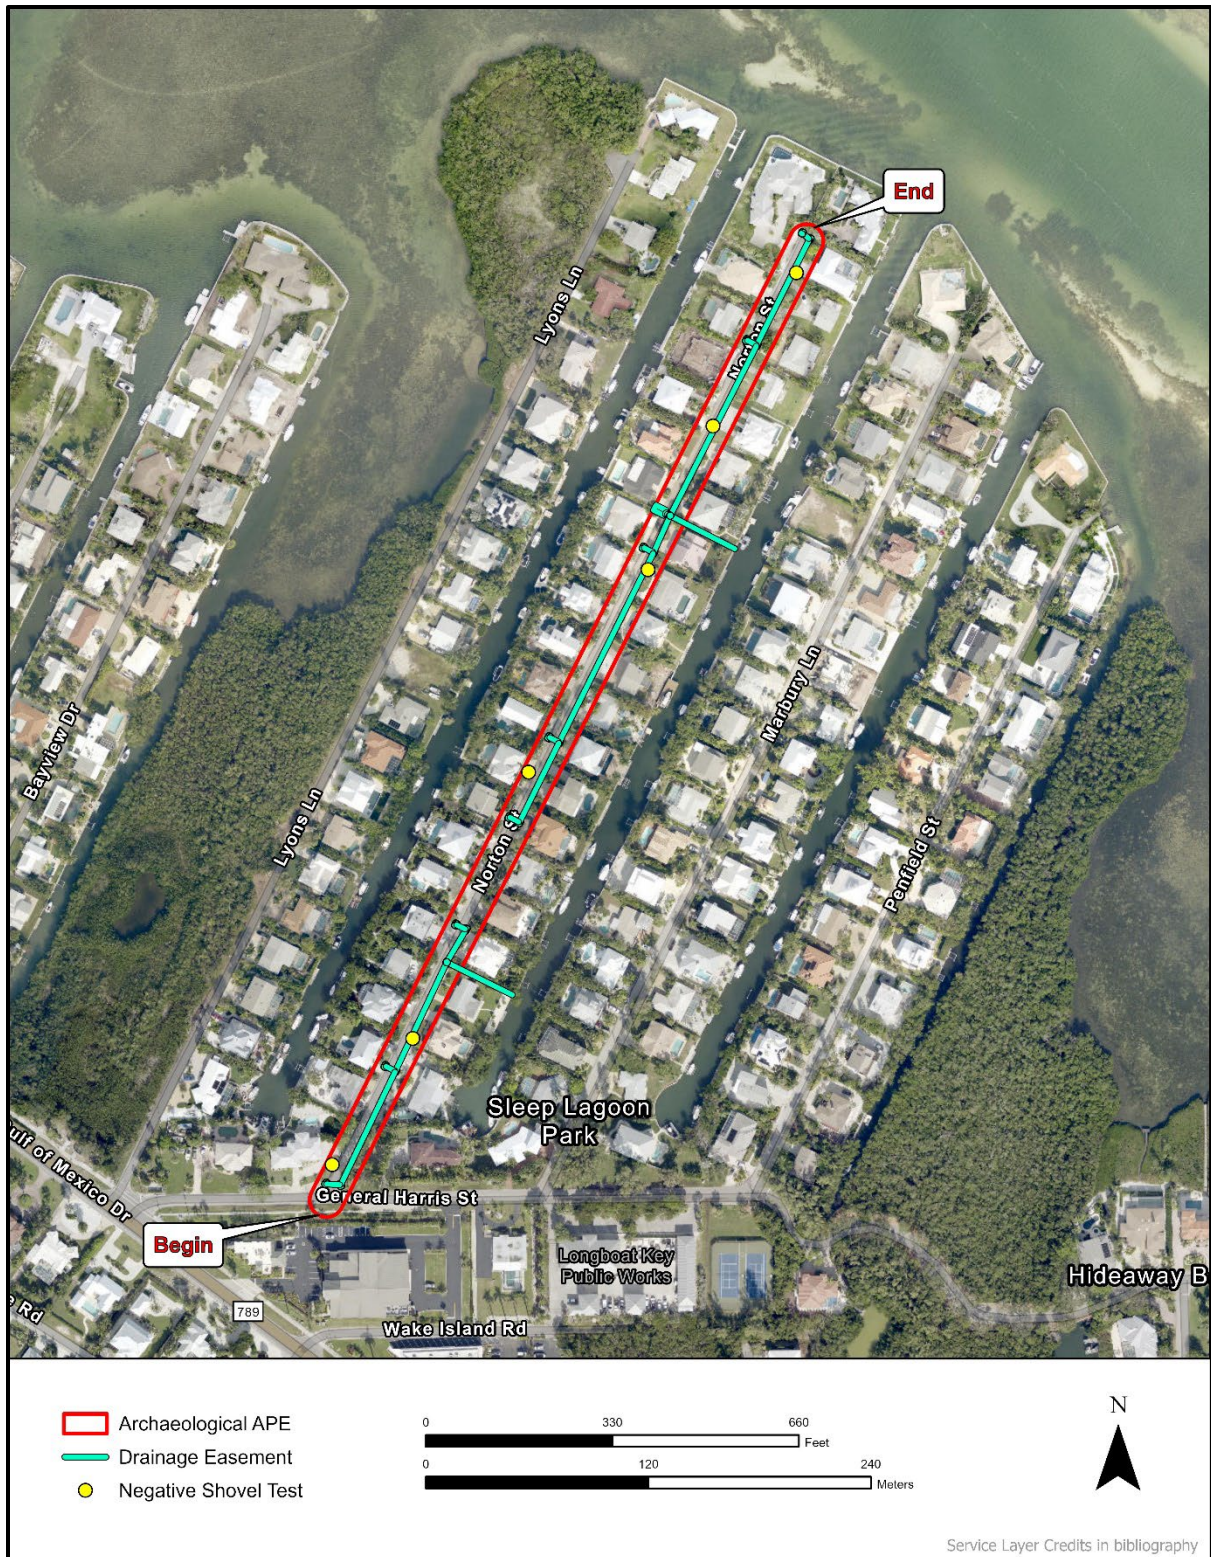
Figure 5.1. Location of the shovel tests within the Norton Street Drainage Improvements archaeological APE.

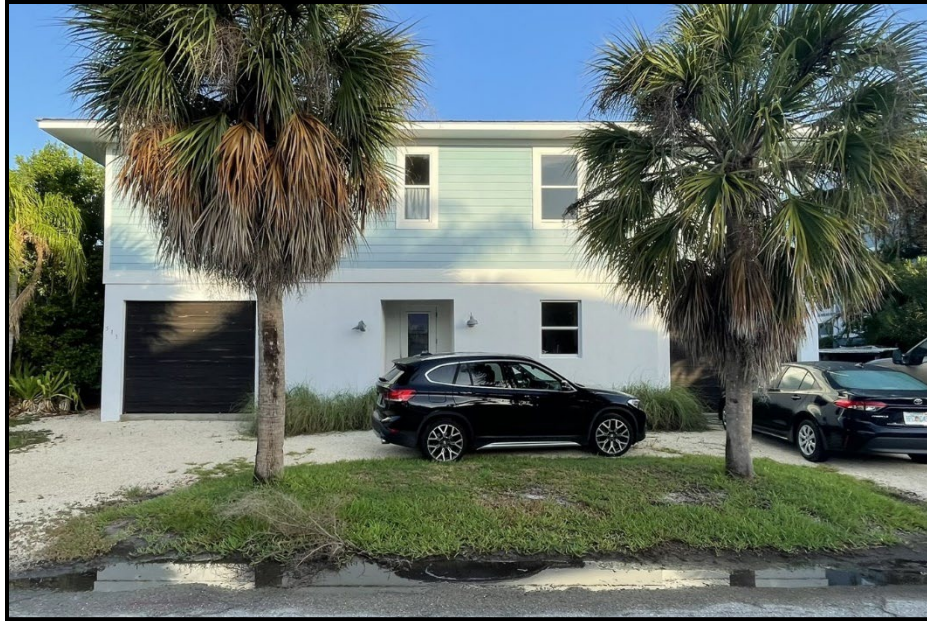
Photo 5.3. 513 Norton Street (8MA02636), looking northwest.

8MA02636: The Masonry Vernacular style building at 513 Norton Street was constructed in ca. 1955 (**Photo 5.3**). The two-story, irregular plan rests on a concrete slab foundation and has a concrete structural system on the ground floor with a stucco exterior and a wood frame structural system on the second floor covered with novelty siding. The gable-on-hip roof over the primary mass is covered with 3V crimp sheet metal. Visible windows include individual one-over-one vinyl single-hung sash and fixed units. Distinguishing architectural features include overhanging eaves and storage garages with retractable wood doors on the northeast and southwest additions. Alterations include replacement roofing, siding, doors, and windows. Second floor rooms and storage garages were later added between 2007 and 2008 on the north-east and south-west elevations. Overall, the building has been altered, lacks sufficient architectural features, and is not a significant embodiment of a type, period, or method of construction. In addition, background research did not reveal any historic associations with significant persons and/or events. As a result, 8MA02636 does not appear eligible for listing in the NRHP, either individually or as part of a historic district.

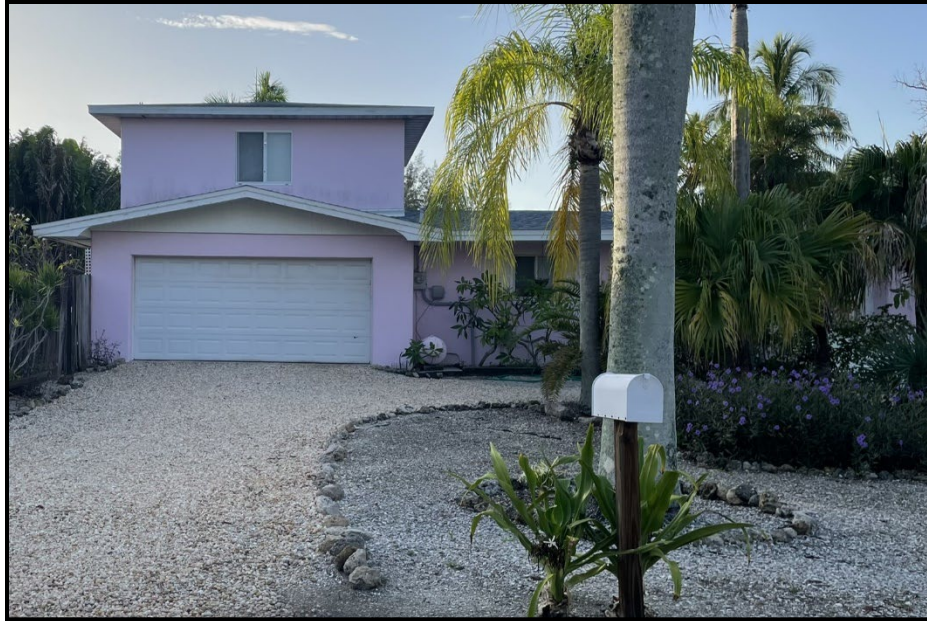
Photo 5.4. 514 Norton Street (8MA02637), looking southeast.

8MA02637: The Masonry Vernacular style building at 514 Norton Street was constructed in ca. 1960 (**Photo 5.4**). The two-story, irregular plan rests on a concrete slab foundation and has concrete block structural system covered with stucco. The intersecting-gable, hip, and flat roofs over the primary mass are covered with composition shingles and built-up roofing. Visible windows include individual and paired one-by-one vinyl horizontal sliding units. Distinguishing architectural features include overhanging eaves, faux-shutters, wood siding in the gable ends, and an integrated two-car garage. Alterations include replacement roofing, siding, doors, and windows. A second-floor addition is located on the northeast elevation. Overall, the building has been altered, lacks sufficient architectural features, and is not a significant embodiment of a type, period, or method of construction. In addition, background research did not reveal any historic associations with significant persons and/or events. As a result, 8MA02637 does not appear eligible for listing in the NRHP, either individually or as part of a historic district.

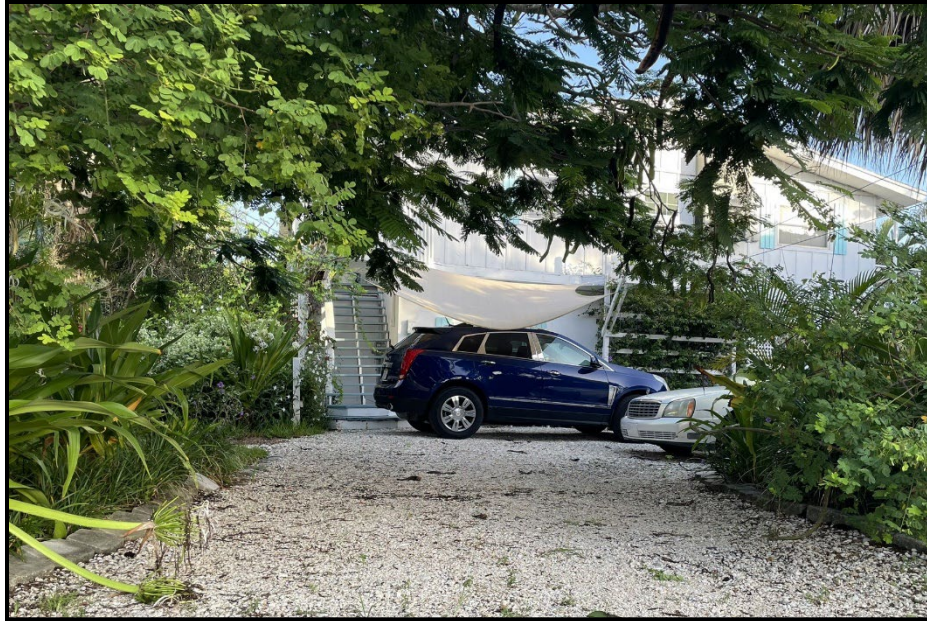
Photo 5.5. 537 Norton Street (8MA02638), looking west.

8MA02638: The Masonry Vernacular style building at 537 Norton Street was constructed in ca. 1969 (**Photo 5.5**). The two-story, rectangular plan rests on a concrete slab foundation and has concrete block structural system covered with stucco and wood siding. The gable roof over the primary mass is covered with composition shingles. Visible windows include individual one-over-one and six-over-six vinyl single-hung sash units. Distinguishing architectural features include overhanging eaves, faux-shutters, stucco on the ground floor and wood siding on the second-floor, external wood stairs on the southwest elevation, lattice covering an open garage, and gable vents. Alterations include replacement roofing, siding, and windows. Overall, the building has been altered, lacks sufficient architectural features, and is not a significant embodiment of a type, period, or method of construction. In addition, background research did not reveal any historic associations with significant persons and/or events. As a result, 8MA02638 does not appear eligible for listing in the NRHP, either individually or as part of a historic district.

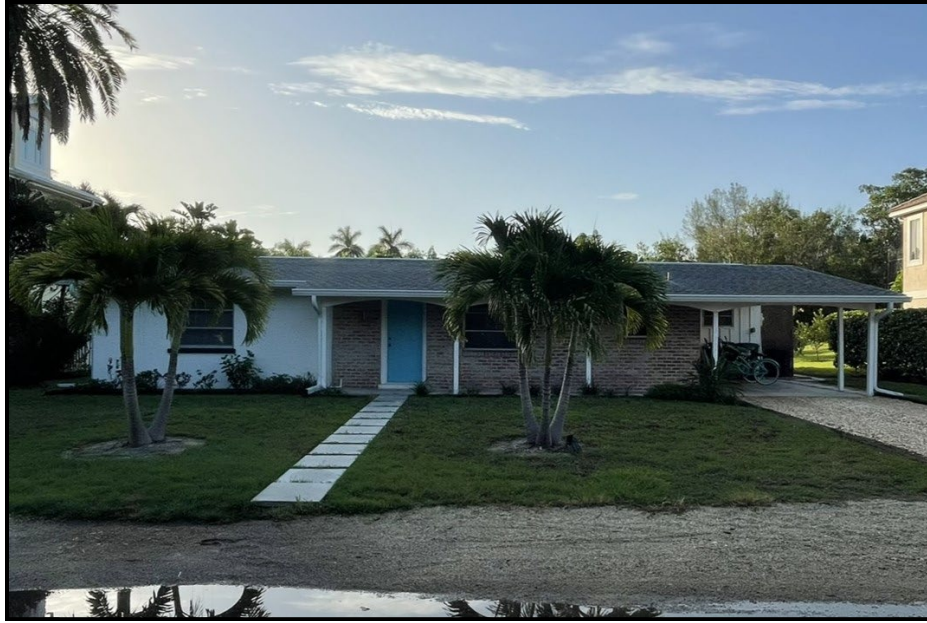
Photo 5.6. 538 Norton Street (8MA02639), looking southeast.

8MA02639: The Masonry Vernacular style building at 538 Norton Street was constructed in ca. 1962 (**Photo 5.6**). The one-story, L-shaped plan rests on a concrete slab foundation and has a concrete block structural system with a brick and concrete block exterior. The gable and flat roofs over the primary mass are covered with composition shingles and built-up roofing, respectively. Visible windows include individual one-over-one metal single-hung sash units and individual three-stacked metal awning units. Distinguishing architectural features include overhanging eaves, an integrated carport, rectangular gable vents, wood siding on the gables, brick façade from the front door to the carport, and rectangular wood columns with supporting arches supporting the porch and carport. Alterations include replacement roofing, siding, doors, and windows. Overall, the building has been altered, lacks sufficient architectural features, and is not a significant embodiment of a type, period, or method of construction. In addition, background research did not reveal any historic associations with significant persons and/or events. As a result, 8MA02639 does not appear eligible for listing in the NRHP, either individually or as part of a historic district.

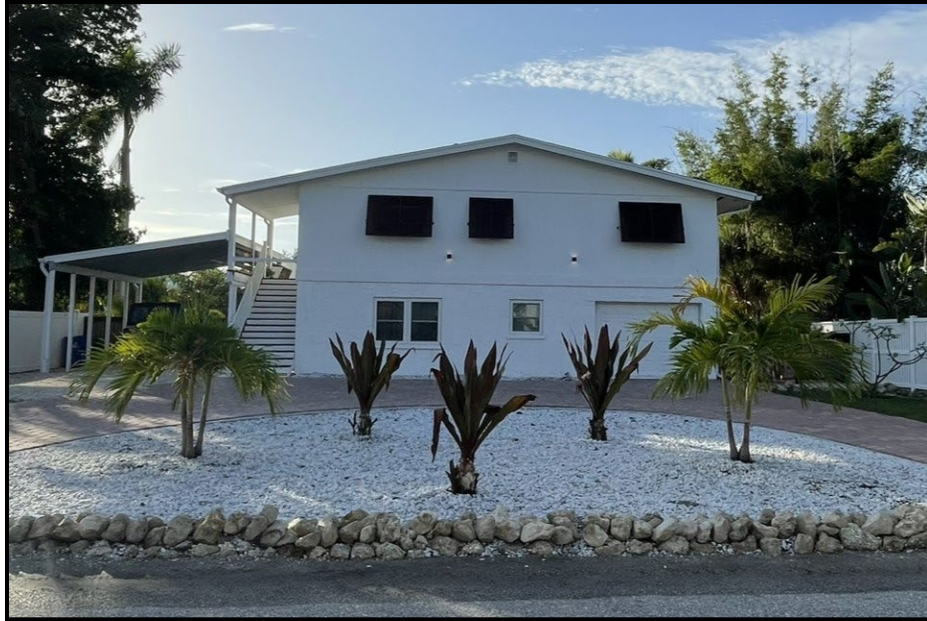
Photo 5.7. 650 Norton Street (8MA02640), looking southeast.

8MA02640: The Masonry Vernacular style building at 650 Norton Street was constructed in ca. 1969 (**Photo 5.7**). The two-story, irregular plan rests on a concrete slab foundation and has concrete block structural system with an artstone and concrete block exterior on the ground floor and wood siding on the second floor. The gable and shed roofs over the primary mass are covered with composition shingles. Visible windows include individual and paired one-over-one vinyl single-hung sash units and individual one-by-one vinyl horizontal sliding units. Distinguishing architectural features include overhanging eaves, a square gable vent, Bahama shutters on the second floor, an integrated one-car garage, and an attached carport. Alterations include replacement roofing, siding, doors, and windows. A carport addition is located on the northeast elevation. Overall, the building has been altered, lacks sufficient architectural features, and is not a significant embodiment of a type, period, or method of construction. In addition, background research did not reveal any historic associations with significant persons and/or events. As a result, 8MA02640 does not appear eligible for listing in the NRHP, either individually or as part of a historic district.

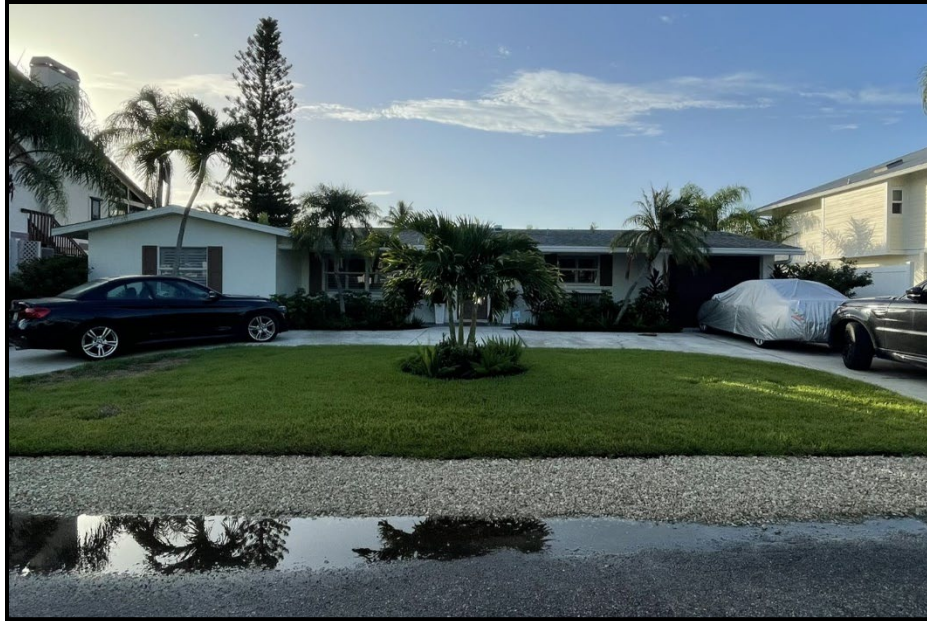
Photo 5.8. 674 Norton Street (8MA02641), looking southeast.

8MA02641: The Masonry Vernacular style building at 674 Norton Street was constructed in ca. 1960 (**Photo 5.8**). The one-story, irregular plan rests on a concrete slab foundation and has concrete block structural system covered with stucco. The intersecting-gable and flat roofs over the primary mass are covered with composition shingles. Visible windows include individual one-over-one vinyl single-hung sash units. Distinguishing architectural features include overhanging eaves, faux-shutters, concrete windowsills, square gable vents, an integrated one-car garage, and two rectangular columns flanking the entryway. Alterations include replacement roofing, siding, doors, and windows. Overall, the building has been altered, lacks sufficient architectural features, and is not a significant embodiment of a type, period, or method of construction. In addition, background research did not reveal any historic associations with significant persons and/or events. As a result, 8MA02641 does not appear eligible for listing in the NRHP, either individually or as part of a historic district.

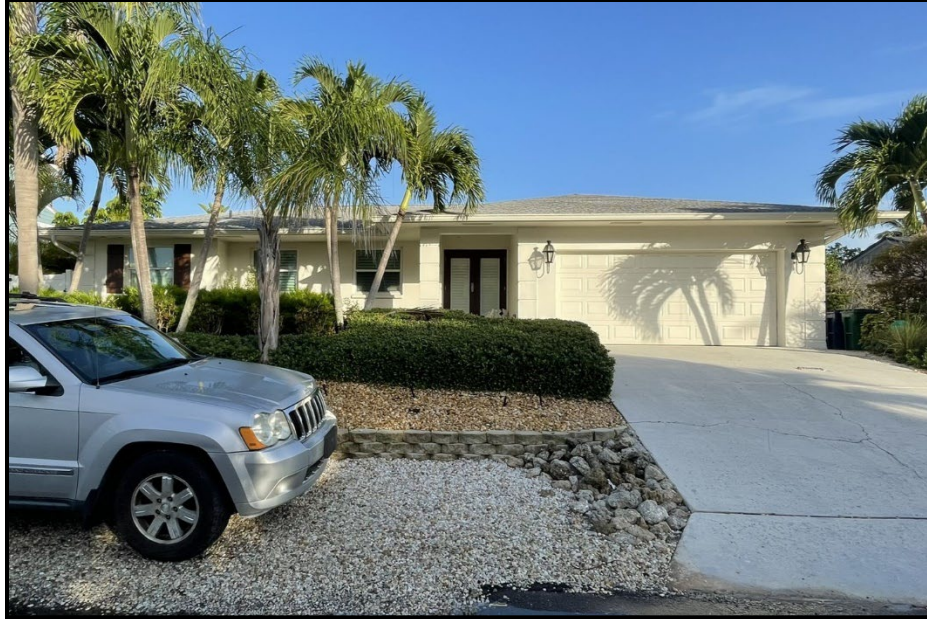
Photo 5.9. 685 Norton Street (8MA02642), looking northwest.

8MA02642: The Masonry Vernacular style building at 685 Norton Street was constructed in ca. 1975 (**Photo 5.9**). The one-story, irregular plan rests on a concrete slab foundation and has concrete block structural system covered with stucco and artblock. The hip and flat roofs over the primary mass are covered with composition shingles and built-up roofing, respectively. Visible windows include individual one-over-one vinyl single-hung sash units. Distinguishing architectural features include overhanging eaves, faux-shutters, artblock on the façade corners and porch column, and an integrated two-car garage. Alterations include replacement roofing, siding, doors, and windows. An extension addition is located on the southwest elevation. Overall, the building has been altered, lacks sufficient architectural features, and is not a significant embodiment of a type, period, or method of construction. In addition, background research did not reveal any historic associations with significant persons and/or events. As a result, 8MA02642 does not appear eligible for listing in the NRHP, either individually or as part of a historic district.

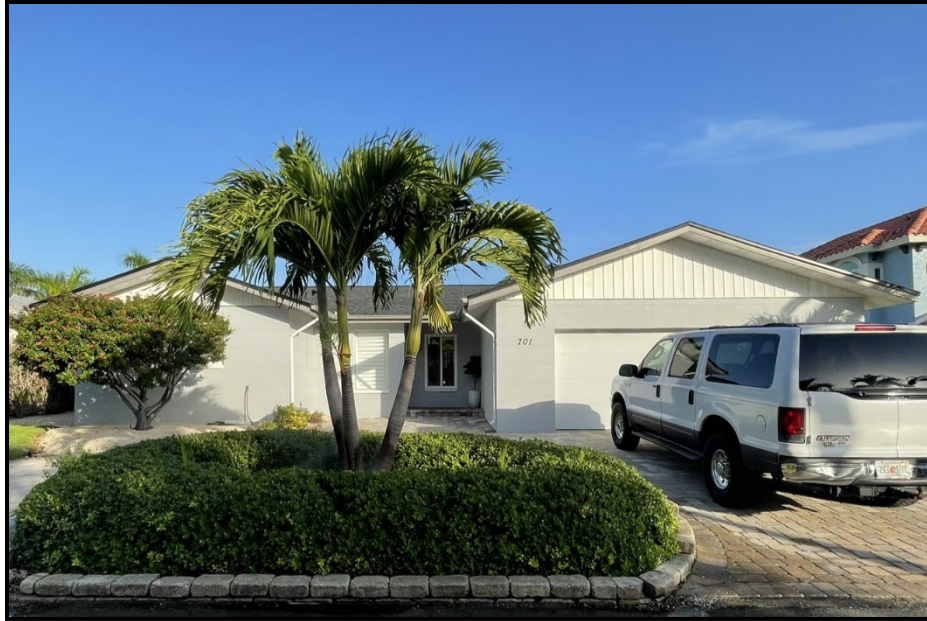
Photo 5.10. 701 Norton Street (8MA02643), looking northwest.

8MA02643: The Masonry Vernacular style building at 701 Norton Street was constructed in ca. 1971 (**Photo 5.10**). The one-story, irregular plan rests on a concrete slab foundation and has a painted concrete block structural system with wood siding in the gable ends. The intersecting-gable and flat roofs over the primary mass are covered with composition shingles and built-up roofing. Visible windows include individual one-over-one vinyl single-hung sash units, individual one-by-one vinyl horizontal sliding units, and individual vinyl 3-panel slider, and individual vinyl fixed window units. Distinguishing architectural features include overhanging eaves, wood siding on the gables, square gable vents, and an integrated two-car garage. Alterations include replacement roofing, siding, doors, and windows. An extension addition is located on the northwest elevation. Overall, the building has been altered, lacks sufficient architectural features, and is not a significant embodiment of a type, period, or method of construction. In addition, background research did not reveal any historic associations with significant persons and/or events. As a result, 8MA02643 does not appear eligible for listing in the NRHP, either individually or as part of a historic district.

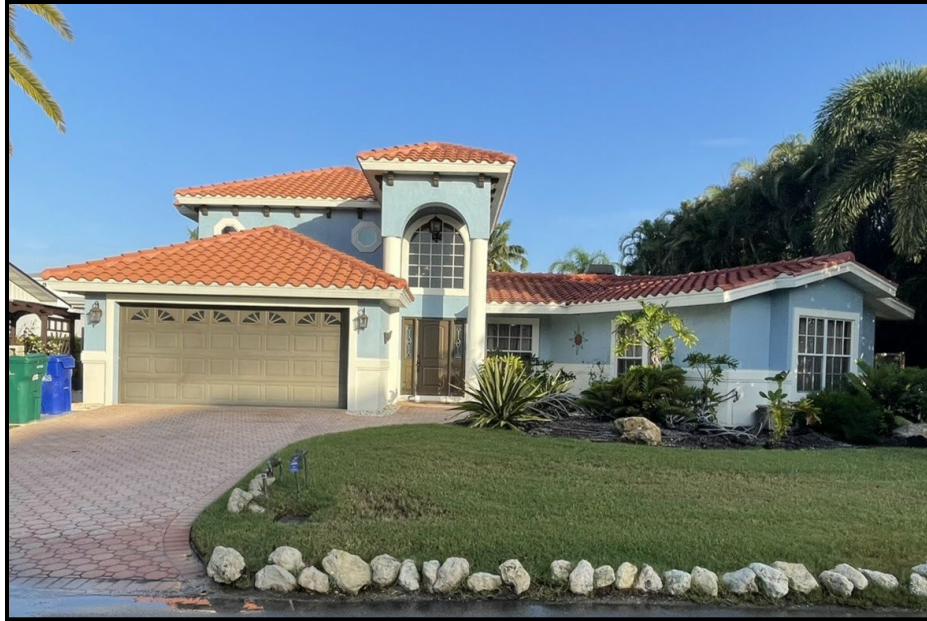
Photo 5.11. 713 Norton Street (8MA02644), looking northwest.

8MA02644: The Masonry Vernacular style building at 713 Norton Street was constructed in ca. 1963 (**Photo 5.11**). The two-story, irregular plan rests on a concrete slab foundation and has concrete block structural system covered with stucco. The gable and hip roofs over the primary mass are covered with Spanish tile. Visible windows include individual and paired one-over-one, six-over-six, and eight-over-eight vinyl single-hung sash units and individual single pane and five-by-six vinyl fixed units. Distinguishing architectural features include overhanging eaves, an integrated two-car garage, cylindrical porch columns, faux rafter tails, and a large fixed arched window above the front door. Alterations include replacement roofing, siding, doors and windows. There is a second-floor addition, as well as extension additions on the southeast and northwest elevations. Overall, the building has been altered, lacks sufficient architectural features, and is not a significant embodiment of a type, period, or method of construction. In addition, background research did not reveal any historic associations with significant persons and/or events. As a result, 8MA02644 does not appear eligible for listing in the NRHP, either individually or as part of a historic district.

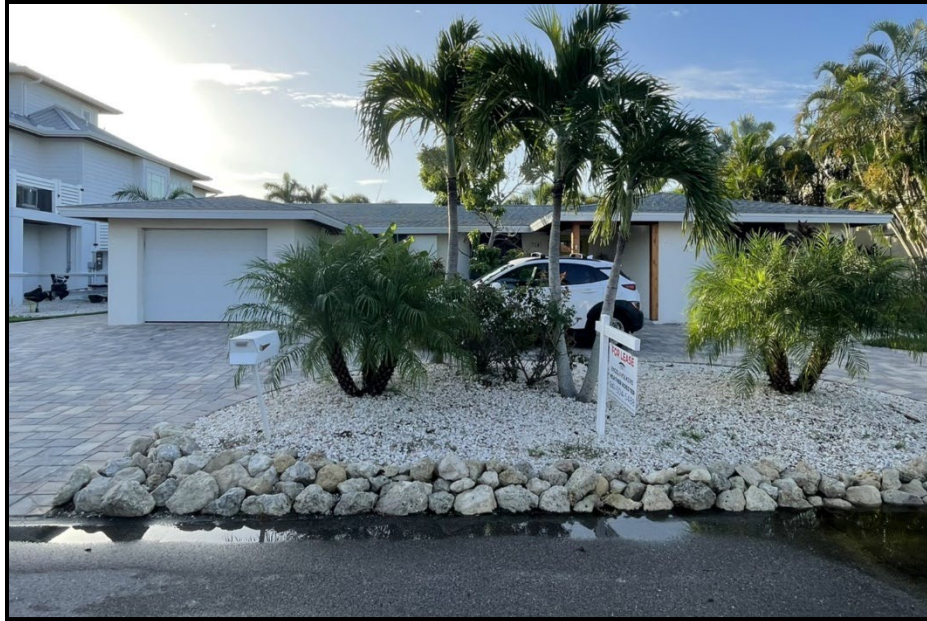
Photo 5.12. 714 Norton Street (8MA02645), looking southeast.

8MA02645: The Masonry Vernacular style building at 714 Norton Street was constructed in ca. 1967 (**Photo 5.12**). The one-story, irregular plan rests on a concrete slab foundation and has concrete block structural system covered with stucco. The gable and hip roofs over the primary mass are covered with composition shingles. The windows are not visible since they are obscured by the Bahama shutters. Distinguishing architectural features include overhanging eaves, Bahama shutters, wood siding on the gable end, rectangular wood columns supporting the porch, and an integrated one-car garage. Alterations include replacement roofing, siding, doors, and windows. An extension addition is located on the southeast elevation. Overall, the building has been altered, lacks sufficient architectural features, and is not a significant embodiment of a type, period, or method of construction. In addition, background research did not reveal any historic associations with significant persons and/or events. As a result, 8MA02645 does not appear eligible for listing in the NRHP, either individually or as part of a historic district.

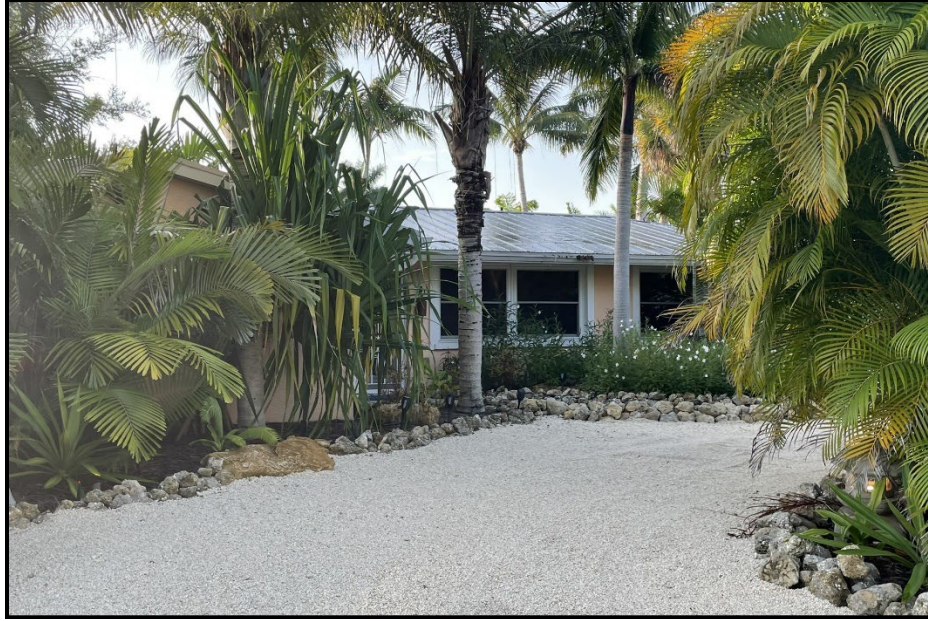
Photo 5.13. 638 Norton Street (8MA02648), looking southeast.

8MA02648: The Masonry Vernacular style building at 638 Norton Street was constructed in ca. 1964 (**Photo 5.13**). The one-story, irregular plan rests on a concrete slab foundation and has concrete block structural system covered with stucco. The intersecting gable roofs over the primary mass are covered with 3V crimp sheet metal. Visible windows include individual and paired one-over-one vinyl single-hung sash units. Distinguishing architectural features include overhanging eaves, and an integrated one-car garage. Alterations include replacement roofing, siding, doors, and windows. Overall, the building has been altered, lacks sufficient architectural features, and is not a significant embodiment of a type, period, or method of construction. In addition, background research did not reveal any historic associations with significant persons and/or events. As a result, 8MA02648 does not appear eligible for listing in the NRHP, either individually or as part of a historic district.

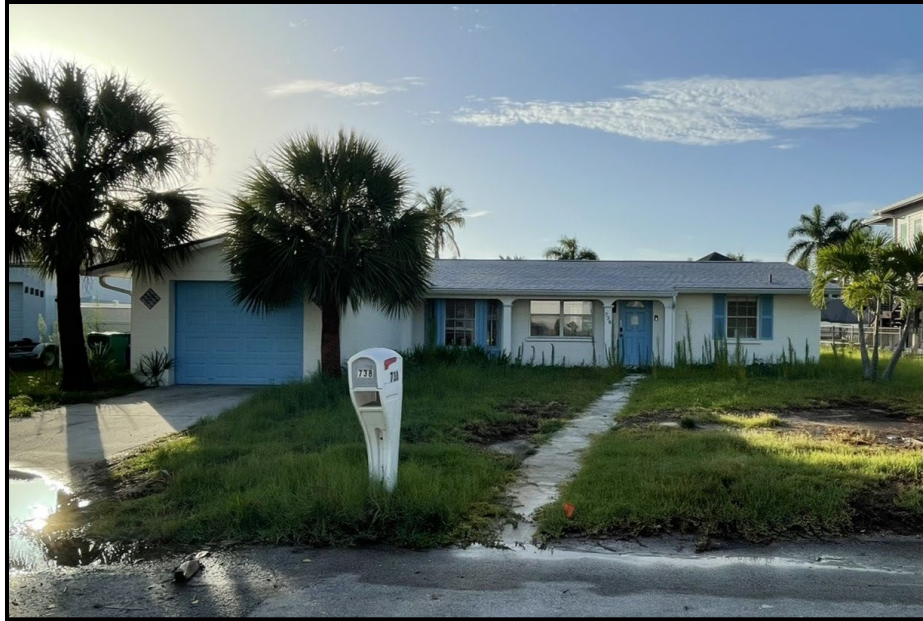
Photo 5.14. 738 Norton Street (8MA02649), looking southeast.

8MA02649: The Masonry Vernacular style building at 738 Norton Street was constructed in ca. 1967 (**Photo 5.14**). The one-story, L-shaped plan rests on a concrete slab foundation and has a painted concrete block structural system with wood siding in the gable ends. The intersecting gable roofs over the primary mass are covered with composition shingles. Visible windows include individual and paired six-over-six vinyl single-hung sash units, and a bay window comprised of a six-over-six vinyl single-hung sash unit flanked with four-over-four vinyl single-hung sash units. Distinguishing architectural features include overhanging eaves, faux-shutters, a bay window, rectangular gable vent, an integrated one-car garage, wood siding on the gable ends, decorative tile designs flanking the garage, and porch columns. Alterations include replacement roofing, siding, doors, and windows. Overall, the building has been altered, lacks sufficient architectural features, and is not a significant embodiment of a type, period, or method of construction. In addition, background research did not reveal any historic associations with significant persons and/or events. As a result, 8MA02649 does not appear eligible for listing in the NRHP, either individually or as part of a historic district.

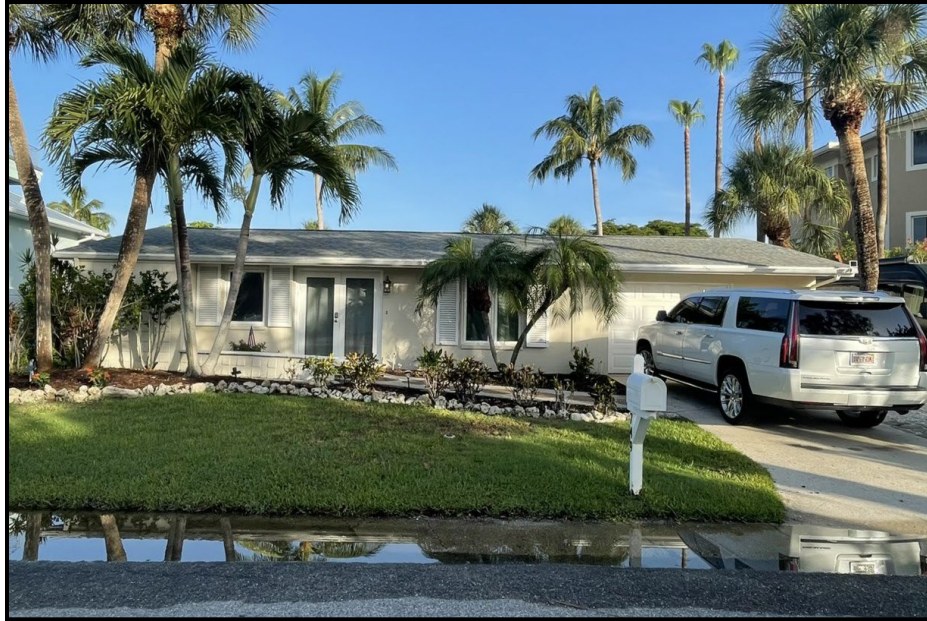
Photo 5.15. 749 Norton Street (8MA02650), looking northwest.

8MA02650: The Masonry Vernacular style building at 749 Norton Street was constructed in ca. 1971 (**Photo 5.15**). The one-story, irregular plan rests on a concrete slab foundation and has a painted concrete block structural system covered with wood siding and artblock accents. The gable roof over the primary mass is covered with composition shingles. Visible windows include individual vinyl casement units. Distinguishing architectural features include overhanging eaves, a square gable vent, wood siding on the gables, an integrated one-car garage, faux-shutters, a large metal HVAC system along the southwest elevation, and artblock on the southwest elevation. Alterations include replacement roofing, siding, doors, and windows. Overall, the building has been altered, lacks sufficient architectural features, and is not a significant embodiment of a type, period, or method of construction. In addition, background research did not reveal any historic associations with significant persons and/or events. As a result, 8MA02650 does not appear eligible for listing in the NRHP, either individually or as part of a historic district.

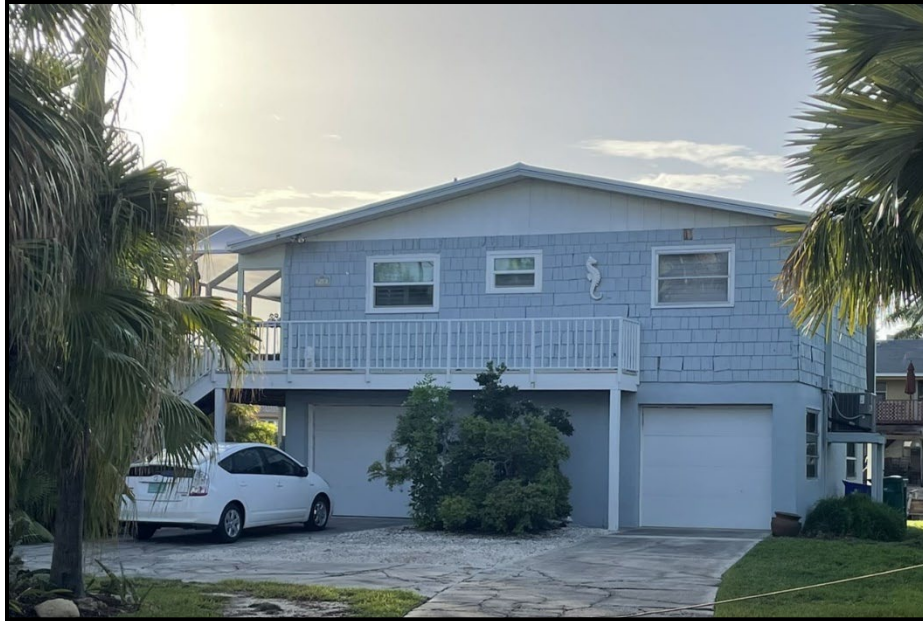
Photo 5.16. 762 Norton Street (8MA02651), looking east.

8MA02651: The Masonry Vernacular style building at 762 Norton Street was constructed in ca. 1968 (**Photo 5.16**). The two-story, rectangular plan rests on a concrete slab foundation and has a concrete block structural system covered with stucco, wood shingles, and wood siding. The gable roof over the primary mass is covered with composition shingles. Visible windows include individual one-over-one vinyl sing-hung sash units, individual four-stacked metal awning units, and individual vinyl picture window units. Distinguishing architectural features include overhanging eaves, two integrated one-car garages, wood shingles on the second floor exterior, wood siding on the gables, and exterior stairs to the balcony on the second story. Alterations include replacement roofing, siding, doors, and windows. A second story screened patio addition is located on the north-east elevation. Overall, the building has been altered, lacks sufficient architectural features, and is not a significant embodiment of a type, period, or method of construction. In addition, background research did not reveal any historic associations with significant persons and/or events. As a result, 8MA02651 does not appear eligible for listing in the NRHP, either individually or as part of a historic district.
