**Building Official Inspection Report**  
**February 26, 2014**  
**1620 Gulf of Mexico Drive**  
**The Colony**

### Building Official Report

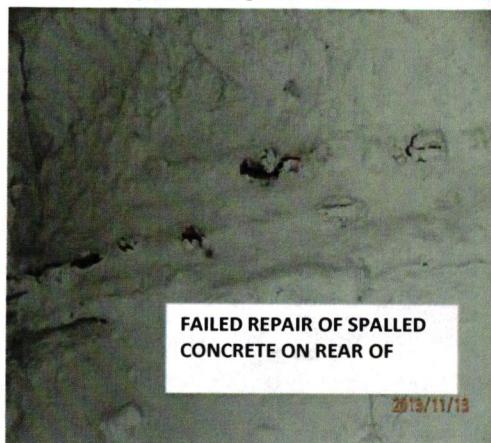
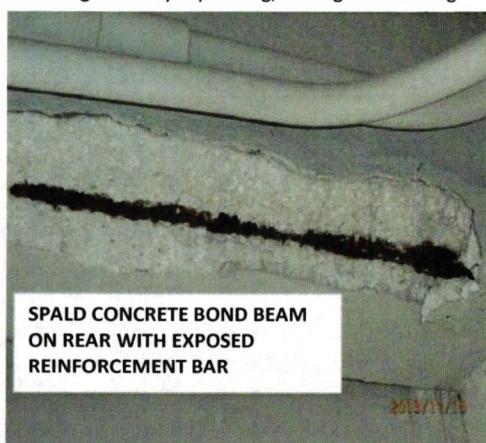
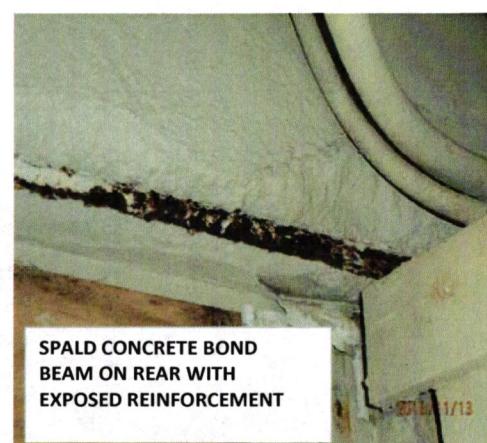
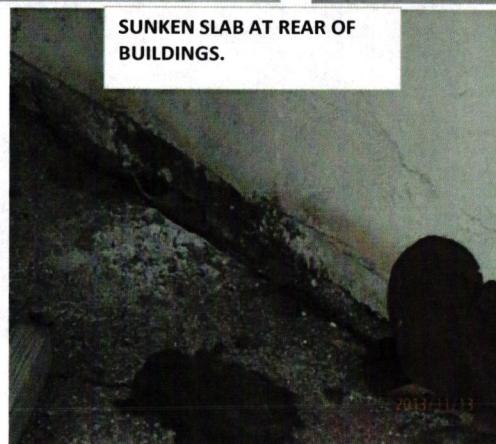
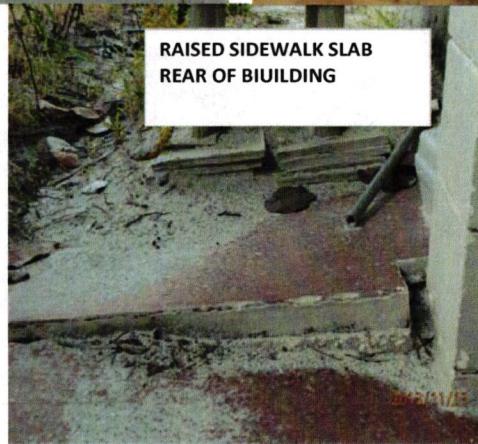
Rear of building in the lintel beam.

Rear of building walkway separating, sinking and heaving

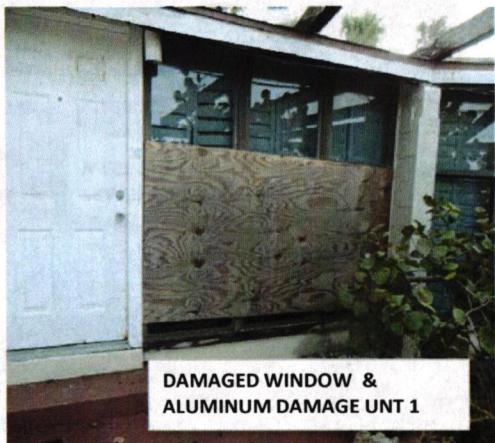
Windows damaged due to vandalizing.

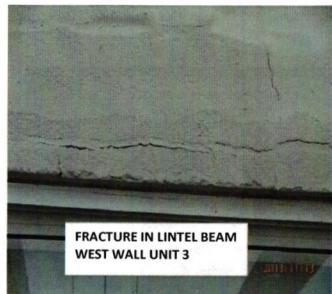
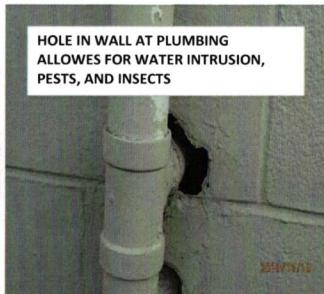
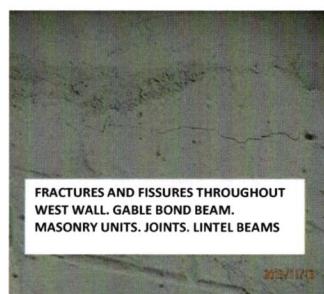
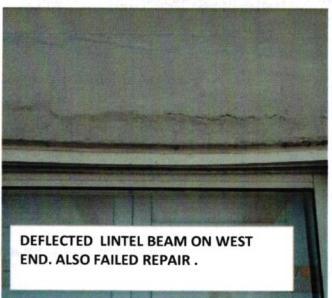
Around plumbing stack on west end of building

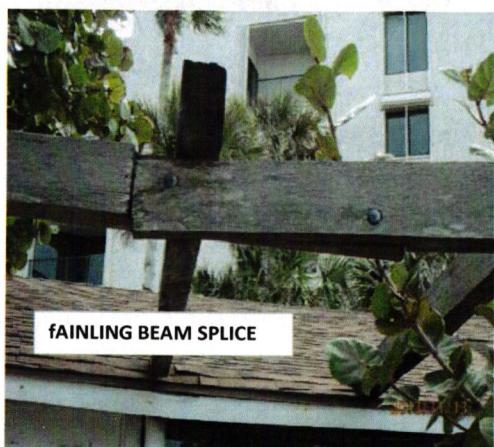
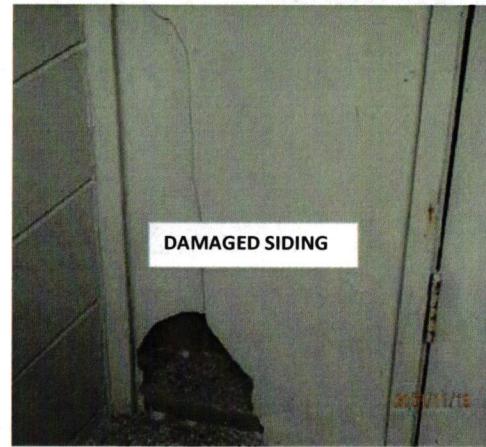
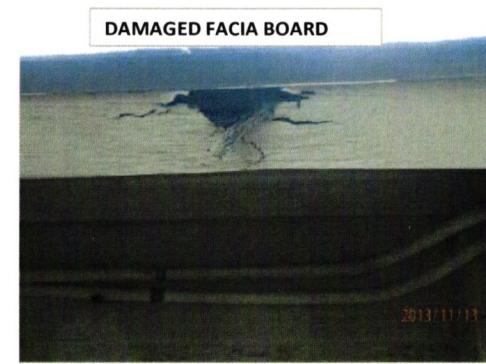
Roof sheathing supporting trellis beams.  
Soffits, fascia boards, siding, trim boards, door jambs

Splice in support beam of trellis,  
plywood failing to support trellis,  
Splice in support beam of trellis

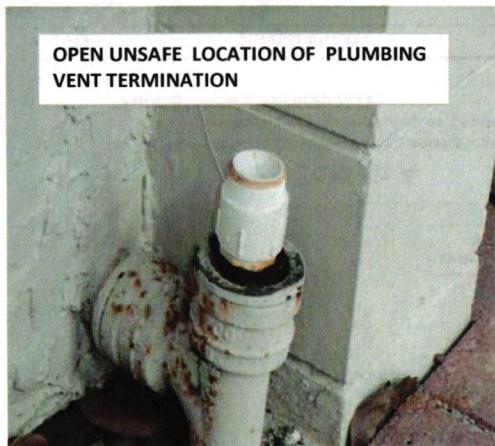
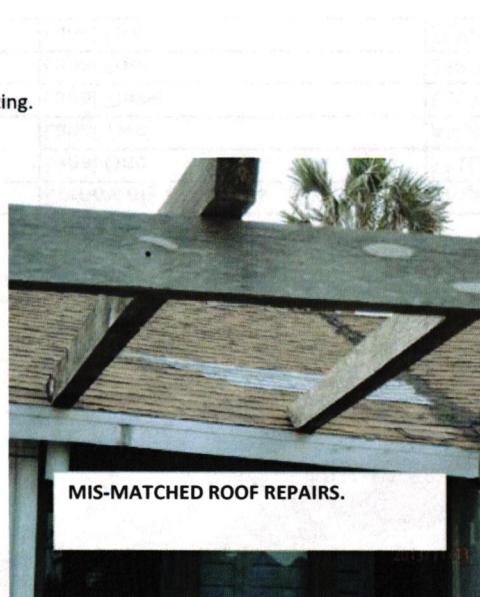
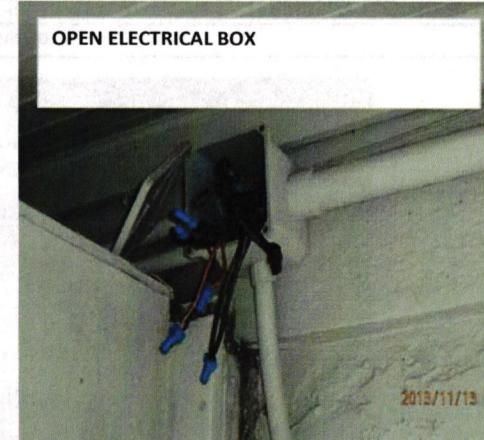
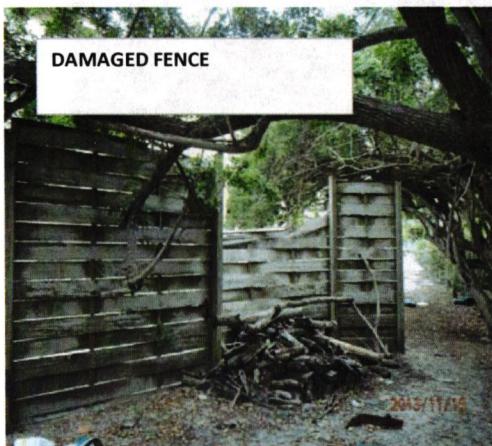
Roof at end of its life. Showing signs of leaking.

Mismatched roofing repairs.

Wood fence damaged

Windows and doors boarded due to damage from vandalizing.

Open plumbing vent and drain.

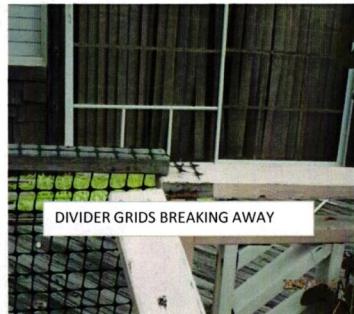
Window grids breaking away

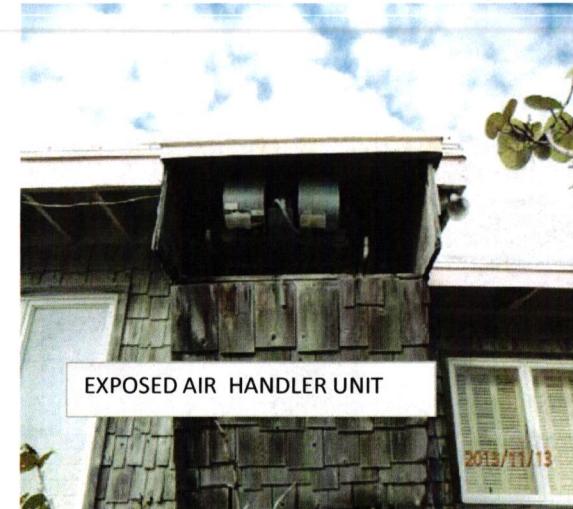
Cast iron drains

AC units to a point that they no longer function  
Awnings have fallen from failed connections

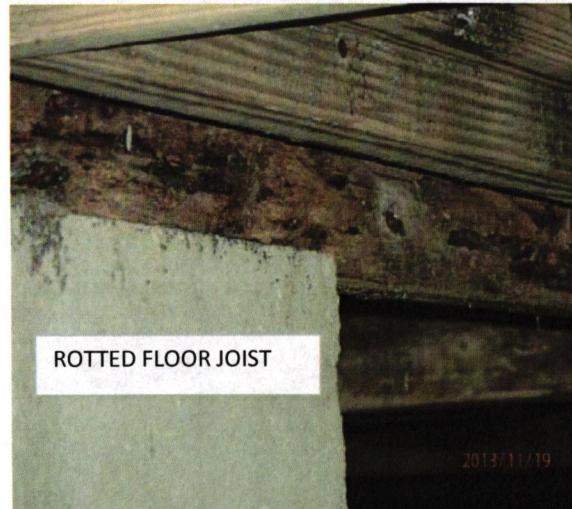
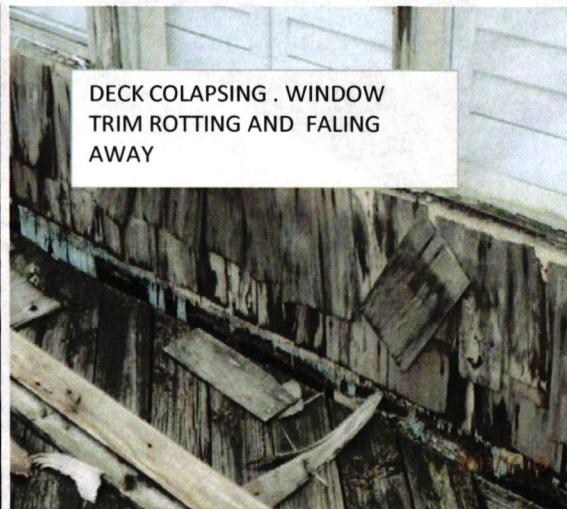
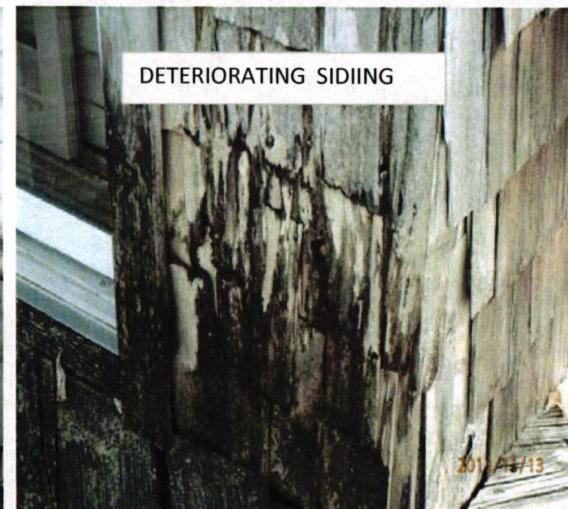
Signs of Possible damage due to termites

Joists and supports appear to be failing through out deck systems.

Through out deck systems, joists, decking surface, guard and hand railing. Window planter boxes falling from walls, lattice skirting.

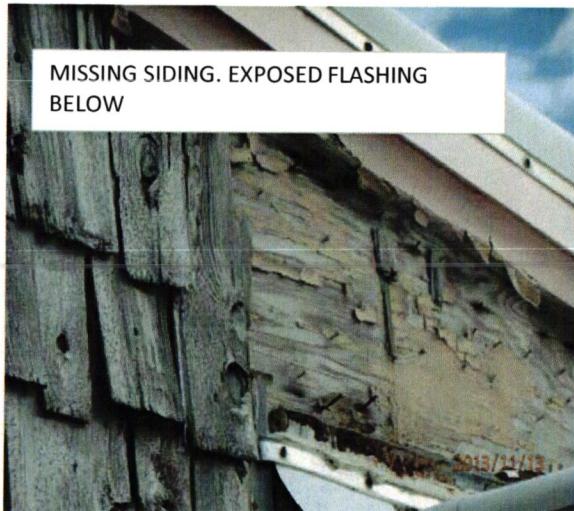
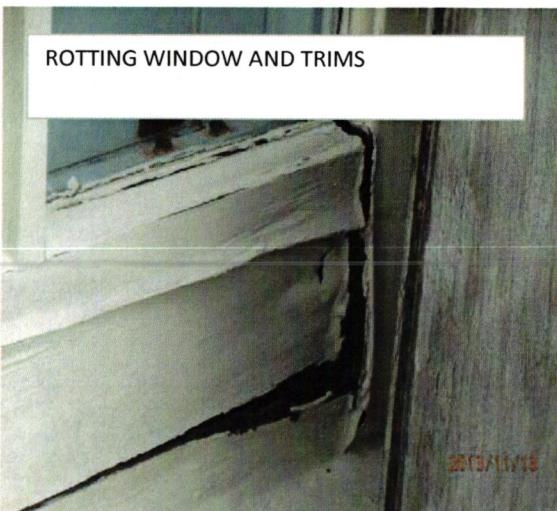
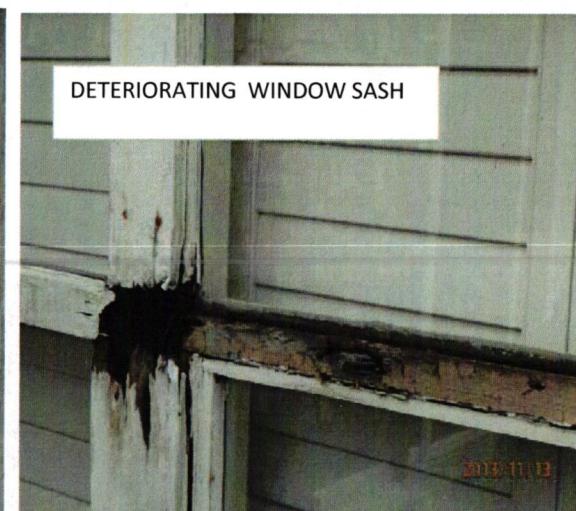
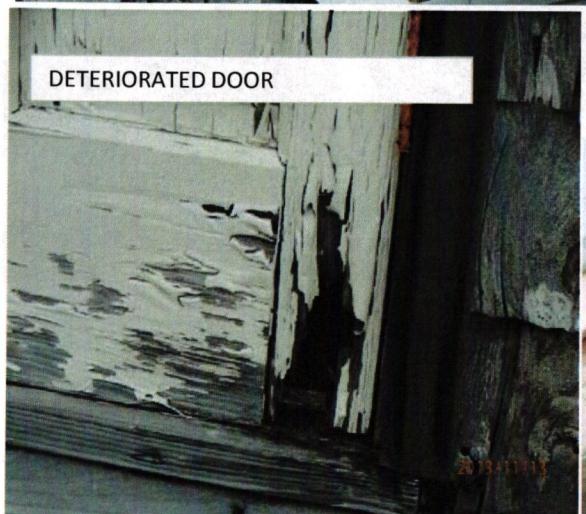
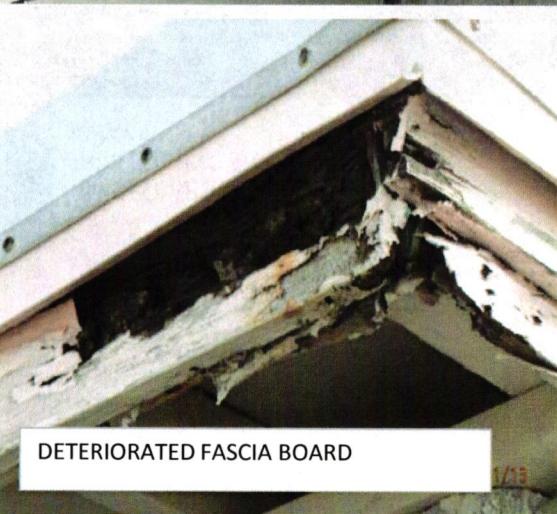
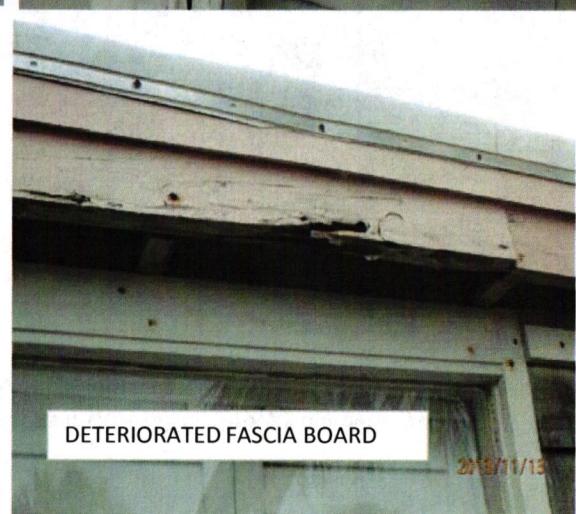
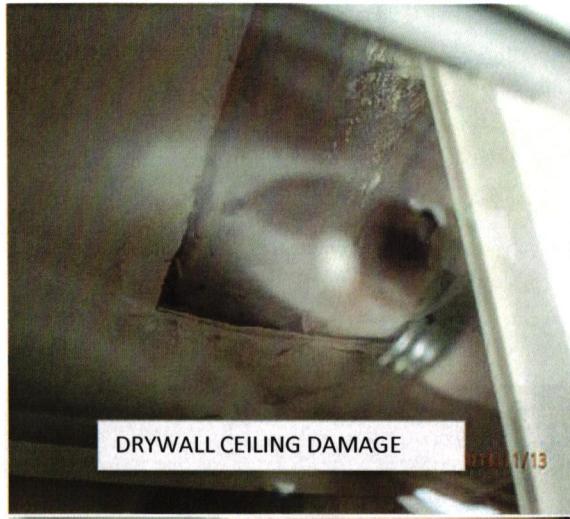
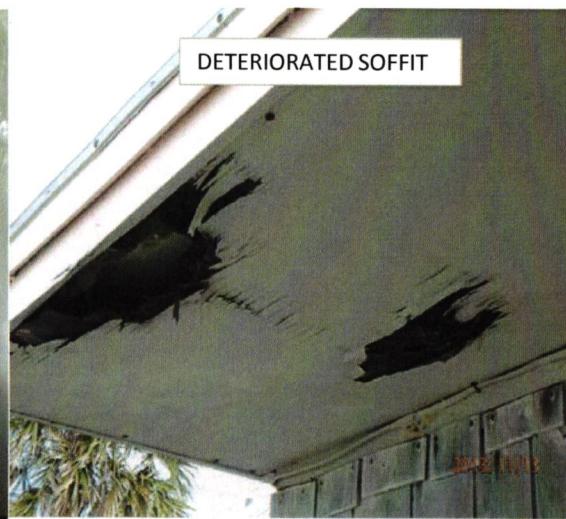
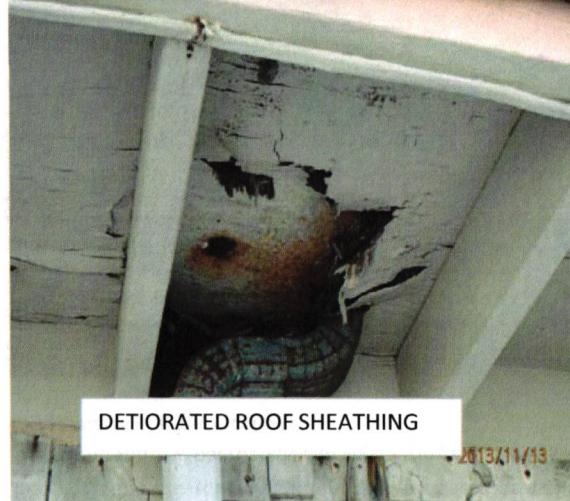
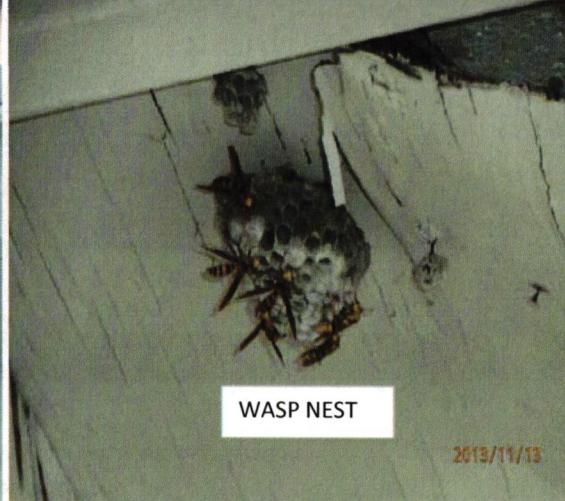
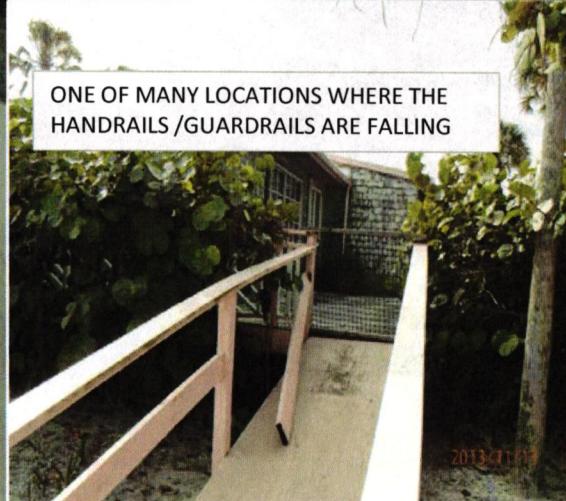
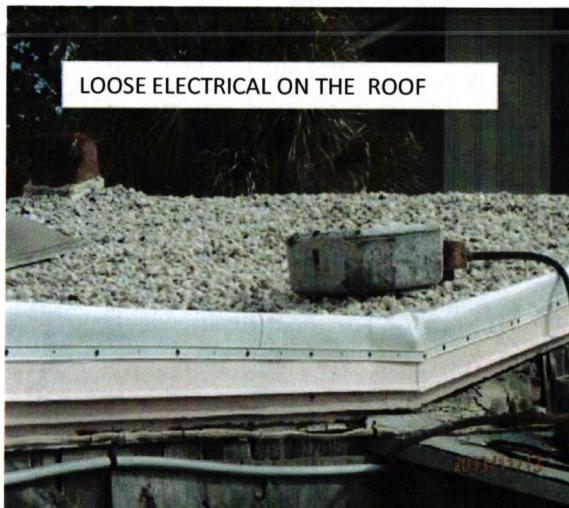
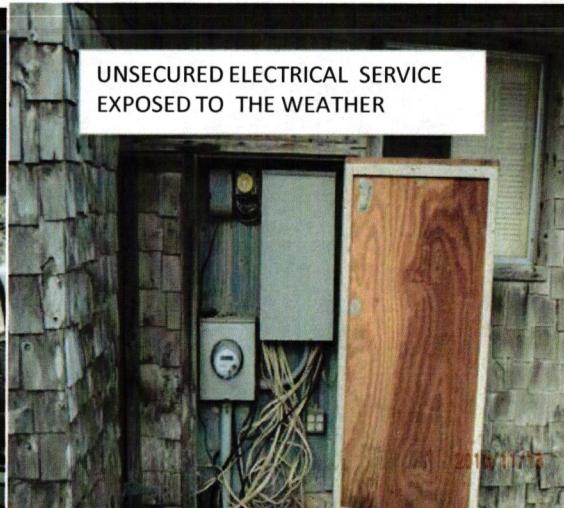
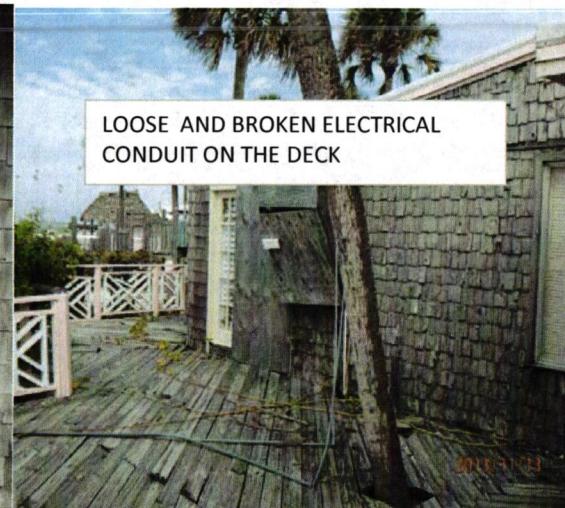
Roof leaks found throughout. Interior/exterior damage as a result

Doors and window boarded due to vandalizing and from failure from water and deterioration.

Wasps nests in a few locations

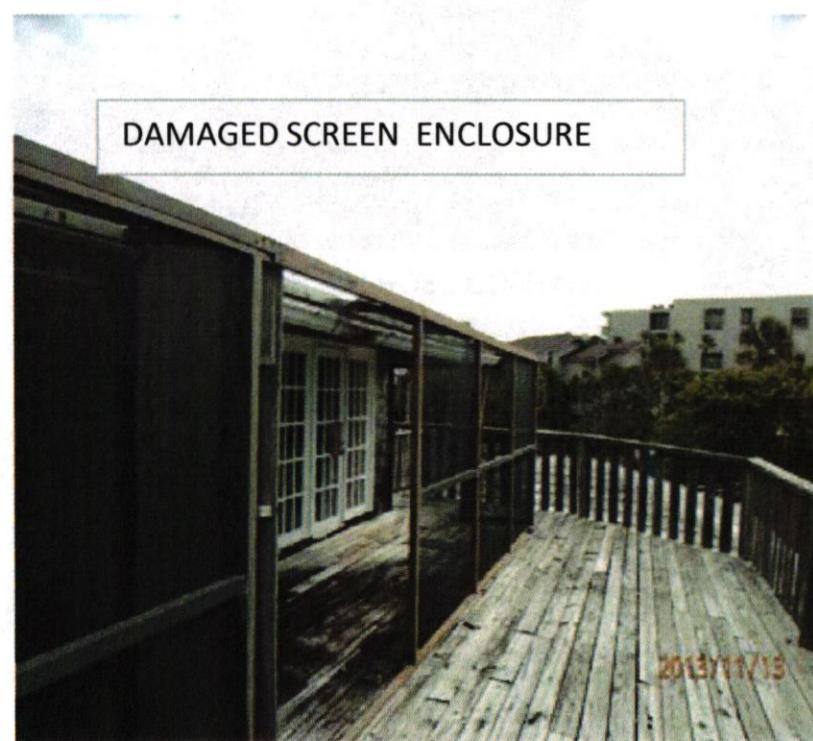
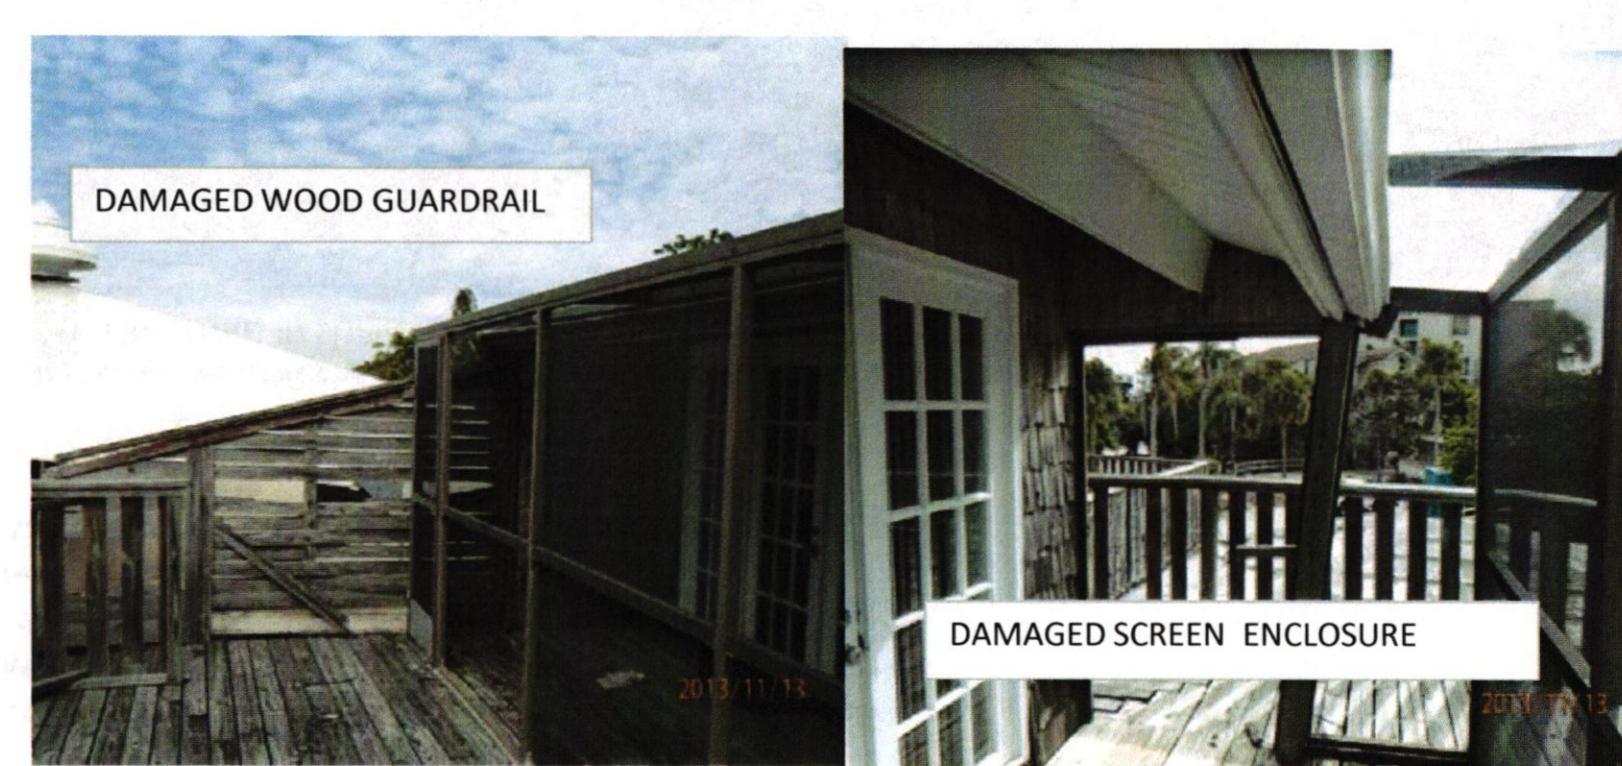
Screen enclosures to presidential suites

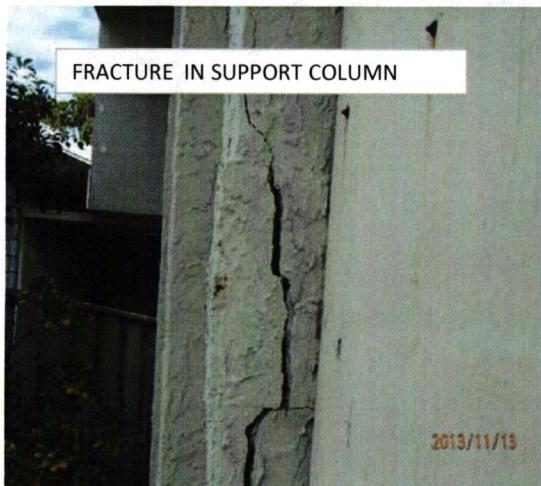
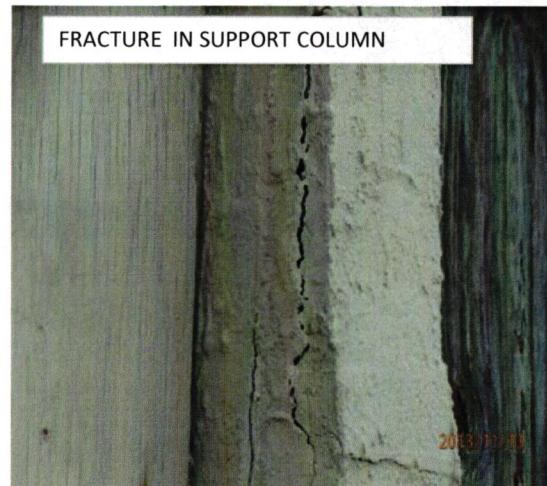
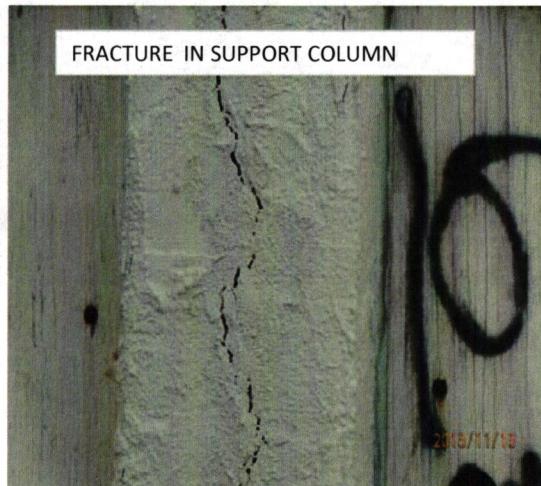
Critical on northwest side. Also found throughout the building

Northwest especially

At bulged location on northwest side columns of windows

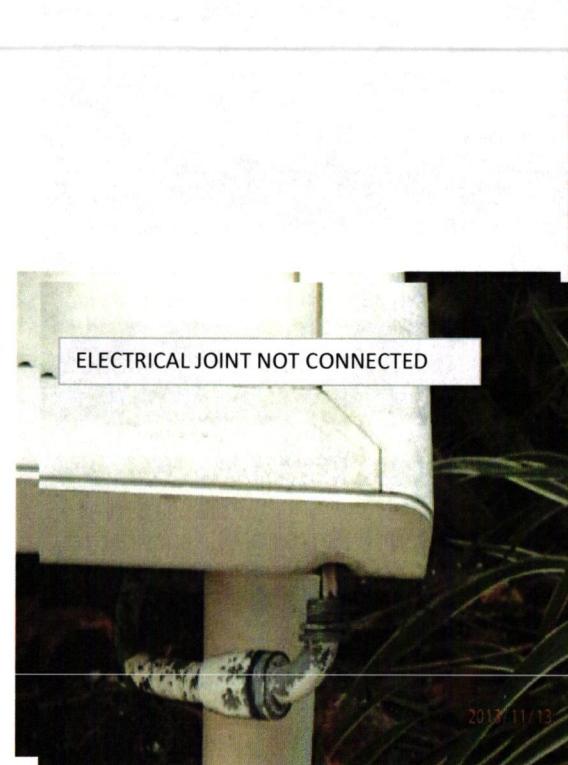
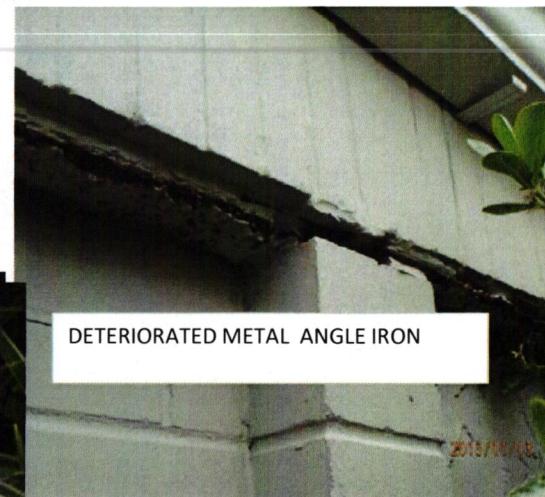
Exposed I beams, canopies. Doors showing signs of failure. Large canopy area in rear on tube steel and weld joints

Many locations on the canopies.

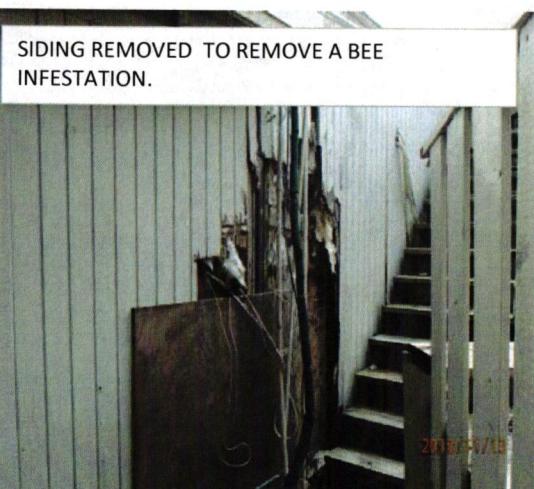
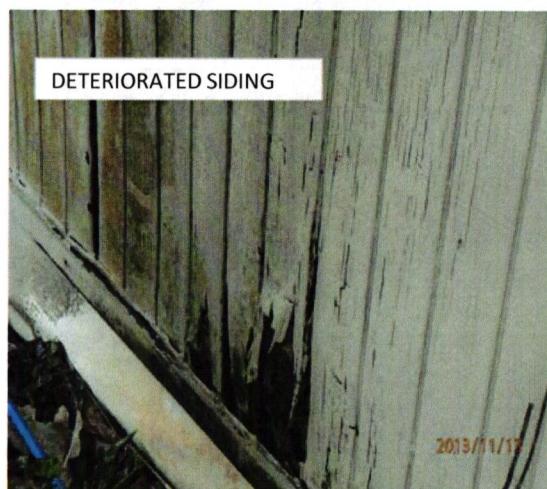
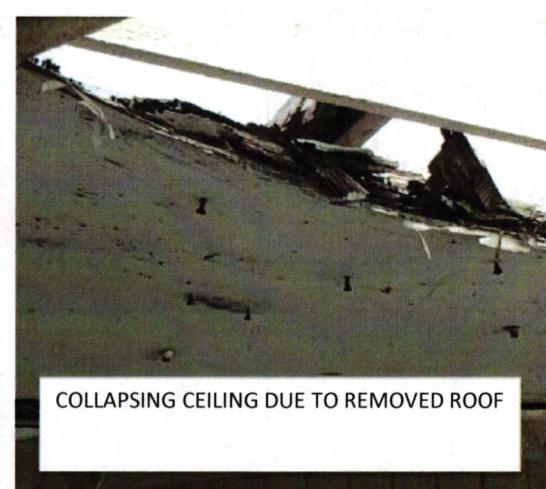
Extensive rot at siding along the bottom. Roof system over entry to

Bee infestation at the rear caused removal of siding

Found vertical separation at on window of realtors office.

Roof over Monkey entry, guard rails, handrails, decking.

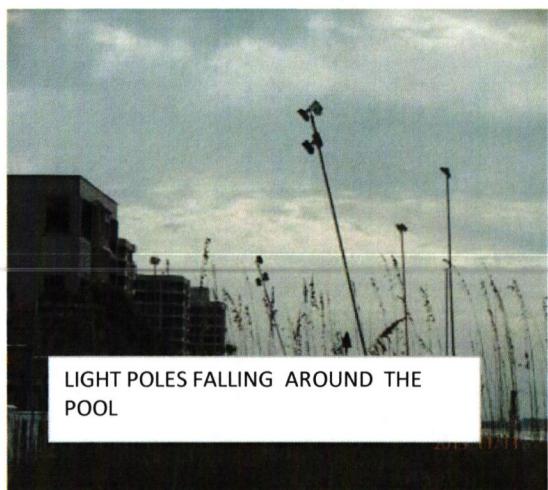
LIGHT POLES FALLING AROUND THE POOL

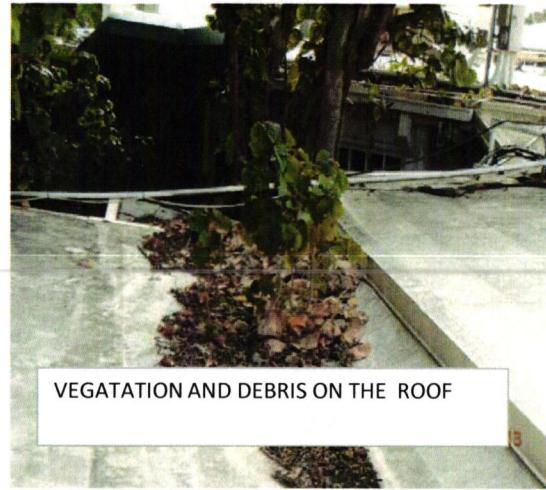
VEGATATION AND DEBRIS ON THE ROOF

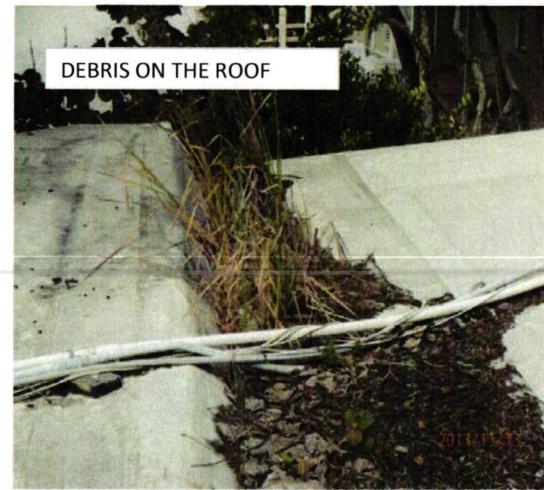
DEBRIS ON THE ROOF

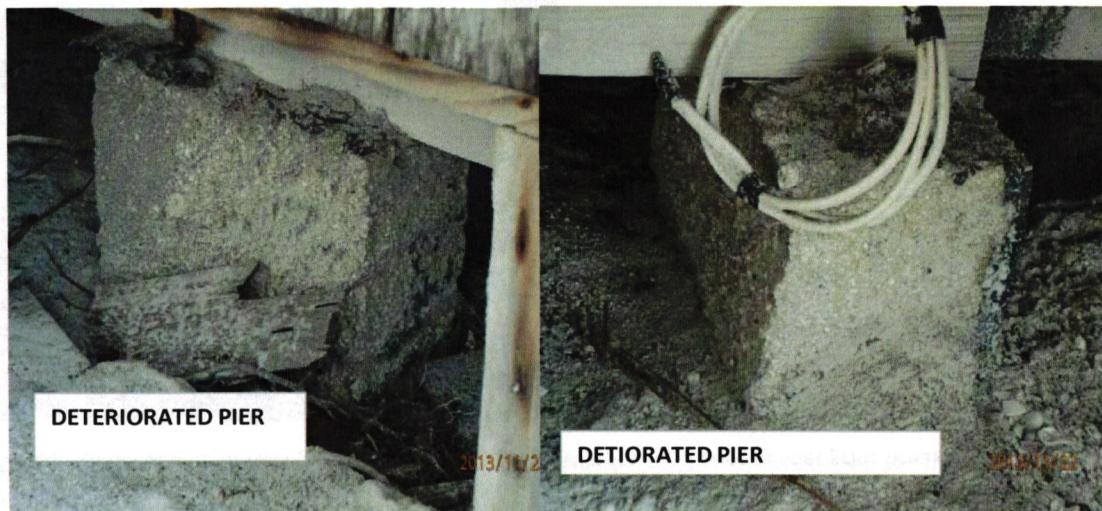
This building is seaward of the coastal construction control line. Code limitation associated to working on the foundation.

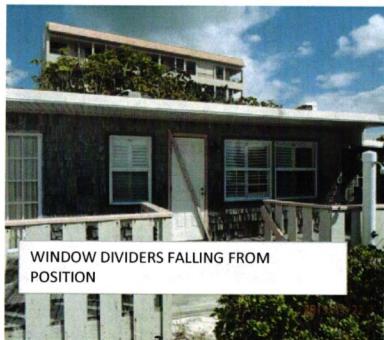
Window and door divider grids breaking away

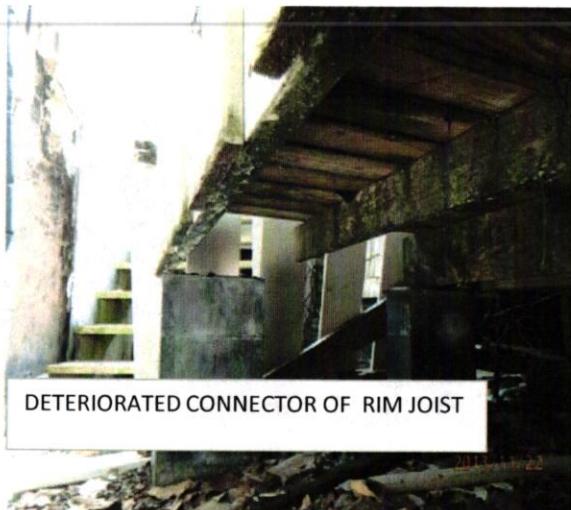
Deterioration	Strap connector rim board to columns
Elastic deformation	
Ultimate deformation	
Metal fatigue	
Detached, dislodged, or failing connections	Rim board to columns

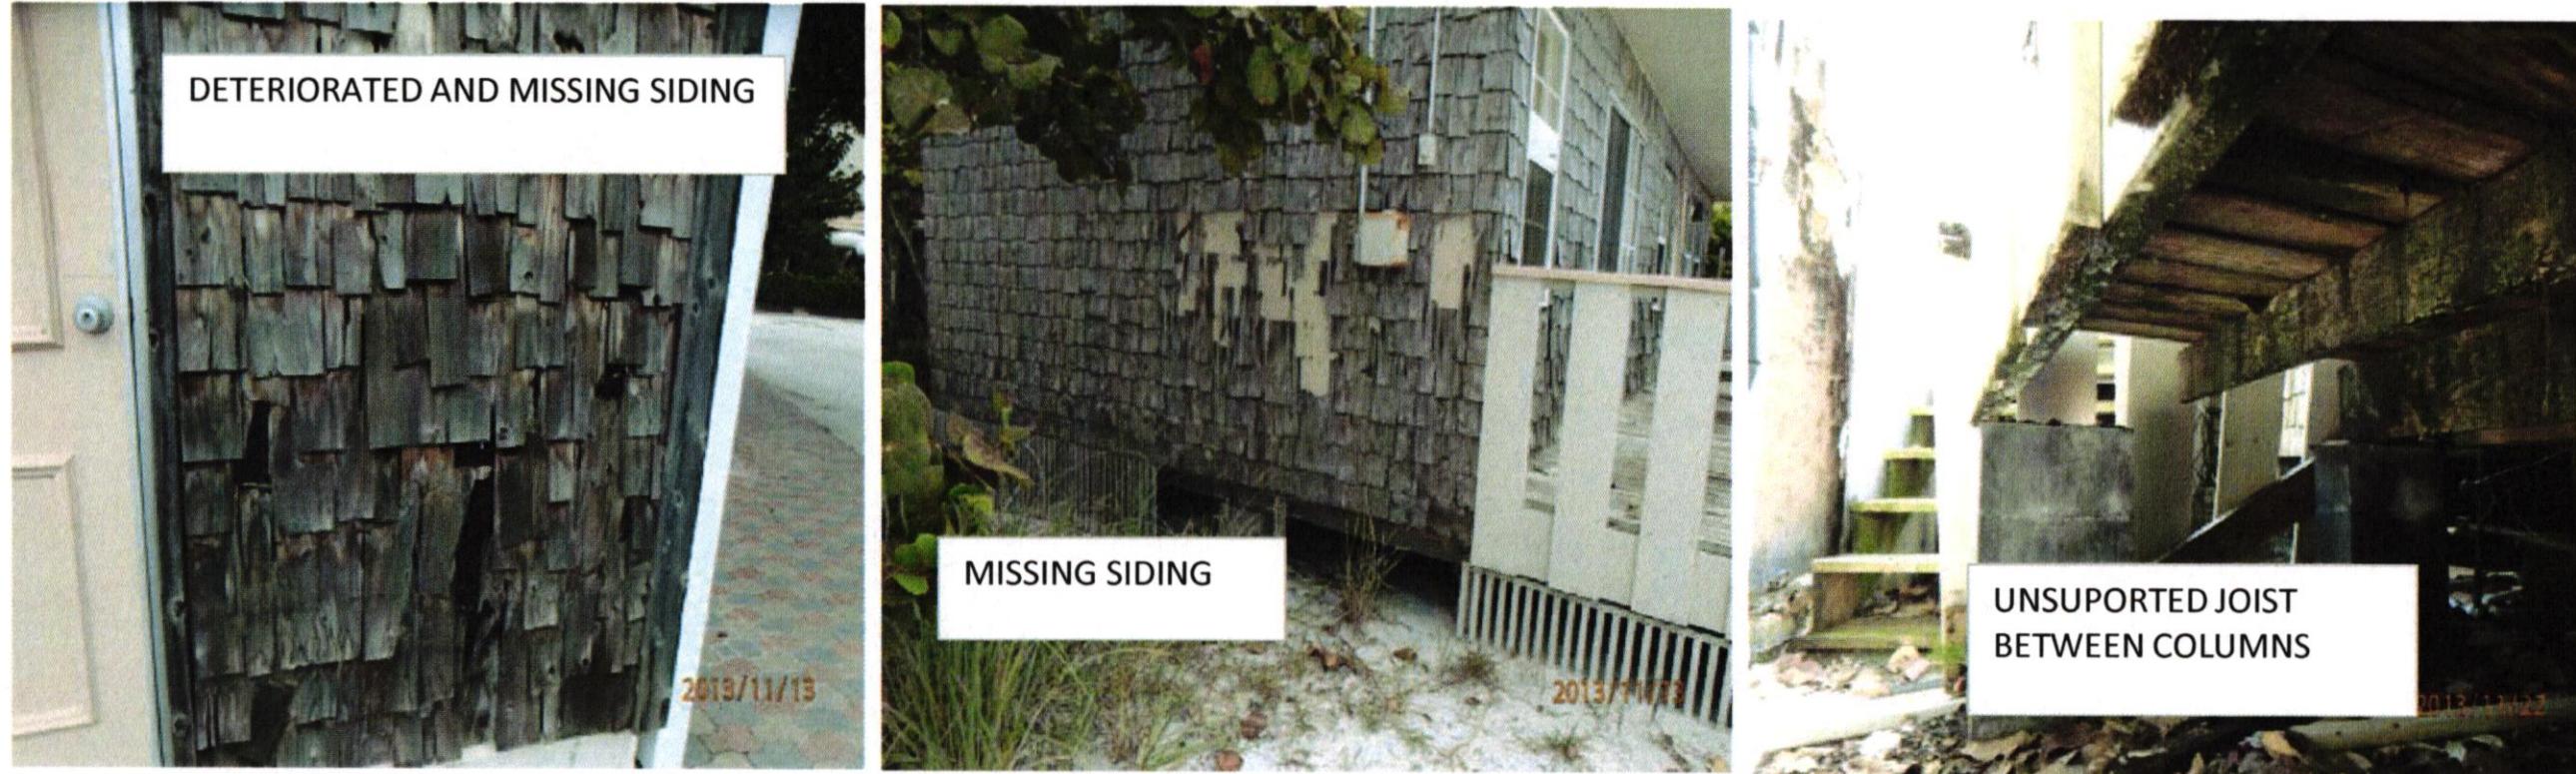
Siding falling from building, exposed sheathing behind. Doors and trims.

Rear deck not properly seated on  
the columns. Rim board not  
Lattice skirting, railings, joists.

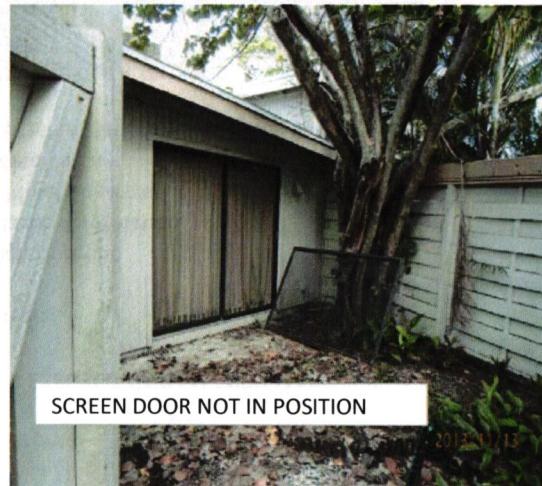
SCREEN DOOR NOT IN POSITION

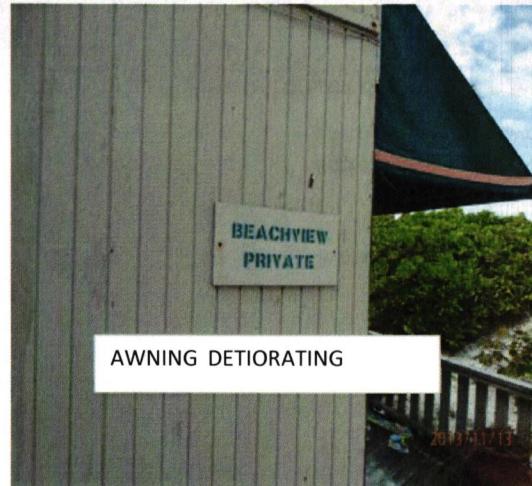
AWNING DETERIORATING

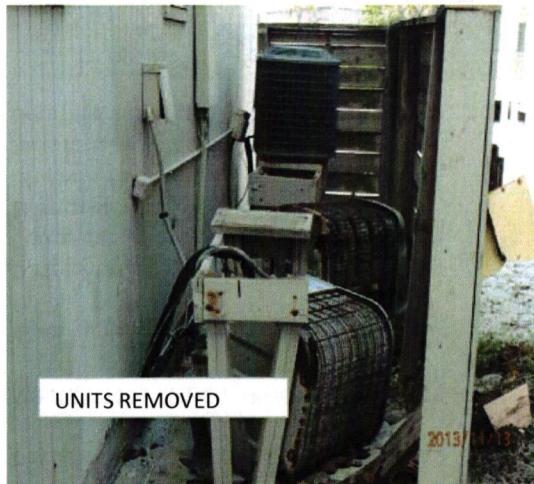
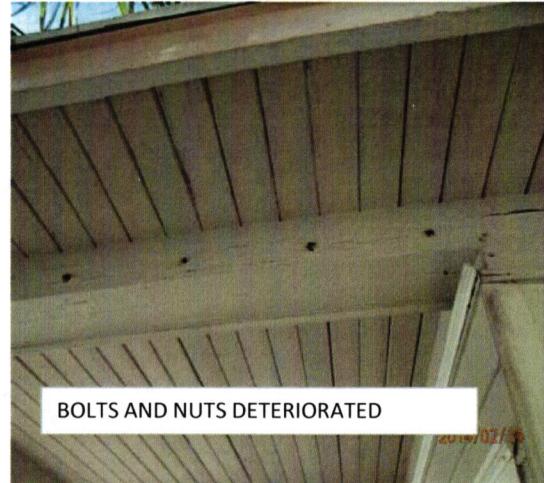
Awnings at all units, air conditioning units

Bottom of air conditioning units

Corroded joints to awnings.

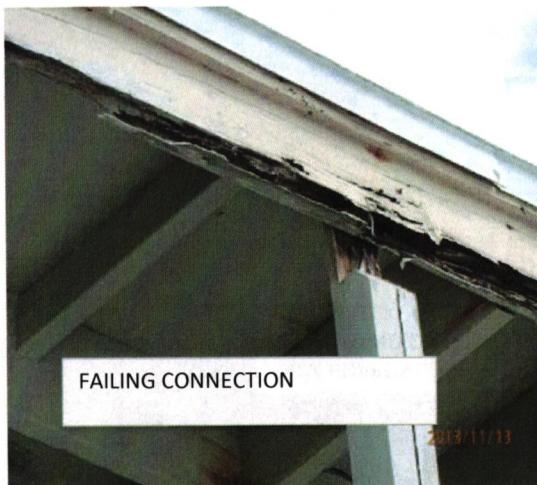
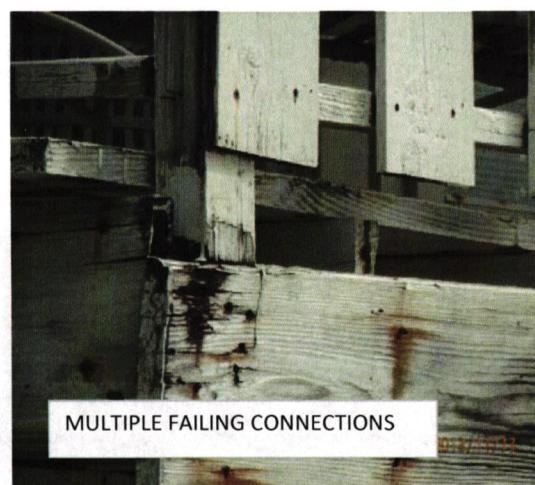
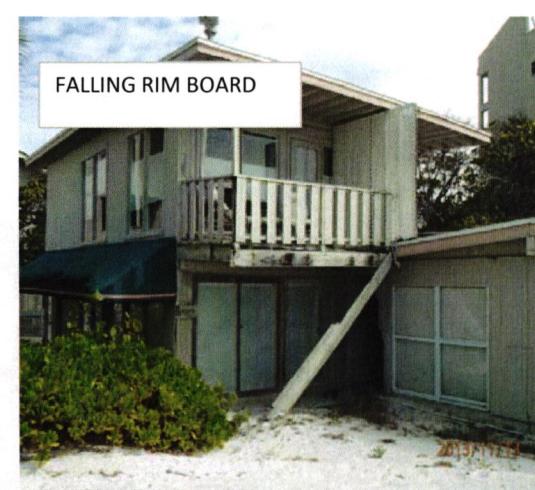
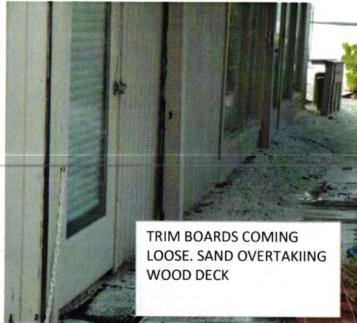
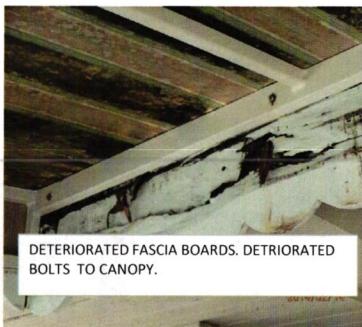
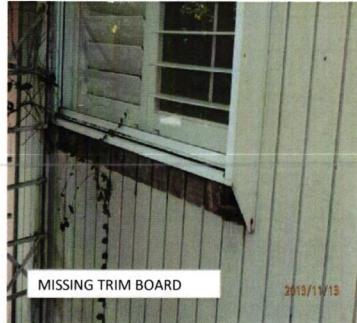
Sidings, trims, fascia boards, doors, windows, air conditioning stands, deck joists.

Signs of damage from termite at trims, holes in siding may be from birds and insects. Hole at vagabond a/c once had a dead animal .

Air conditioning stands. Cantilevered balcony to beachview units

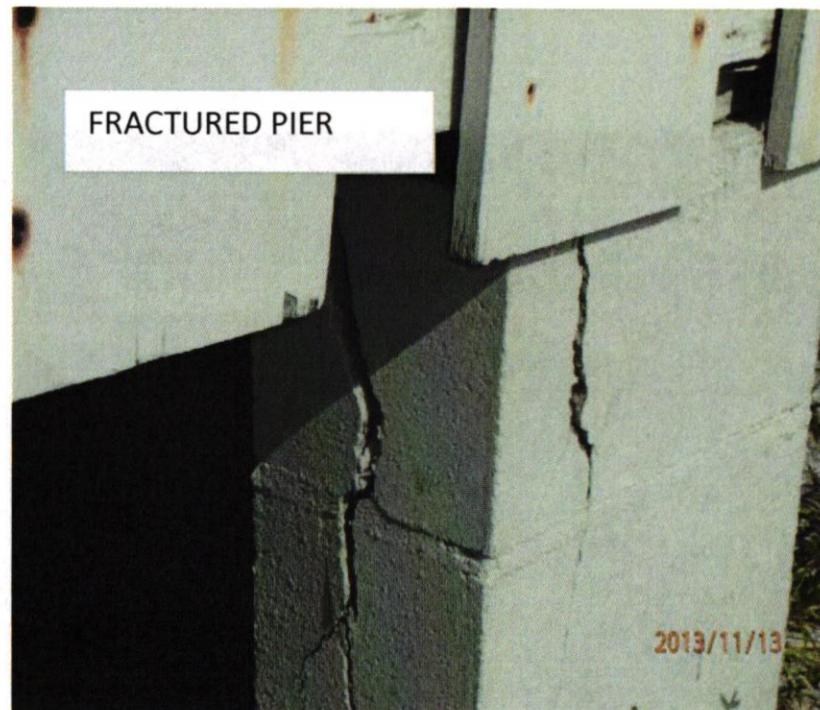
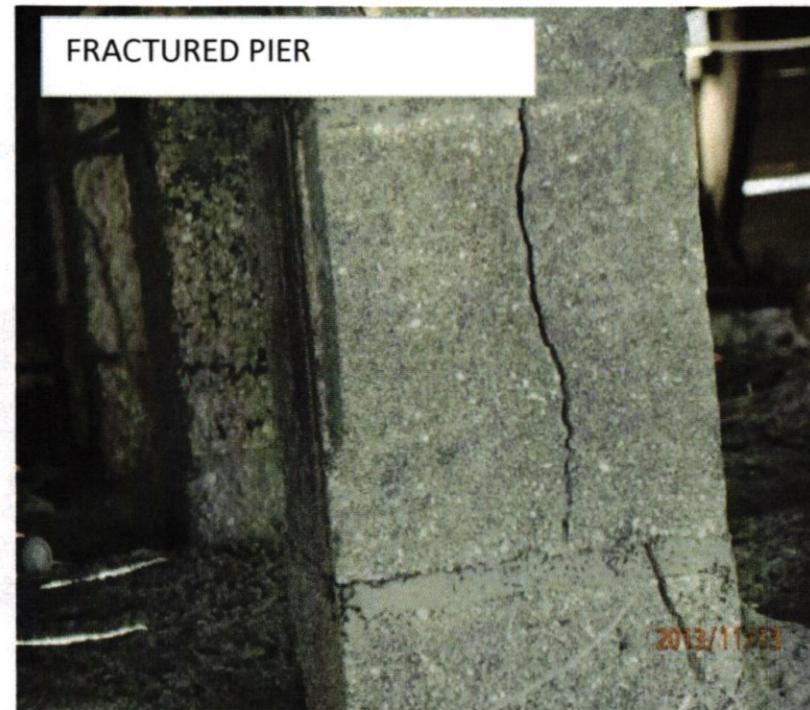
Column supports to deck

Column supports to building and deck.

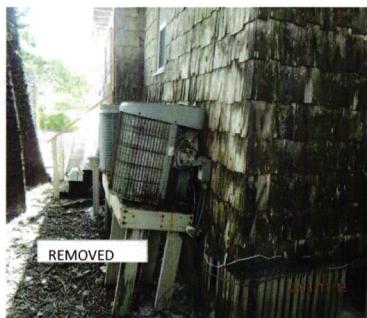
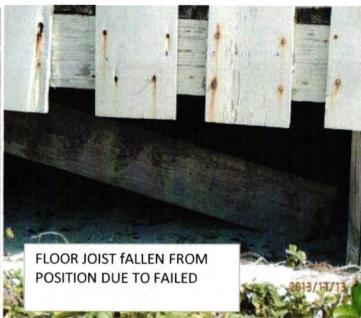
Deterioration  
Elastic deformation  
Ultimate deformation  
Metal fatigue  
Detached, dislodged, or Joist connectors

Air conditioning units. Air handler unit

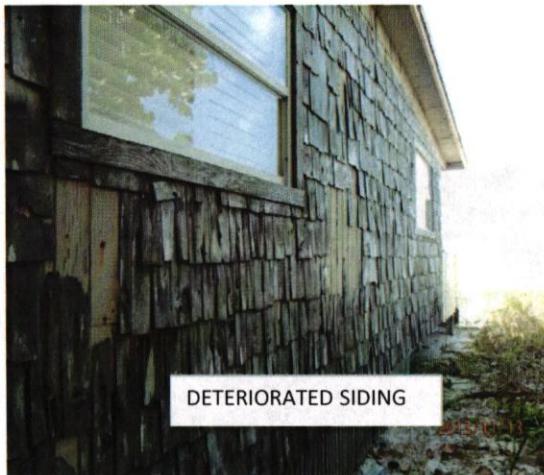
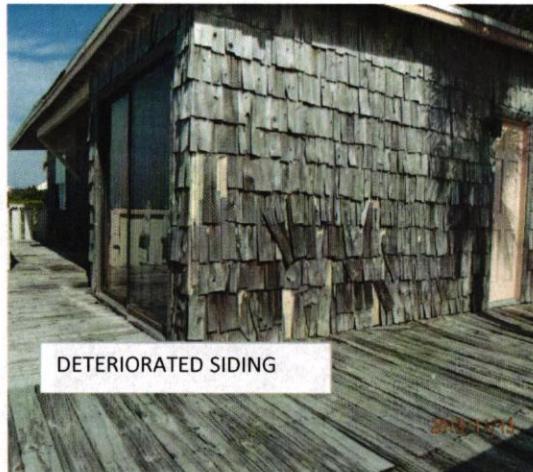
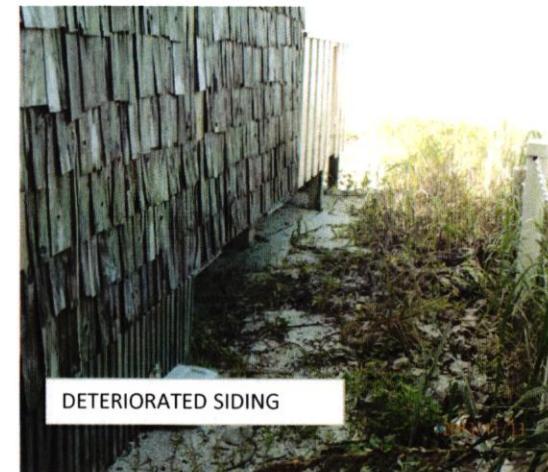
Deck waling surface, sidings, trims, doors, windows, fascia boards, railings.  
Signs of insect damage to sheathing behind wood siding.

Fencing falling down, joists have fallen, railing pulling down. Air conditioning stands.

Joists, decking, siding, railings. Lattice skirting falling from structure

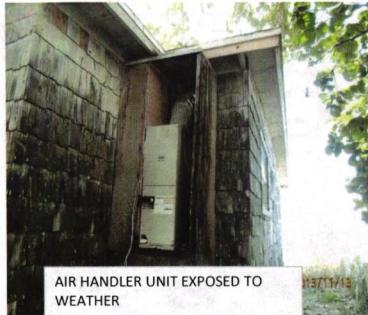
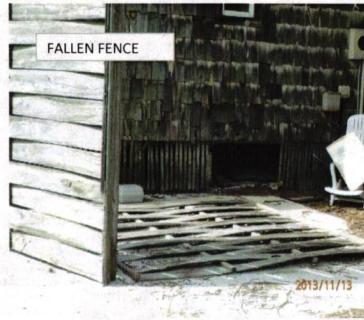
Air handler unit exposed to weather

Fencing falling to ground.

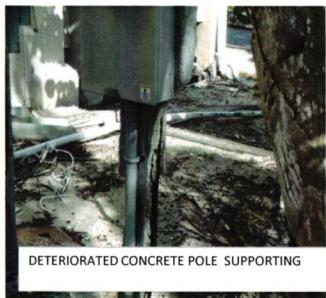
Service meter supports

Upper bond beam south wall at railing

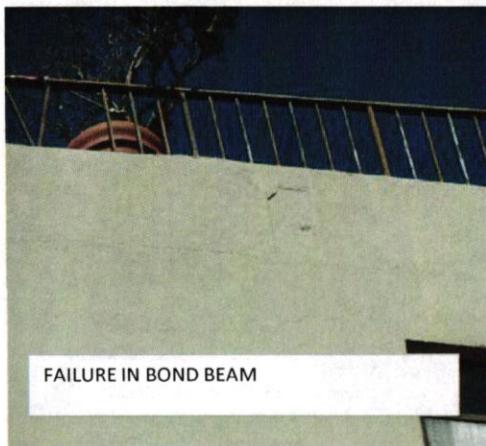
breaks of plaster and mortar at window buttresses

FAILURE IN BOND BEAM
