**Building Official Inspection Report**  
**February 26, 2014**  
**1620 Gulf of Mexico Drive**  
**The Colony**

### Building Official Report

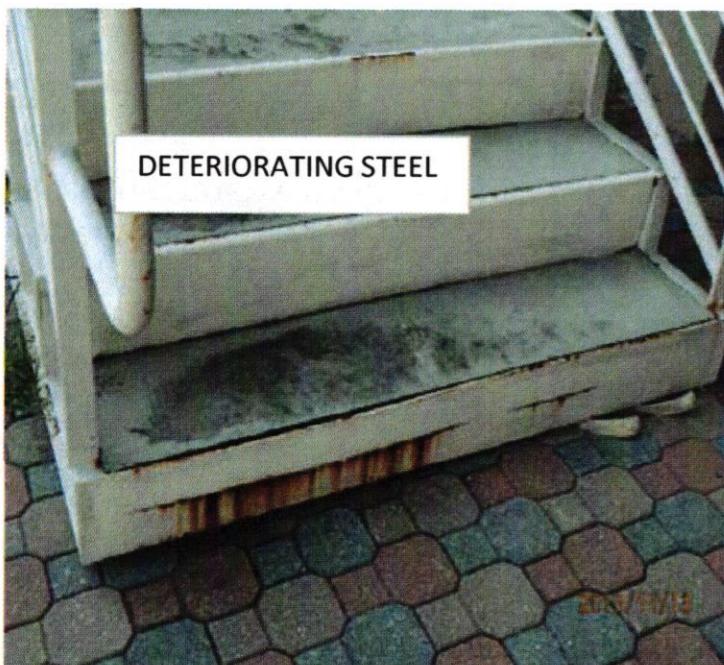
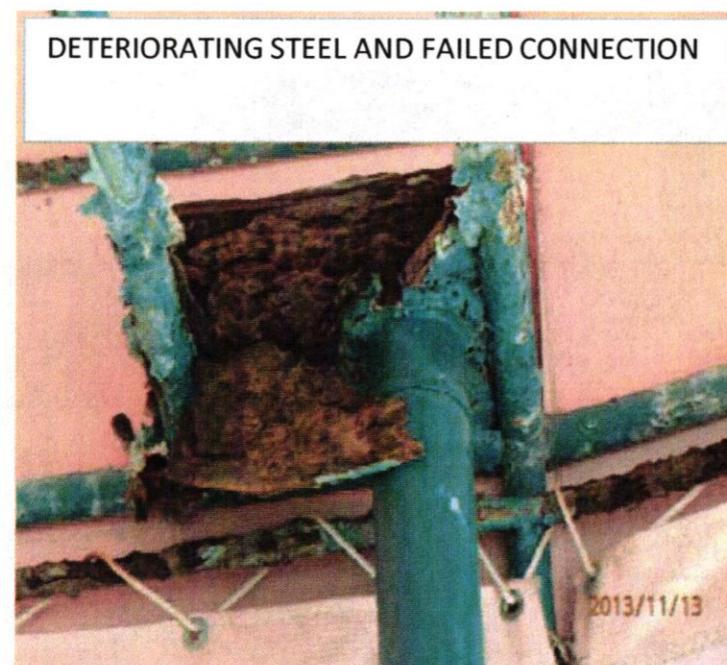
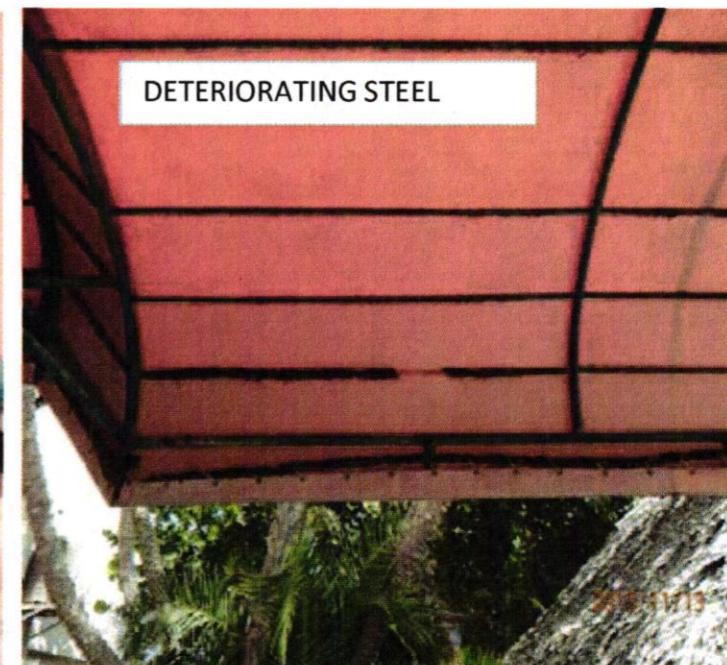
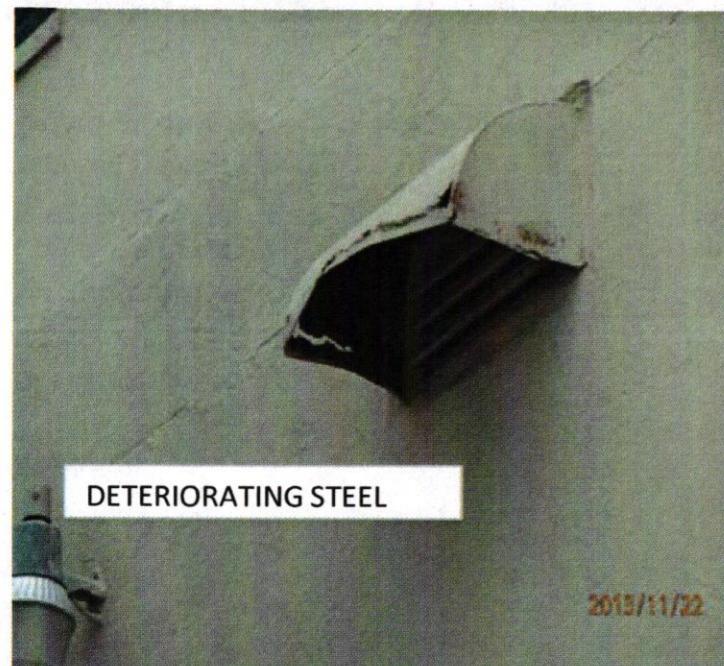
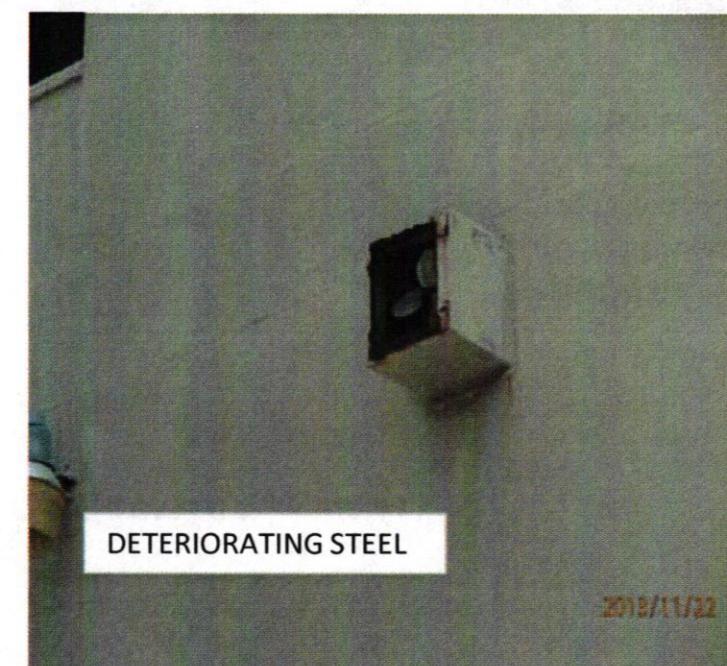
Bracing to parapet walls, fabric canopies  
Railing to sixth floor patio, fabric canopies.

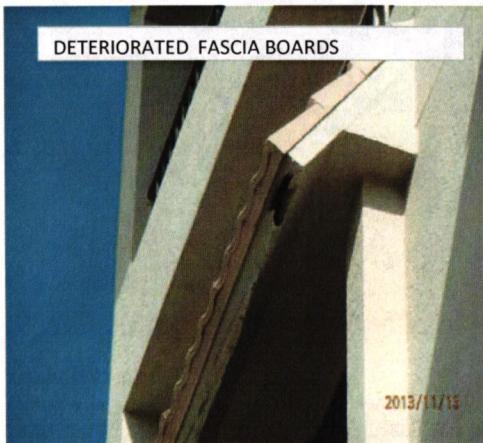
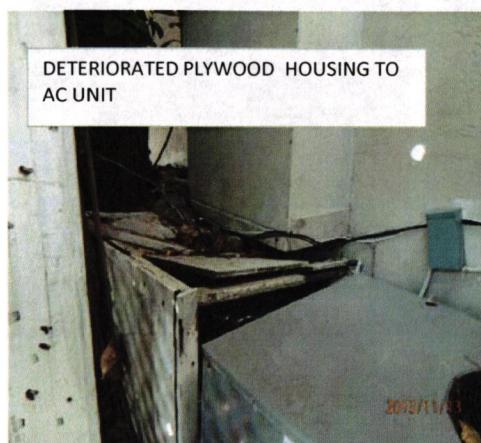
fascia boards and trims

Housing for ductwork. Sign over drive canopy.

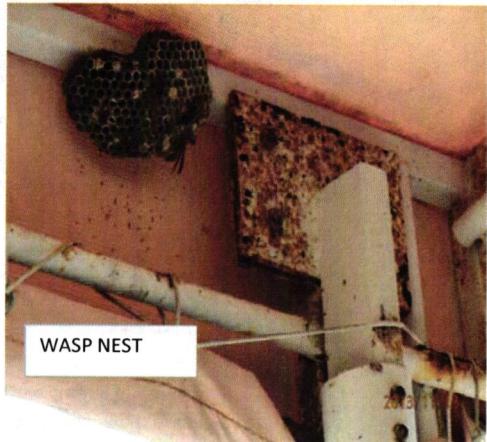
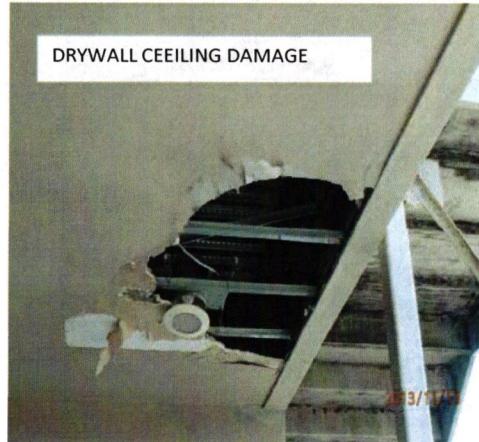
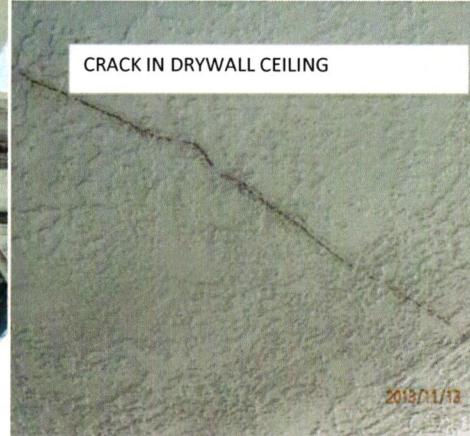
Building has been posted for a non working fire alarm system including the required monitoring. Restricted access.  
Building has been posted for failing joists and connection. Temporary shoring in place. No permanent work completed.  
The interior of the building has extensive mold. No report indicating that it is a health hazard.  
Boarding of opening due to vandalizing.  
Drywall soffits and ceilings cracking, damaged and falling.  
Found windows propped open. Closed days later.  
Wasps nest found.

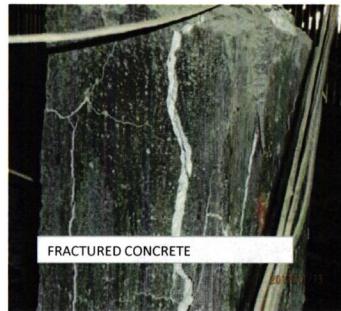
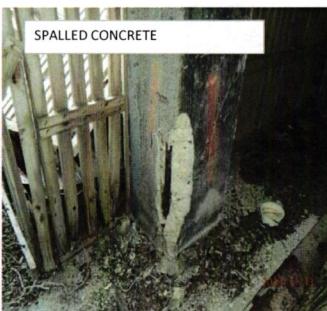
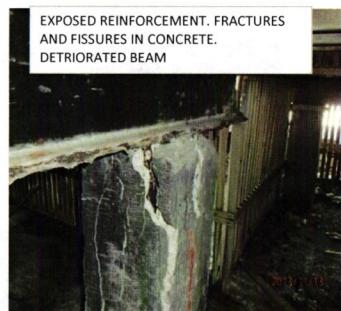
Extensive on approximately 75% of the piers

Extensive on approximately 40% of the piers

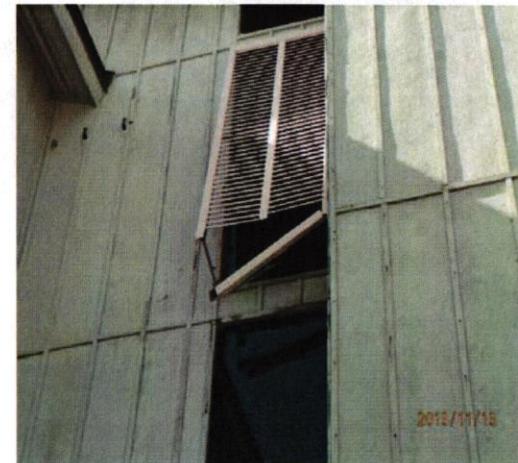
Shutter supports

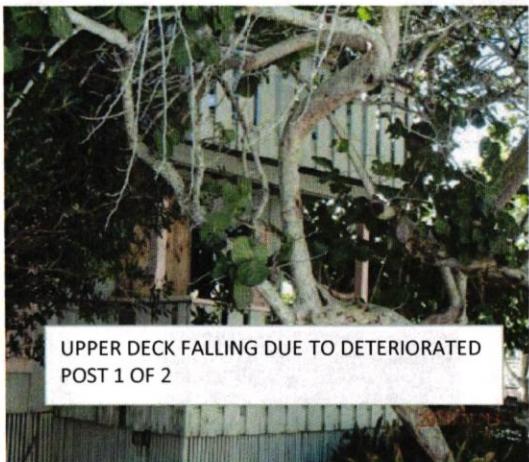
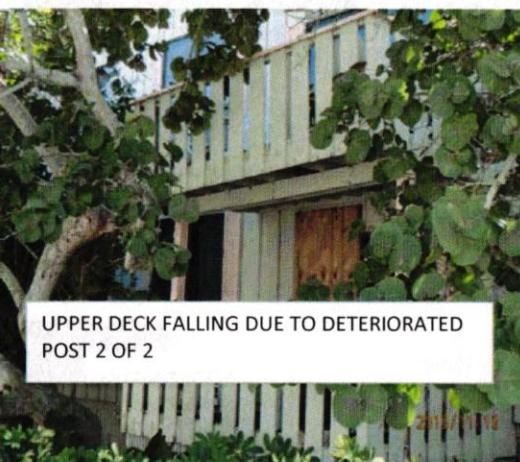
Signs of termite and other insect damage. Extensive on the siding. Currently has wasp nests, Extensive on holes from birds.

Upper deck of one unit has sunk approximately 4 inches due to rot. A/C unit stands. Siding, trims, floor framing, posts, wood shutters, fascia and soffits. The entry stairs and lower deck walkway show signs of failing to support. Railings pulling from walls. Railing missing balusters. Lattice skirting falling from position.

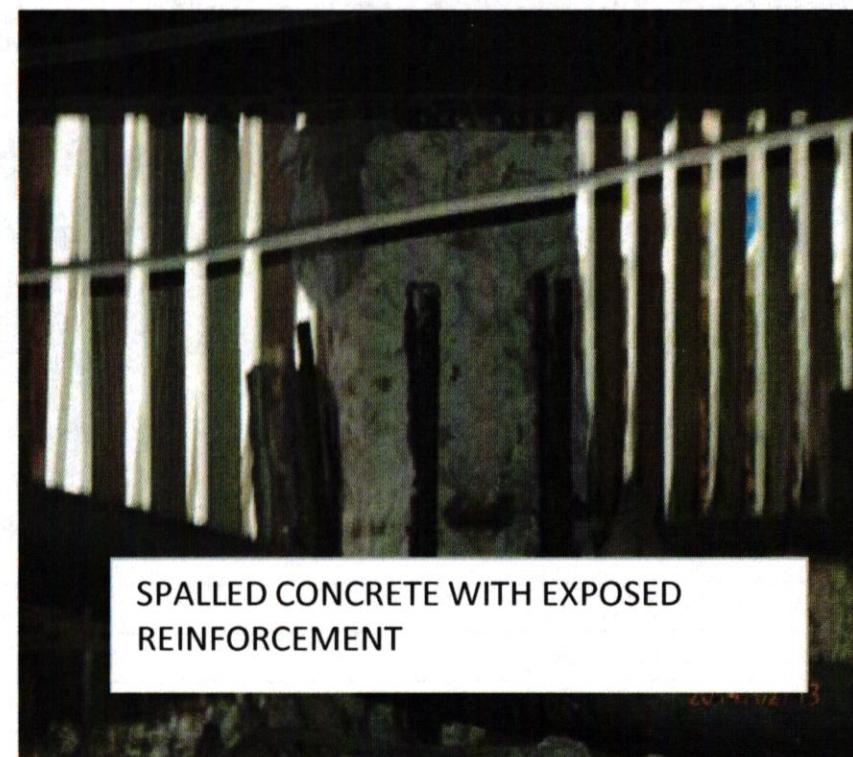
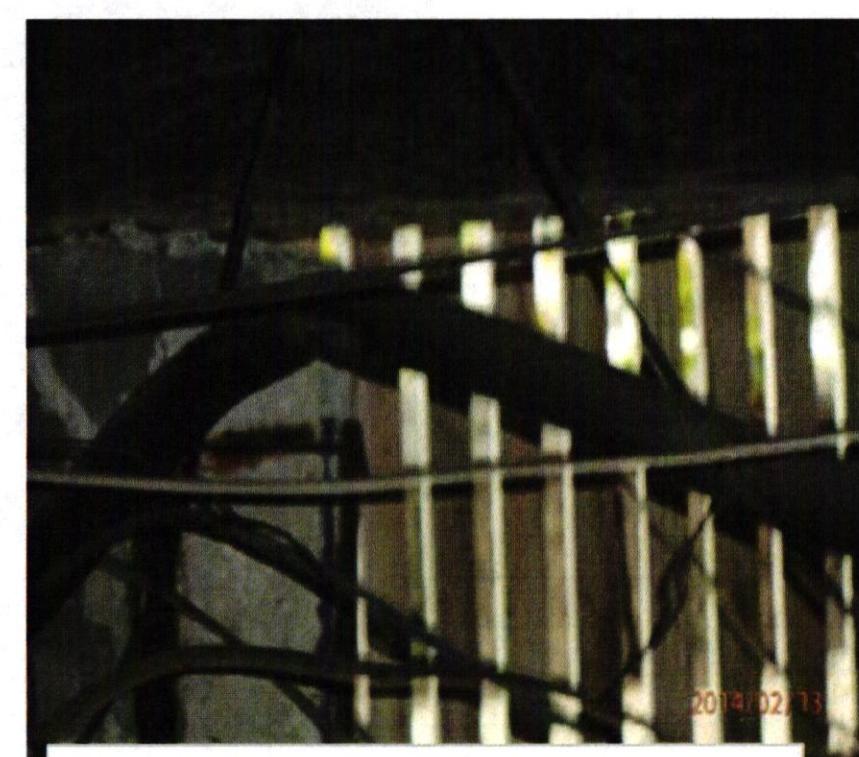
SPALLED CONCRETE WITH EXPOSED REINFORCEMENT

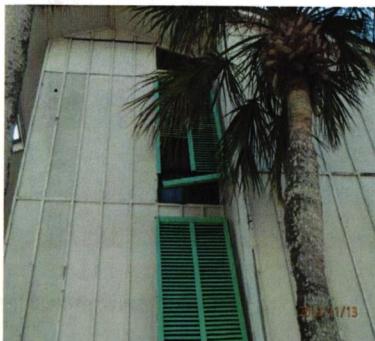
Detached, dislodged, or failing connections.

Connection poles to shutters.

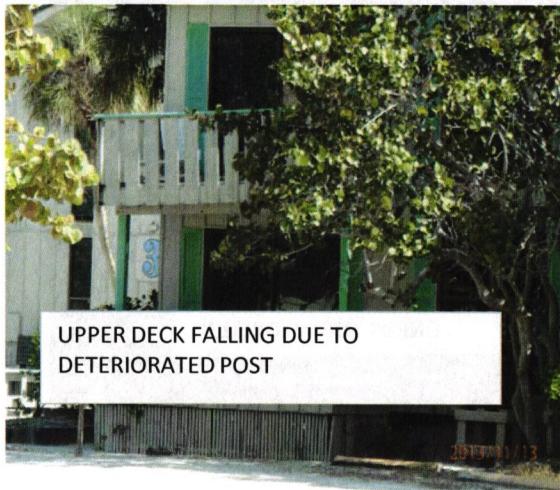
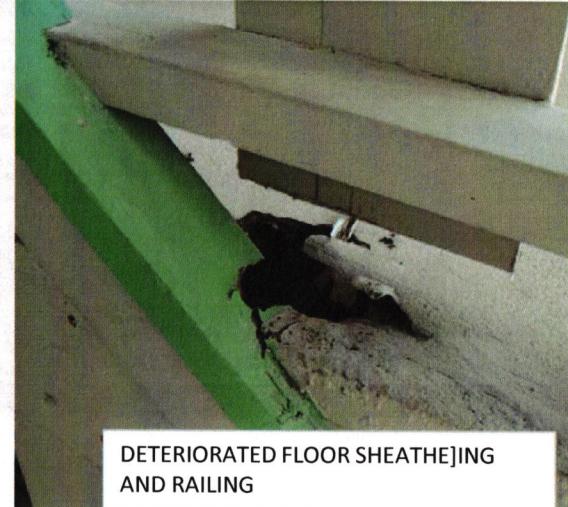
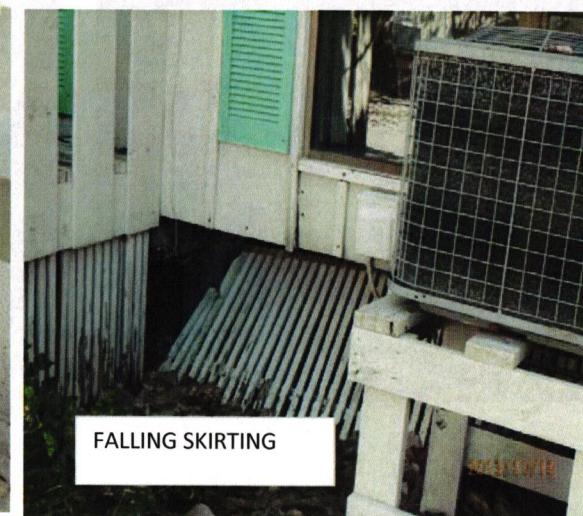
Signs of termite and other insect damage. Extensive on the siding. Currently has wasp nests.

One upper level deck has rotted post and has dropped approximately 4 inches. A/C unit stands.

Siding, trims, floor framing, wood shutters, fascia and soffits. The entry stairs and lower walkway show signs of failing to support. Railings pulling from walls. Railing missing balusters.

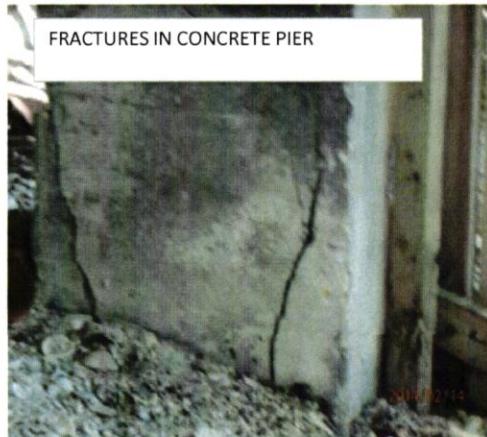
Approximately 25% of the piers

Extensive on approximately 20% of the piers

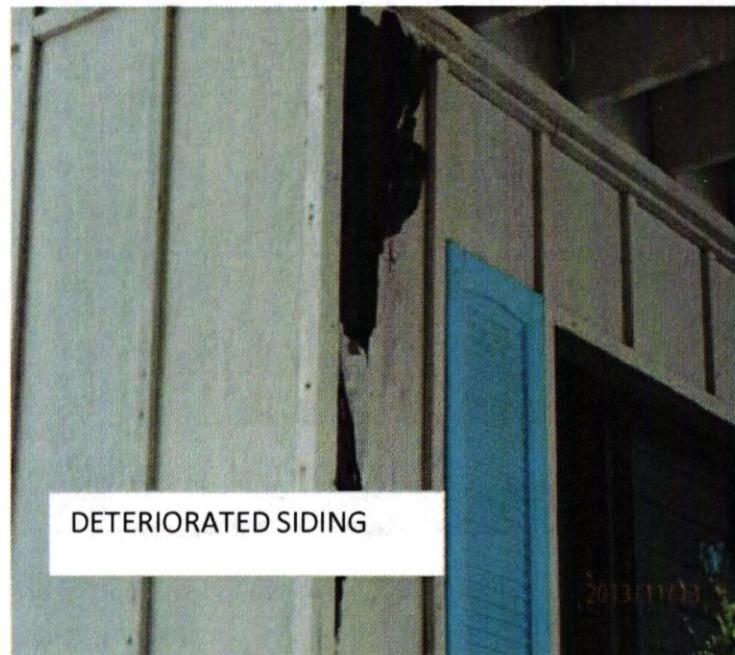
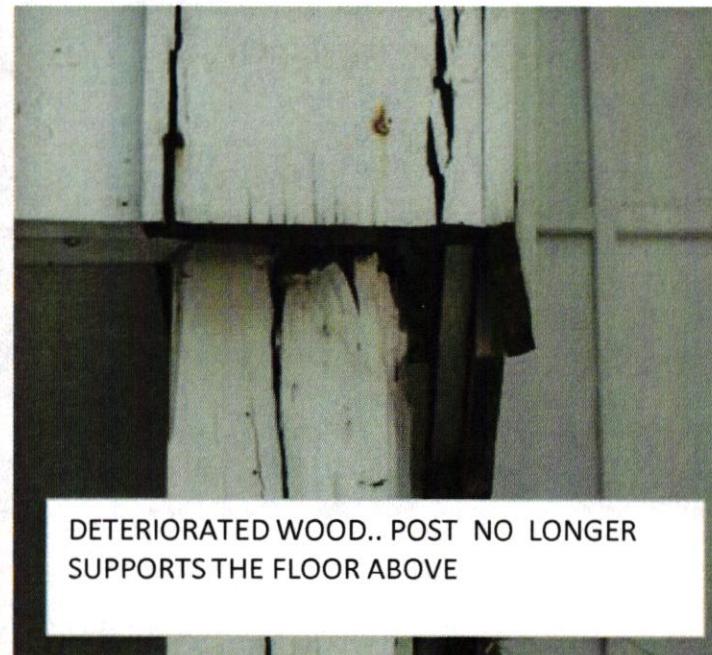
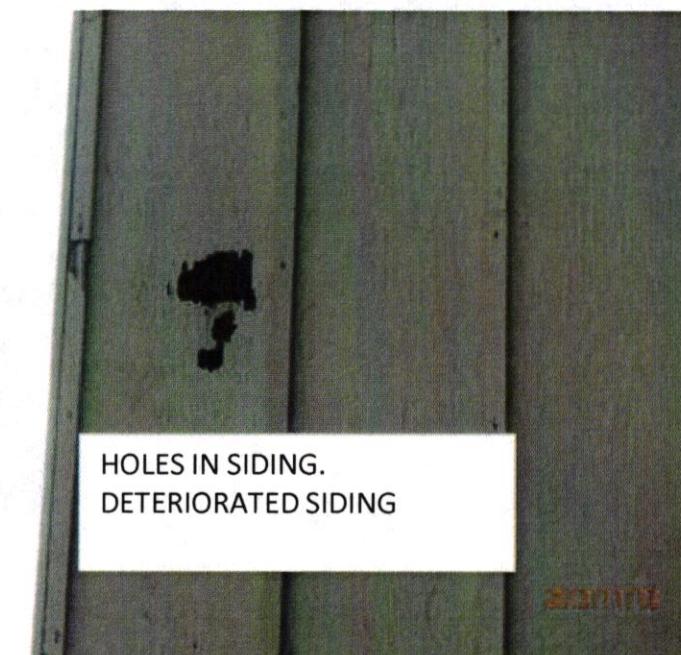
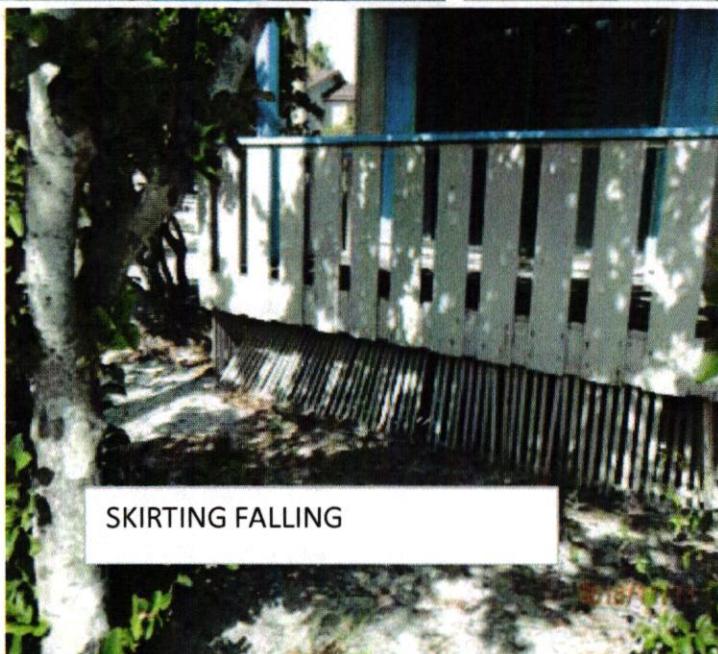
Signs of termite and other insect damage. Extensive on the siding. Holes in siding from birds.

walkway show signs of failing to support. Railings pulling from walls. Railing missing balusters.

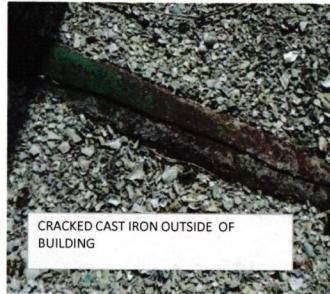
Cast iron building drains corroded and broken  
Un-attended furniture/items on patios  
Abandoned ac units under building.  
Boarded up windows and doors due to vandalizing.  
Air conditioning unit are beginning to fail. A/C unit may fall and have potential to have electrical issues as well as possible leaking for the refrigerant.  
Lattice skirting falling from position.

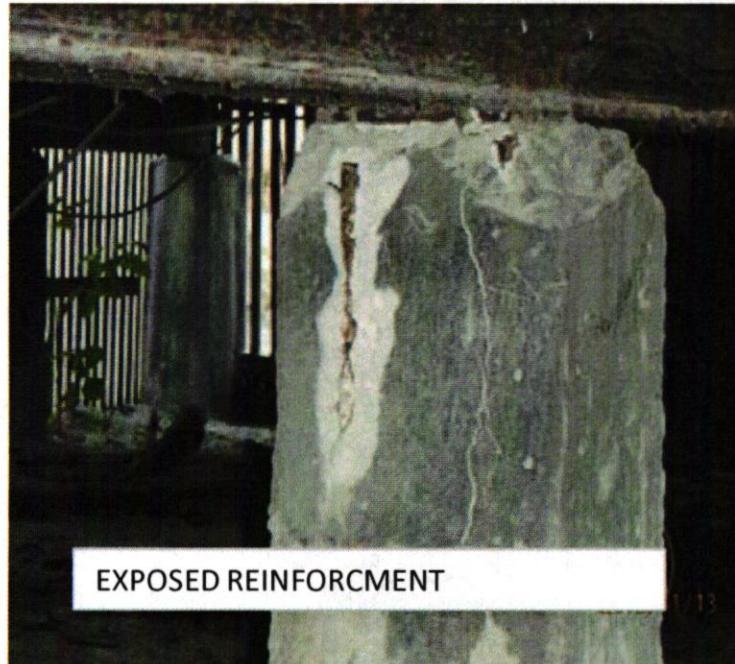
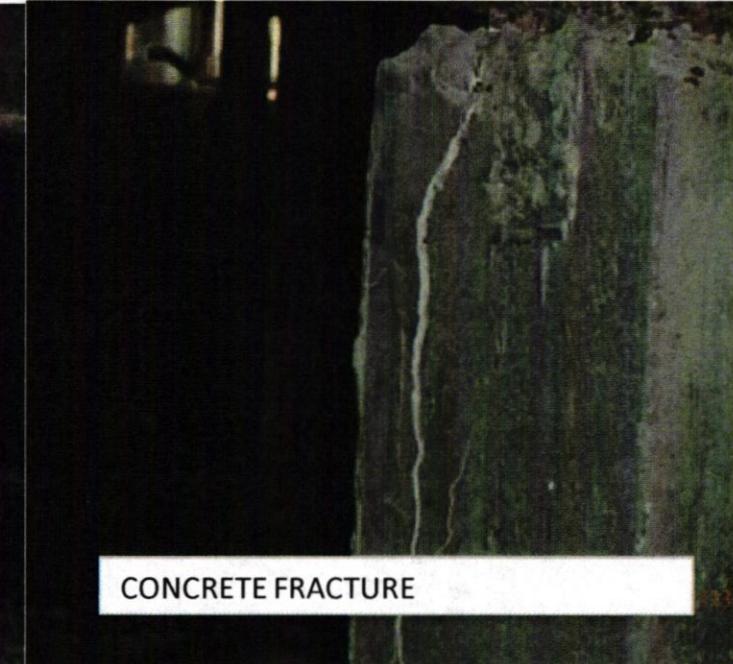
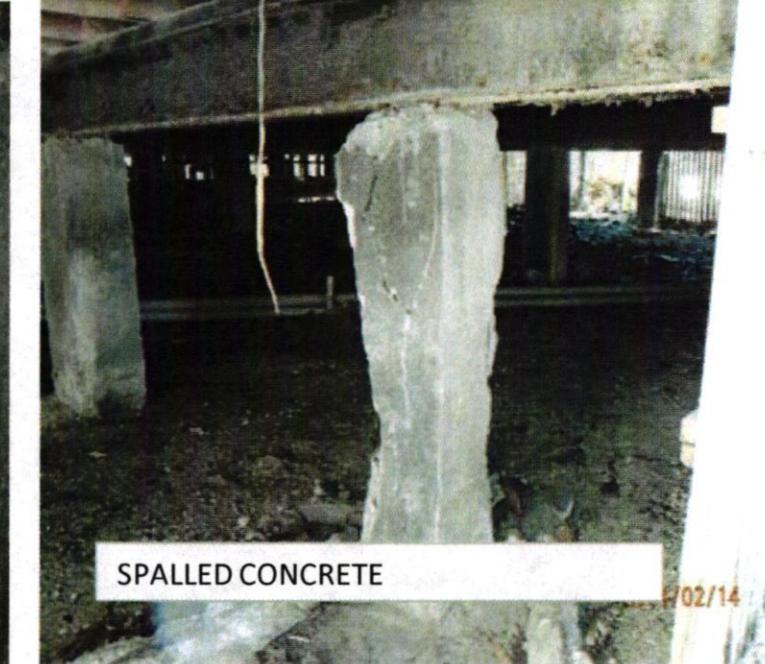
Approximately 35% of the piers

Extensive on approximately 20% of the piers

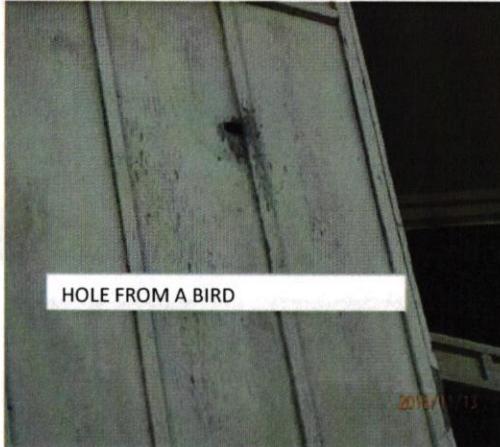
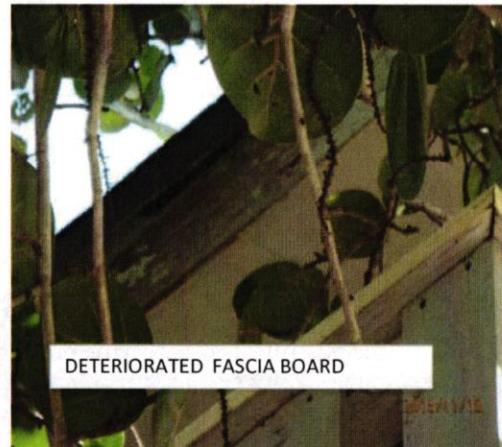
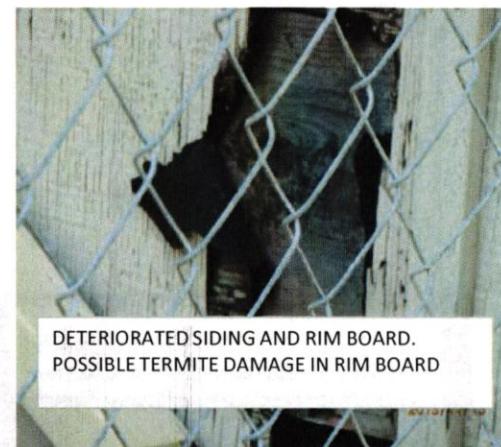
Signs of termite and other insect damage. Extensive on the siding. Holes in siding from birds.

Column failing to support upper walkway deck and living roof above. A/C unit stands.

Siding, trims, floor framing, wood shutters, fascia and soffits. The entry stairs and lower walkway show signs of failing to support. Railings pulling from walls. Railing missing balusters.

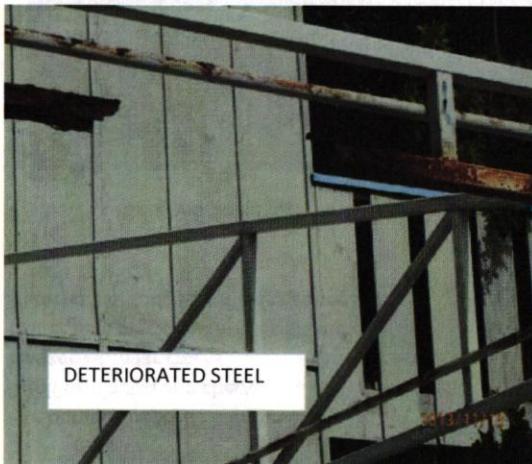
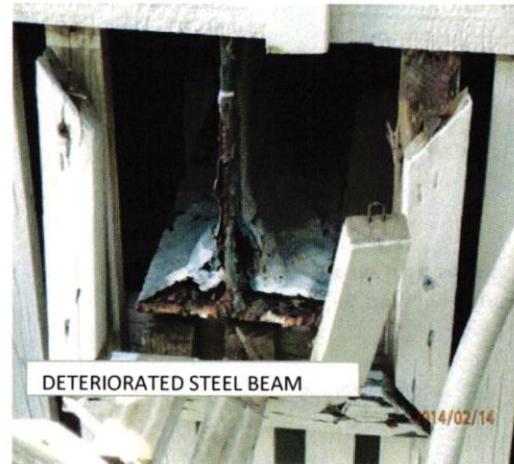
Bottom of I-beams. Some joist hangers and visible clips. Many A/C units are showing signs of failure. Fabric canopy.

A/C units at the bottom. Fabric canopy.  
Fabric canopy.

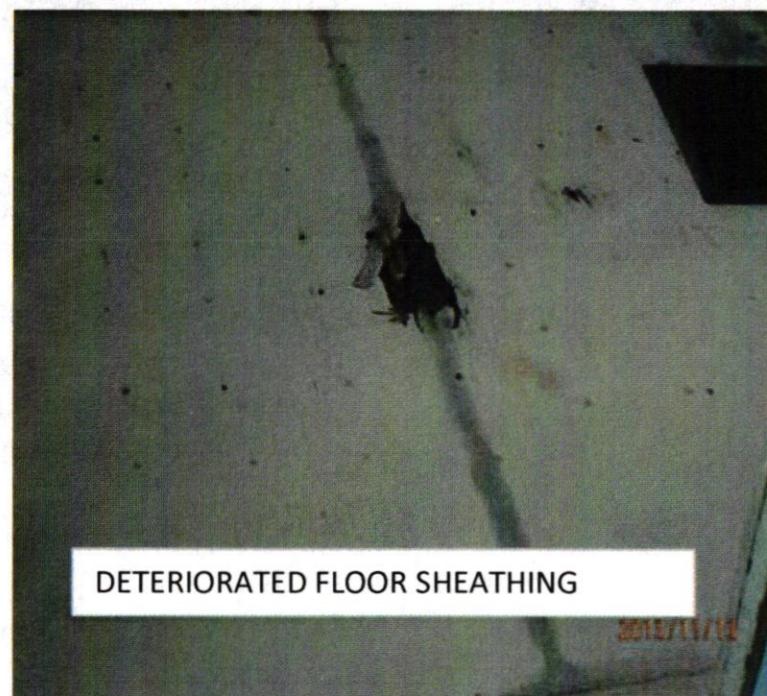
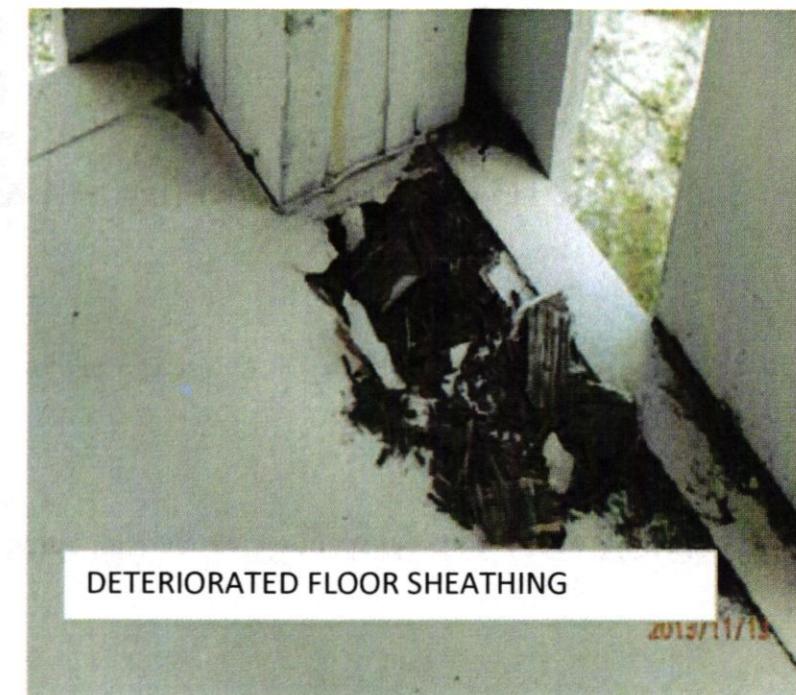
Signs of termite and other insect damage. Extensive on the siding. Holes in siding from birds.

Inadequate support A/C unit stands.

Siding, trims, floor framing, wood shutters, fascia and soffits. The entry stairs and lower walkway show signs of failing to support. Railings pulling from walls. Railing missing balusters.

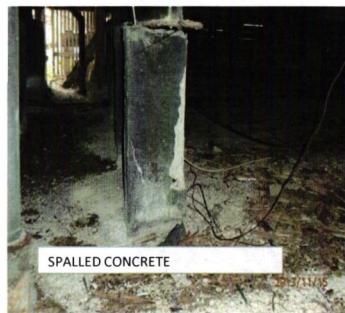
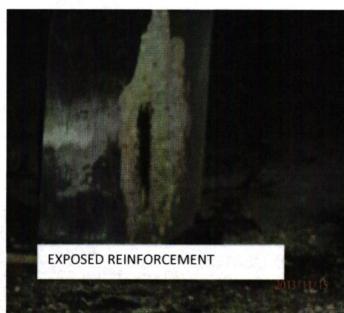
Approximately 20% of the piers

Extensive on approximately 20% of the piers

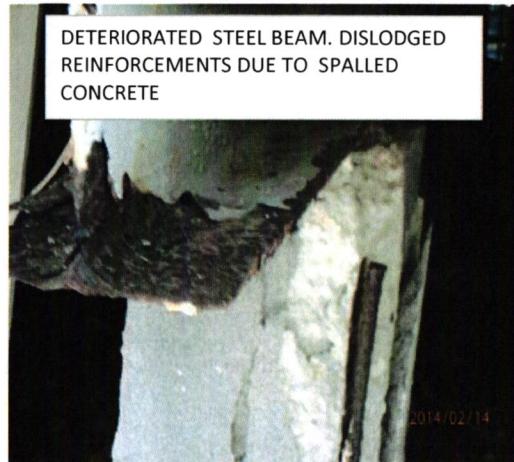
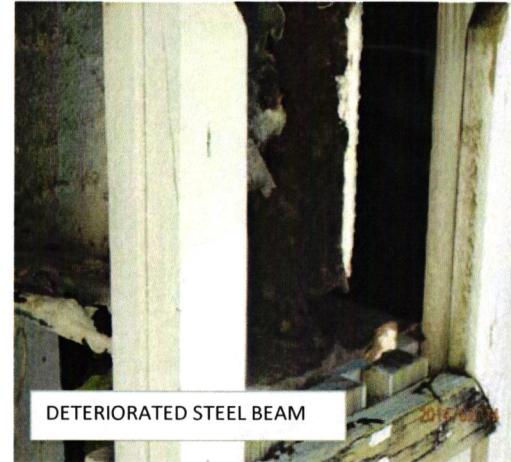
Bottom of I-beams. Some joist hangers and visible clips. Many A/C units are showing signs of failure.

A/C units at the bottom

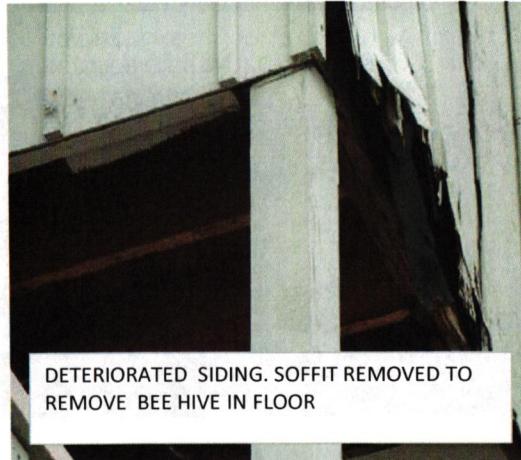
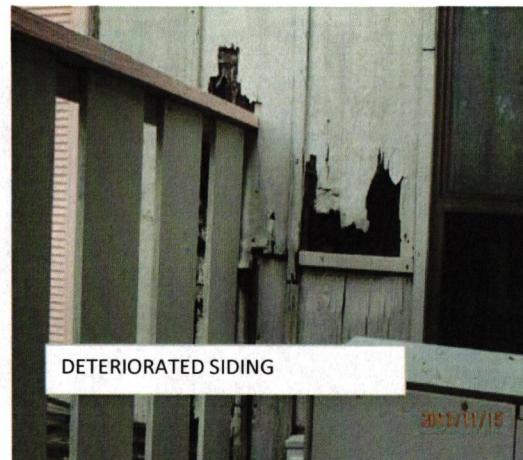
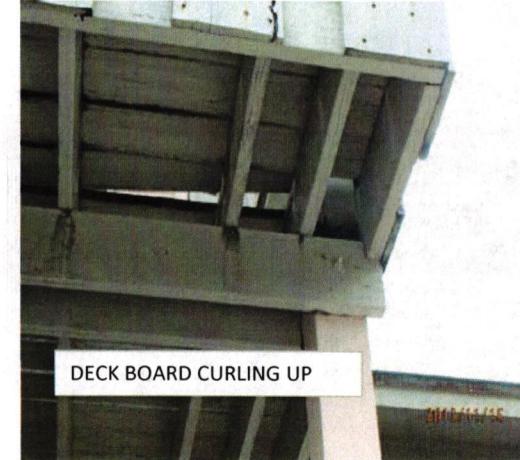
Signs of termite and other insect damage. Extensive on the siding. Holes in siding from birds.

Siding, trims, floor framing, wood shutters, fascia and soffits. The entry stairs and lower walkway show signs of failing to support. Railings pulling from walls. Railing missing balusters.

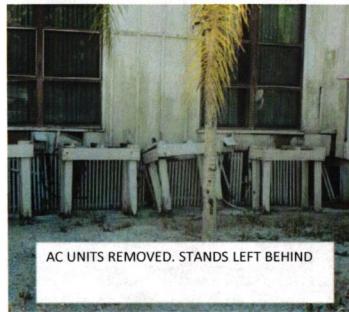
Cast iron building drains corroded and broken  
Un-attended furniture/items on patios  
Abandoned ac units under building.  
Boarded up windows and doors due to vandalizing.  
Security fencing does not provide for complete restrict  
Air conditioning unit are beginning to fail. A/C unit may fall and have potential to have electrical issues as well as possible leaking for the refrigerant.  
Removed soffit material due to having bee infestation.  
Lattice skirting falling from position.

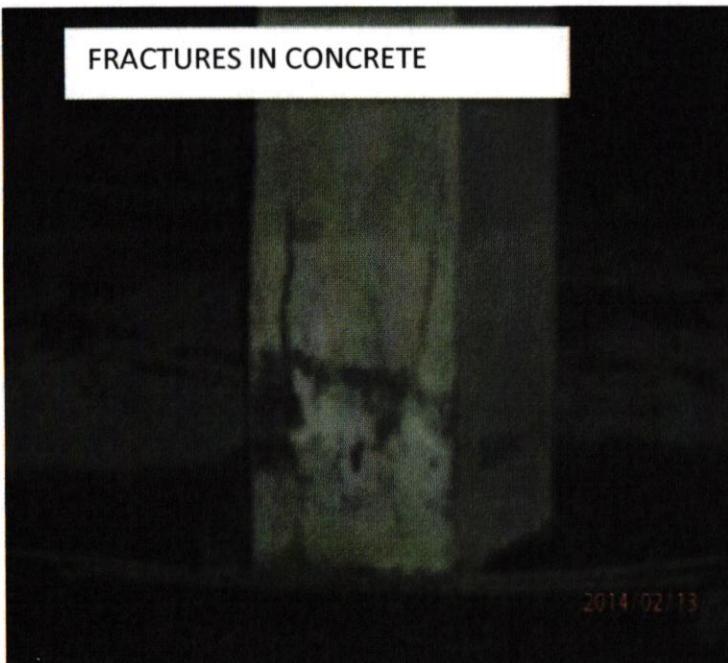
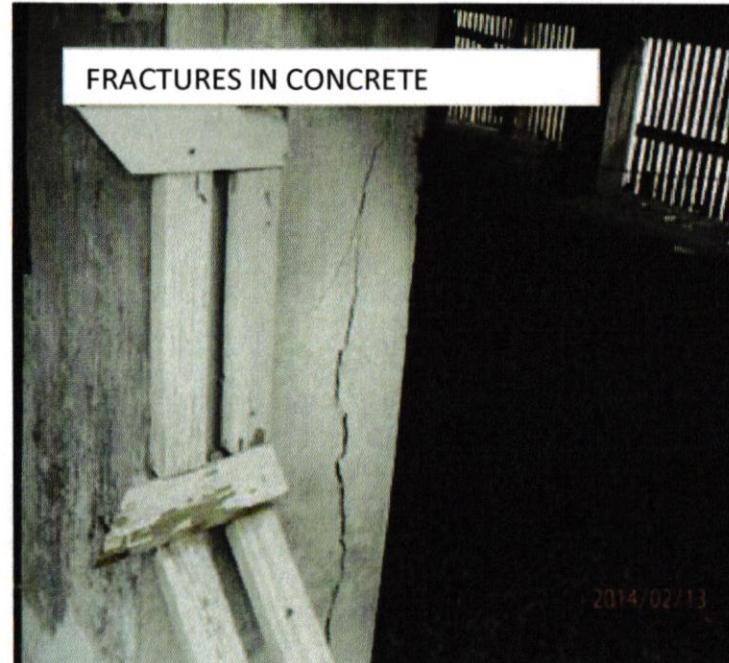
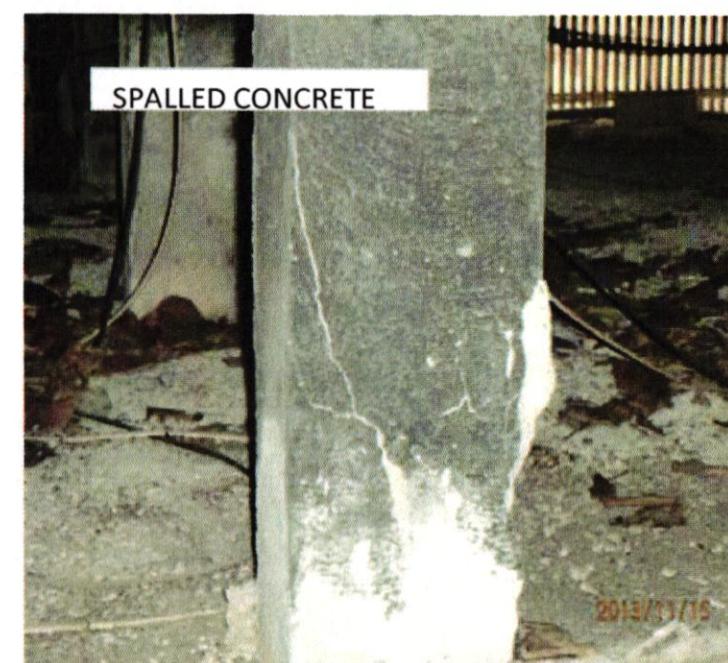
This building appears to be seaward of the coastal construction control line. Code limitation associated to working on the foundation.

Approximately 20% of the piers

Extensive on approximately 20% of the piers

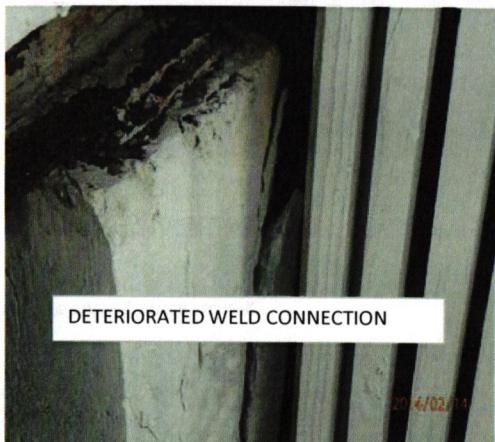
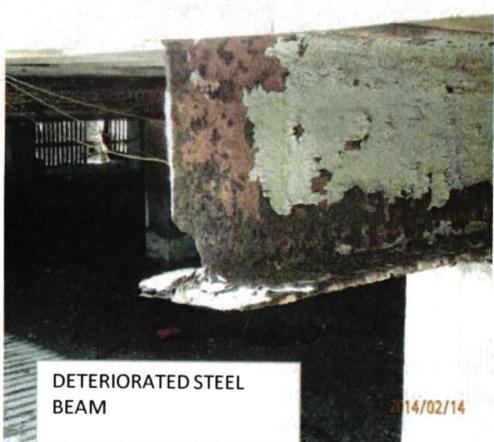
Bottom of I-beams. Some joist hangers and visible clips. Many A/C units are showing signs of failure.

A/C units at the bottom

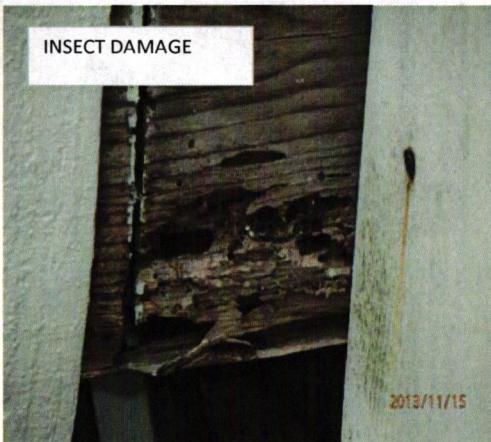
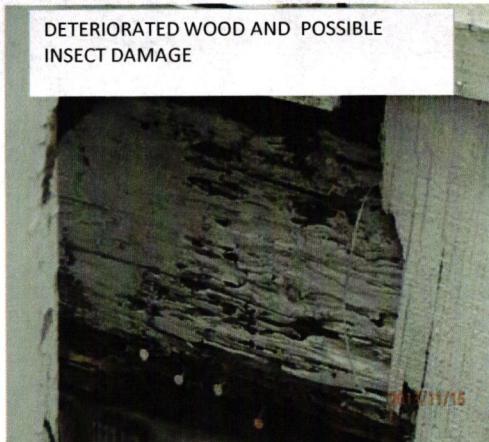
Signs of termite and other insect damage. Extensive on the siding. Sign of animal digging into upper walkway. Holes in siding from birds.

Siding, trims, floor framing, wood shutters, fascia and soffits. The entry stairs and lower walkway show signs of failing to support. Railings pulling from walls. Railing missing balusters.

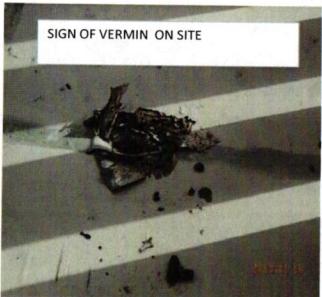
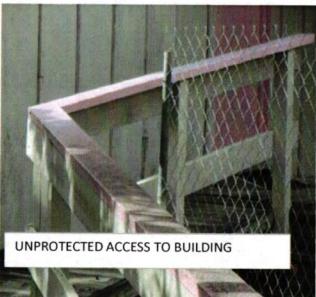
Cast iron building drains corroded and broken  
Un-attended furniture/items on patios  
Abandoned ac units under building.  
Boarded up windows and doors due to vandalizing.  
Security fencing does not restrict access to building.  
Air conditioning unit are beginning to fail. A/C unit may fall and have potential to have electrical issues as well as possible leaking for the refrigerant.  
Lattice skirting falling from position.

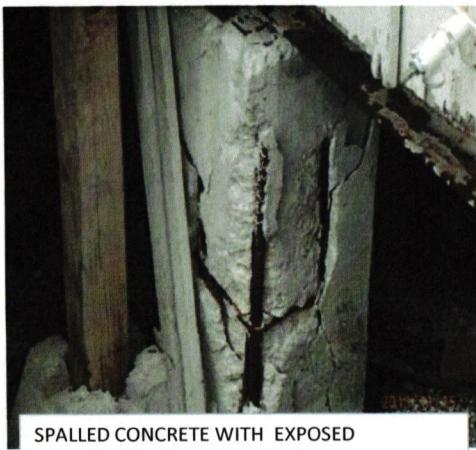
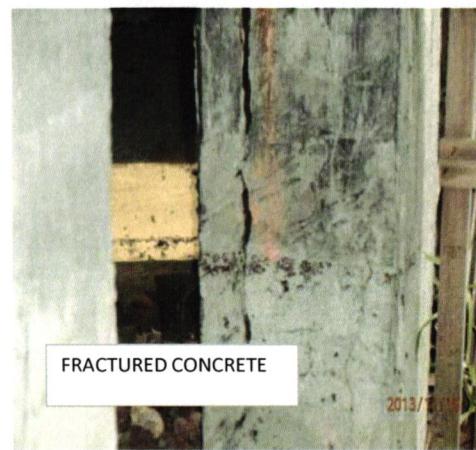
This building is seaward of the coastal construction control line. Code limitation associated to working on the foundation.

Approximately 50% of the piers, some extensive  
75 % or more of the piers.  
Approximately 40% of the piers  
Extensive on approximately 40% of the piers

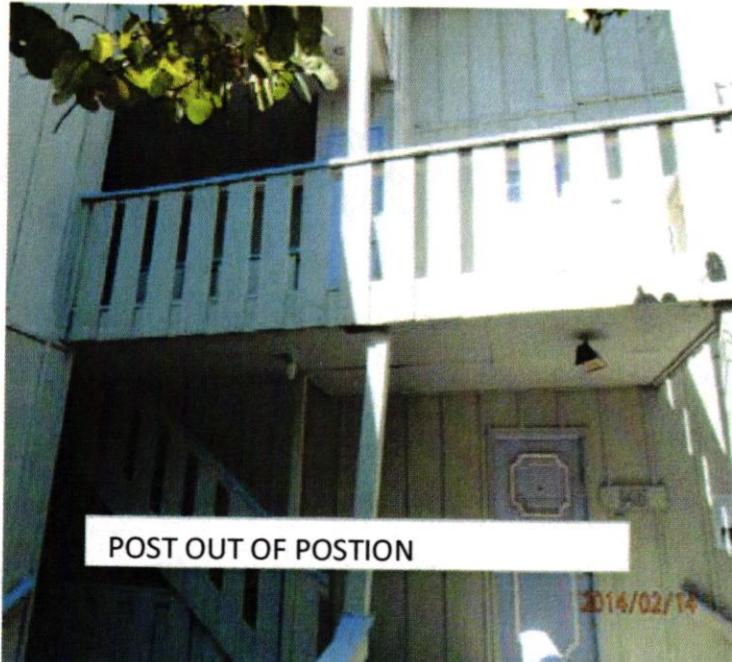
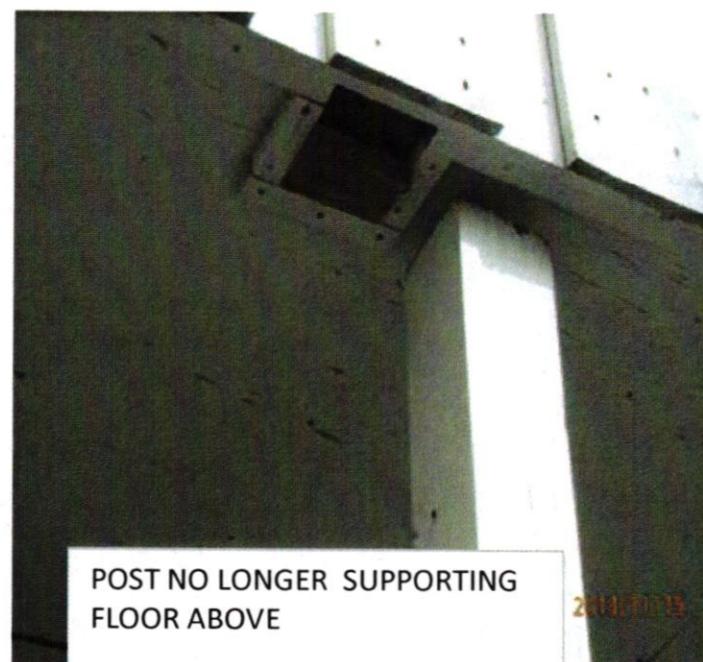
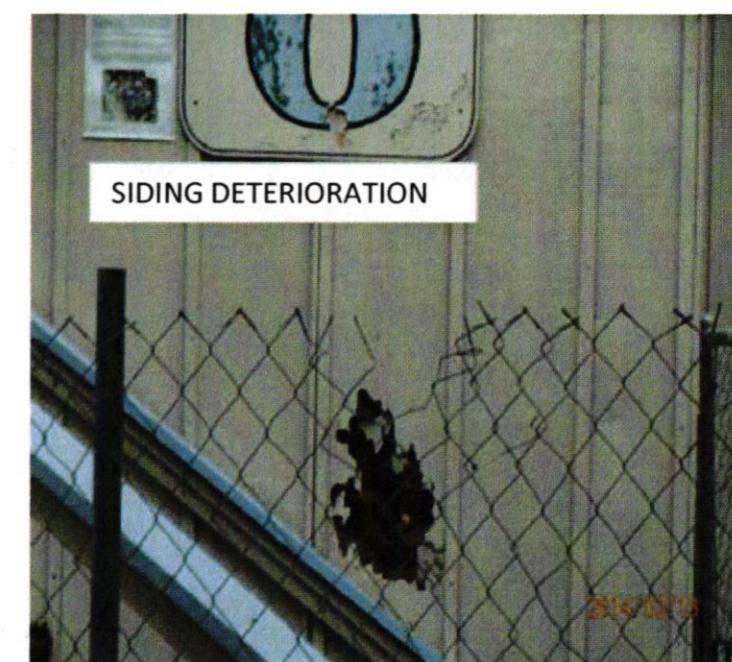
Signs of termite and other insect damage. Extensive on the siding. Holes in siding from birds.

Siding, trims, floor framing, wood shutters, fascia and soffits. The entry stairs and lower walkway show signs of failing to support. Railings pulling from walls. Railing missing balusters.

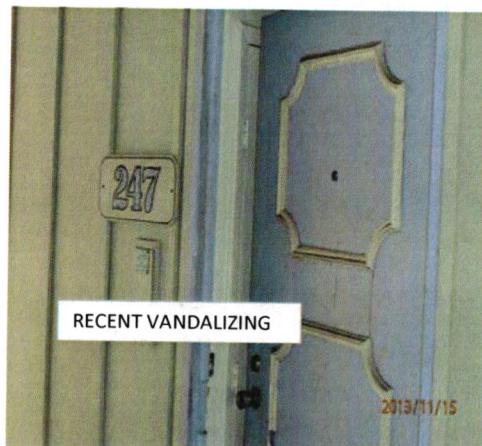
Cast iron building drains corroded and broken  
Un-attended furniture/items on patios  
Abandoned ac units under building.  
Boarded up windows and doors due to vandalizing.  
Door to one unit recently vandalized.  
Air conditioning unit are beginning to fail. A/C unit may fall and have potential to have electrical issues as well as possible leaking for the refrigerant.  
Lattice skirting falling from position.

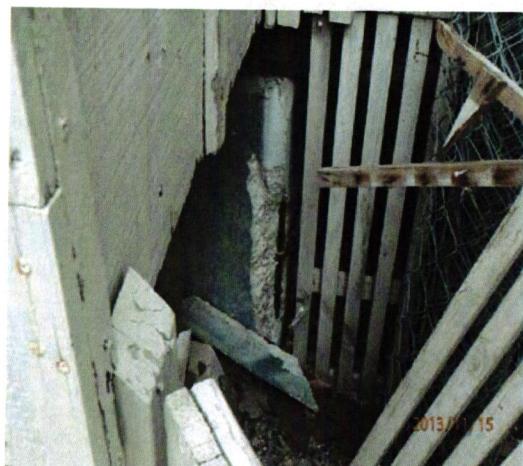
This building is seaward of the coastal construction control line. Code limitation associated to working on the foundation.

Approximately 50% of the piers, some extensive  
75 % or more of the piers.  
Approximately 40% of the piers  
Extensive on approximately 40% of the piers

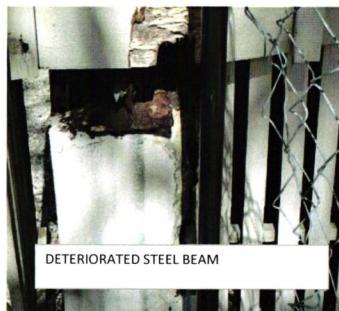
A/C units at the bottom

Bottom of I-beams. Some joist hangers and visible clips. Many A/C units are showing signs of failure.

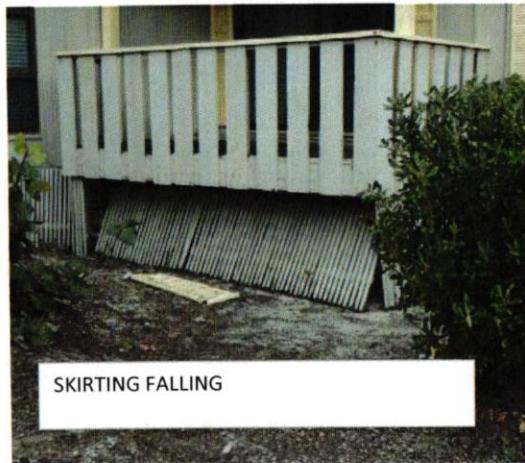
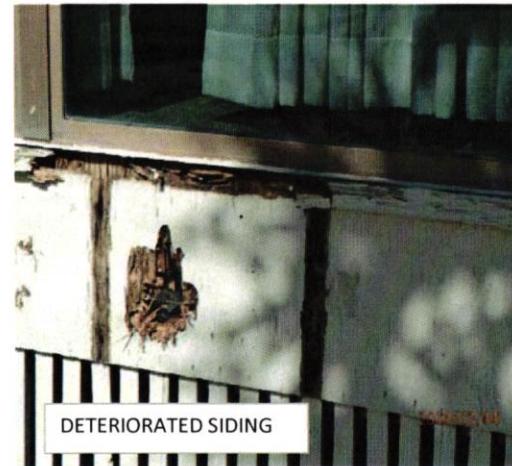
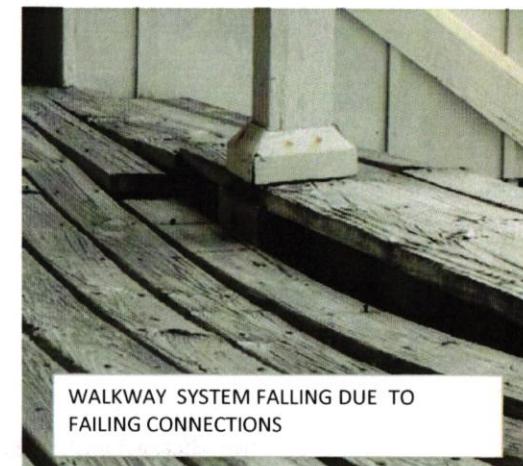
Signs of termite and other insect damage. Extensive on the siding. Holes in siding from birds.

Post not supporting walkway. This building has extensive failure of the lower deck walkway. A/C unit stands.

Siding, trims, floor framing, wood shutters, fascia and soffits. The entry stairs and lower walkway show signs of failing to support. Railings pulling from walls. Railing missing balusters.

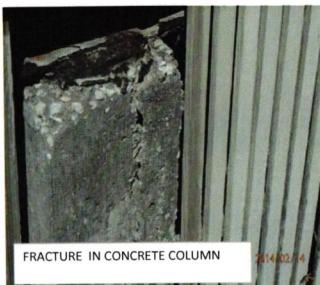
This building is seaward of the coastal construction control line. Code limitation associated to working on the foundation.

Approximately 40% of the piers

Extensive on approximately 20% of the piers

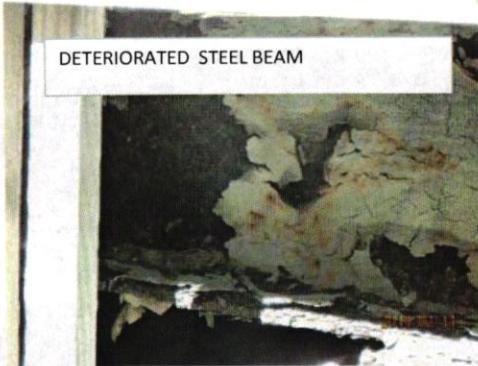
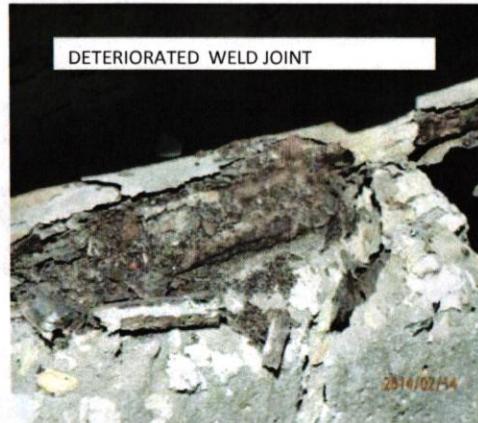
A/C units at the bottom

Bottom of I-beams. Some joist hangers and visible clips. Many A/C units are showing signs of failure.

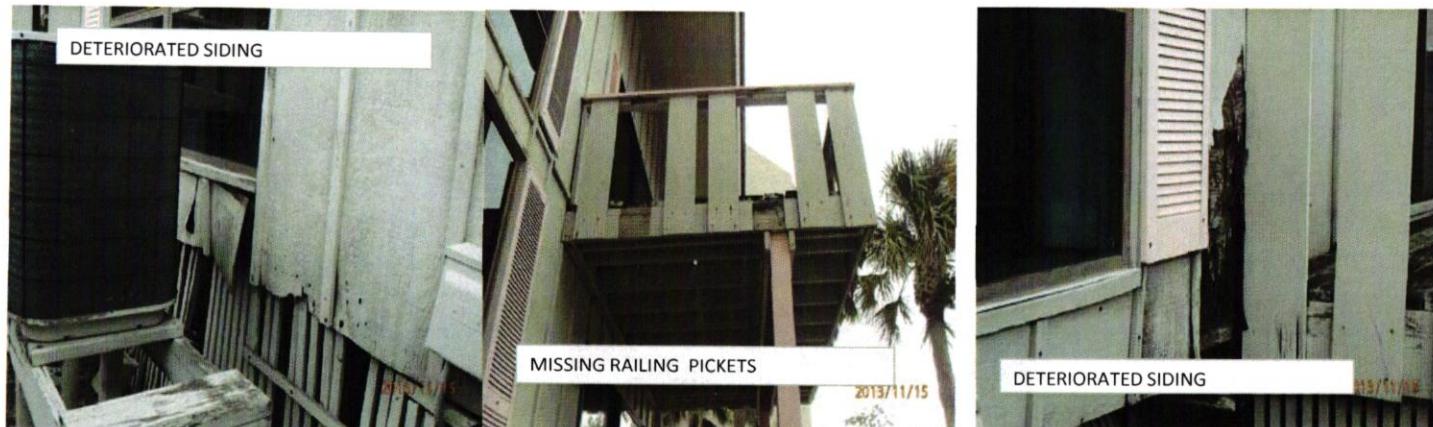
Signs of termite and other insect damage. Extensive on the siding. Holes in siding from birds.

Siding, trims, floor framing, wood shutters, fascia and soffits. The entry stairs and lower walkway show signs of failing to support. Railings pulling from walls. Railing missing balusters.
