**Building Official Inspection Report**  
**February 26, 2014**  
**1620 Gulf of Mexico Drive**  
**The Colony**

### Building Official Report

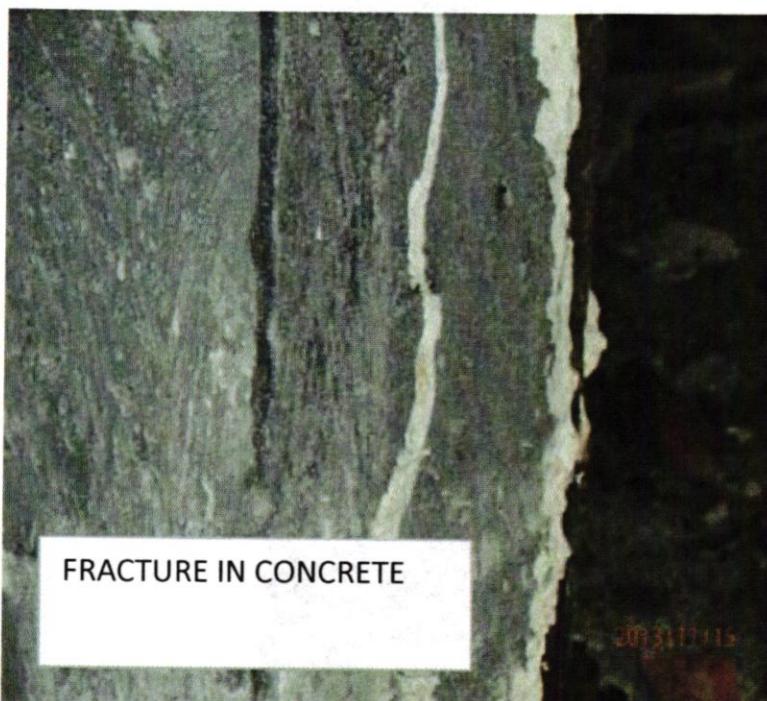
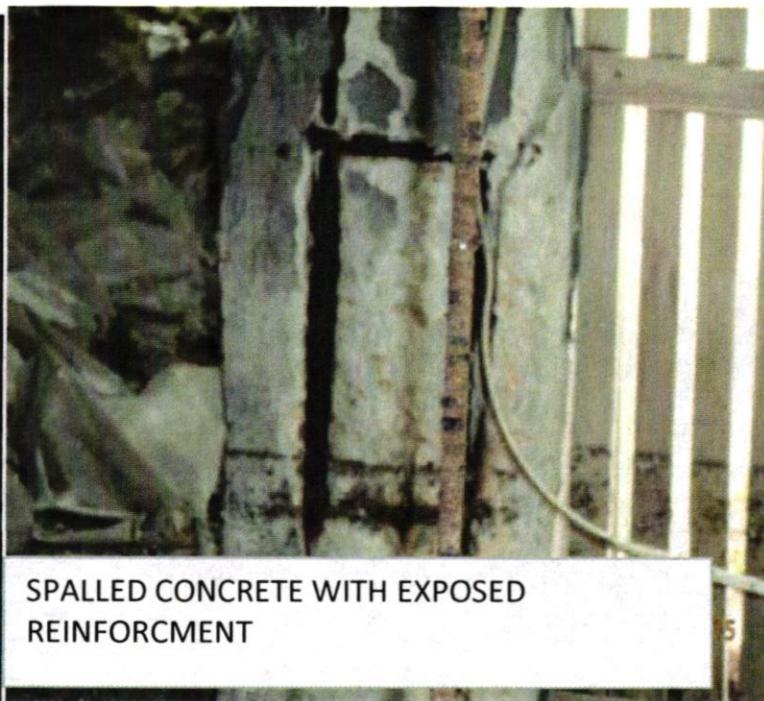
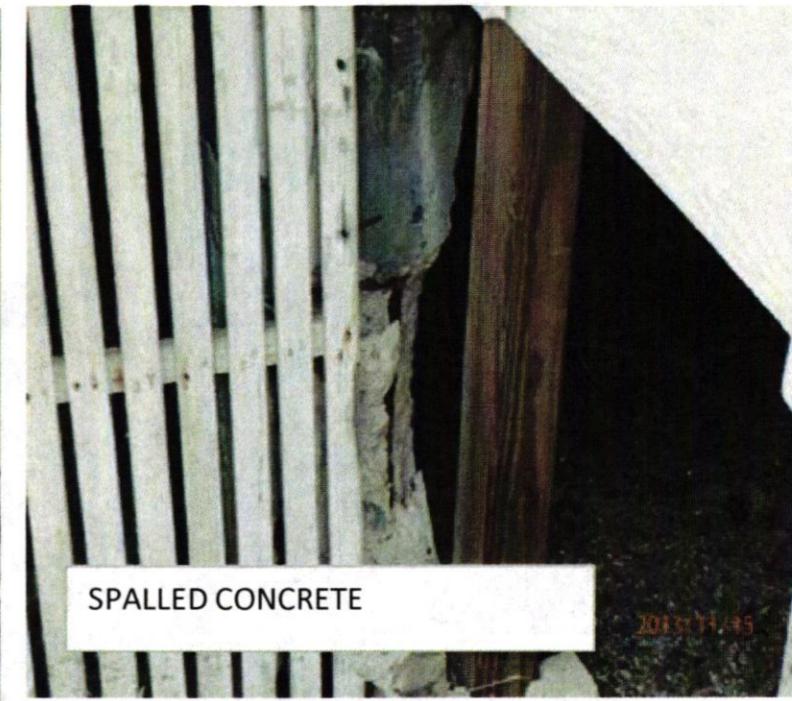
This building is seaward of the coastal construction control line. Code limitation associated to working on the foundation.

Approximately 35% of the piers, some extensive  
60 % or more of the piers.  
Approximately 20% of the piers  
Extensive on approximately 20% of the piers

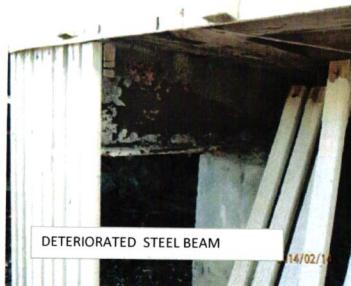
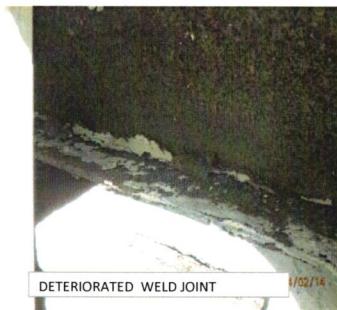
Bottom of I- beams. Some joist hangers and visible clips. Many A/C units are showing signs of failure.

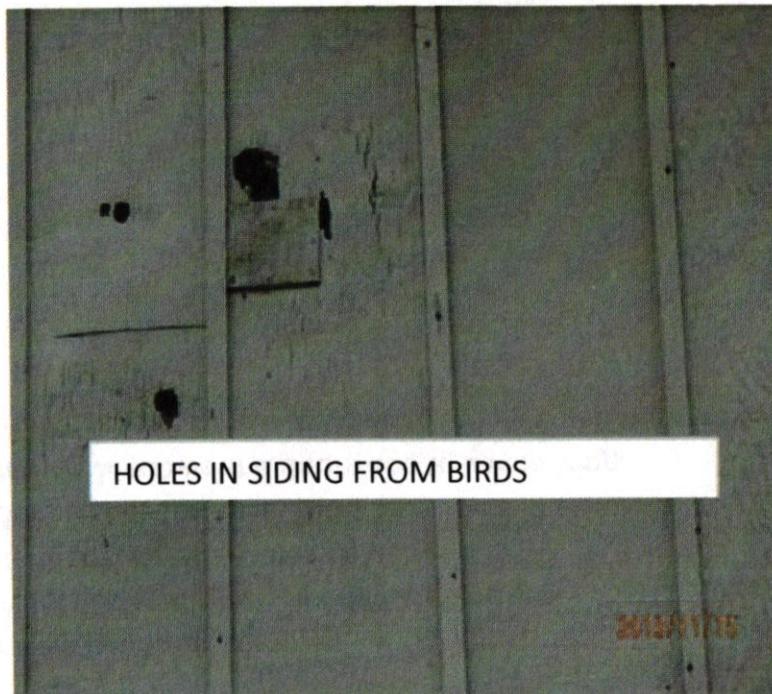
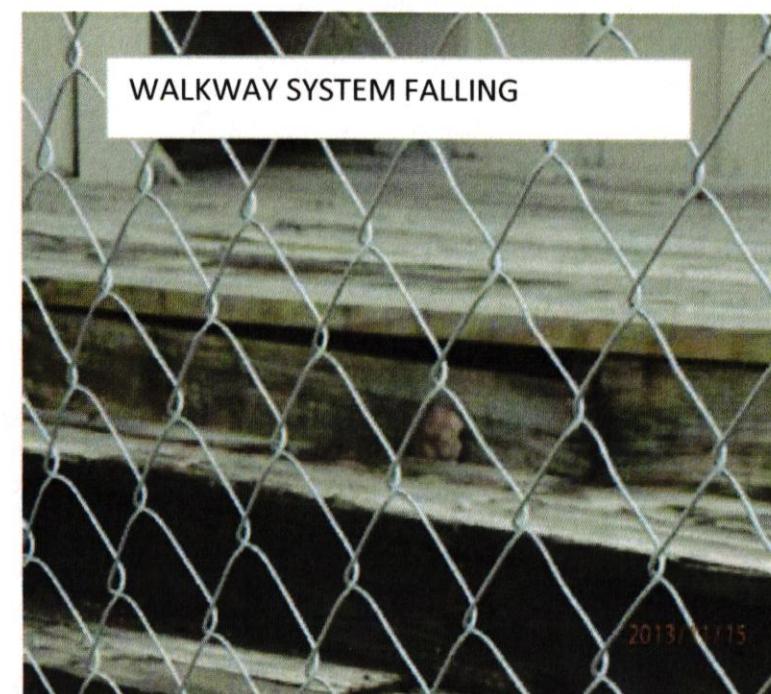
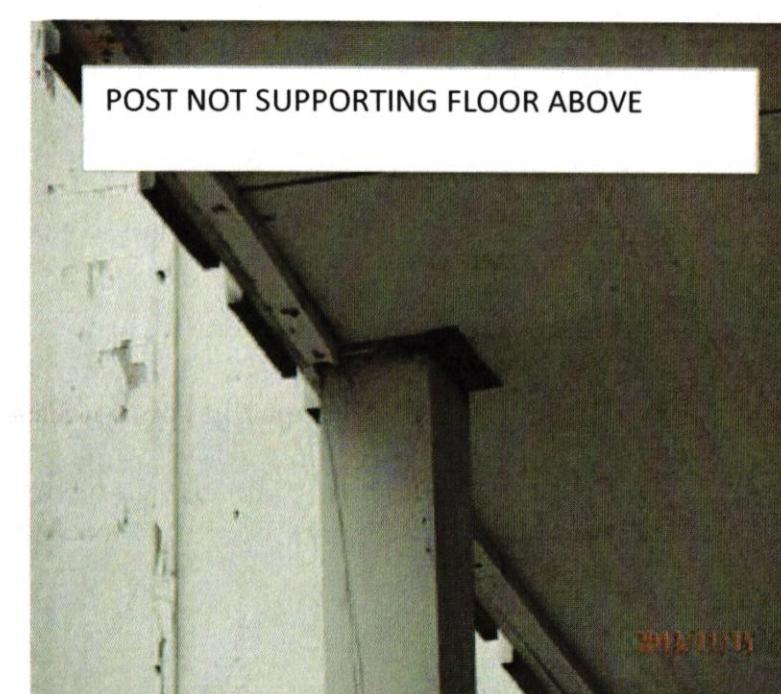
Signs of termite and other insect damage. Extensive on the siding. Currently has wasp nests. Holes in siding from birds.

A/C unit stands

Siding, trims, floor framing, wood shutters, fascia and soffits. The entry stairs and lower walkway show signs of failing to support. Railings pulling from walls. Railing missing balusters.

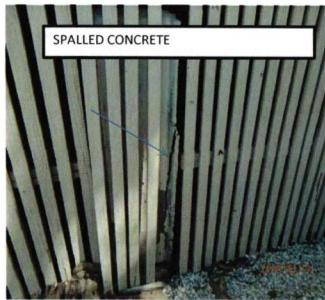
Approximately 40% of the piers

Extensive on approximately 40% of the piers

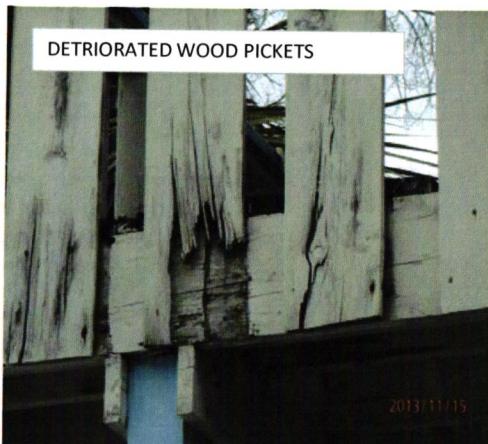
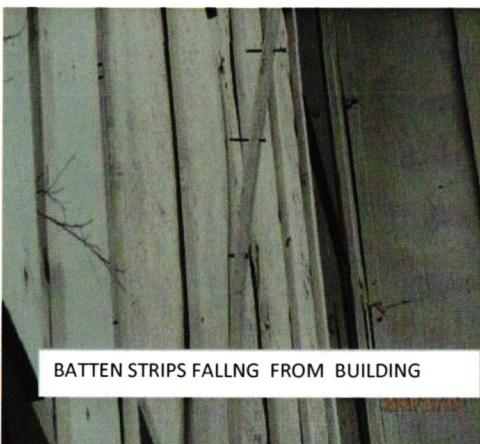
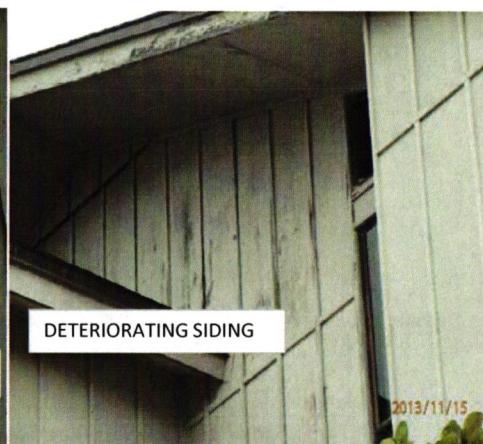
Signs of termite and other insect damage. Extensive on the siding. Holes in siding from birds.

Siding, trims, floor framing, wood shutters, fascia and soffits. The entry stairs and lower walkway show signs of failing to support. Railings pulling from walls. Railing missing balusters.

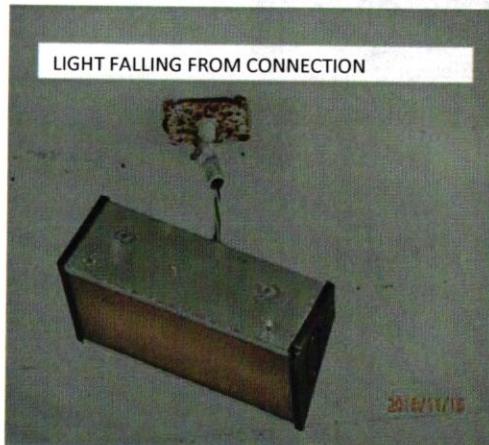
Cast iron building drains corroded and broken  
Un-attended furniture/items on patios  
Abandoned ac units under building.  
Boarded up windows and doors due to vandalizing.  
Air conditioning unit are beginning to fail. A/C unit may fall and have potential to have electrical issues as well as possible leaking for the refrigerant.  
Security light hanging by wires  
Tree branch has fallen onto security fence.

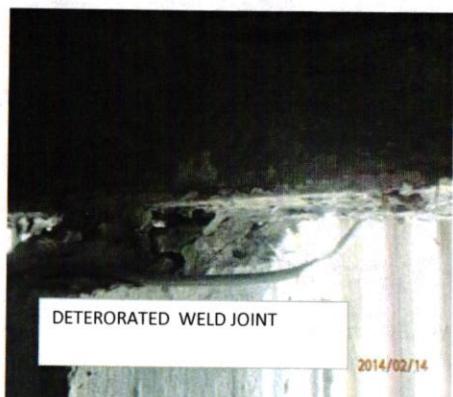
Bottom of I- beams. Some joist hangers and visible clips. Many A/C units are showing signs of failure.

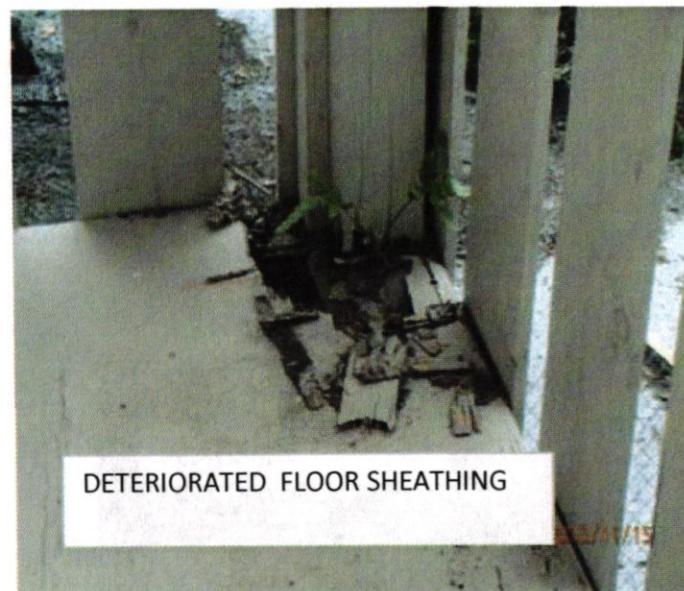
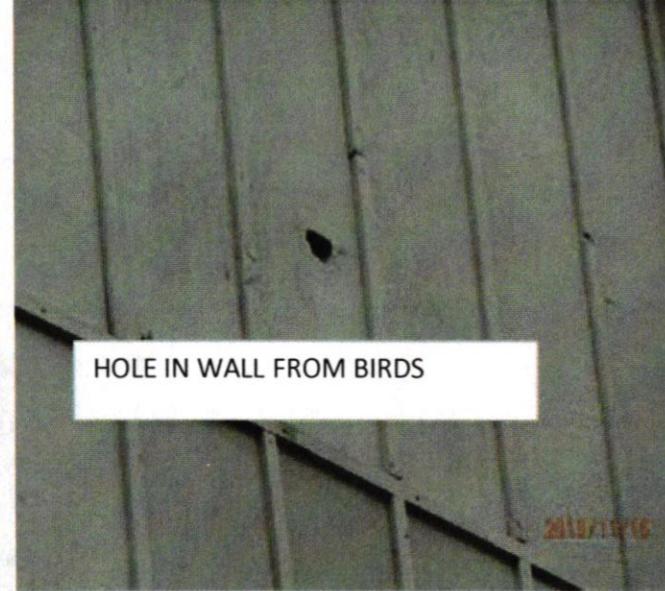
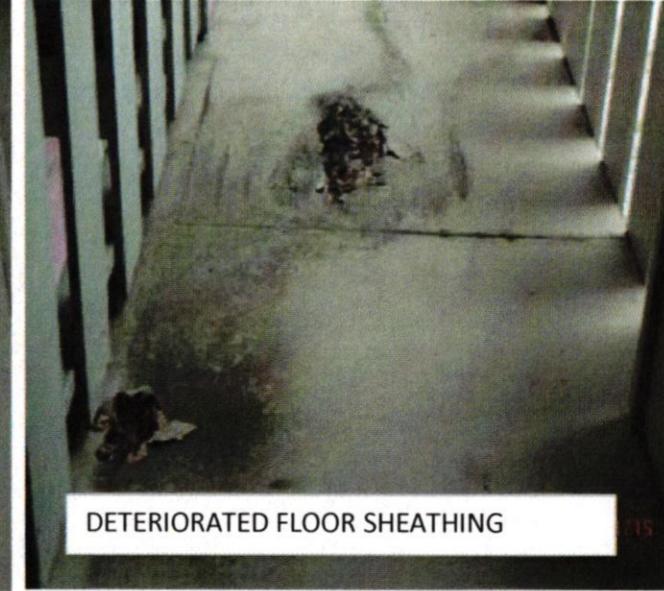
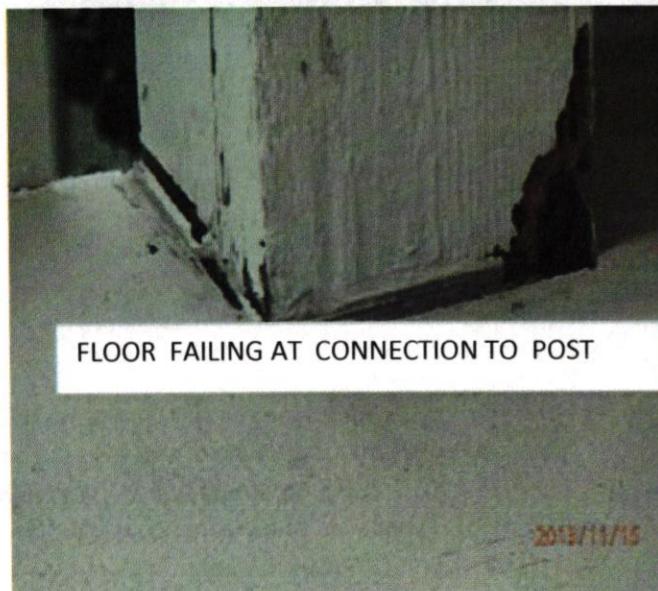
Signs of termite and other insect damage. Extensive on the siding. Holes in siding from birds.

Upper walkway deck showing extensive rot and is showing signs of dropping. A/C unit stands.

Siding, trims, floor framing, wood shutters, fascia and soffits. The entry stairs and lower walkway show signs of failing to support. Railings pulling from walls. Railing missing balusters.

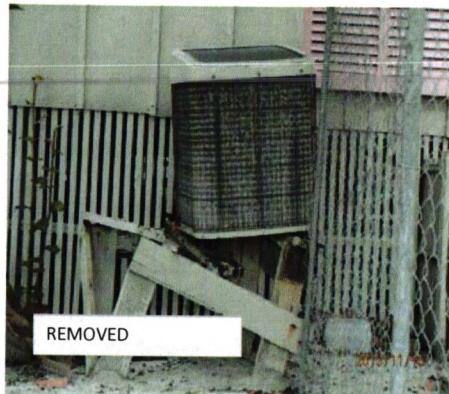
Cast iron building drains corroded and broken

Boarded up windows and doors due to vandalizing.

Air conditioning unit are beginning to fail. A/C unit may fall and have potential to have electrical issues as well as possible leaking of the refrigerant.

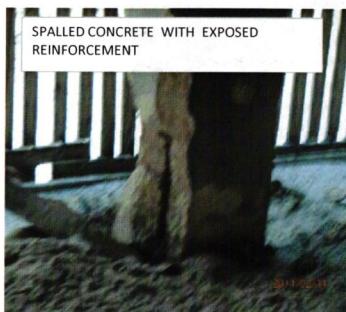
Approximately 15% of the piers

Extensive on approximately 10% of the piers

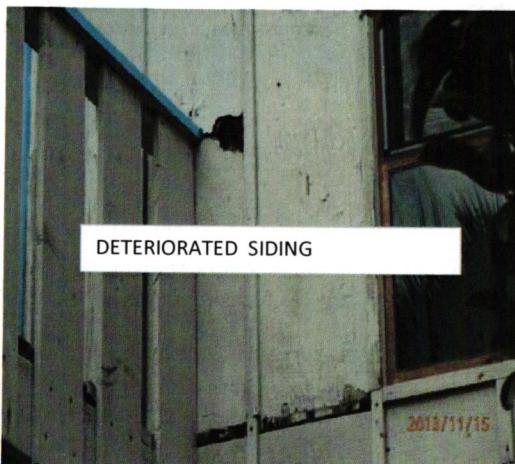
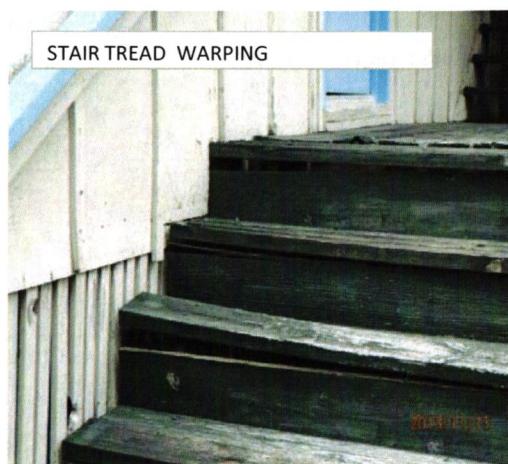
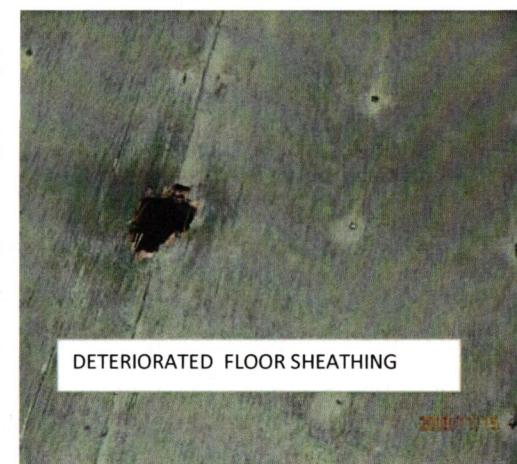
Signs of termite and other insect damage. Extensive on the siding. Sign of an animal digging into the upper deck sheathing. Holes in siding from birds.

A/C unit stands.

Siding, trims, floor framing, wood shutters, fascia and soffits. The entry stairs and lower walkway show signs of failing to support. Railings pulling from walls. Railing missing balusters.

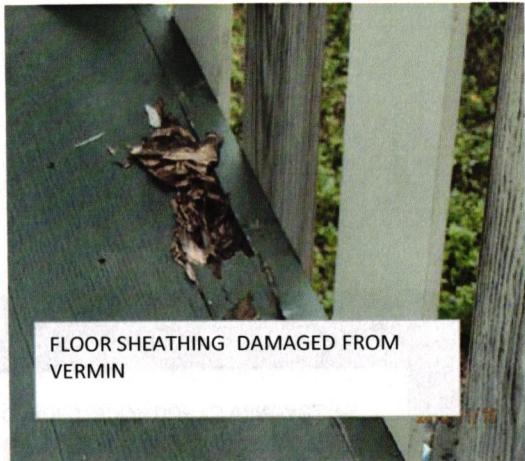
FLOOR SHEATHING DAMAGED FROM VERMIN

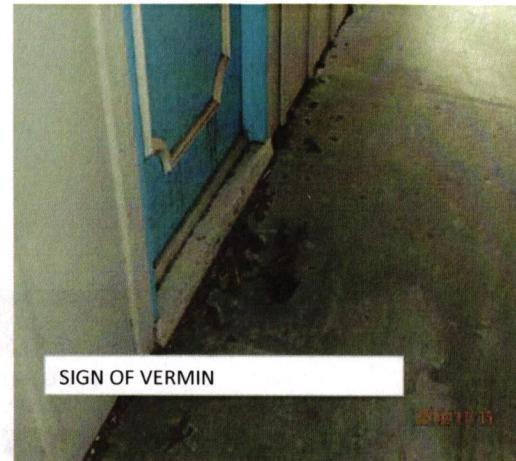
SIGN OF VERMIN

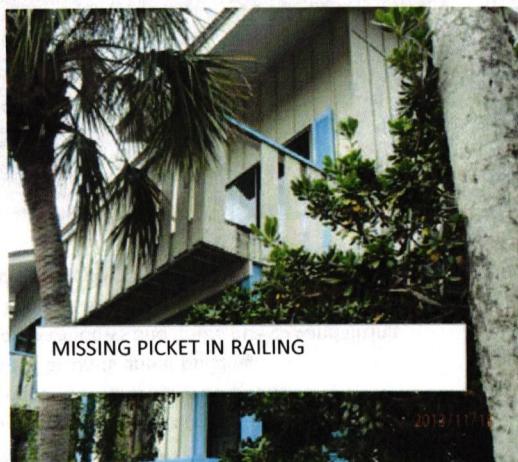
MISSING PICKET IN RAILING

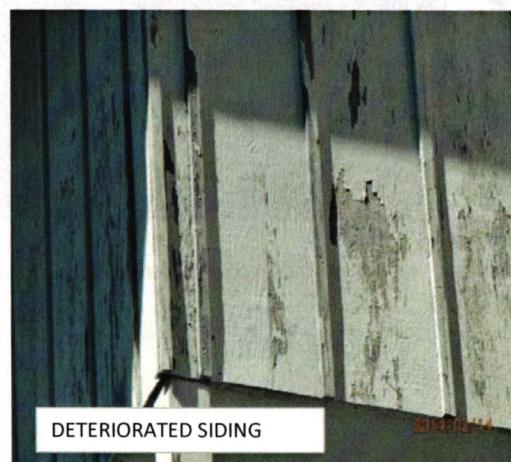
DETERIORATED SIDING

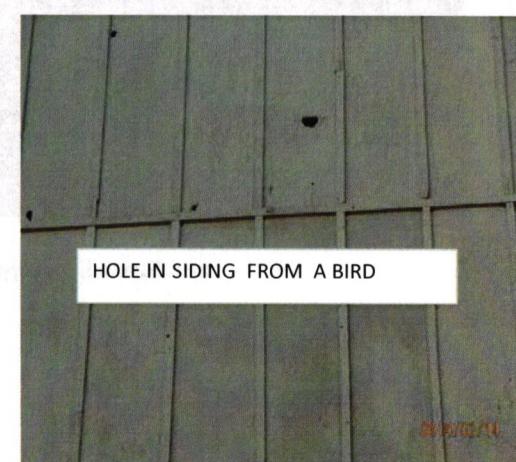
HOLE IN SIDING FROM A BIRD

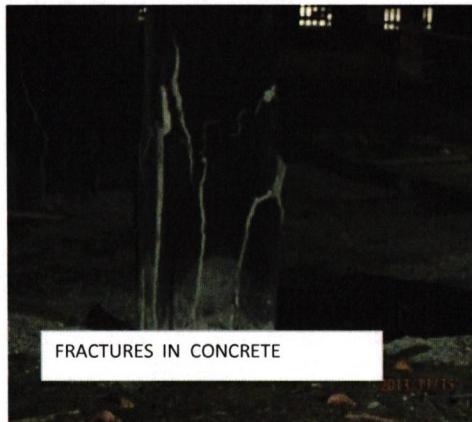
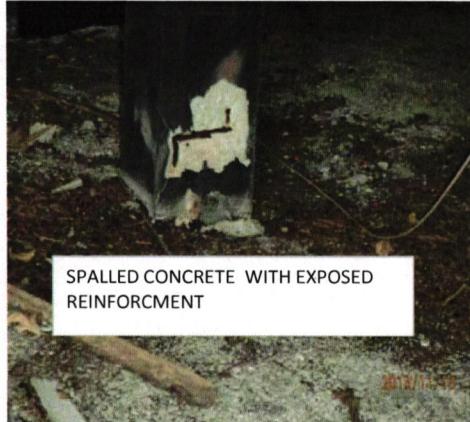
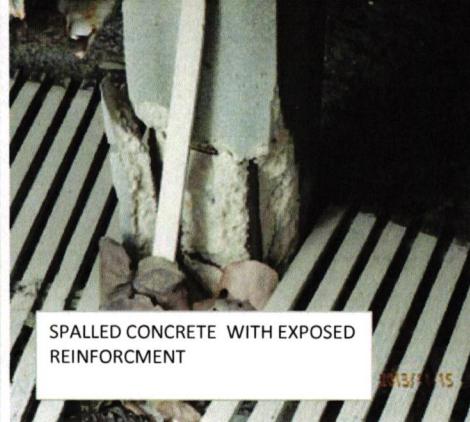
Approximately 15% of the piers

Extensive on approximately 15% of the piers

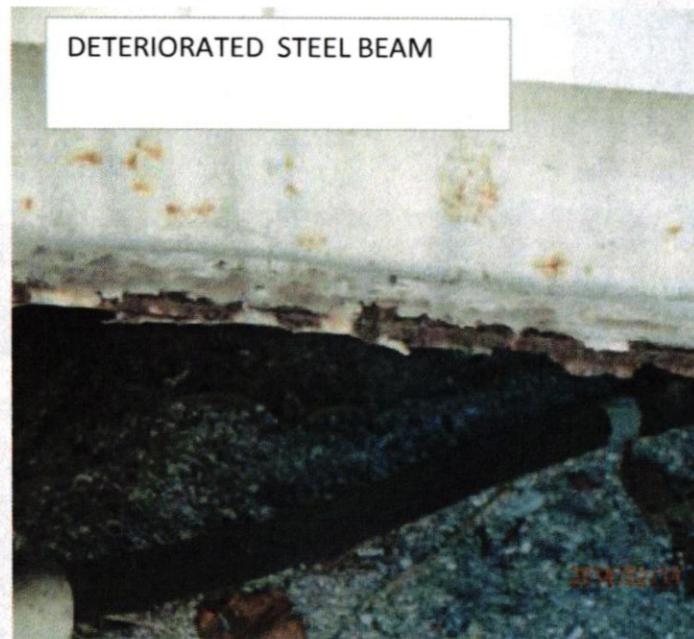
Bottom of I-beams. Some joist hangers and visible clips. Many A/C units are showing signs of failure.

A/C units at the bottom

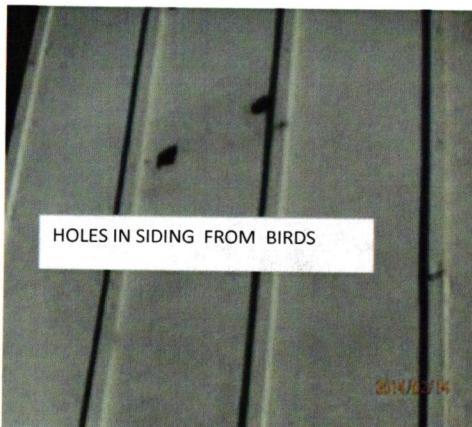
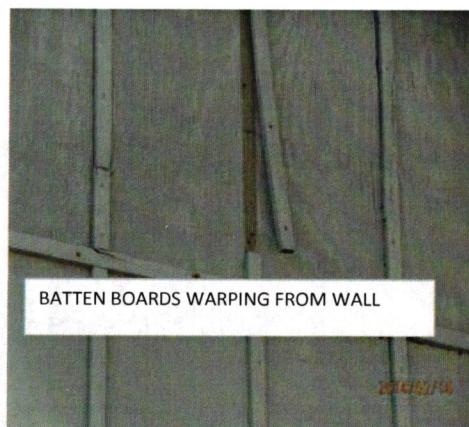
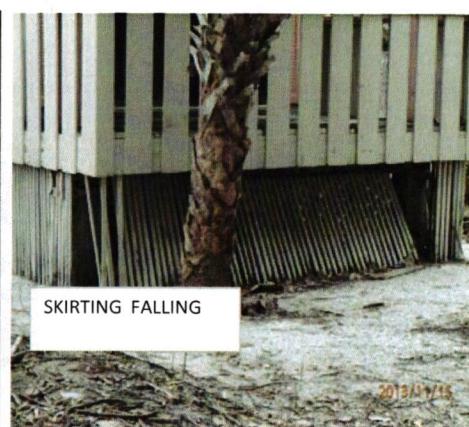
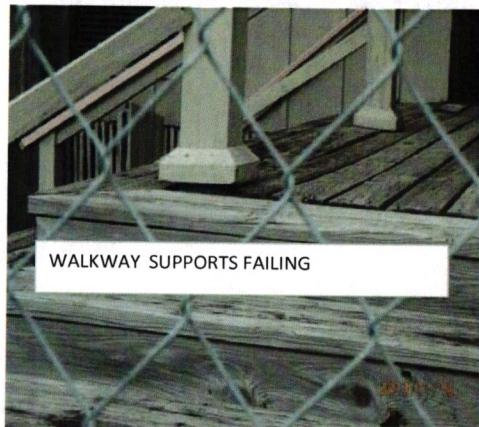
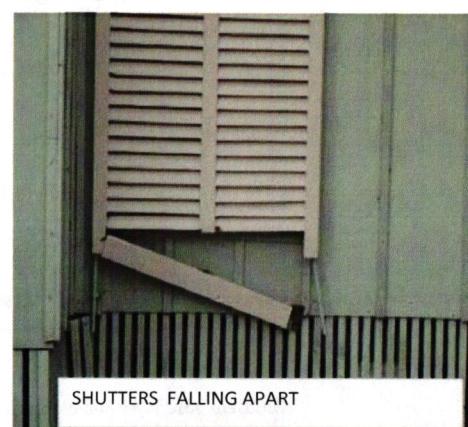
Many porch beams deflected 1/2-inch and more at the center.  
Siding, trims, floor framing, upper floor deck , wood shutters, .  
Signs of termite and other insect damage. Extensive on the siding. Holes in siding from birds.

Some deck joists  
A/C unit stands  
Siding, trims, floor framing, wood shutters, fascia and soffits. The entry stairs and lower walkway show signs of failing to support. Railings pulling from walls. Railing missing balusters.

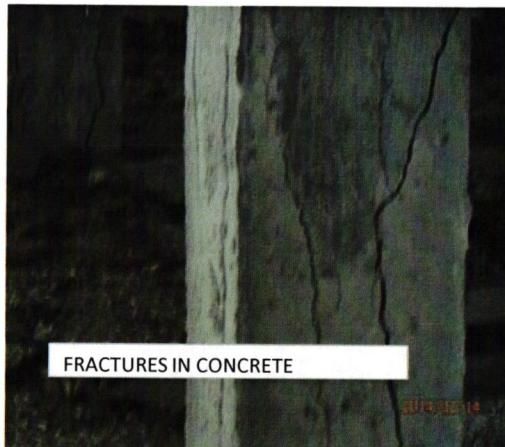
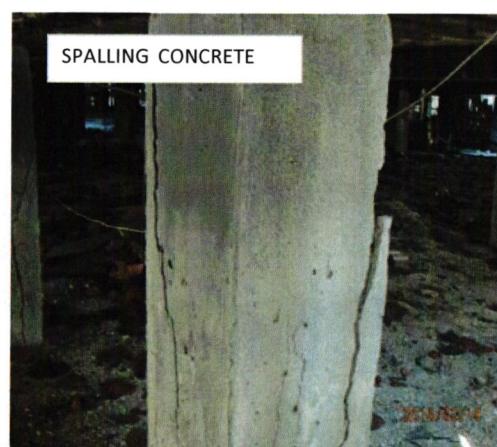
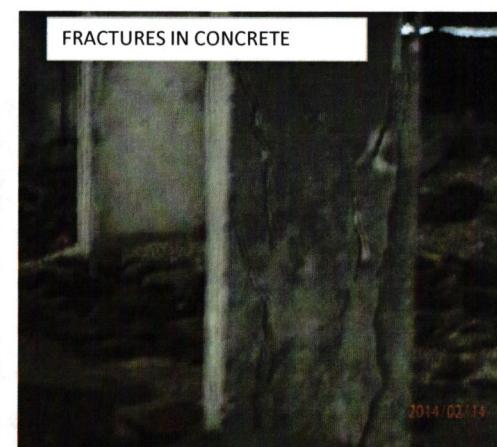
This building appears seaward of the coastal construction control line. Code limitation associated to working on the foundation.

Approximately 30% of the piers, some extensive  
50 % or more of the piers.  
Approximately 15% of the piers  
Extensive on approximately 10% of the piers

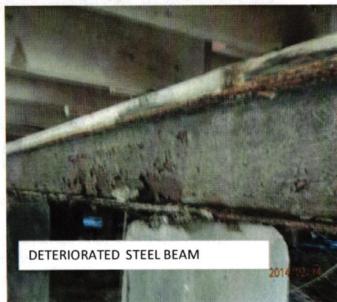
Bottom of I-beams. Some joist hangers and visible clips. Many A/C units are showing signs of failure.

A/C units at the bottom

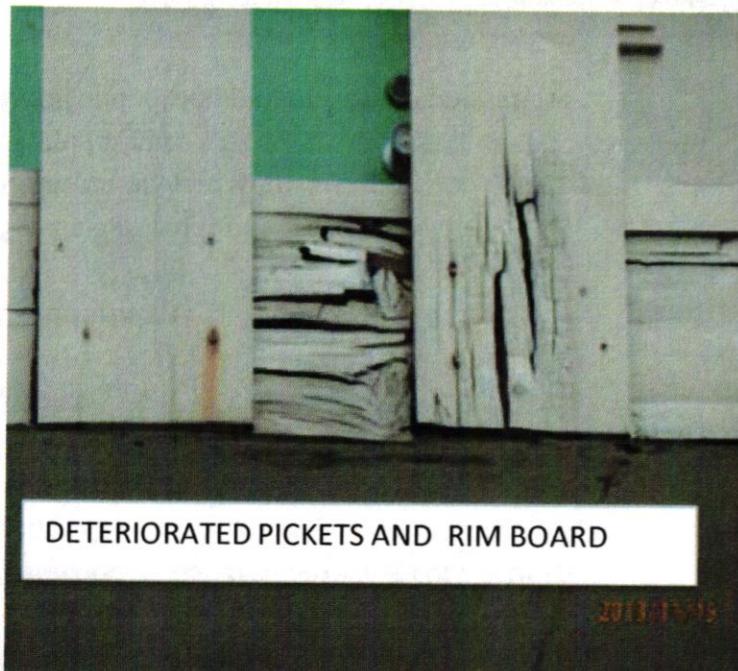
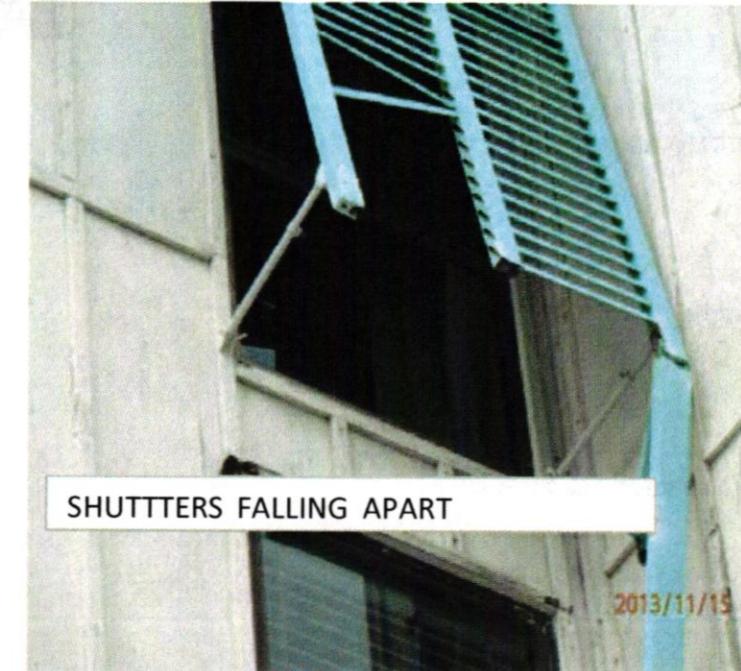
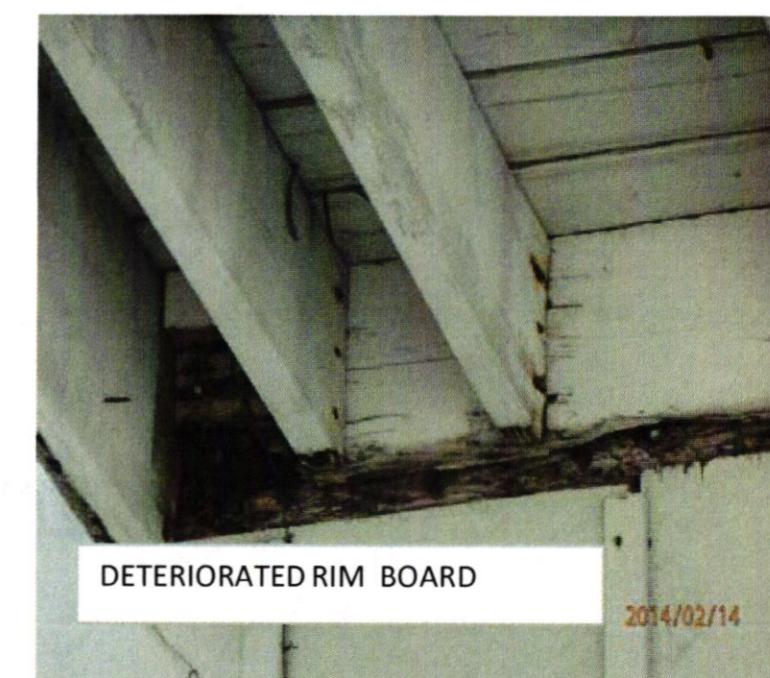
Signs of termite and other insect damage. Extensive on the siding. Holes in siding from birds.

Siding, trims, floor framing, wood shutters, fascia and soffits. The entry stairs and lower walkway show signs of failing to support. Railings pulling from walls. Railing missing balusters.

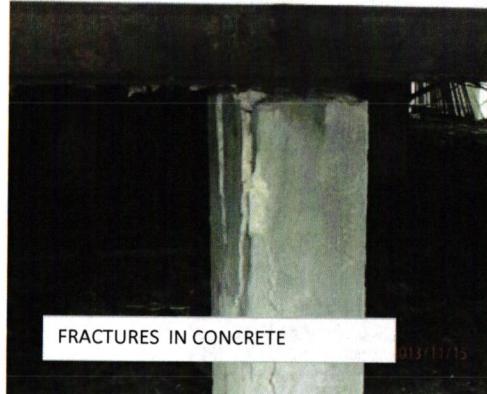
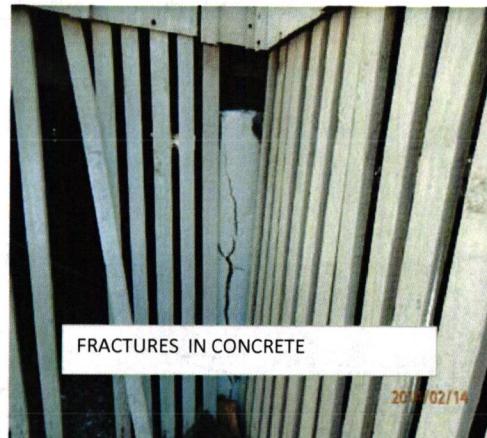
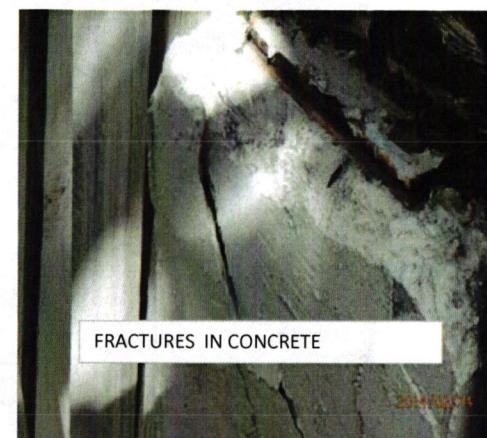
This building is seaward of the coastal construction control line. Code limitation associated to working on the foundation.

Approximately 30% of the piers, some extensive  
50 % or more of the piers.  
Approximately 20% of the piers  
Extensive on approximately 10% of the piers

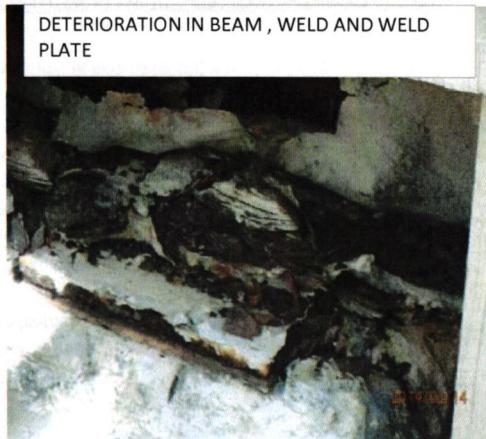
Bottom of I-beams. Some joist hangers and visible clips. Many A/C units are showing signs of failure.

A/C units at the bottom

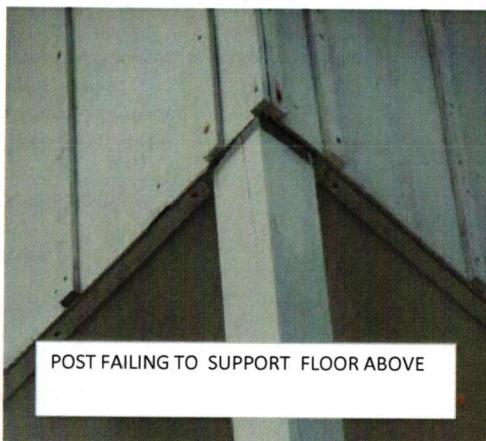
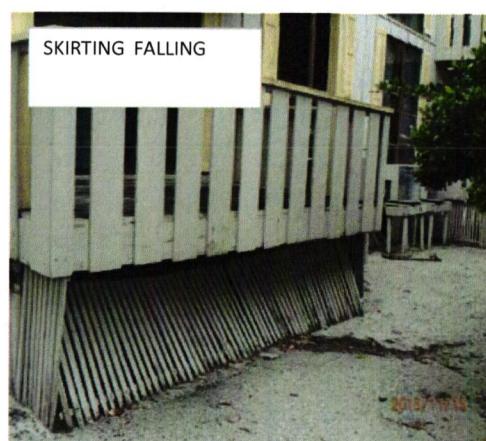
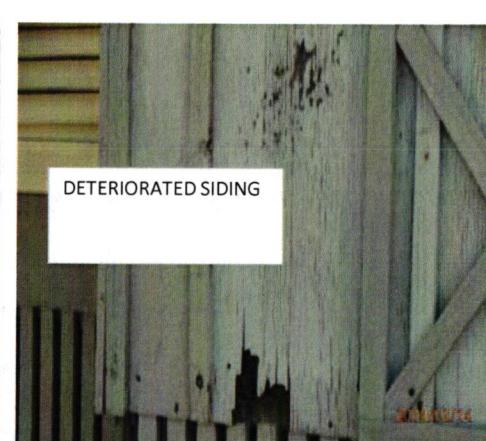
Signs of termite and other insect damage. Extensive on the siding. Holes in siding from birds.

Siding, trims, floor framing, wood shutters, fascia and soffits. The entry stairs and lower walkway show signs of failing to support. Railings pulling from walls. Railing missing balusters.

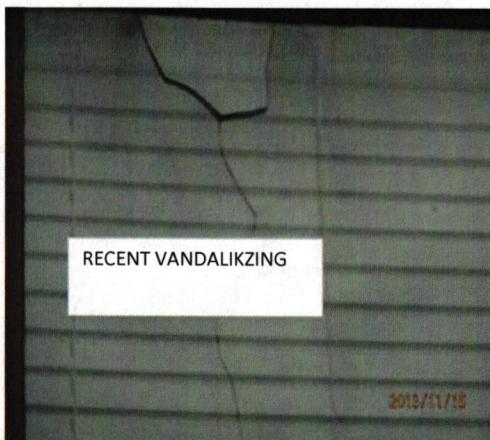
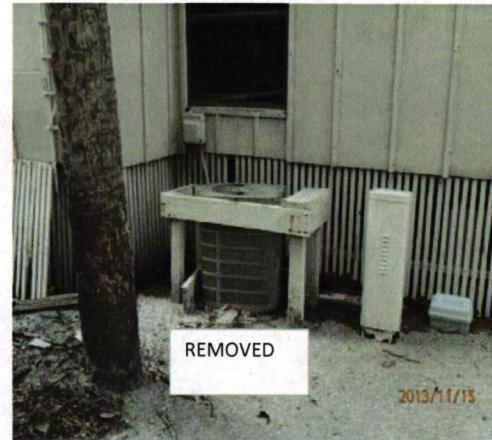
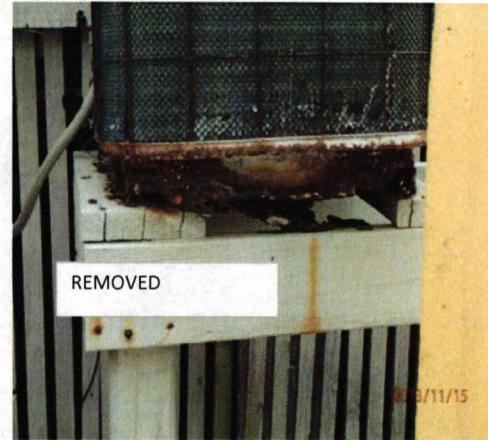
Cast iron building drains corroded and broken

Boarded up windows and doors due to vandalizing. Broken window due to recent vandalizing.

Air conditioning unit are beginning to fail. A/C unit may fall and have potential to have electrical issues as well as possible leaking for the refrigerant. One unit has dropped to the ground.

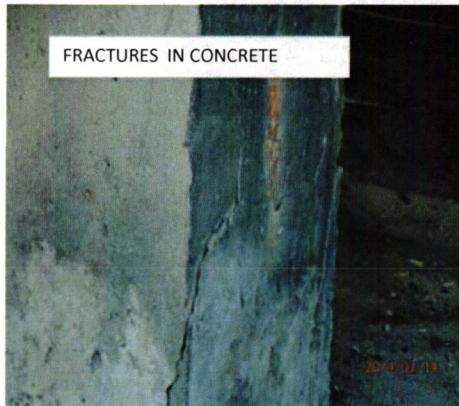
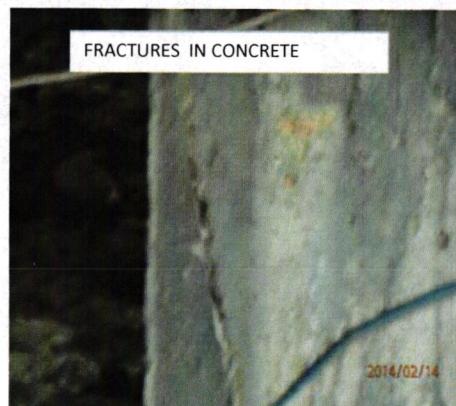
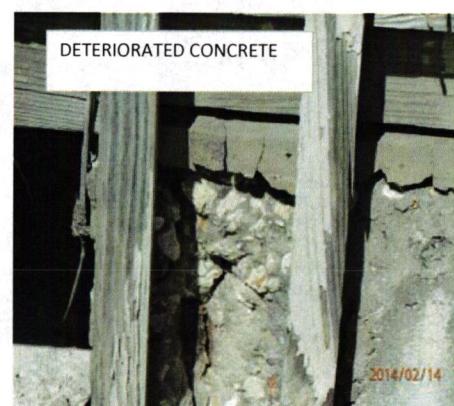
This building is seaward of the coastal construction control line. Code limitation associated to working on the foundation.

Approximately 50% of the piers, some extensive  
75 % or more of the piers.  
Approximately 40% of the piers  
Extensive on approximately 40% of the piers

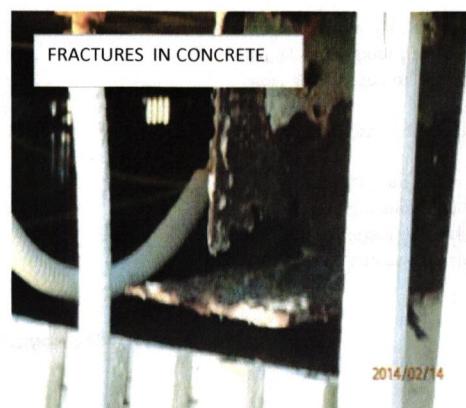
Bottom of I-beams. Some joist hangers and visible clips. Many A/C units are showing signs of failure.

A/C units at the bottom

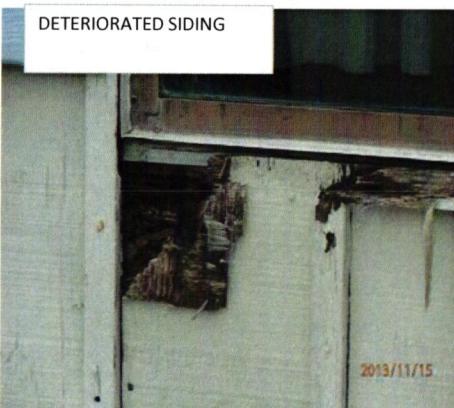
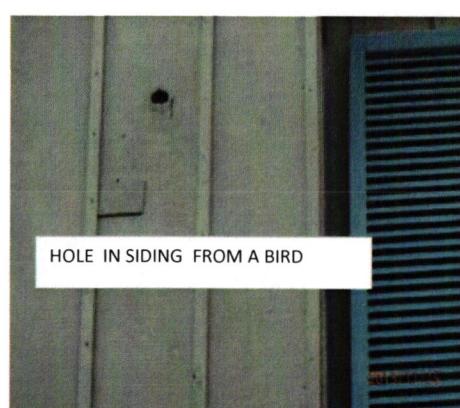
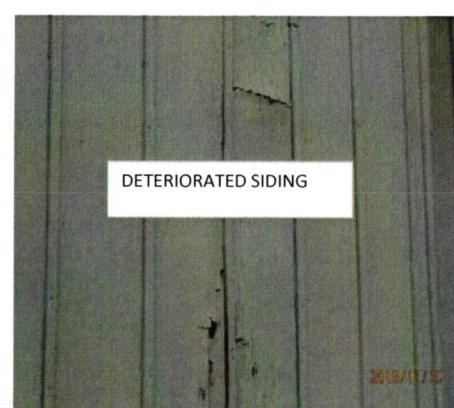
Signs of termite and other insect damage. Extensive on the siding. Currently has wasp nests.

Post appears to not be supporting upper walkway. A/C unit stands

Siding, trims, floor framing, wood shutters, fascia and soffits. The entry stairs and lower walkway show signs of failing to support. Railings pulling from walls. Railing missing balusters.

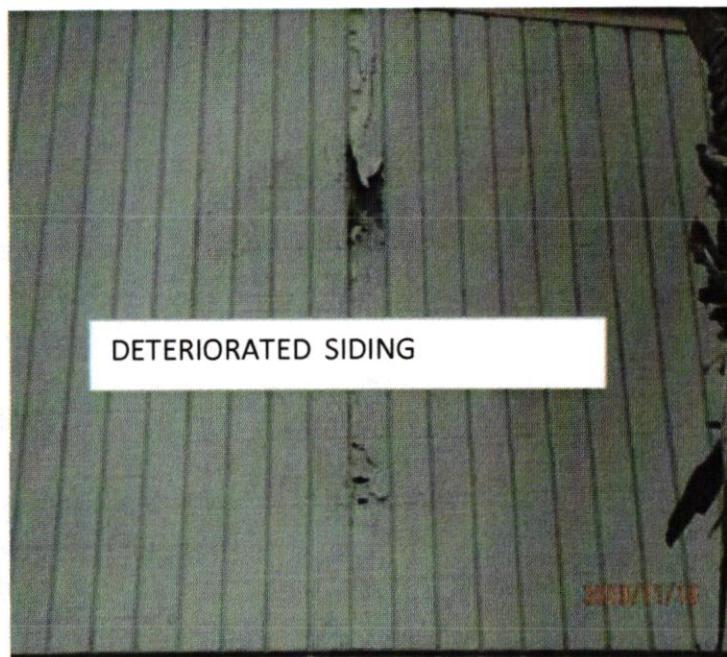
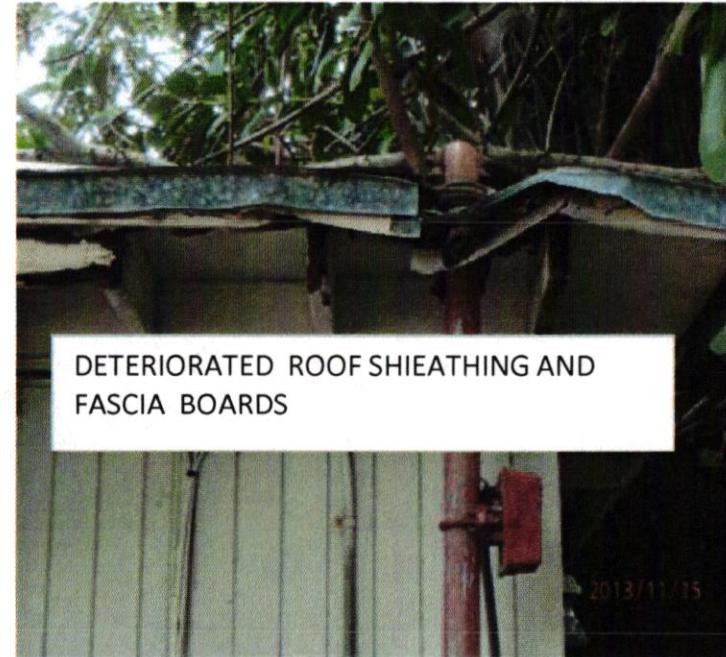
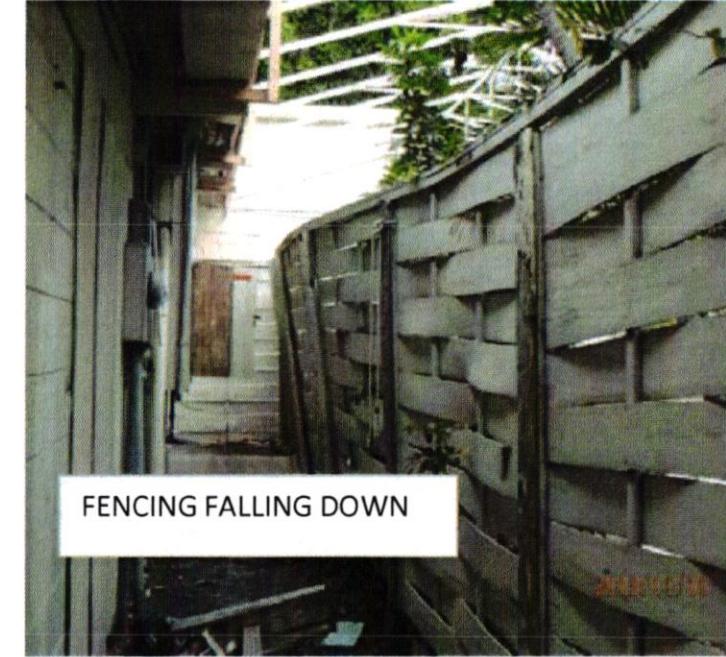
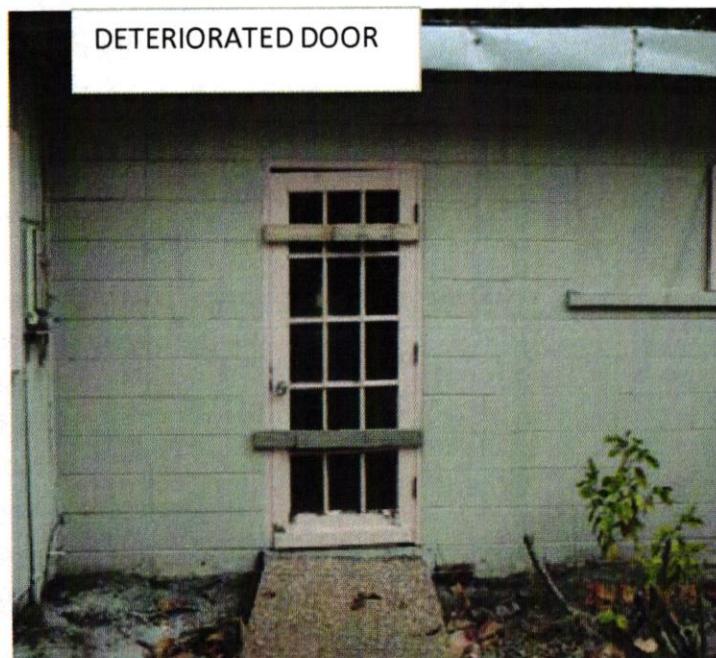
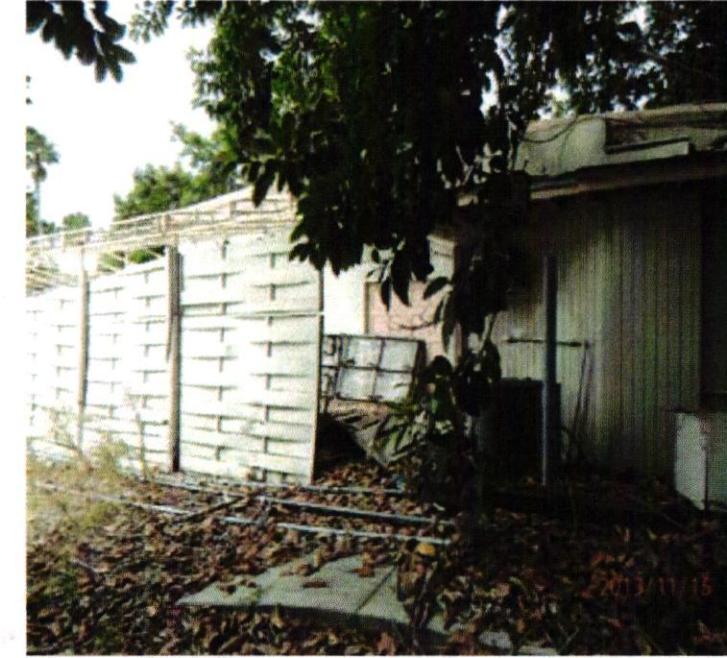
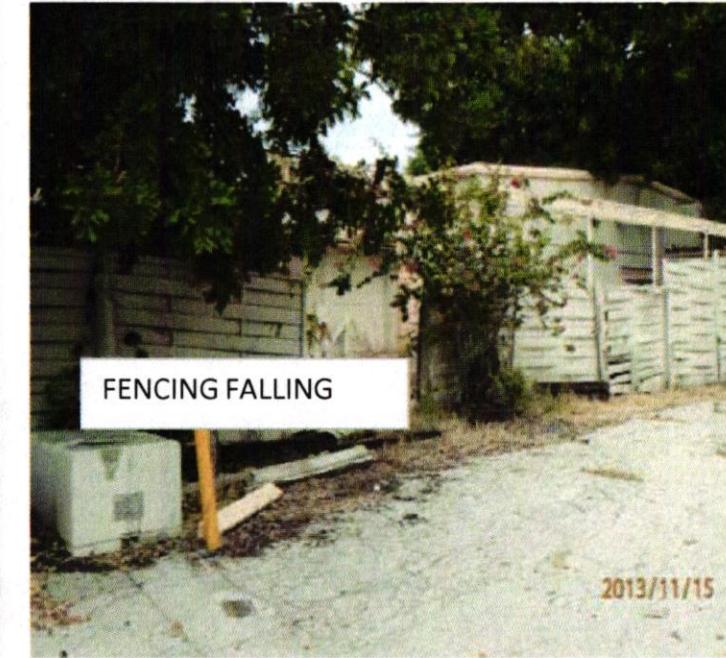
Roof sheathing. Siding, fascia boards, trims, doors, windows.

Signs of termite damage

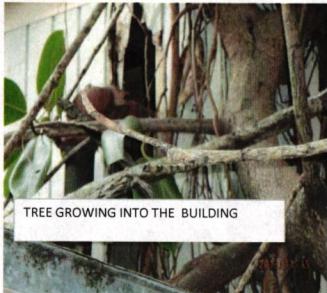
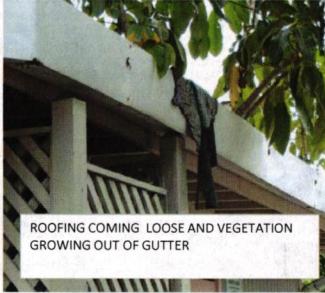
Roofing appears to be failing.  
Fencing failing.  
Tree growing into building.  
Vegetation growing from roof and gutters.  
Boarding due to vandalizing and condition of doors.  
Broken conduit exposing electrical conductors not

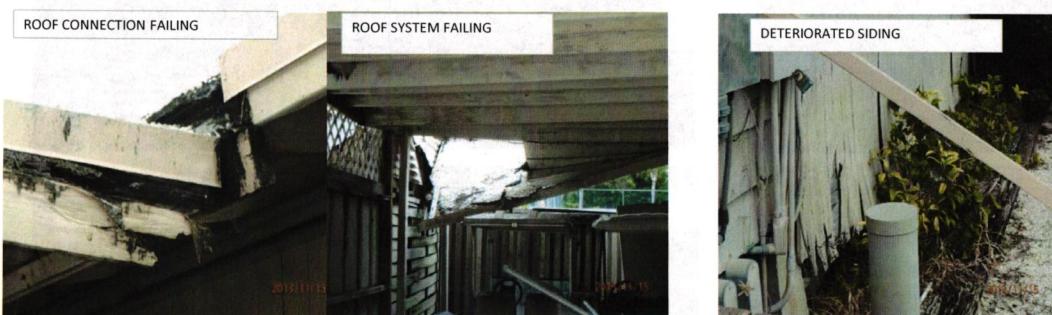
Signs of termite damage.

One shed roof is collapsing. Siding damage due to vandalizing.

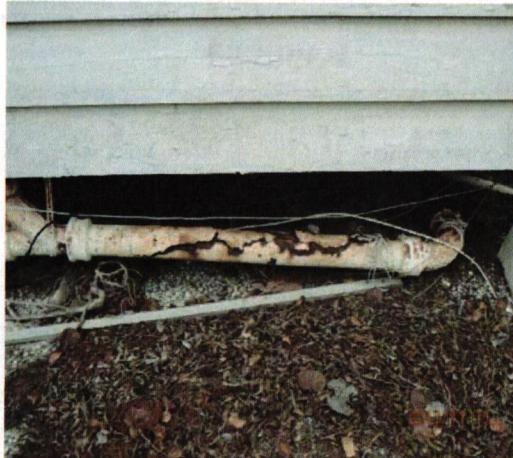
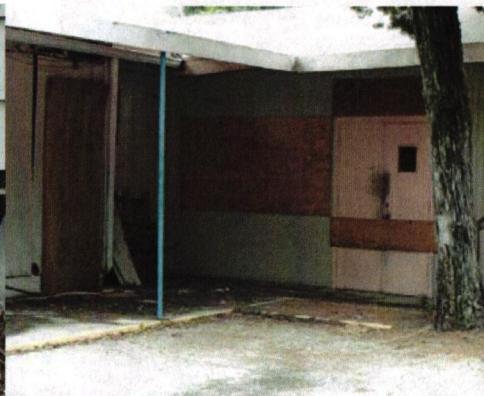
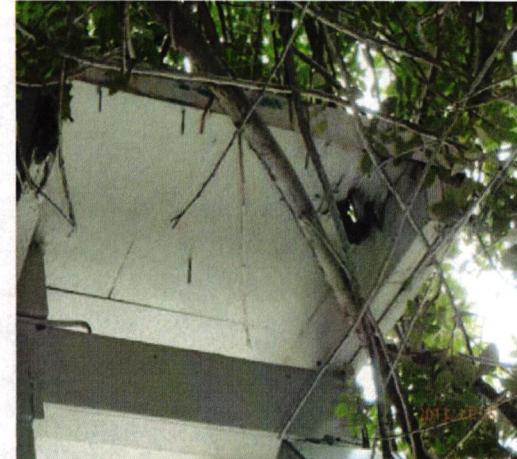
Broken, corroded, and cracked building drains.

Roofing at end of its life.

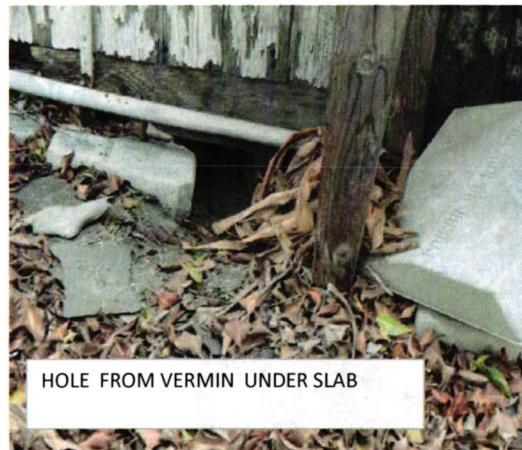
HOLE FROM VERMIN UNDER SLAB

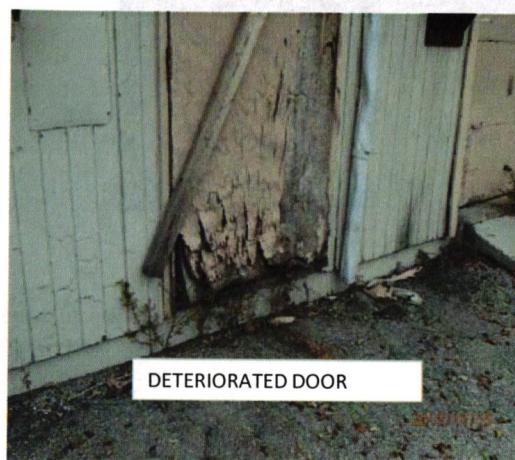
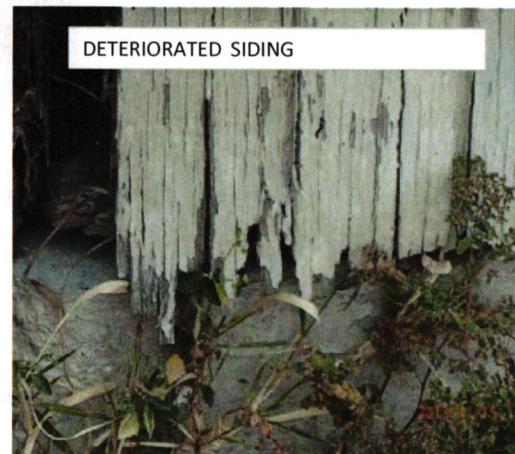
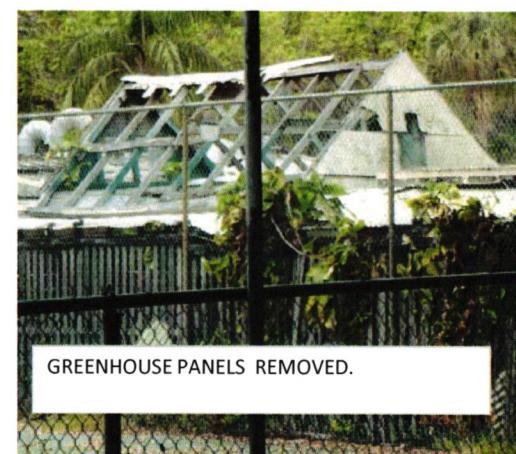
Siding, fascia boards, trims, doors. Roof framing over green house  
Appears to have some kind of animal under slab at rear.

Doors from building openings.

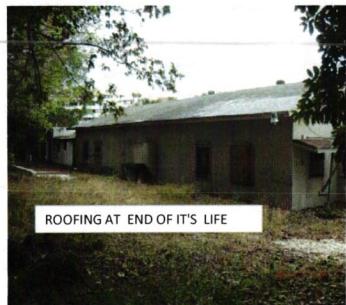
Roofing at end of its life. Many areas have patches.

Boarded up due to vandalizing and door condition.
