**Building Official Inspection Report**  
**February 26, 2014**  
**1620 Gulf of Mexico Drive**  
**The Colony**

### Building Official Report

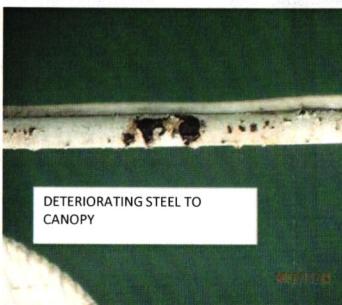
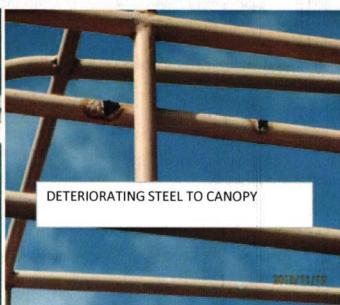
Fabric canopy frames

Fabric awning structures

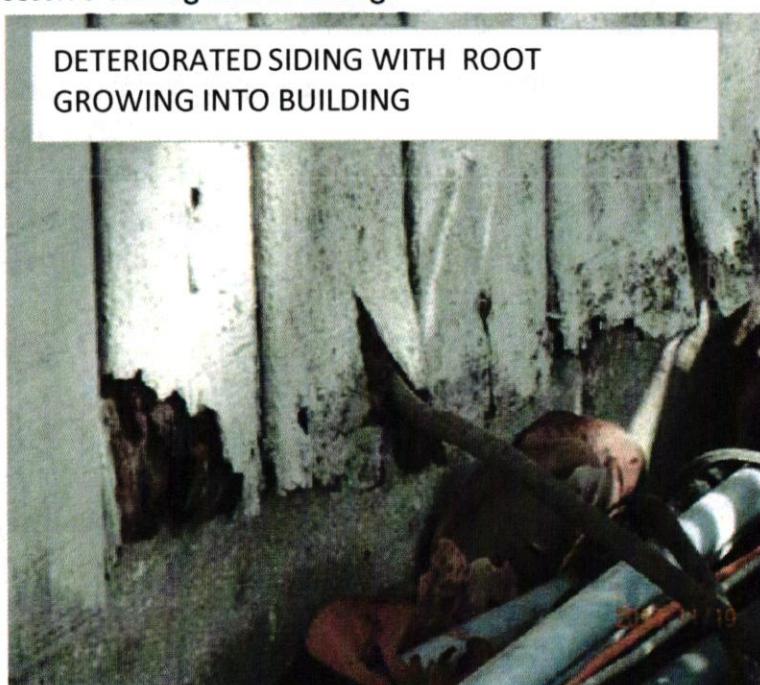
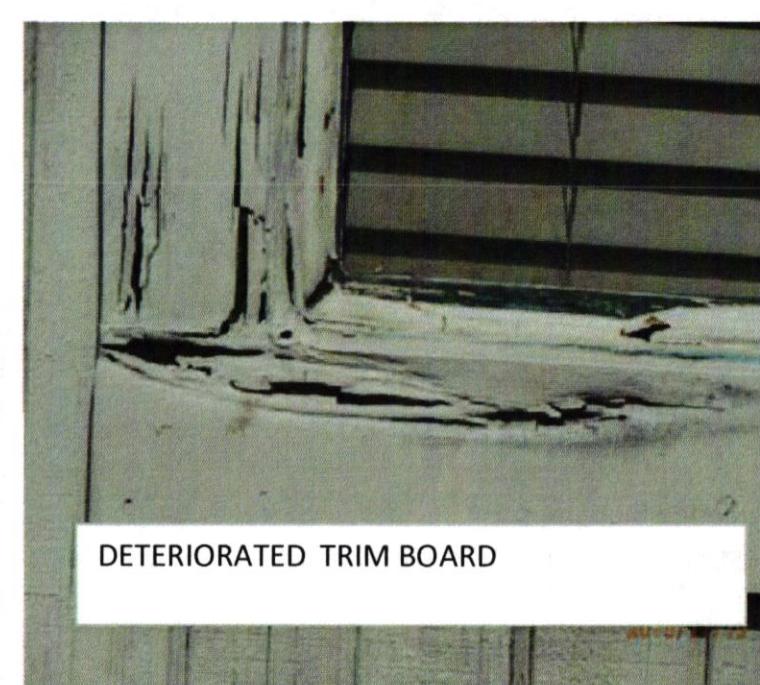
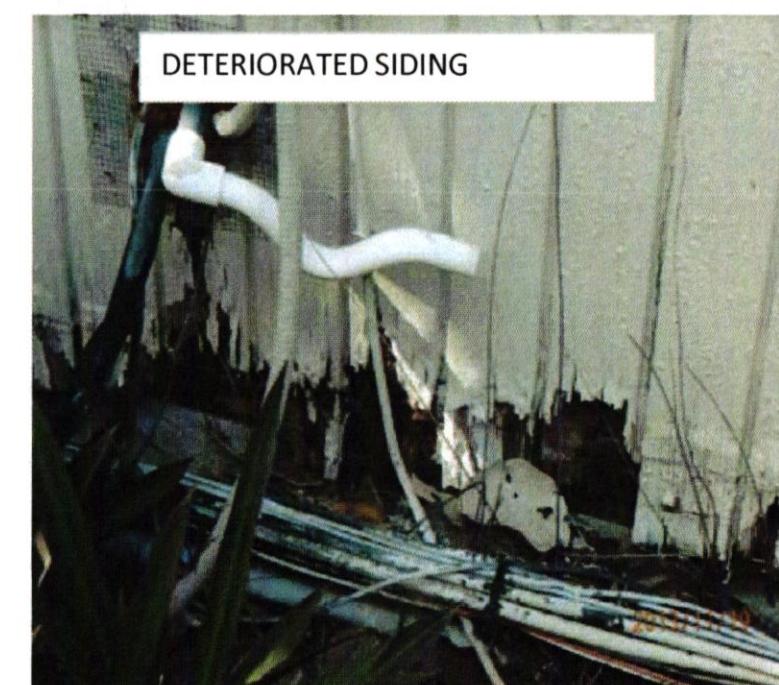
Signs of termite damage.

Doors from building openings. Rear deck walking surface is lifting and signs of rot.

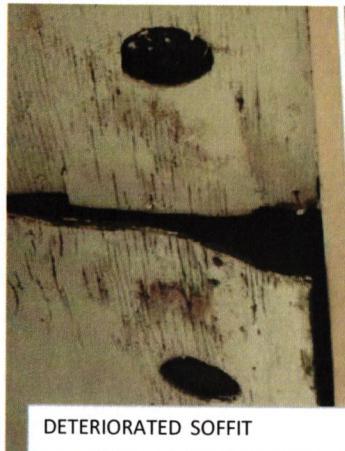
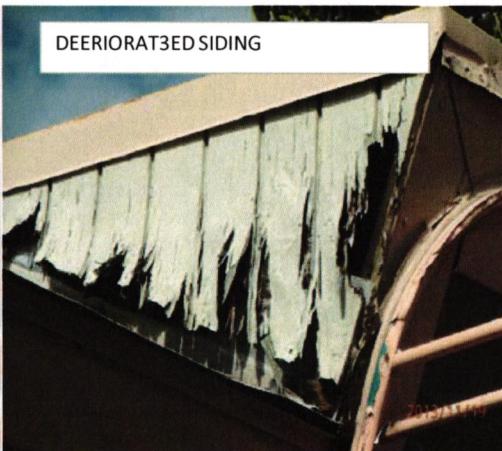
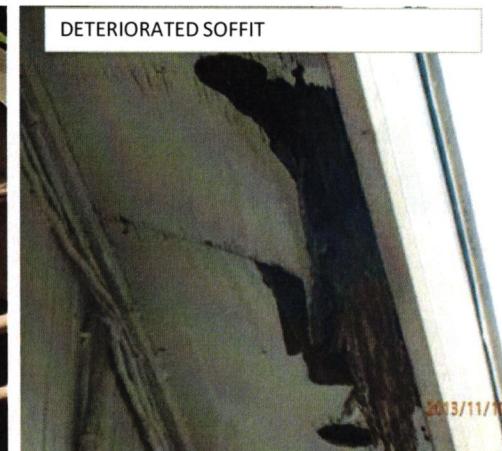
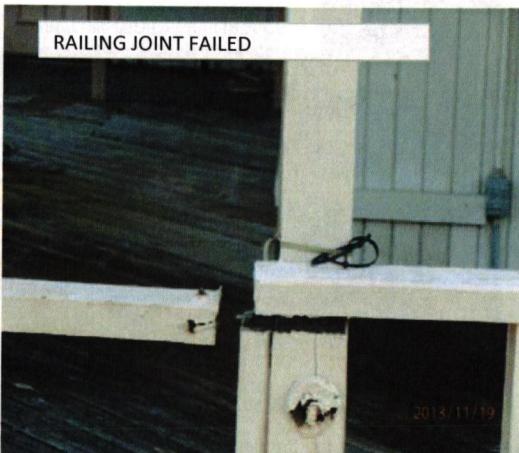
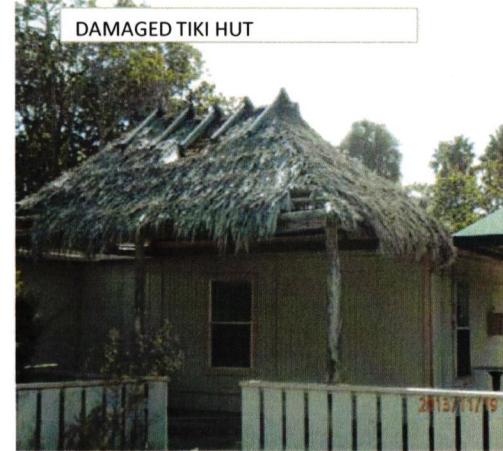
Roofing at end of its life. Many locations of damaged and missing roofing.  
Torn fabric on rear canopy.  
Tiki structure at rear is deteriorating and the roof thatch are falling off.  
Roots are growing through the siding and into the building wall.

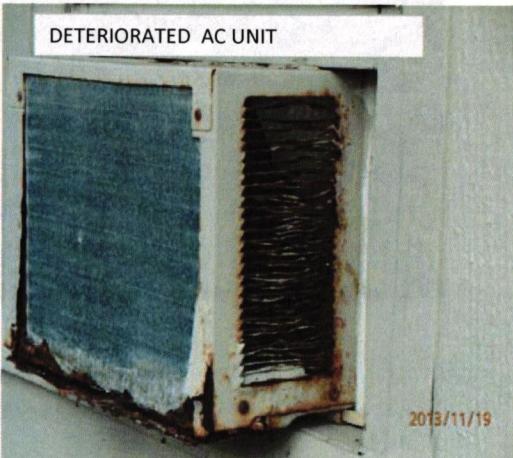
Air conditioner unit corroded beyond usefulness
