ENGINEERING INSPECTION REPORT

THE COLONY BEACH and TENNIS RESORT

Longboat Key, Florida

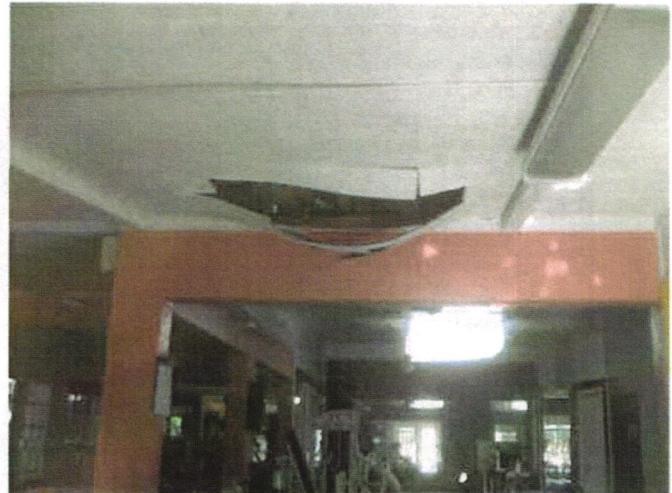
50	Fitness Center – roof leaks/ceiling damage	2125	Conference Center
51	Fitness Center – roof	2317	Conference Center
52	Guardhouse	2337	Guardhouse
53	Maintenance	2346	Maintenance
54	Maintenance – rotted siding	2135	Maintenance
55	Maintenance – roof	2308	Maintenance
56	Maintenance – collapsed storage shed	2145	Maintenance
57	Housekeeping/Accounting	2147	Housekeeping/Accounting
58	Housekeeping - roof	2290	Housekeeping/Accounting
59	Housekeeping - roof	2298	Housekeeping/Accounting
60	Accounting – roof	2302	Housekeeping/Accounting
61	Restaurant Complex – east side	2350	Photos of site and view of each building
62	Restaurant Complex – west side	1923	Restaurant Complex
63	Restaurant Complex – north side	1950	Restaurant Complex
64	Restaurant Complex – south side	1908	Restaurant Complex
65	Restaurant Complex – deck at	1898	Restaurant Complex

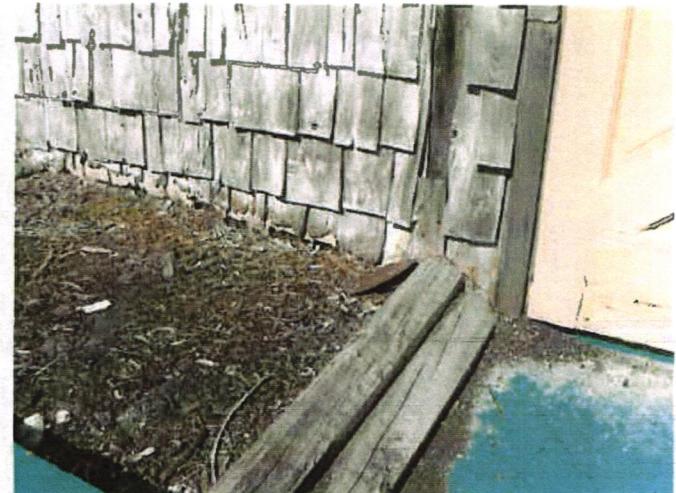
2 nd story Presidential Suite		
66	Restaurant Complex – siding rot, south side	1910	Restaurant Complex
67	Restaurant Complex – roof rot, south side	1914	Restaurant Complex
68	Restaurant Complex – cracked CMU columns, north side	1958	Restaurant Complex
69	Restaurant Complex – cracked CMU columns, north side	1963	Restaurant Complex
70	Restaurant Complex – north wall adjacent to Beachcomber	1974	Restaurant Complex
71	Restaurant Complex – Monkey Bar	1930	Restaurant Complex
72	Restaurant Complex – siding rot/damage, Real Estate Office, west side	1978	Restaurant Complex
73	Restaurant Complex – roof	2262	Restaurant Complex
74	Restaurant Complex – Real Estate Office roof	2249	Restaurant Complex
75	Restaurant Complex – HVAC unit	2254	Restaurant Complex
76	Villa – HVAC units removed	1673	Villa 11
77	Villa - Corroded cast iron drain	1700	Villa 14
78	Villa – Deteriorated walkway	1582	Villa 5

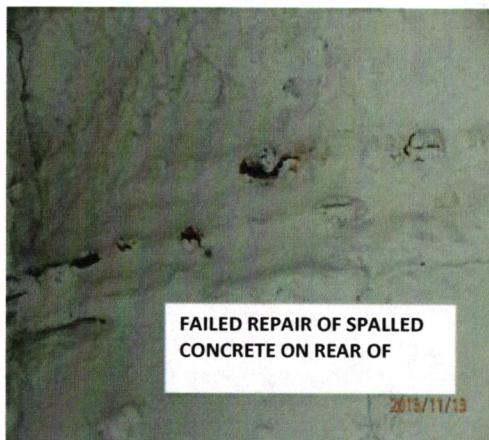
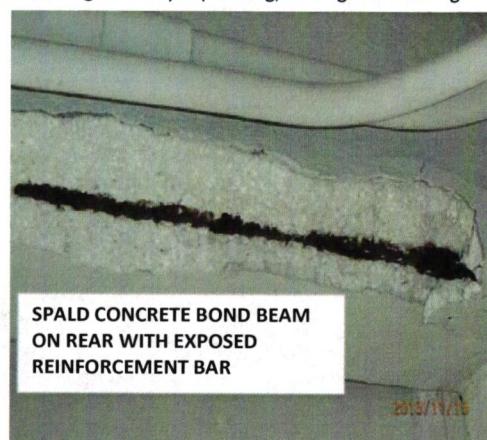
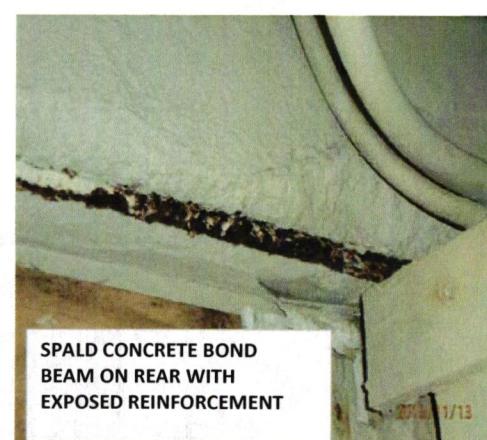
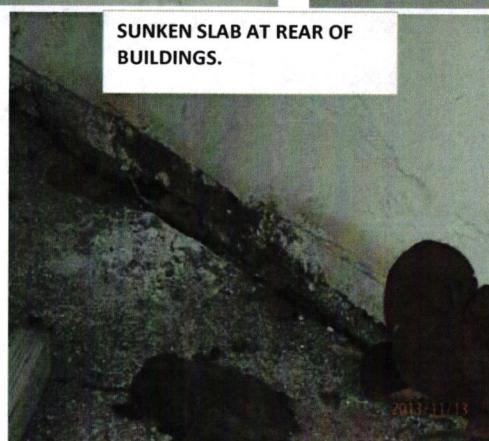
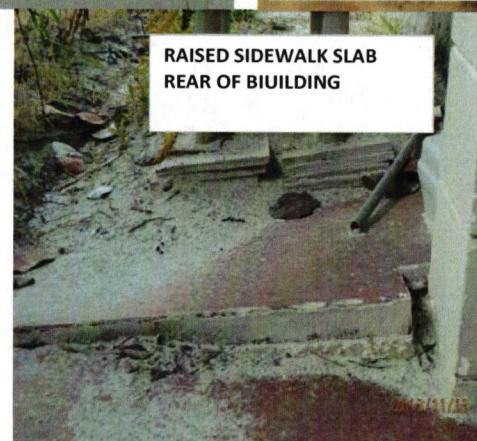
Rear of building in the lintel beam.

Rear of building walkway separating, sinking and heaving

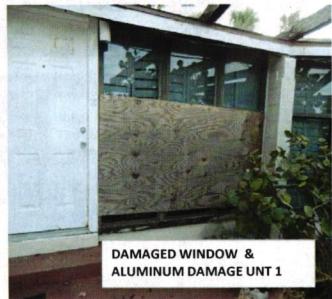
Windows damaged due to vandalizing.

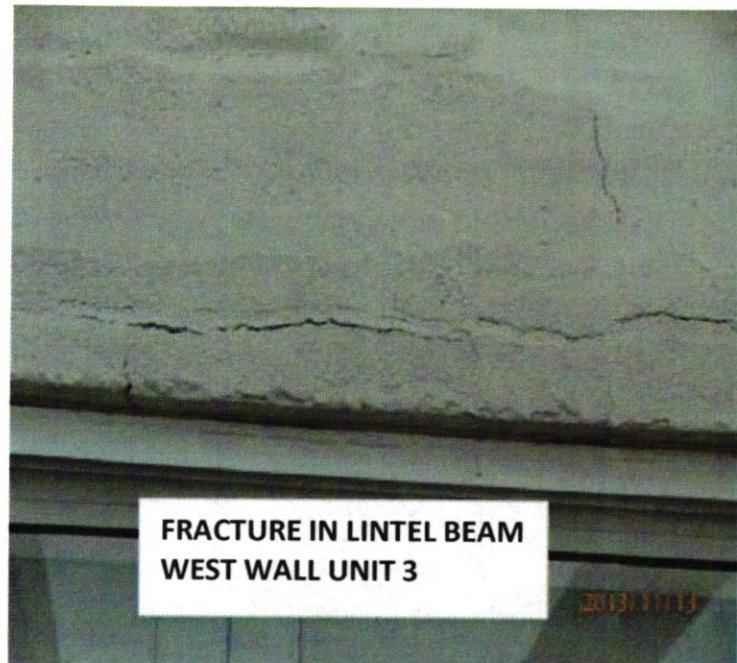
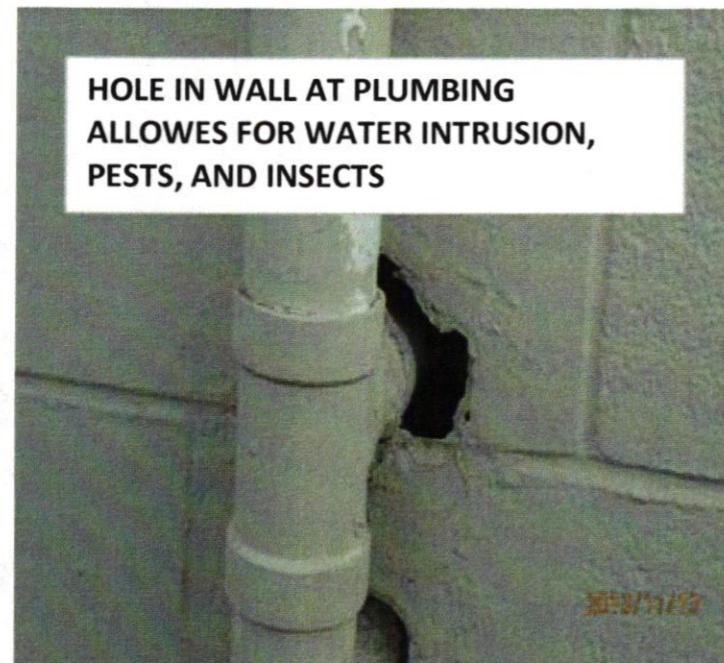
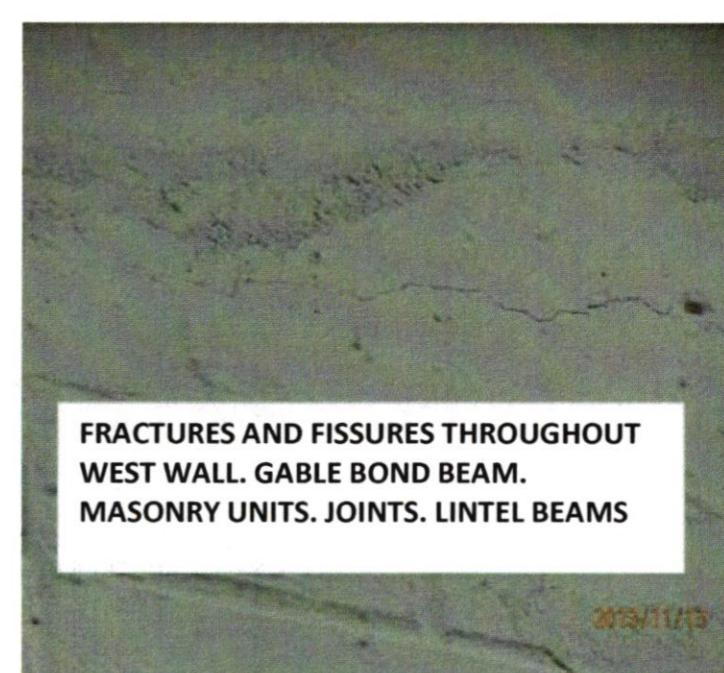
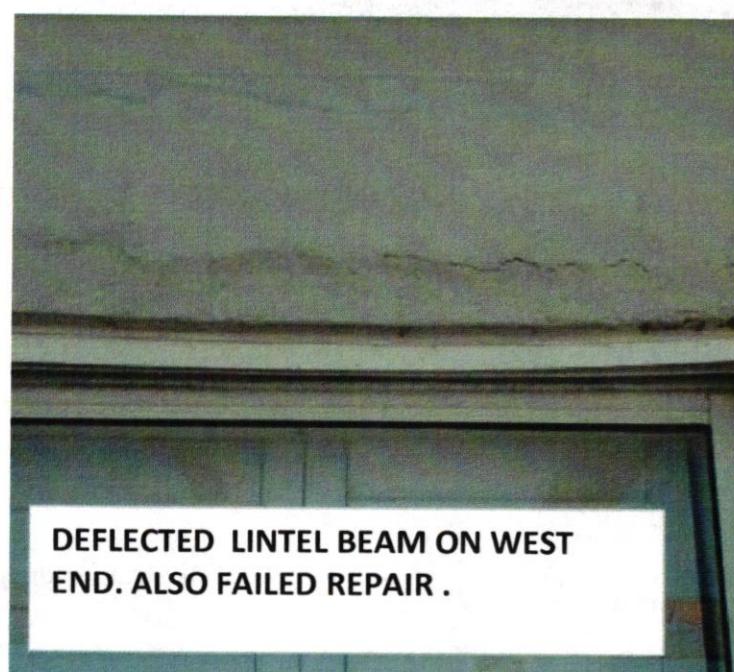
WEST SIDE OF BUILDING

Around plumbing stack on west end of building

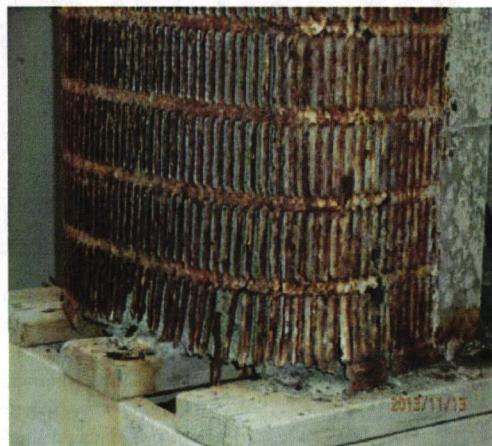
DETERIORATED STEEL AT AIR CONDITIONING UNIT. COULD ALSO

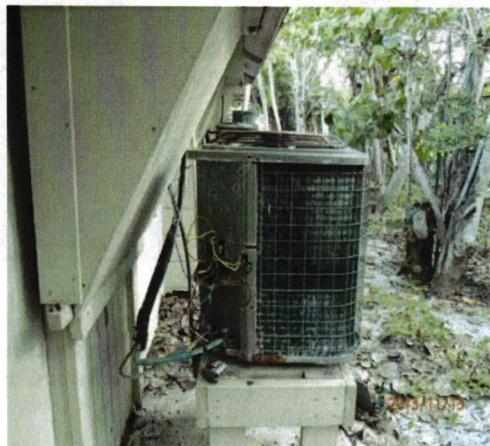
DETERIORATION OF METAL AT MULTIPLE AREAS OF AN AIR CONDITIONIN UNIT.

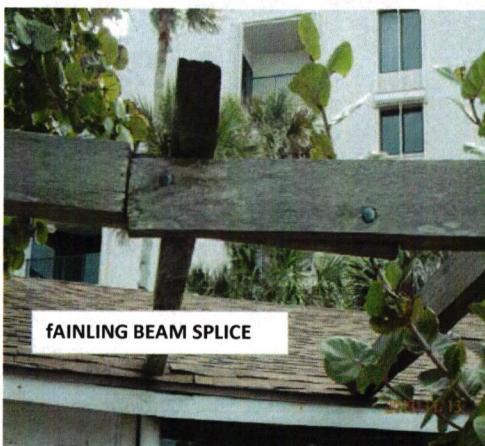
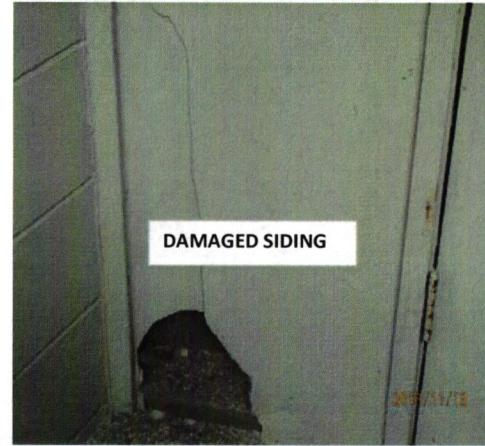
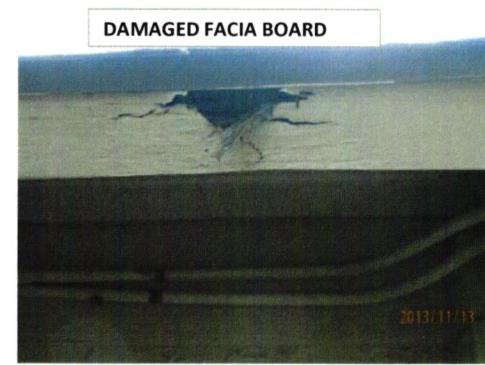
Ultimate deformation	Roof sheathing supporting trellis beams.
Deterioration	Soffits, fascia boards, siding, trim boards, door jambs
Damage from insects, rodents and other vermin	
Fire damage beyond charring	
Significant splits and checks	
Horizontal shear cracks	
Inadequate support	Splice in support beam of trellis, plywood failing to support trellis, Splice in support beam of trellis
Detached, dislodged, or failing connections	
Excessive cutting and notching

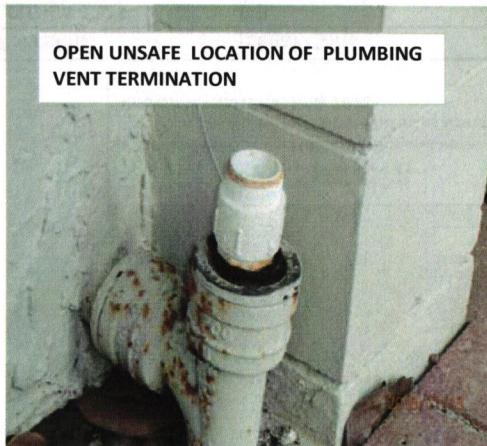
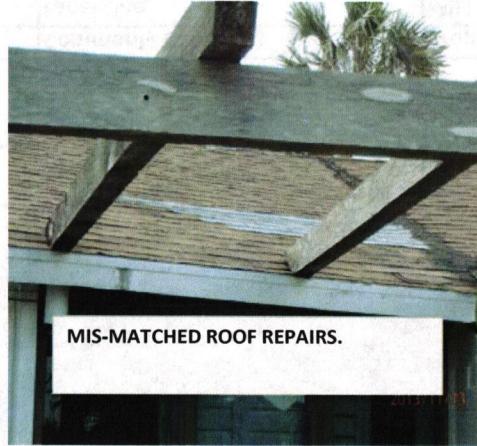
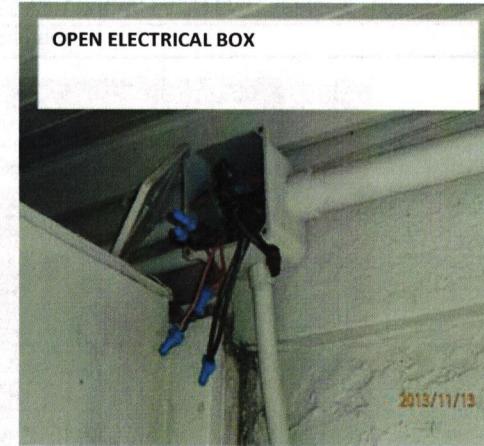
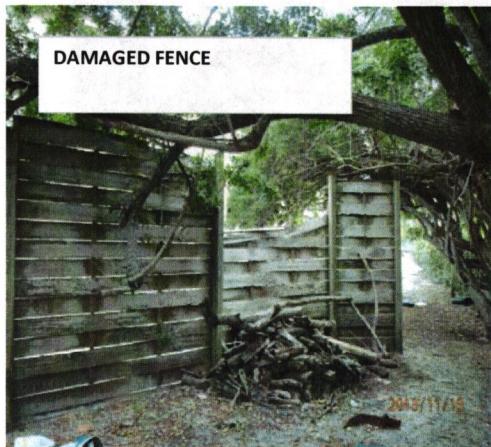
Roof at end of its life. Showing signs of leaking.

Mismatched roofing repairs.

Wood fence damaged

Windows and doors boarded due to damage from vandalizing.

Open plumbing vent and drain.

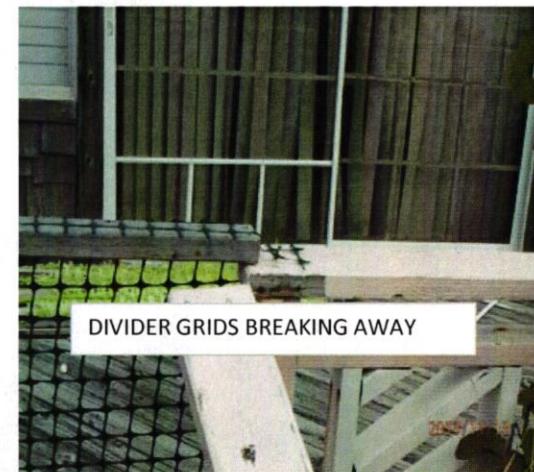
Window grids breaking away

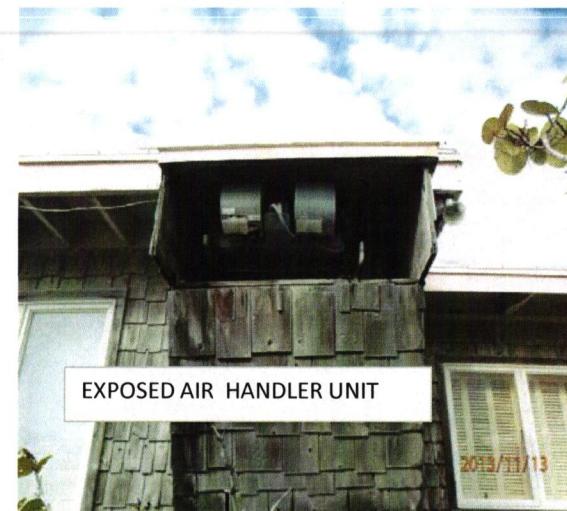
AC units to a point that they no longer function

Awnings have fallen from failed connections

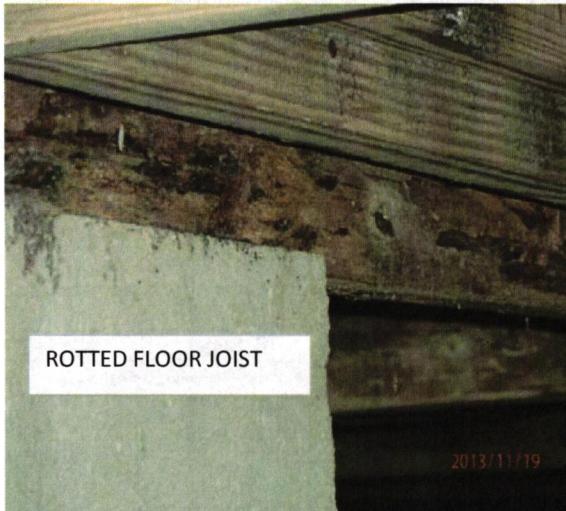
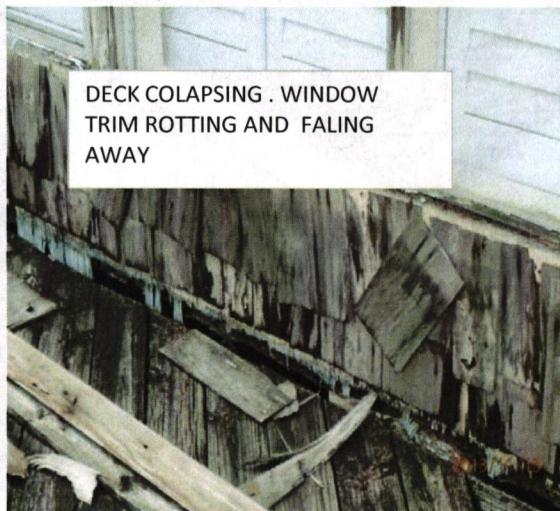
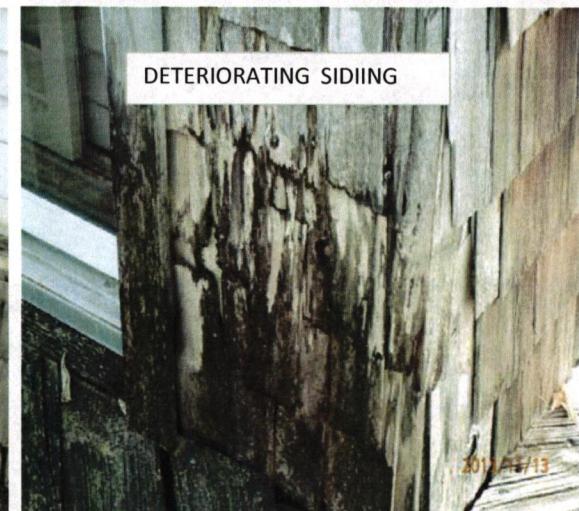
Signs of Possible damage due to termites

Joists and supports appear to be failing through out deck systems.

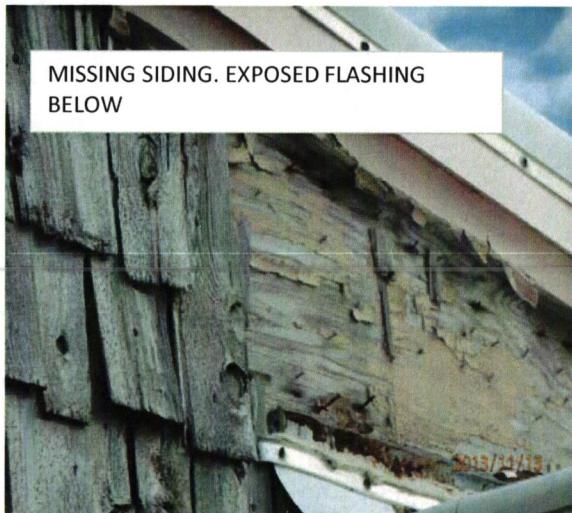
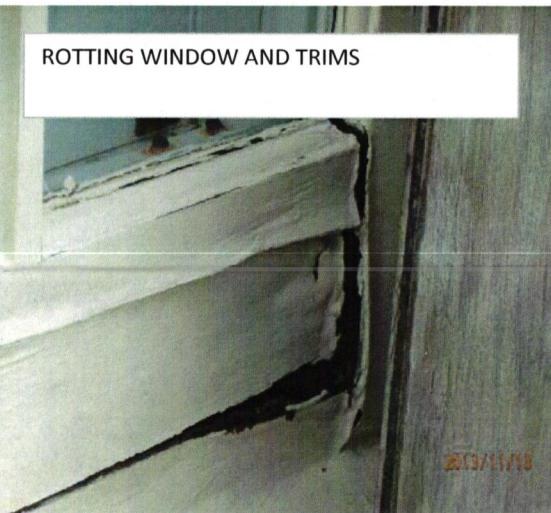
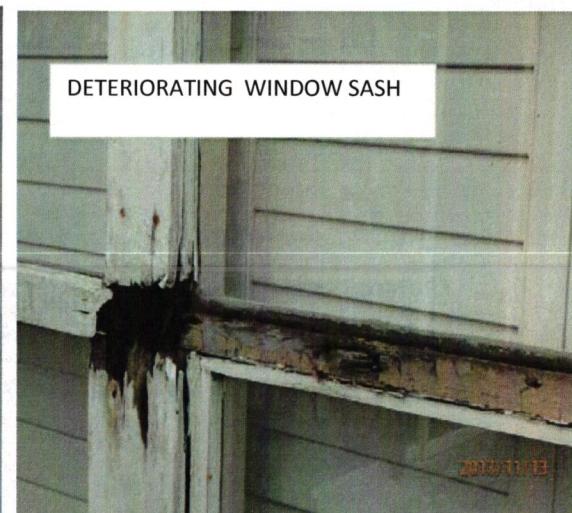
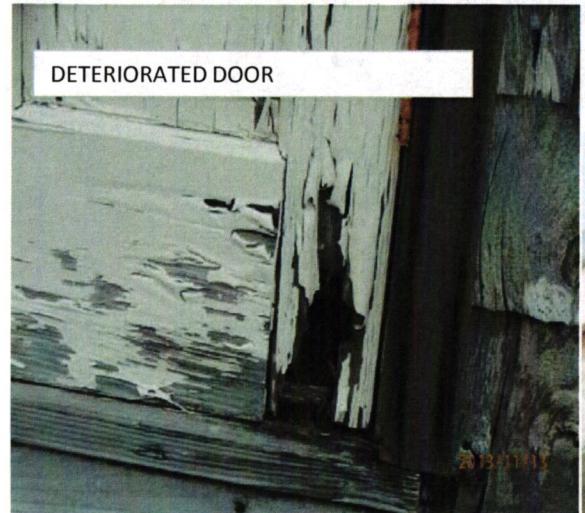
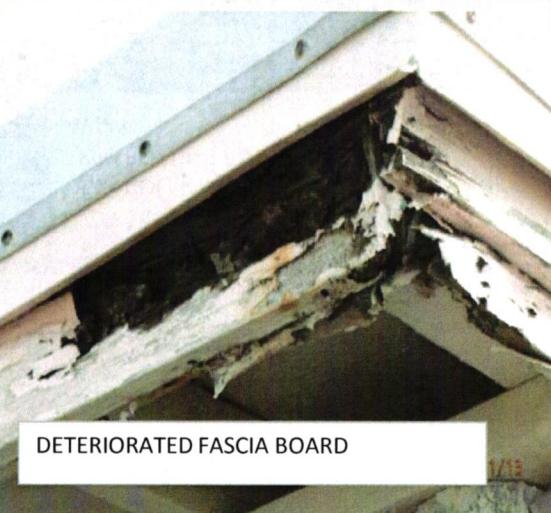
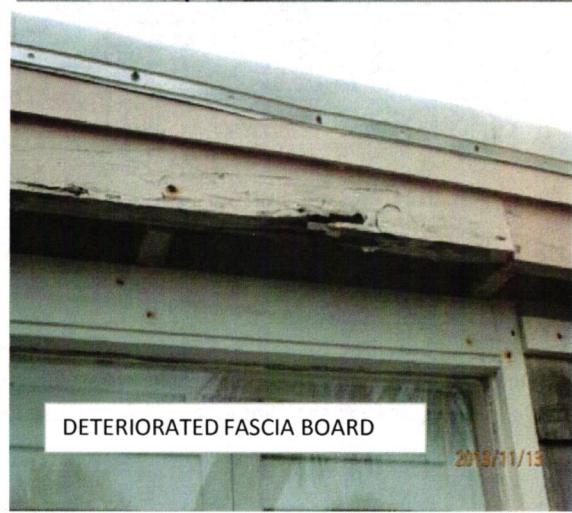
Lanai Units
Building Official Report (Cont.)

Through out deck systems, joists, decking surface, guard and hand railing. Window planter boxes falling from walls, lattice skirting.

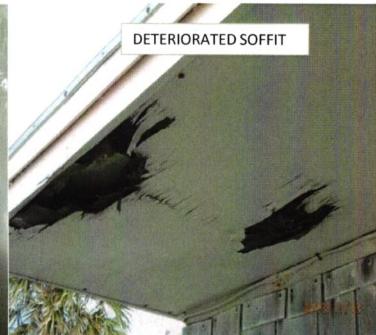
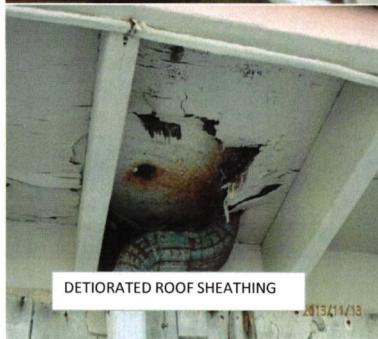
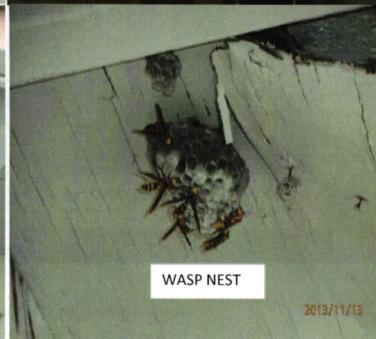
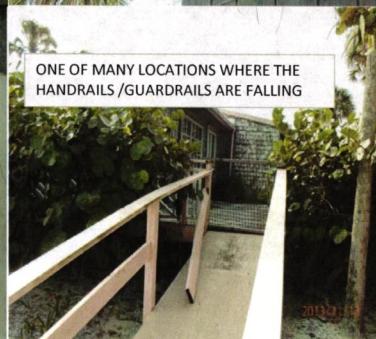
Building Official Report (Cont.)

Roof leaks found throughout. Interior/exterior damage as a result

Doors and window boarded due to vandalizing and from failure from water and deterioration.

Wasps nests in a few locations

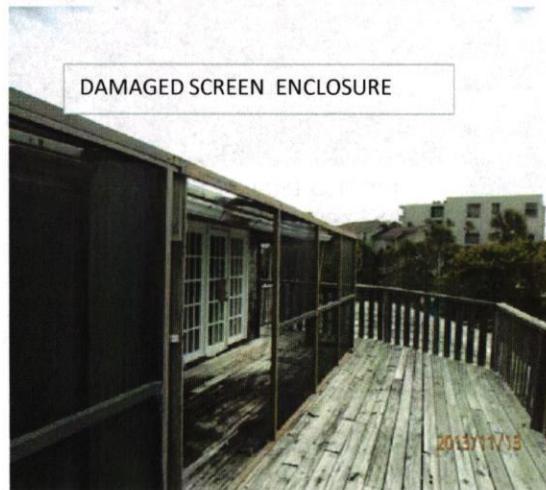
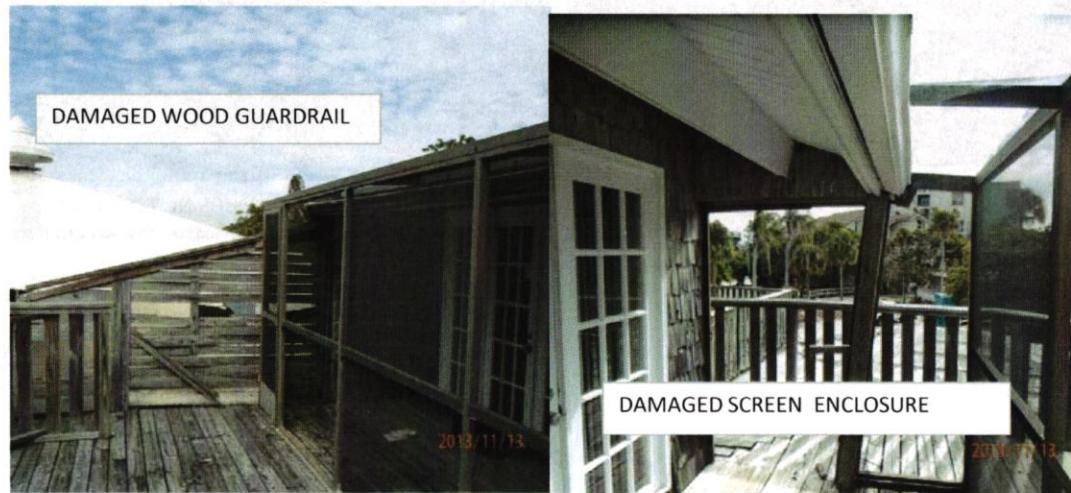
Screen enclosures to presidential suites

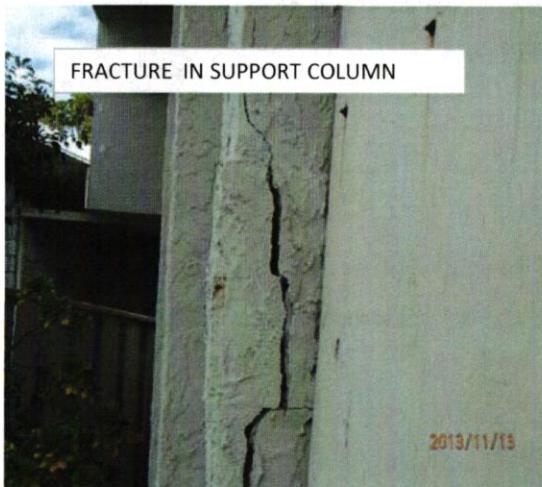
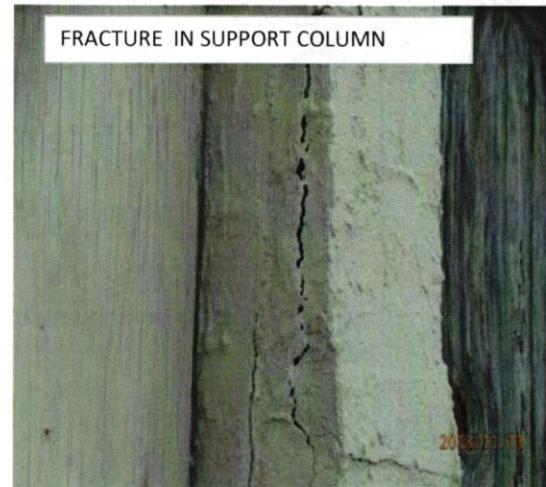
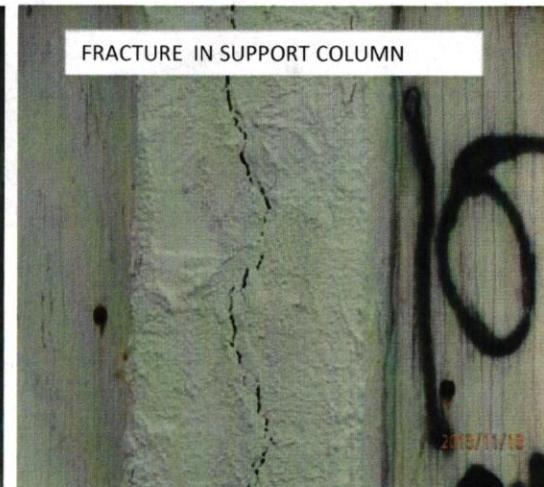
Critical on northwest side. Also found throughout the building

Northwest especially

At bulged location on northwest side columns of windows

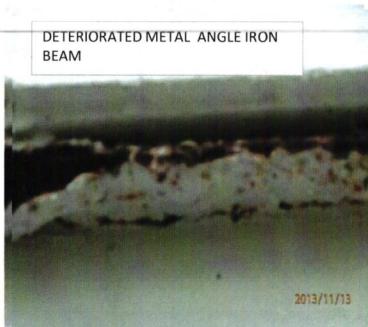
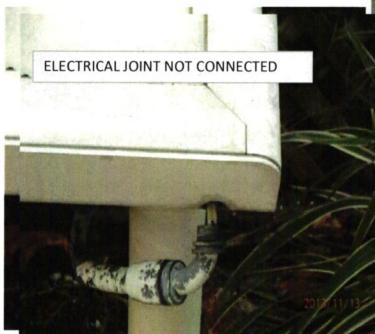
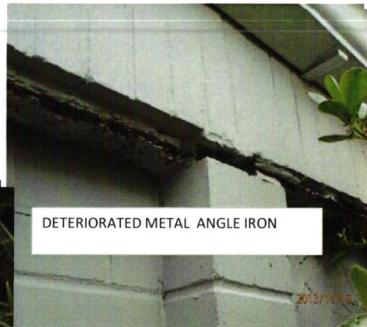
Exposed I beams, canopies. Doors showing signs of failure. Large canopy area in rear on tube steel and weld joints

Many locations on the canopies.

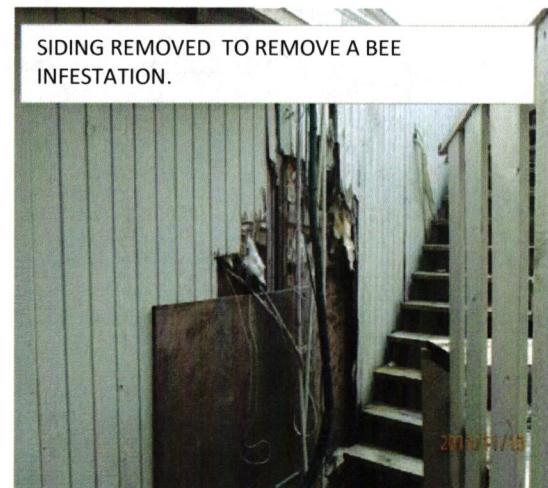
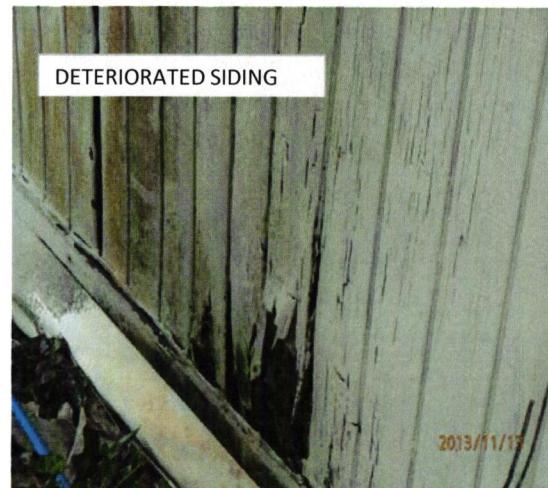
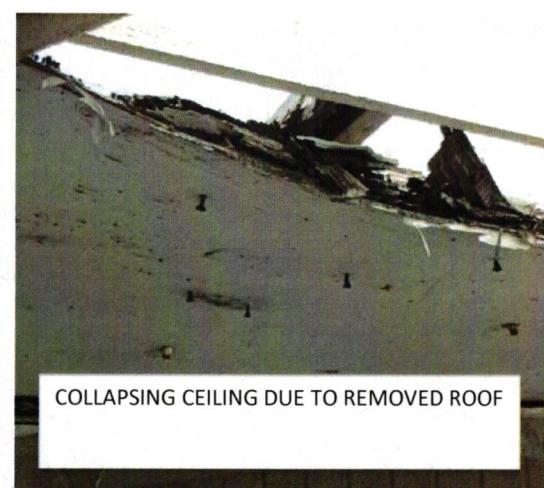
Bee infestation at the rear caused removal of siding

Found vertical separation at on window of realtors office.

Roof over Monkey entry, guard rails, handrails, decking.

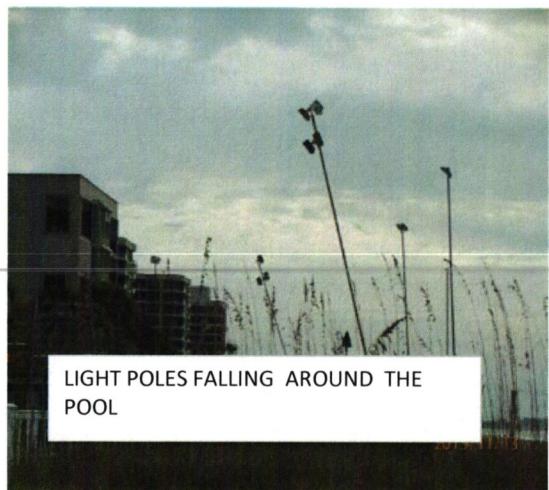
LIGHT POLES FALLING AROUND THE POOL

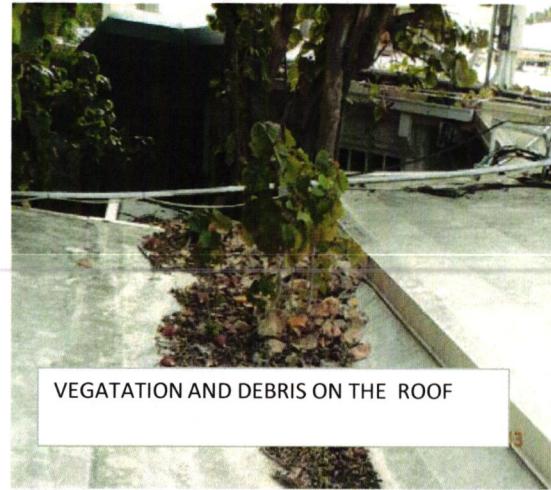
VEGETATION AND DEBRIS ON THE ROOF

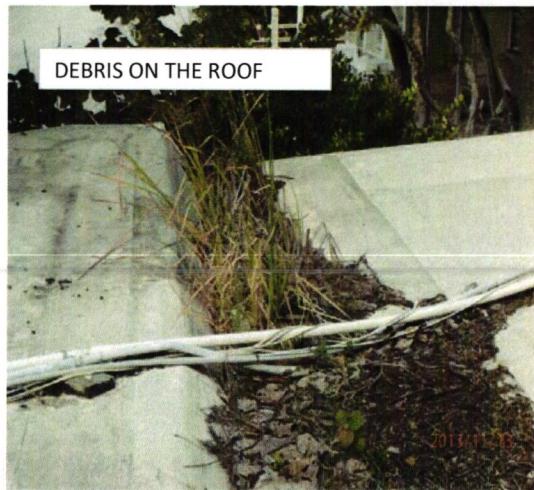
DEBRIS ON THE ROOF

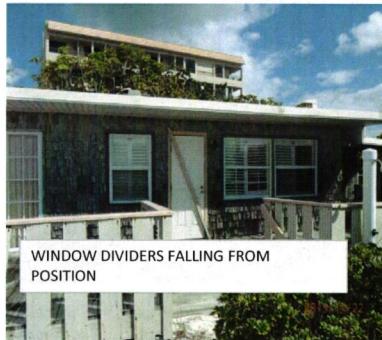
Window and door divider grids breaking away

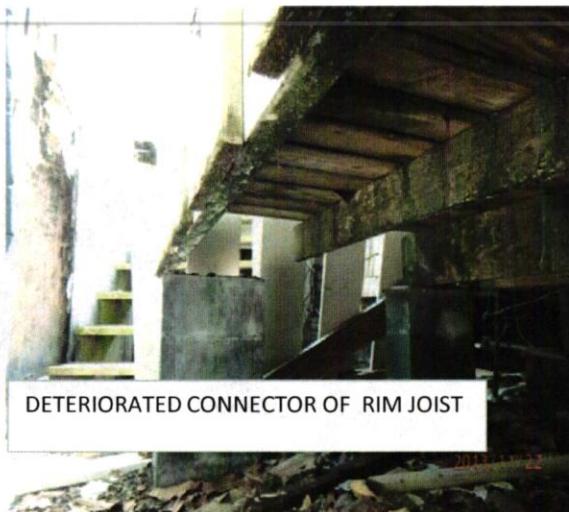
Deterioration	Strap connector rim board to columns
Elastic deformation	
Ultimate deformation	
Metal fatigue	
Detached, dislodged, or failing connections	Rim board to columns

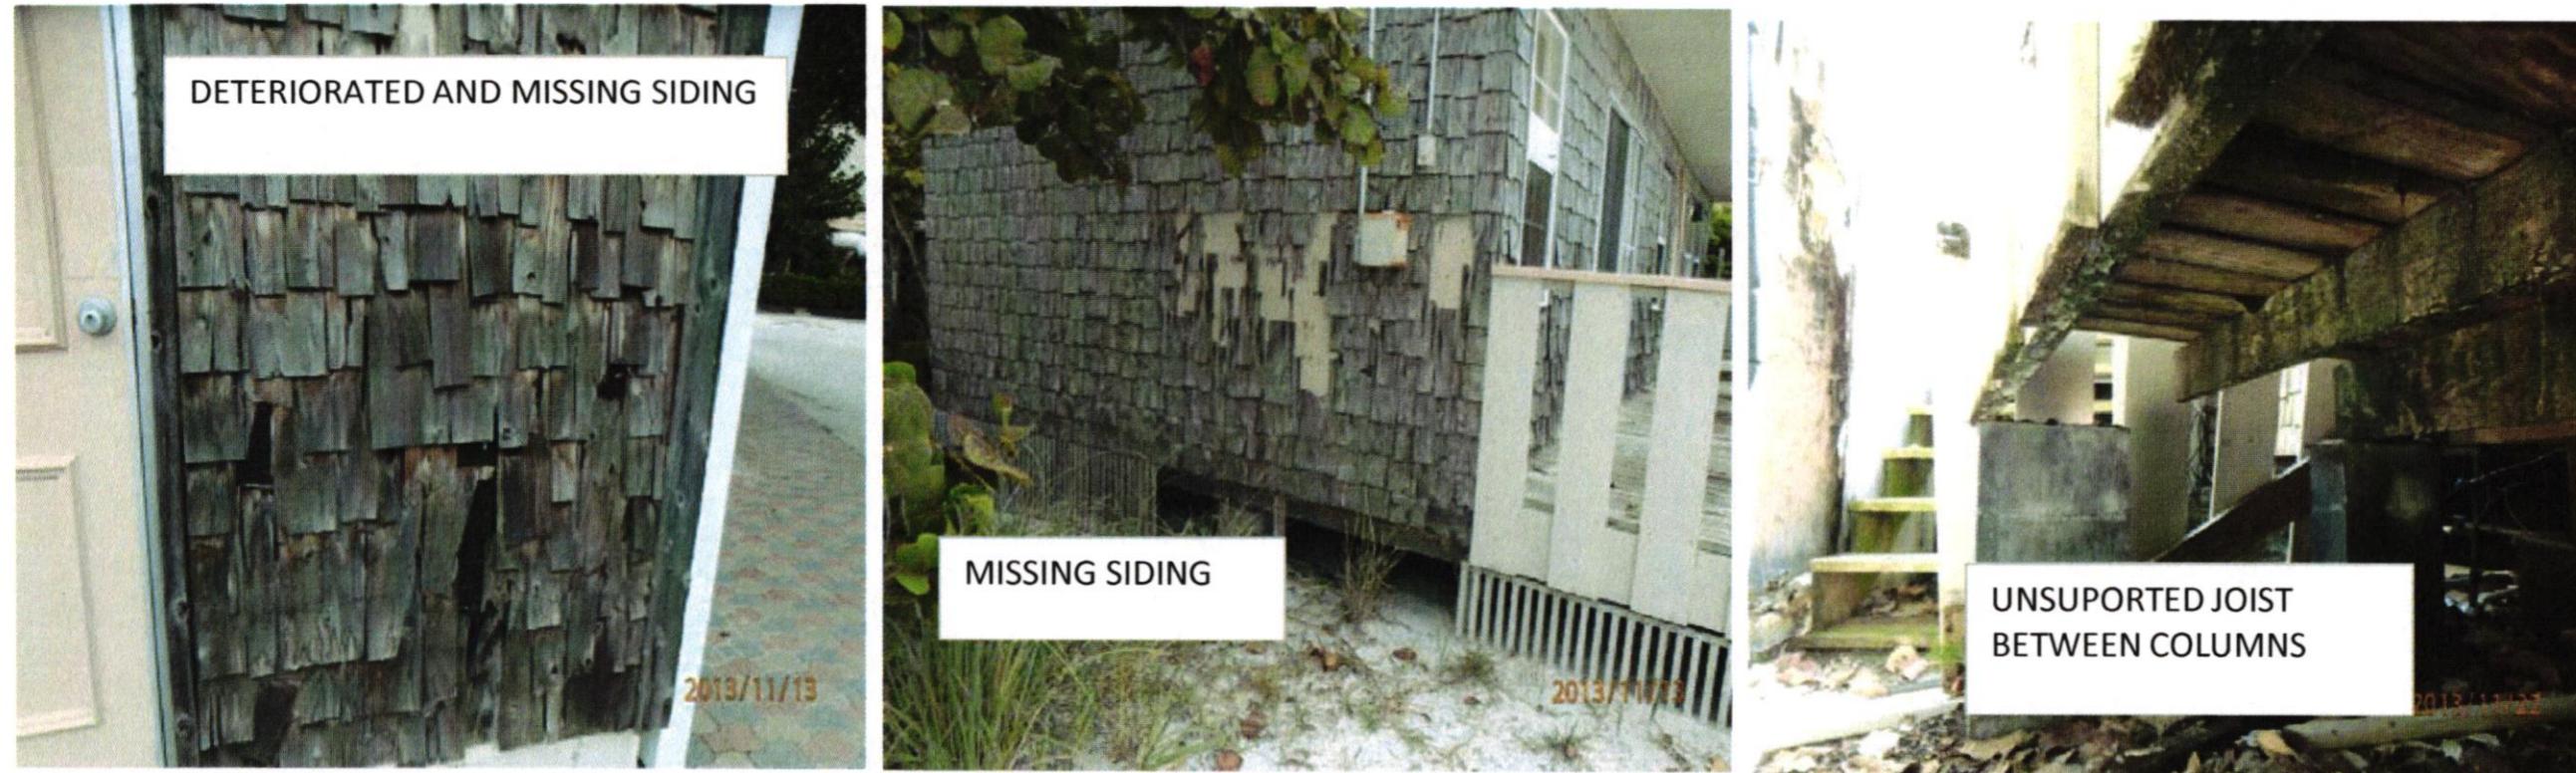
Siding falling from building, exposed sheathing behind. Doors and trims.

Rear deck not properly seated on
the columns. Rim board not
Lattice skirting, railings, joists.

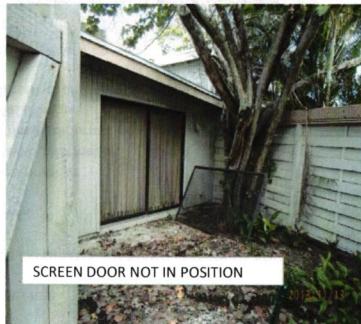
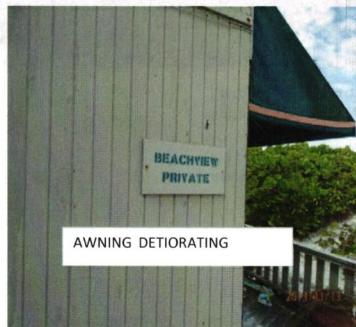
SCREEN DOOR NOT IN POSITION

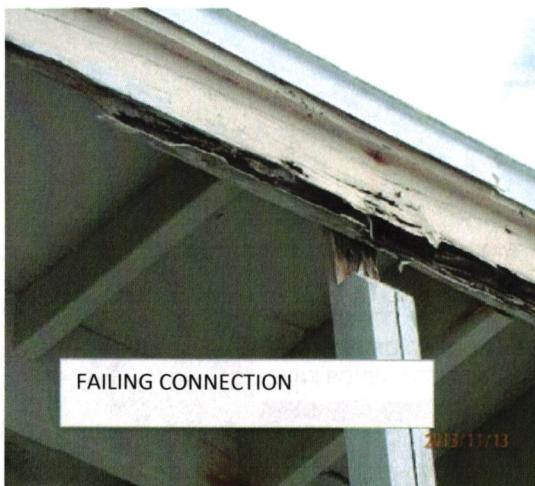
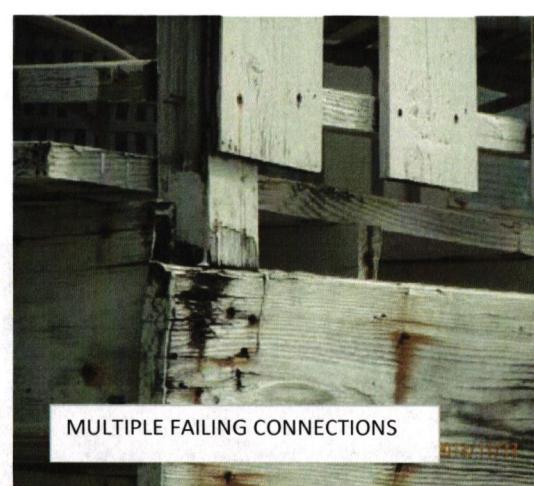
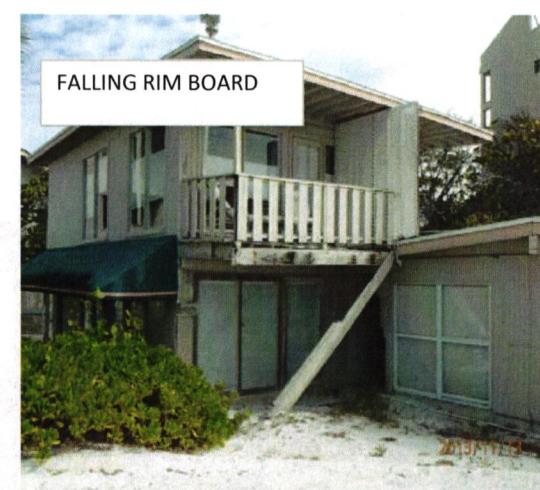
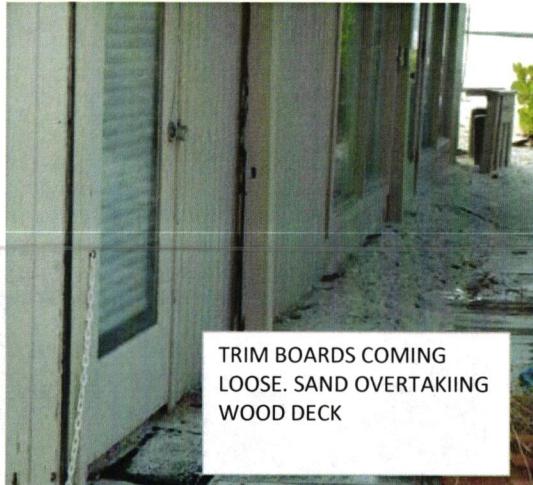
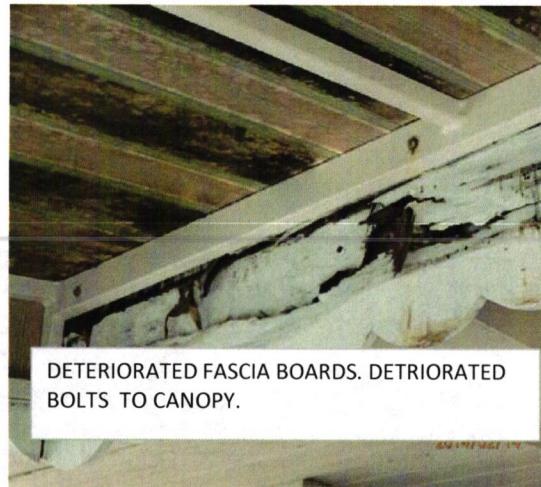
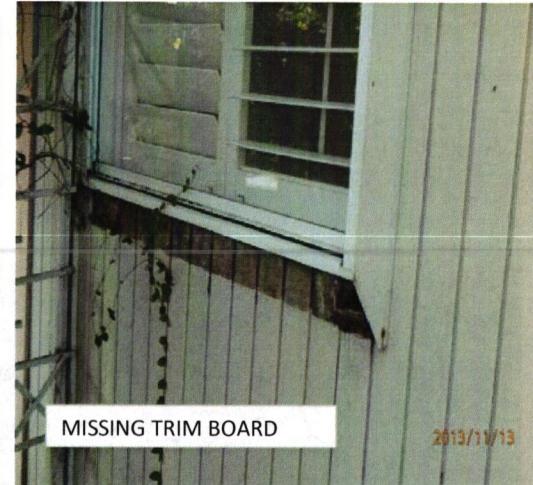
Sidings, trims, fascia boards, doors, windows, air conditioning stands, deck joists.

Signs of damage from termite at trims, holes in siding may be from birds and insects. Hole at vagabond a/c once had a dead animal .

Air conditioning stands. Cantilevered balcony to beachview units

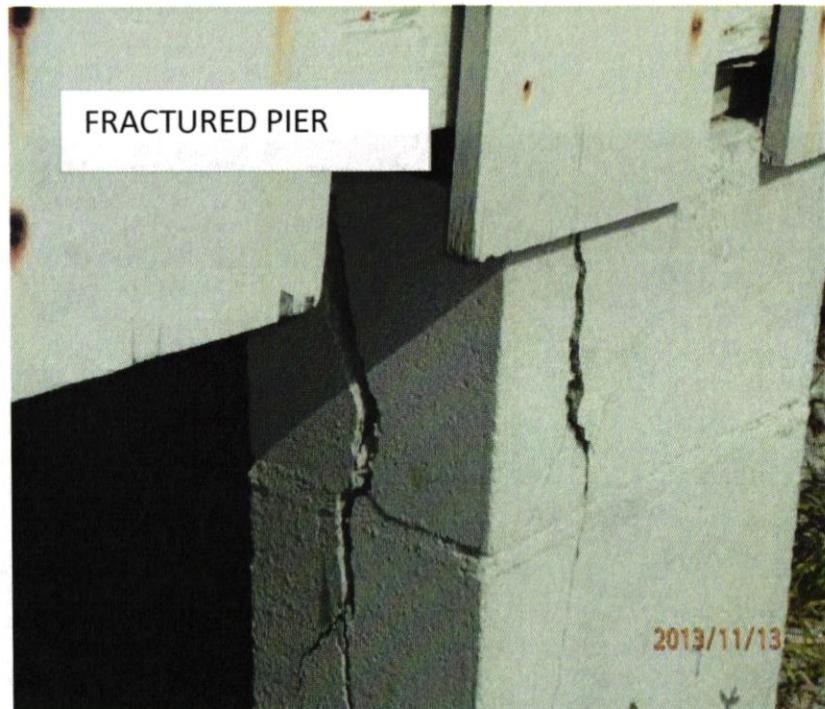
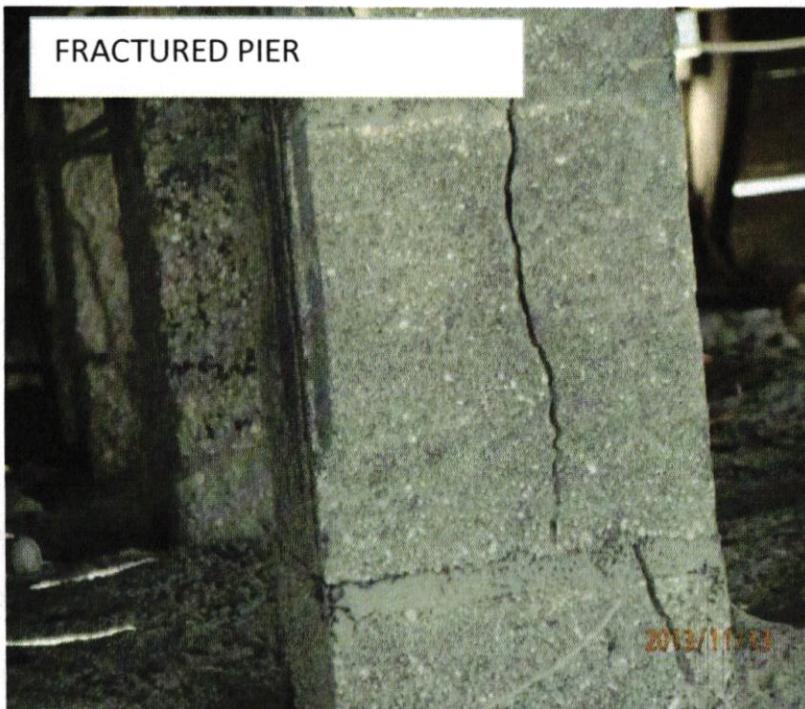
Column supports to deck

Column supports to building and deck.

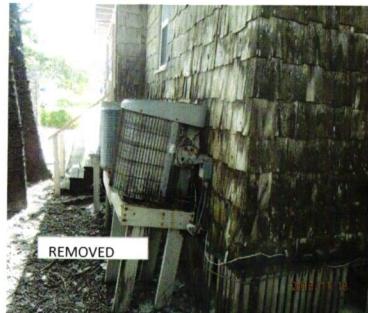
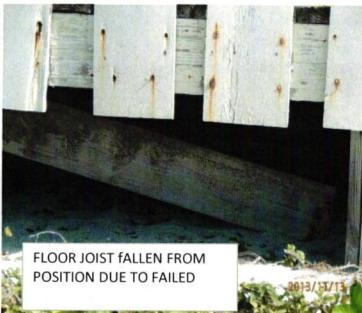
Deterioration
Elastic deformation
Ultimate deformation
Metal fatigue
Detached, dislodged, or Joist connectors

Air conditioning units. Air handler unit

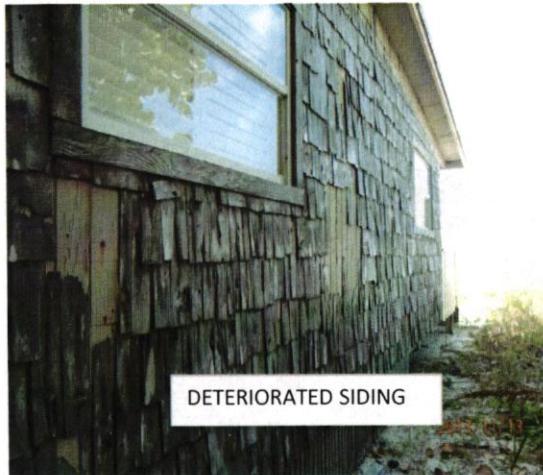
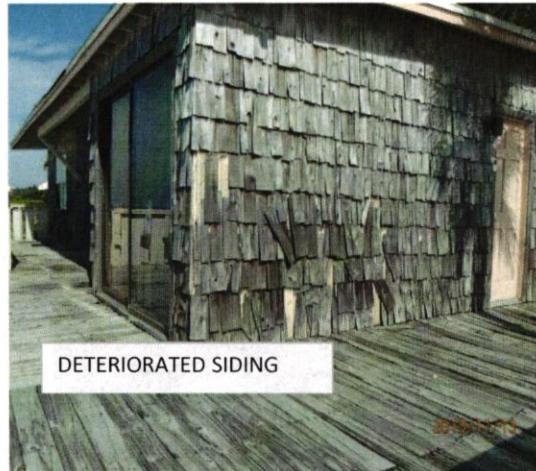
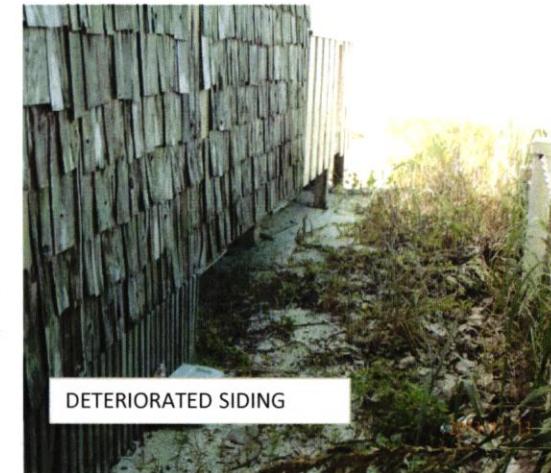
Deck waling surface, sidings, trims, doors, windows, fascia boards, railings.
Signs of insect damage to sheathing behind wood siding.

Fencing falling down, joists have fallen, railing pulling down. Air conditioning stands.

Joists, decking, siding, railings. Lattice skirting falling from structure

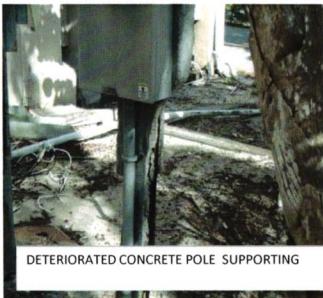
DETERIORATED CONCRETE POLE SUPPORTING

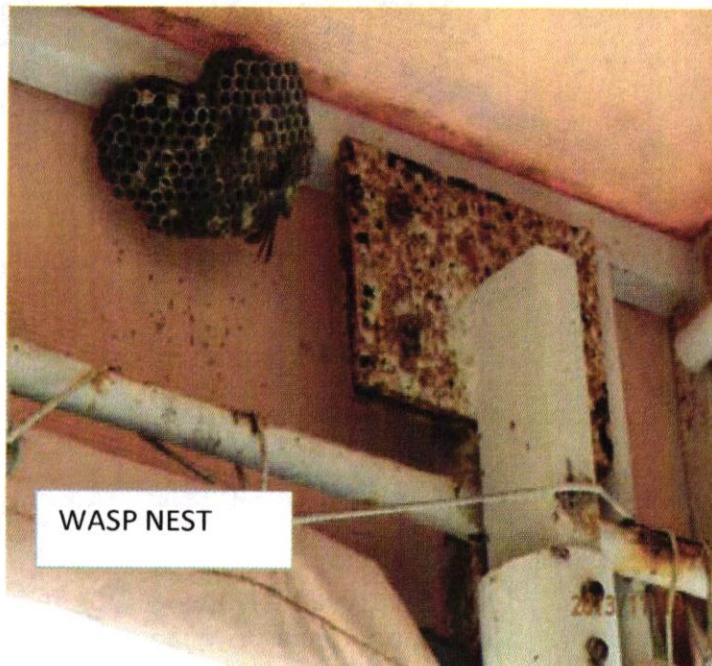
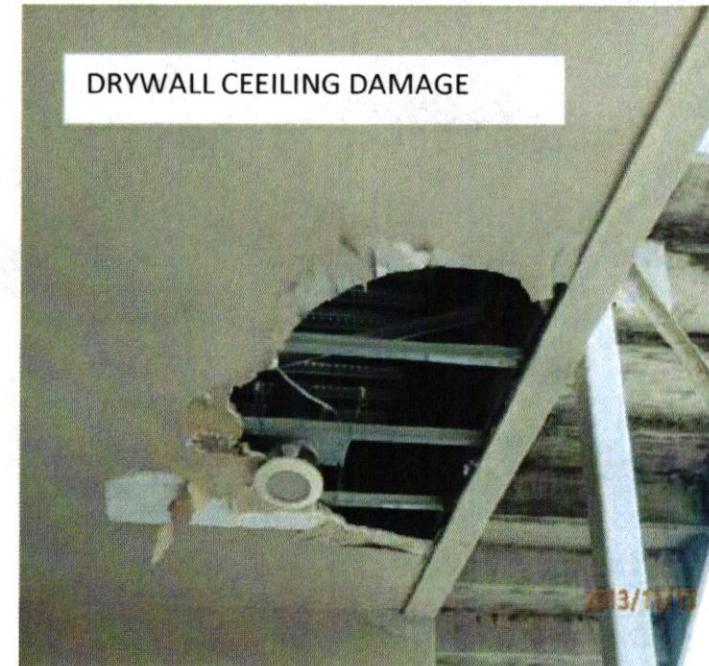
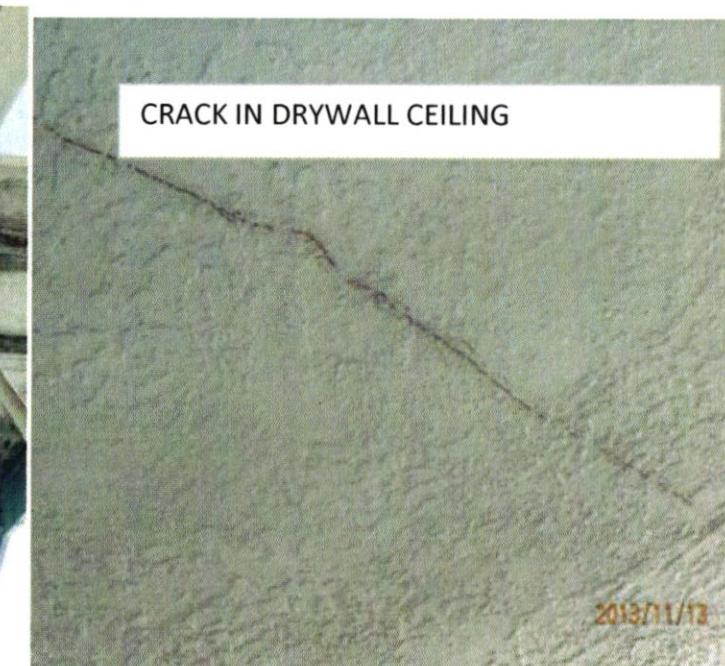
Building has been posted for failing joists and connection. Temporary shoring in place. No permanent work completed.

The interior of the building has extensive mold. No report indicating that it is a health hazard.

Drywall soffits and ceilings cracking, damaged and falling.

Found windows propped open. Closed days later.

Wasps nest found.

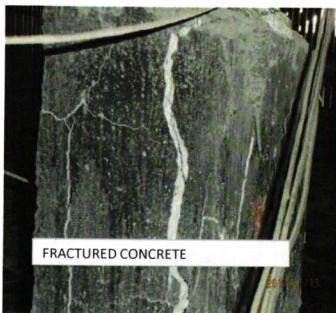
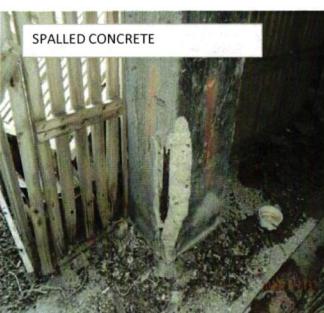
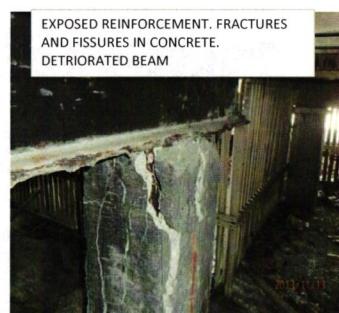
Extensive on approximately 75% of the piers

Extensive on approximately 40% of the piers

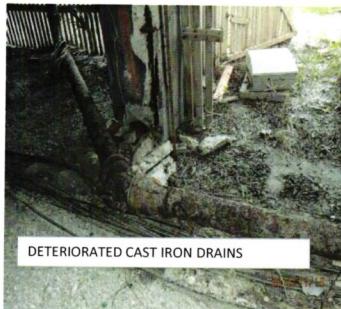
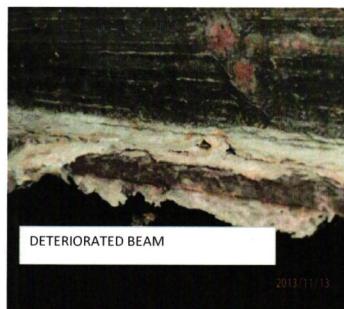
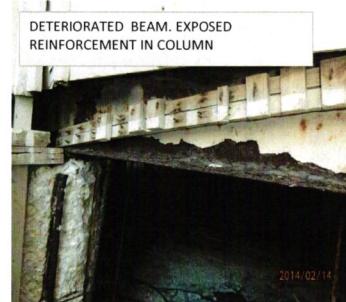
Deterioration	Bottom of I-beams. Some joist hangers and visible clips. Many A/C units are showing signs of failure.
Elastic deformation	
Ultimate deformation	
Metal fatigue	A/C units at the bottom
Detached, dislodged, or Beams to piers.
