ENGINEERING INSPECTION REPORT

THE COLONY BEACH and TENNIS RESORT

Longboat Key, Florida

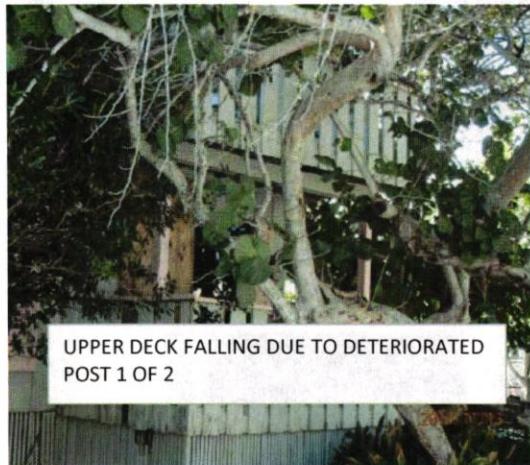
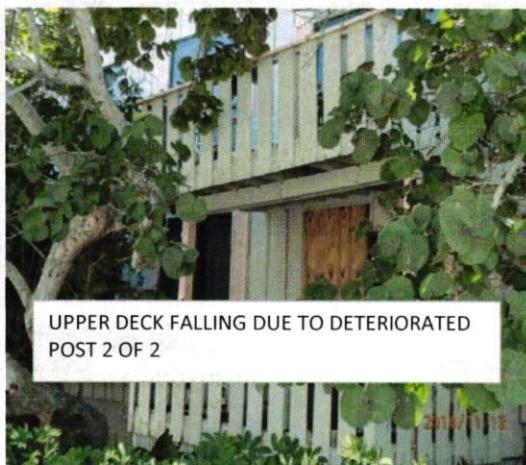
Signs of termite and other insect damage. Extensive on the siding. Currently has wasp nests, Extensive on holes from birds.

Upper deck of one unit has sunk approximately 4 inches due to rot. A/C unit stands
Siding, trims, floor framing, posts, wood shutters, fascia and soffits. The entry stairs and lower deck walkway show signs of failing to support. Railings pulling from walls. Railing missing balusters. Lattice skirting falling from position.

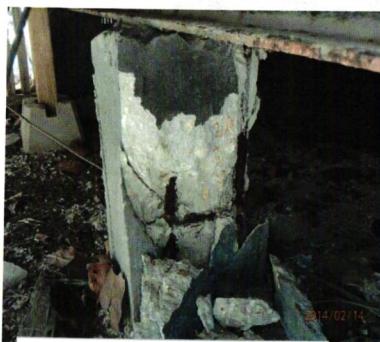
SPALLED CONCRETE WITH EXPOSED REINFORCEMENT

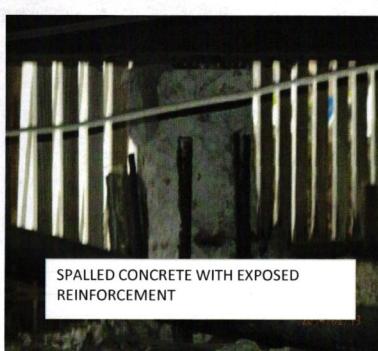
SPALLED CONCRETE WITH EXPOSED REINFORCEMENT

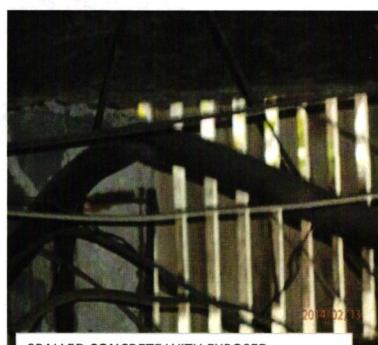
SPALLED CONCRETE WITH EXPOSED REINFORCEMENT

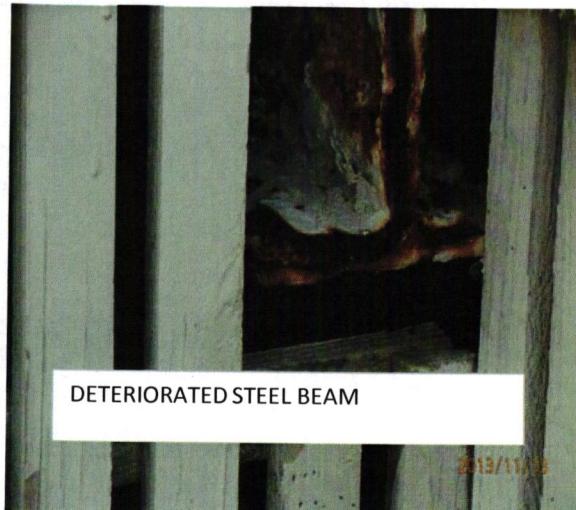
Bottom of I-beams. Some joist hangers and visible clips. Many A/C units are showing signs of failure.

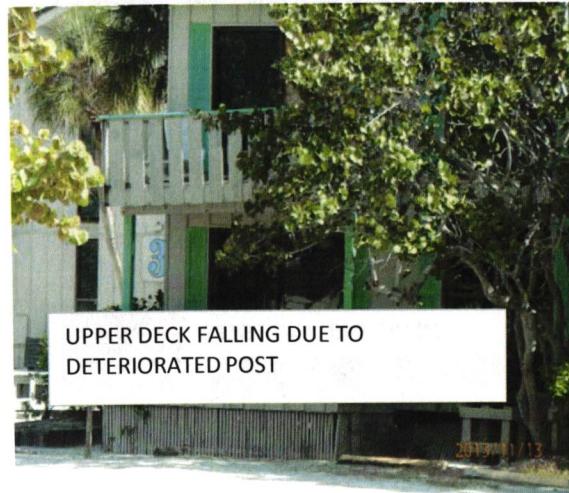
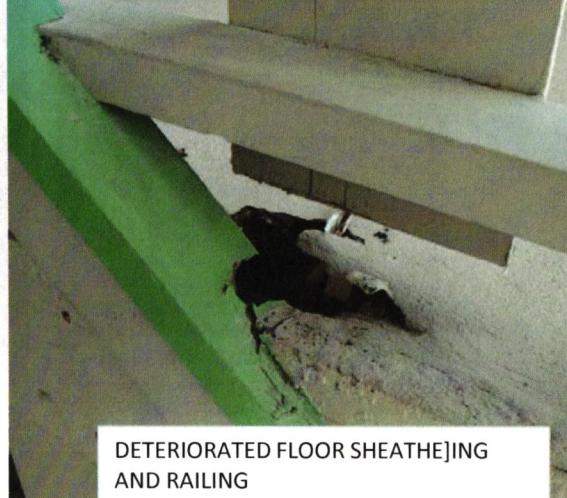
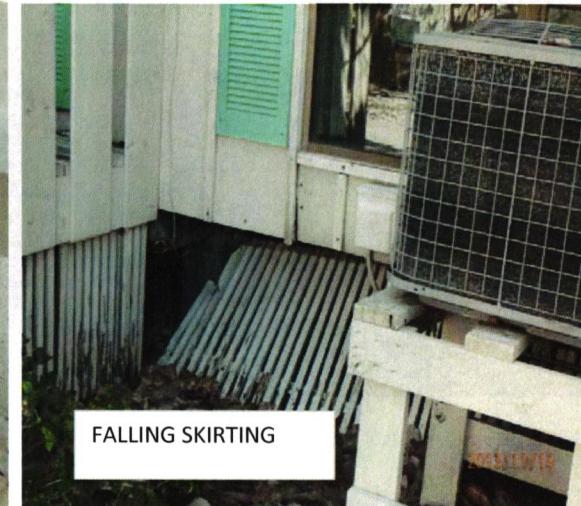
Villa 2

One upper level deck has rotted post and has dropped approximately 4 inches. A/C unit stands.

Siding, trims, floor framing, wood shutters, fascia and soffits. The entry stairs and lower walkway show signs of failing to support. Railings pulling from walls. Railing missing balusters.

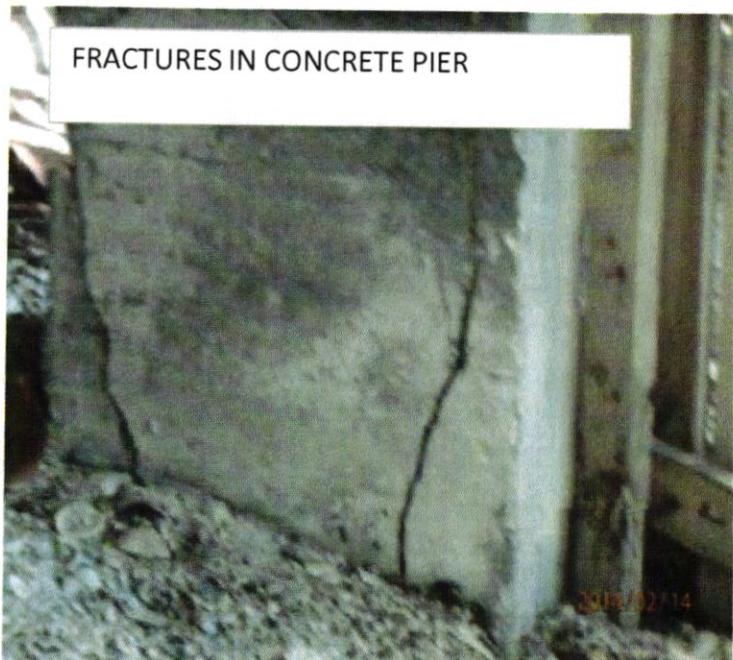
Approximately 25% of the piers

Extensive on approximately 20% of the piers

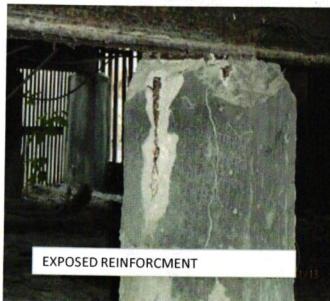
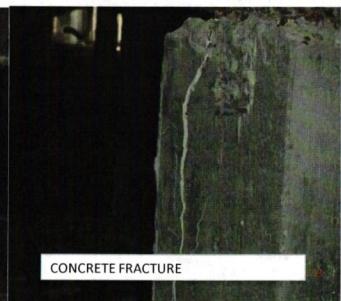
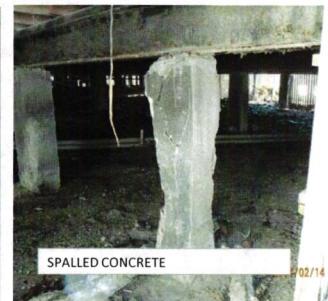
Approximately 35% of the piers, some extensive
75 % or more of the piers.
Approximately 35% of the piers
Extensive on approximately 20% of the piers

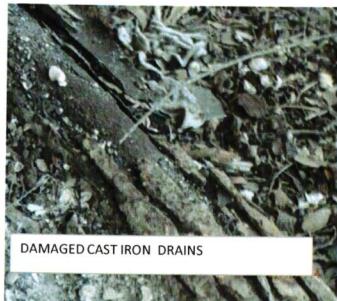
DAMAGED CAST IRON DRAINS

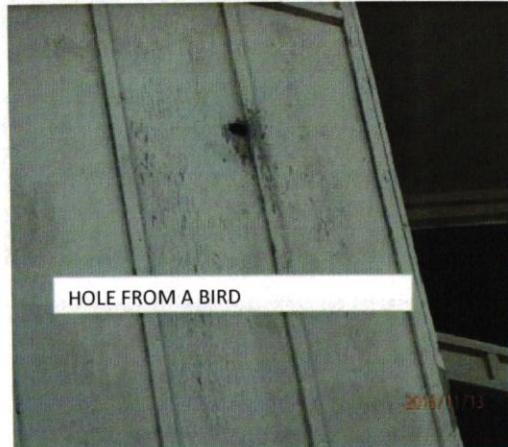
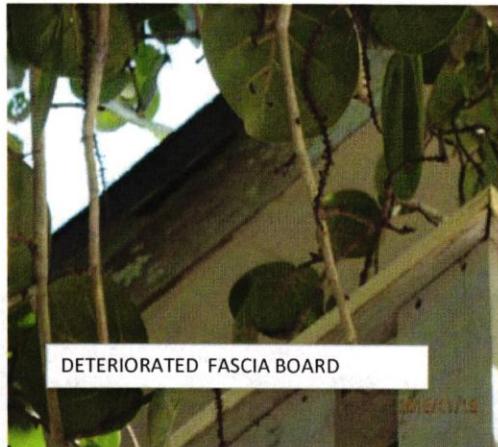
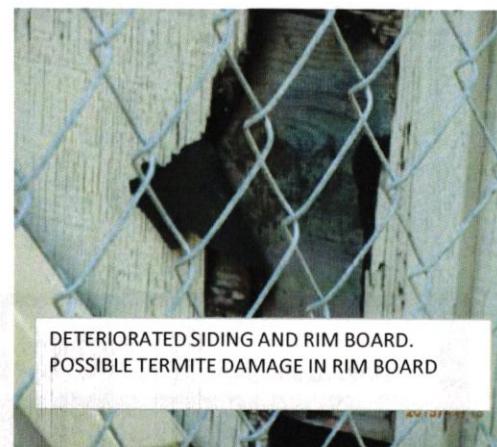
Column failing to support upper walkway deck and living roof above. A/C unit stands.

Siding, trims, floor framing, wood shutters, fascia and soffits. The entry stairs and lower walkway show signs of failing to support. Railings pulling from walls. Railing missing balusters.

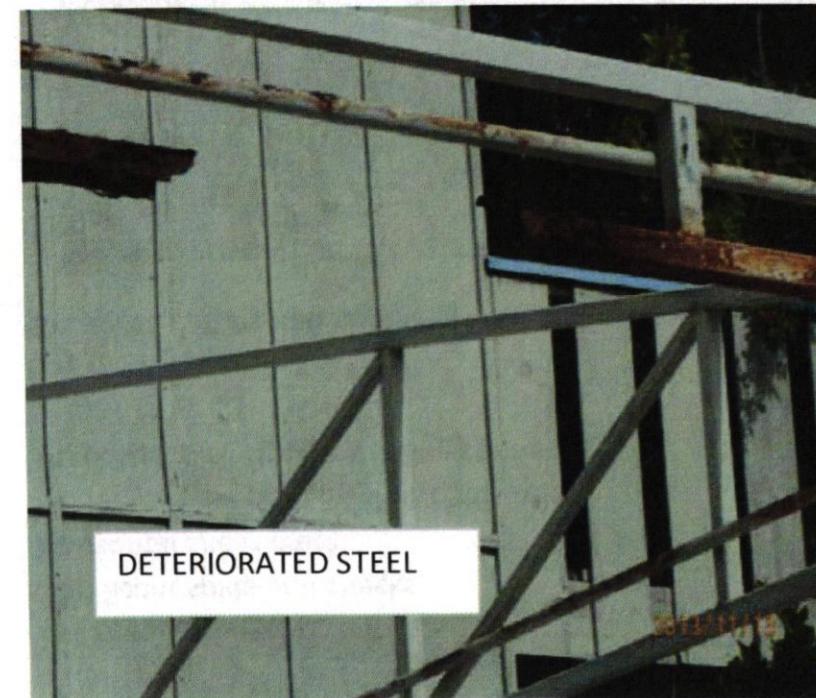
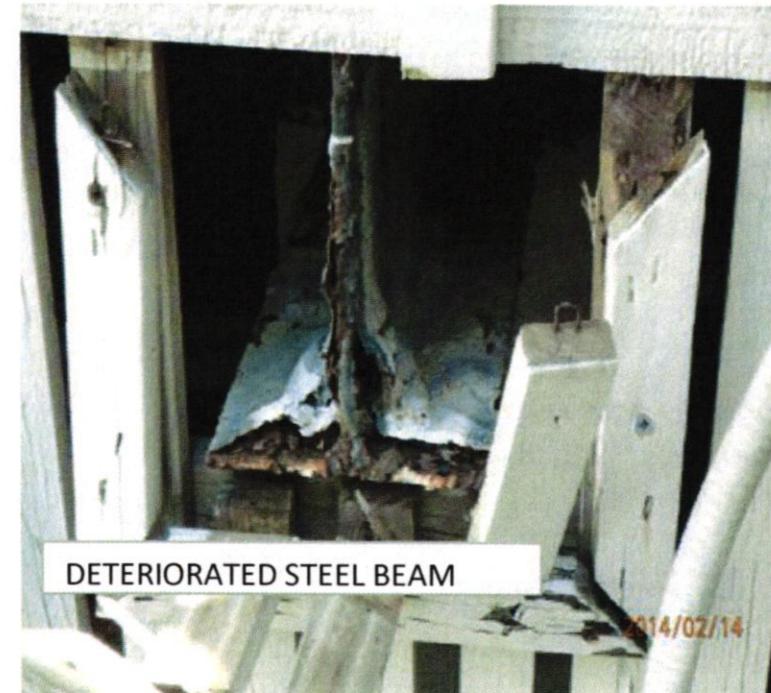
Bottom of I-beams. Some joist hangers and visible clips. Many A/C units are showing signs of failure. Fabric canopy.

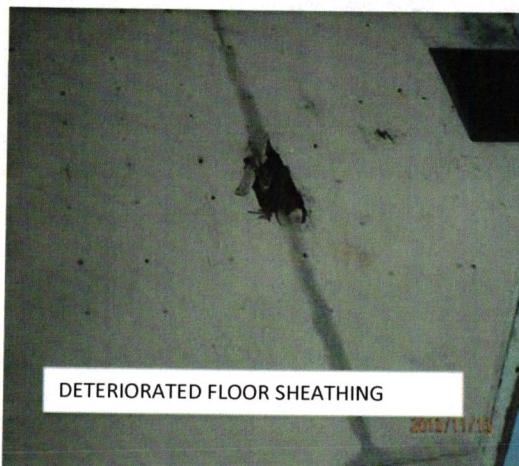
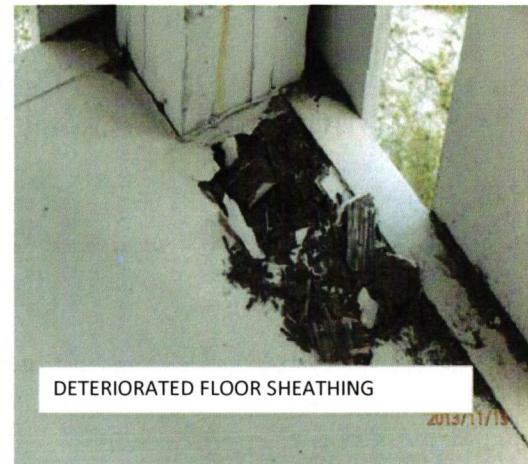
Signs of termite and other insect damage. Extensive on the siding. Holes in siding from birds.

Siding, trims, floor framing, wood shutters, fascia and soffits. The entry stairs and lower walkway show signs of failing to support. Railings pulling from walls. Railing missing balusters.

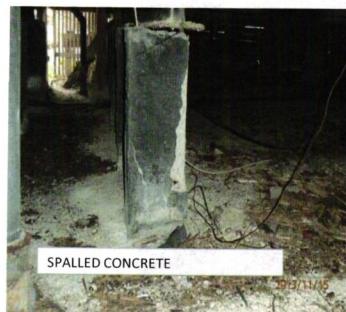
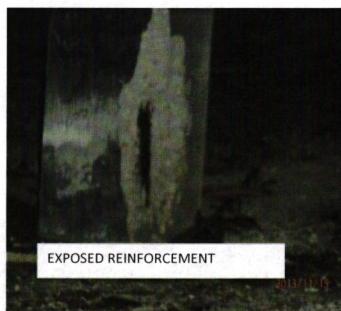
Approximately 20% of the piers

Extensive on approximately 20% of the piers

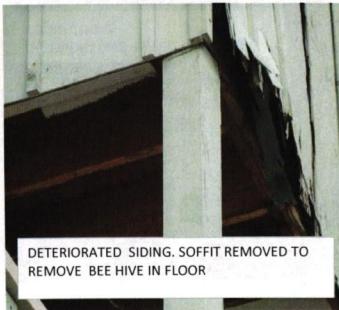
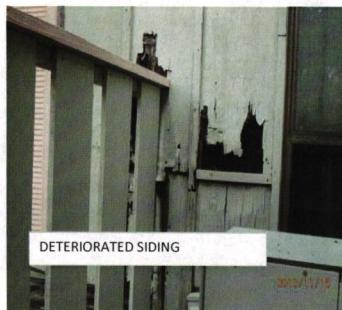
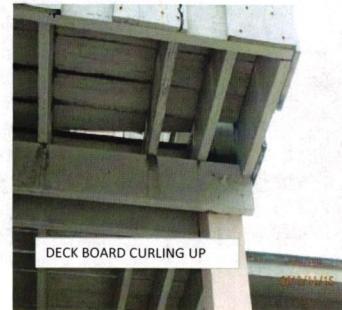
Siding, trims, floor framing, wood shutters, fascia and soffits. The entry stairs and lower walkway show signs of failing to support. Railings pulling from walls. Railing missing balusters.

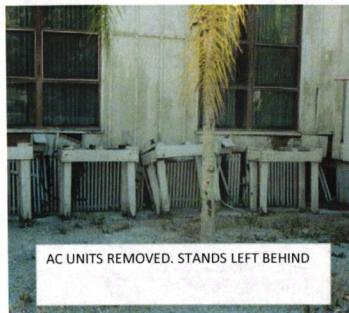
Cast iron building drains corroded and broken
Un-attended furniture/items on patios
Abandoned ac units under building.
Boarded up windows and doors due to vandalizing.
Security fencing does not provide for complete restricti
Air conditioning unit are beginning to fail. A/C unit may fall and have potential to have electrical issues as well as possible leaking for the refrigerant.
Removed soffit material due to having bee infestation.
Lattice skirting falling from position.

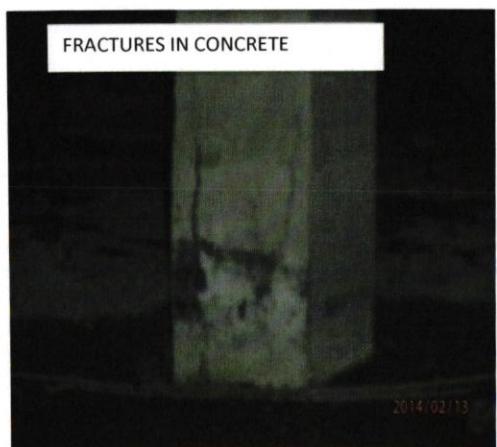
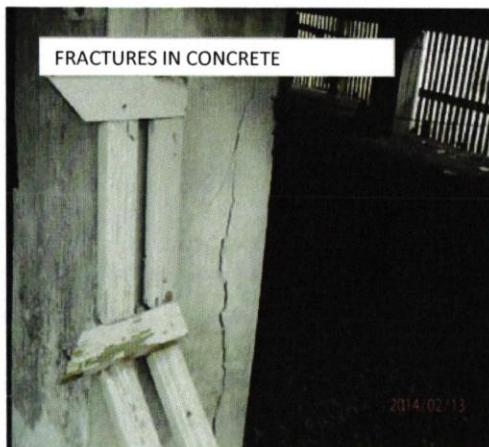
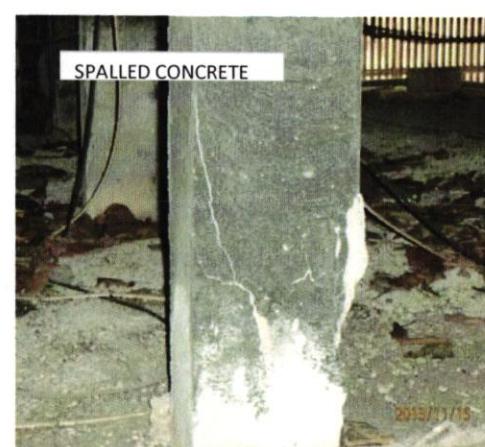
Approximately 20% of the piers

Extensive on approximately 20% of the piers

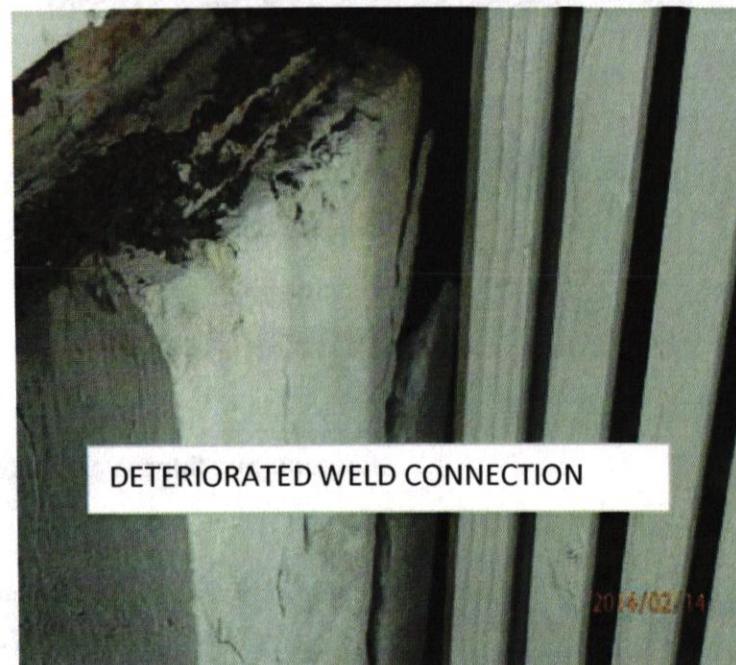
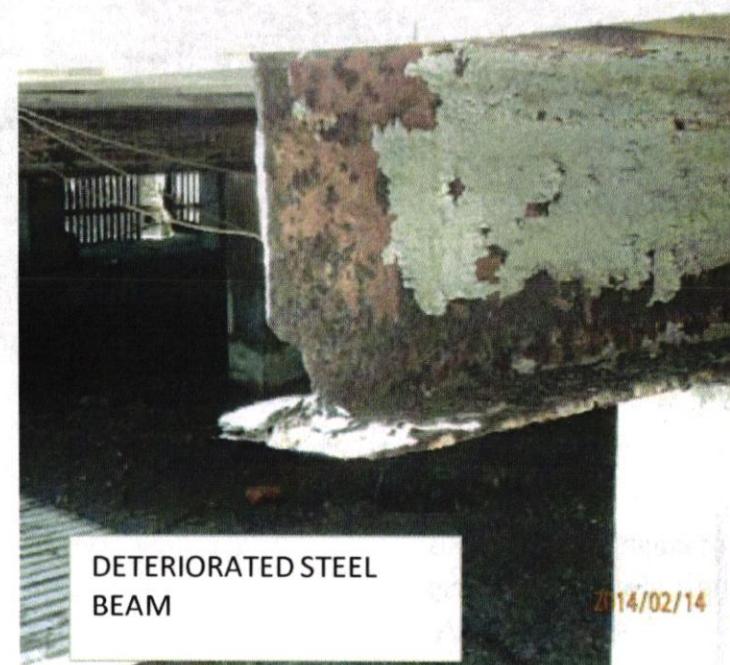
Bottom of I-beams. Some joist hangers and visible clips. Many A/C units are showing signs of failure.

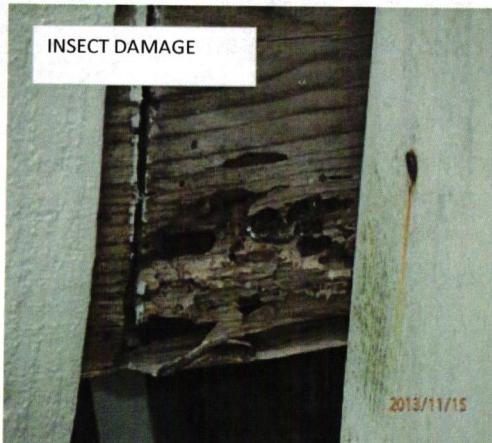
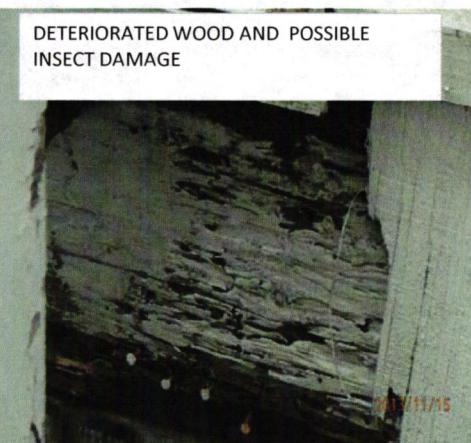
Siding, trims, floor framing, wood shutters, fascia and soffits. The entry stairs and lower walkway show signs of failing to support. Railings pulling from walls. Railing missing balusters.

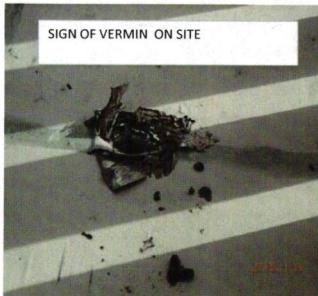
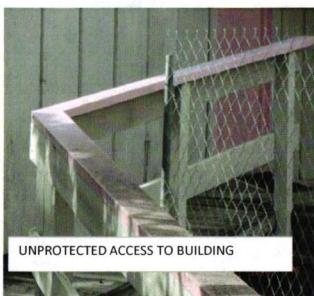
Cast iron building drains corroded and broken
Un-attended furniture/items on patios
Abandoned ac units under building.
Boarded up windows and doors due to vandalizing.
Security fencing does not restrict access to building.
Air conditioning unit are beginning to fail. A/C unit may fall and have potential to have electrical issues as well as possible leaking for the refrigerant.
Lattice skirting falling from position.

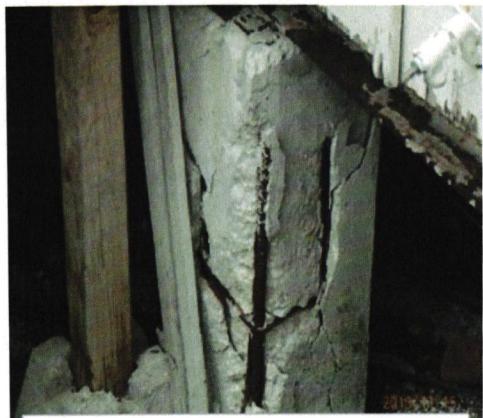
SPALLED CONCRETE WITH EXPOSED REINFORCEMENT .

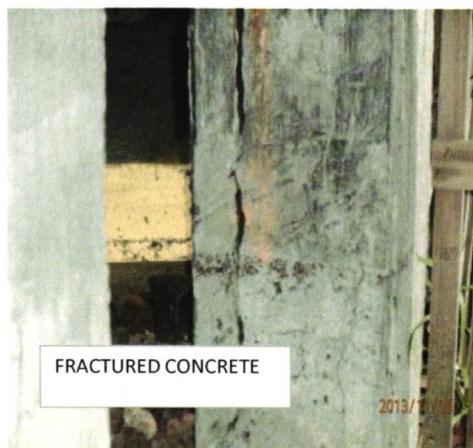
FRACTURED CONCRETE

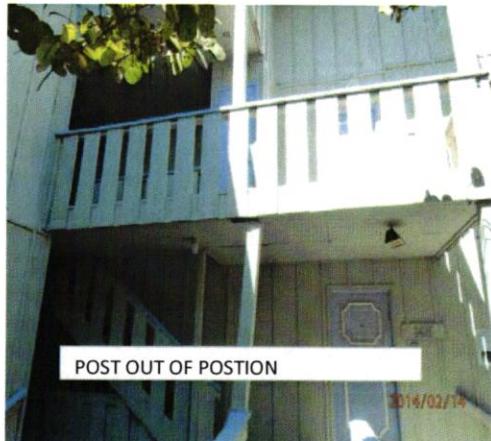
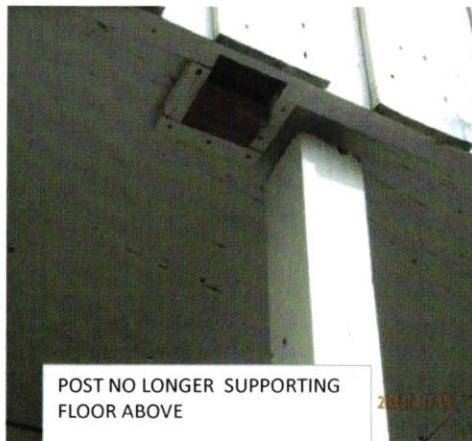
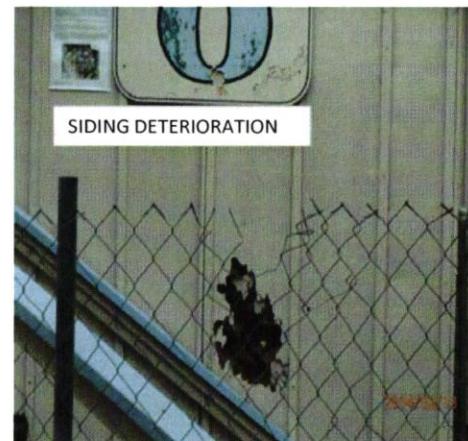
Siding, trims, floor framing, wood shutters, fascia and soffits. The entry stairs and lower walkway show signs of failing to support. Railings pulling from walls. Railing missing balusters.

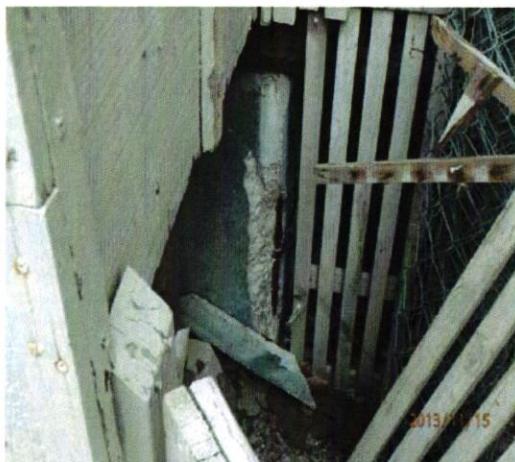
Villa 9

Approximately 40% of the piers

Extensive on approximately 40% of the piers

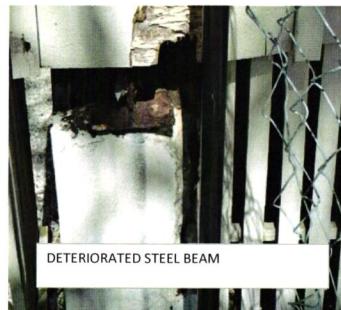
Bottom of I-beams. Some joist hangers and visible clips. Many A/C units are showing signs of failure.

A/C units at the bottom

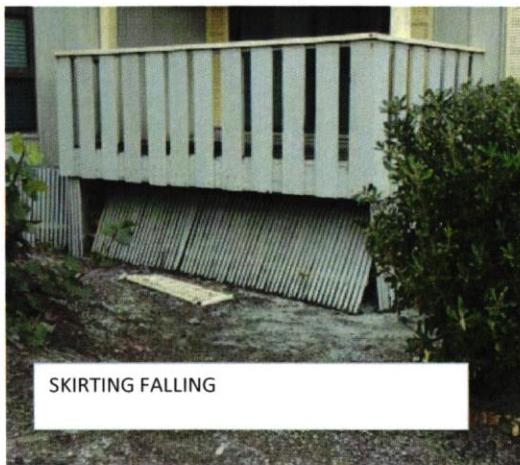
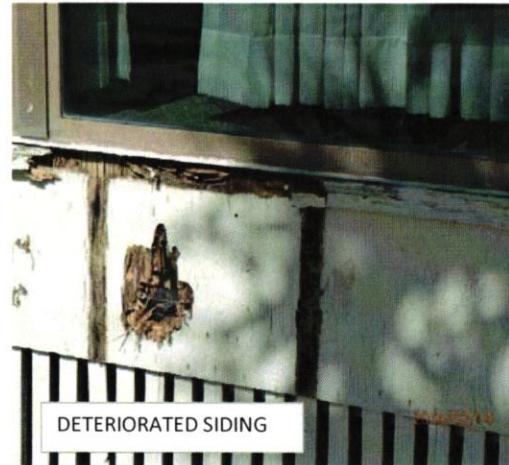
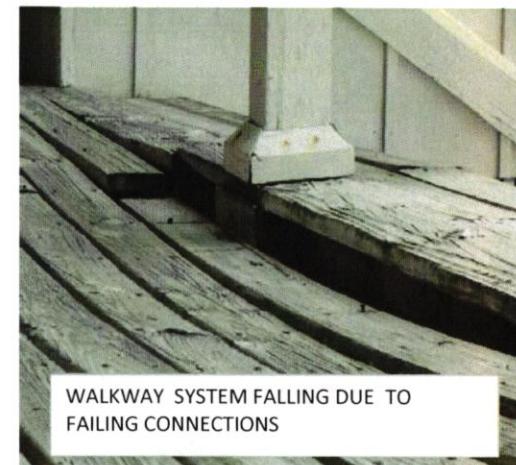
Signs of termite and other insect damage. Extensive on the siding. Holes in siding from birds.

Post not supporting walkway. This building has extensive failure of the lower deck walkway. A/C unit stands.

Siding, trims, floor framing, wood shutters, fascia and soffits. The entry stairs and lower walkway show signs of failing to support. Railings pulling from walls. Railing missing balusters.

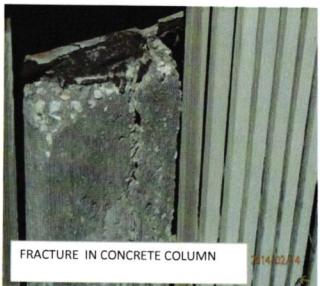
Villa 10
Building Official Report (Cont.)

Approximately 40% of the piers

Extensive on approximately 20% of the piers

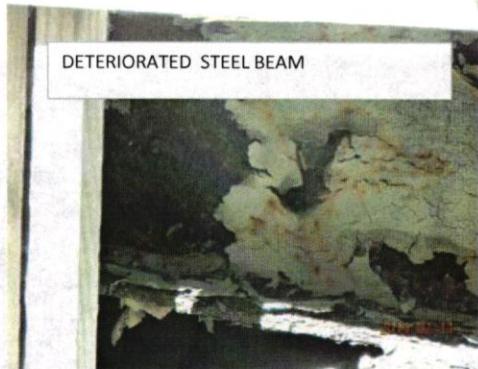
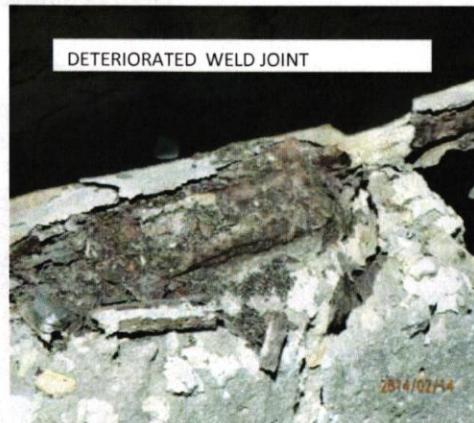
Bottom of I-beams. Some joist hangers and visible clips. Many A/C units are showing signs of failure.

A/C units at the bottom

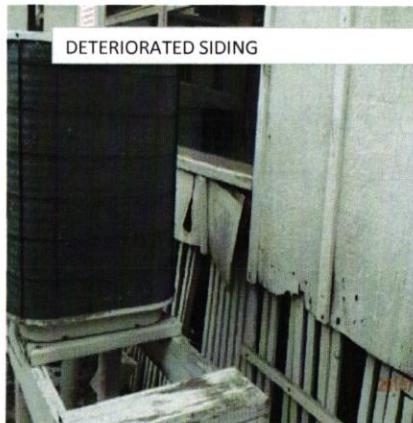
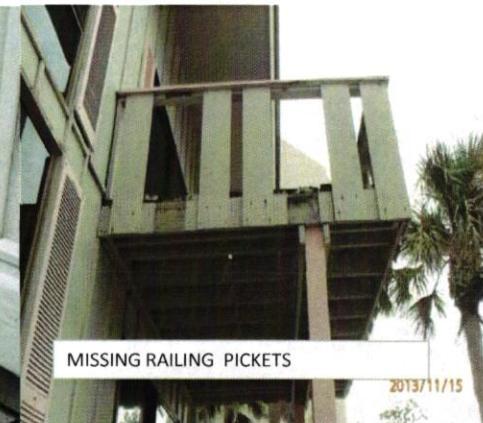
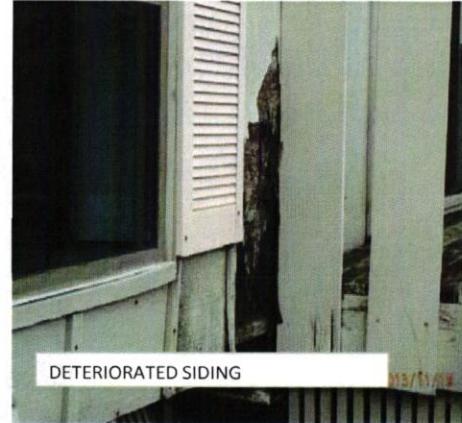
Signs of termite and other insect damage. Extensive on the siding. Holes in siding from birds.

Siding, trims, floor framing, wood shutters, fascia and soffits. The entry stairs and lower walkway show signs of failing to support. Railings pulling from walls. Railing missing balusters.

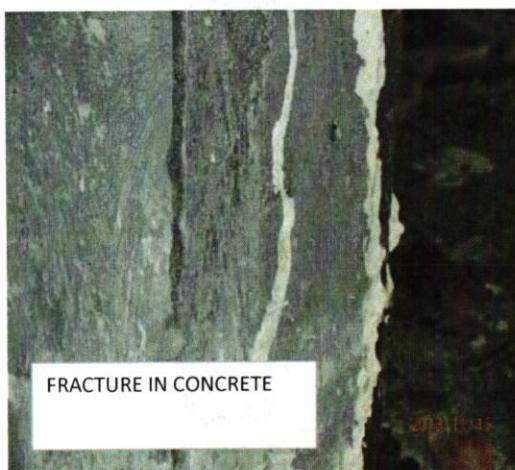
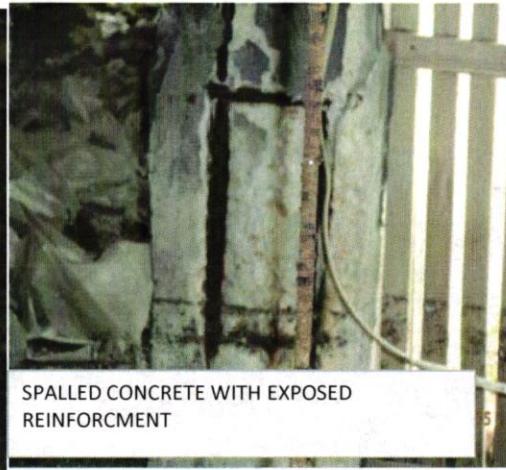
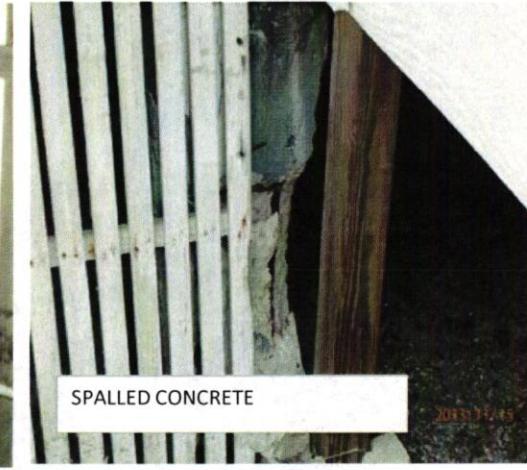
Approximately 35% of the piers, some extensive
60 % or more of the piers.
Approximately 20% of the piers
Extensive on approximately 20% of the piers

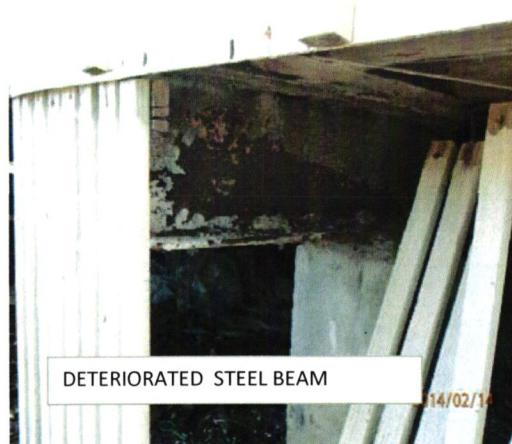
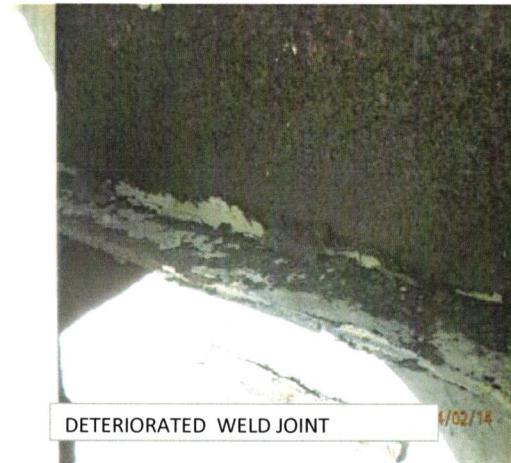
Bottom of I-beams. Some joist hangers and visible clips. Many A/C units are showing signs of failure.

A/C units at the bottom

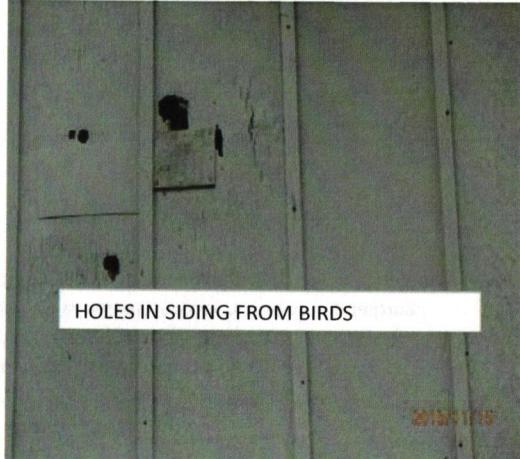
HOLES IN SIDING FROM BIRDS

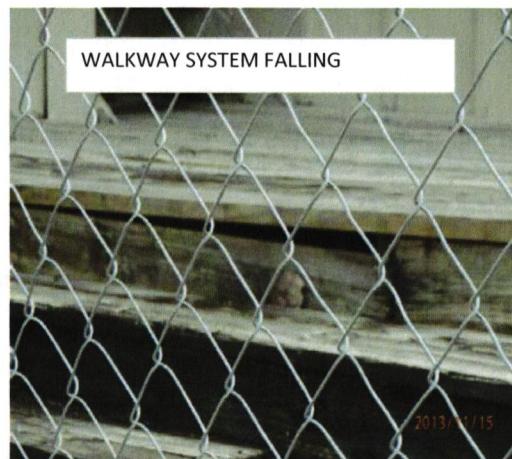
WALKWAY SYSTEM FAILING
2013/11/15

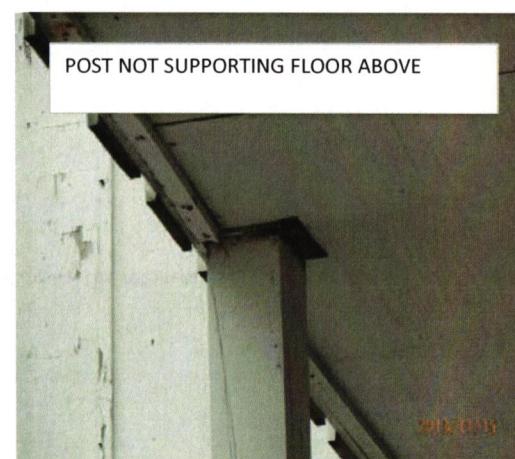
POST NOT SUPPORTING FLOOR ABOVE
2013/11/15

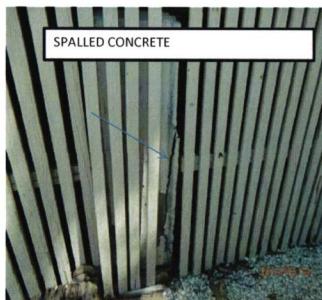
Approximately 40% of the piers

Extensive on approximately 40% of the piers

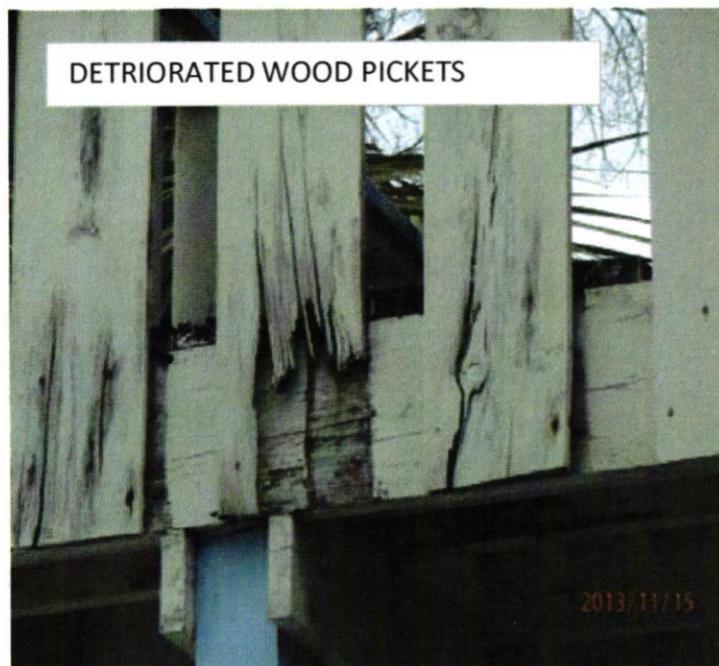
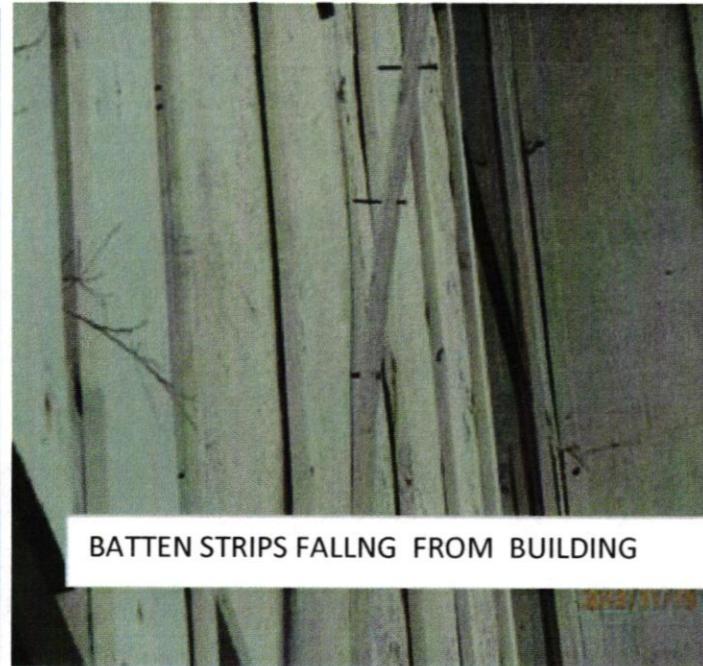
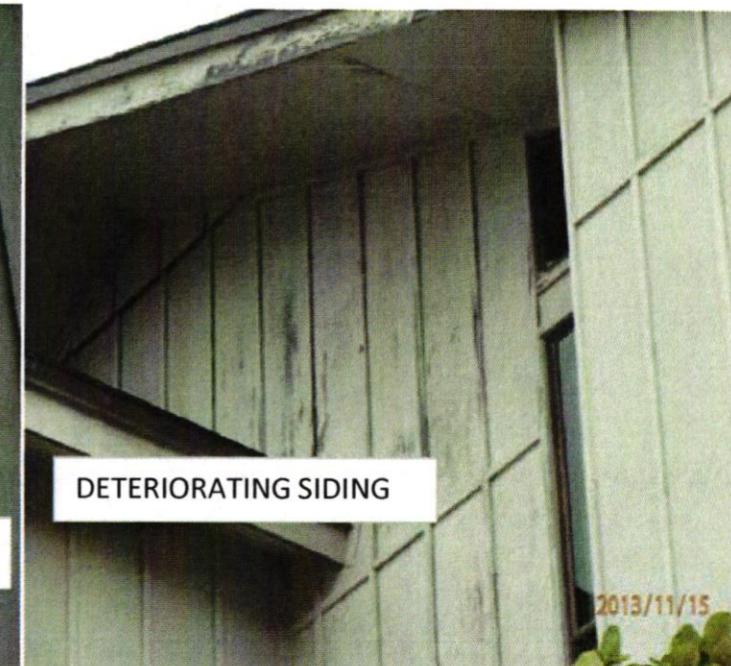
Signs of termite and other insect damage. Extensive on the siding. Holes in siding from birds.

Siding, trims, floor framing, wood shutters, fascia and soffits. The entry stairs and lower walkway show signs of failing to support. Railings pulling from walls. Railing missing balusters.

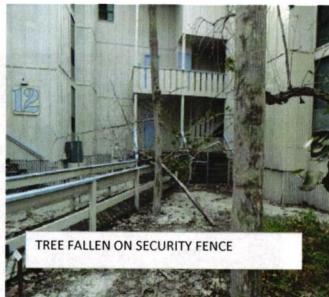
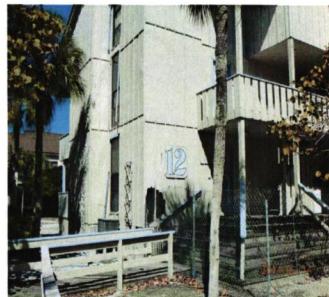
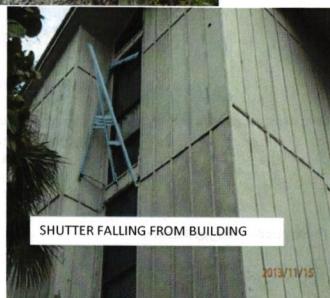
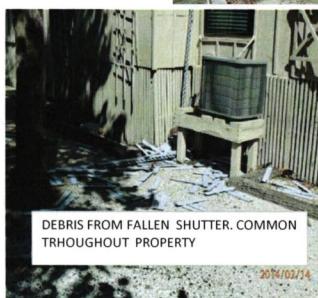
Cast iron building drains corroded and broken

Air conditioning unit are beginning to fail. A/C unit may fall and have potential to have electrical issues as well as possible leaking for the refrigerant.

Security light hanging by wires

Tree branch has fallen onto security fence.

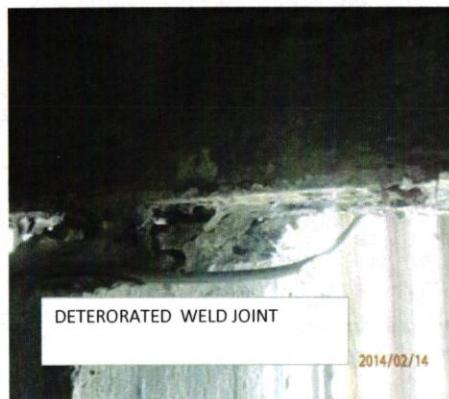
Bottom of I-beams. Some joist hangers and visible clips. Many A/C units are showing signs of failure.

A/C units at the bottom

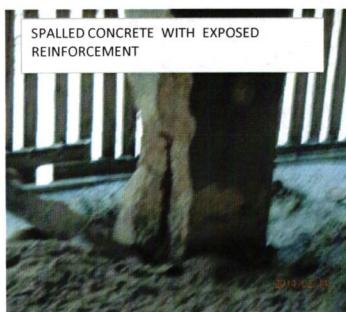
Approximately 15% of the piers

Extensive on approximately 10% of the piers

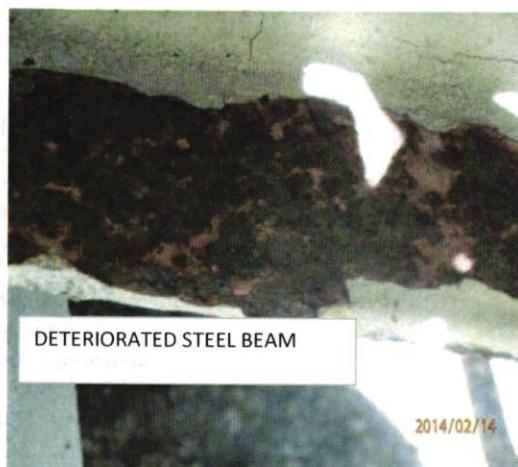
Bottom of I-beams. Some joist hangers and visible clips. Many A/C units are showing signs of failure.

A/C units at the bottom

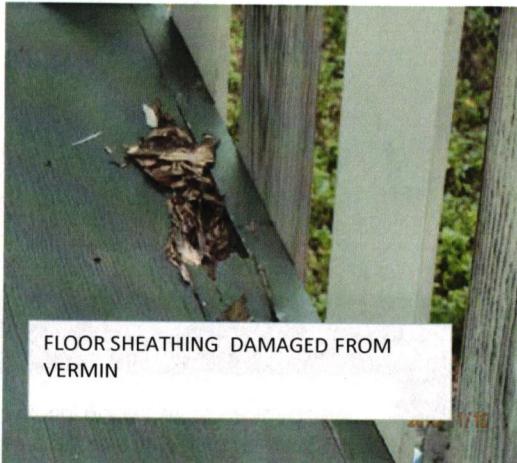
FLOOR SHEATHING DAMAGED FROM VERMIN

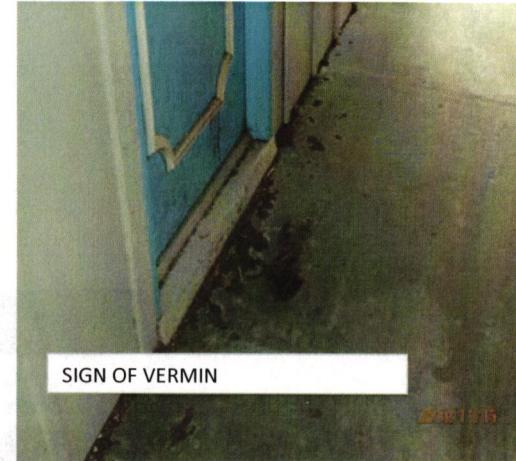
SIGN OF VERMIN

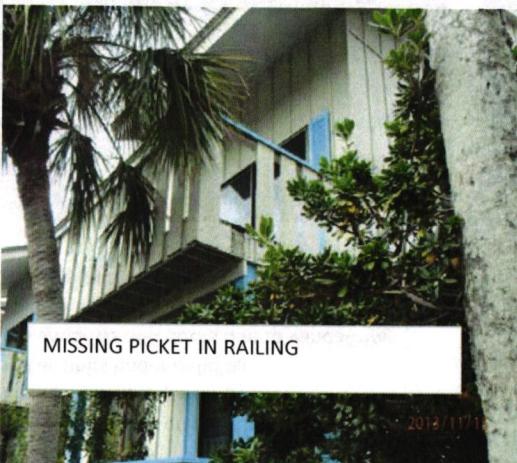
MISSING PICKET IN RAILING

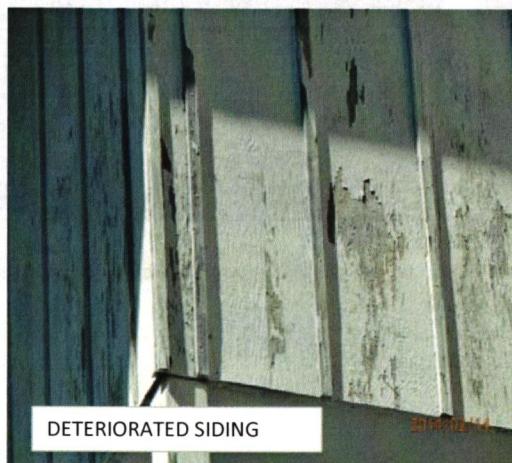
DETERIORATED SIDING

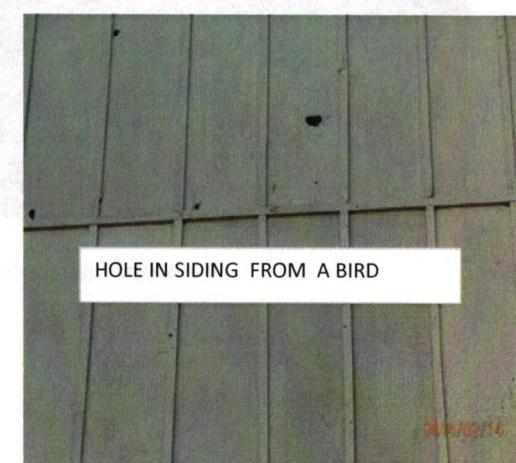
HOLE IN SIDING FROM A BIRD

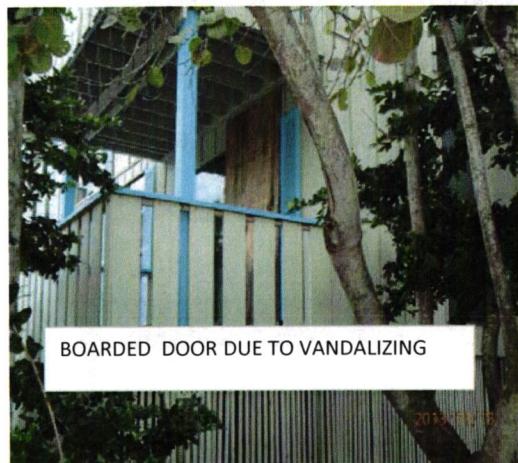
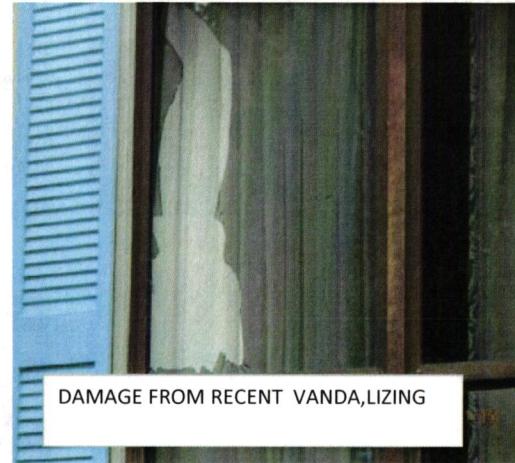
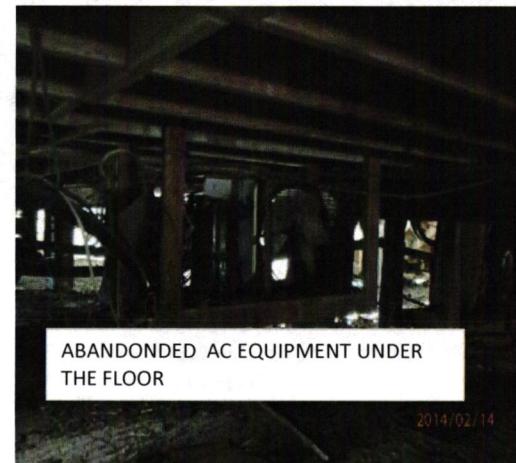
Cast iron building drains corroded and broken

Broken window from recent vandalizing.

Air conditioning unit are beginning to fail. A/C unit may fall and have potential to have electrical issues as well as possible leaking for the refrigerant.

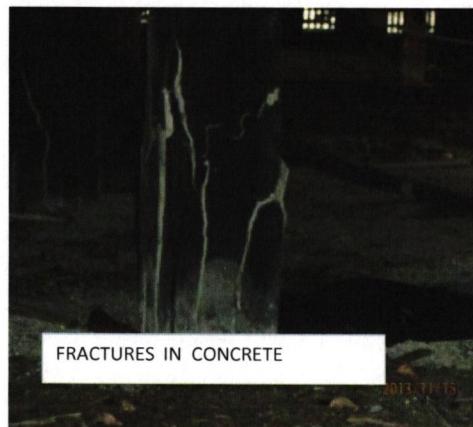
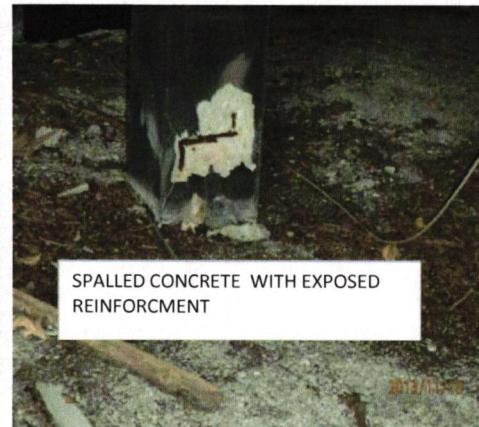
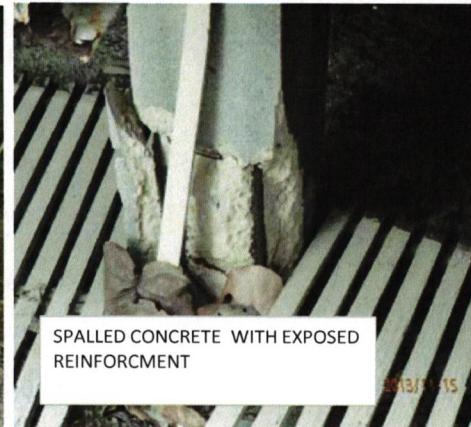
Deterioration
Ultimate deformation
Fractures
Fissures
Spalling
Exposed reinforcement
Detached, dislodged, or failing connections

Approximately 30% of the piers, some extensive
50 % or more of the piers.
Approximately 15% of the piers
Extensive on approximately 15% of the piers

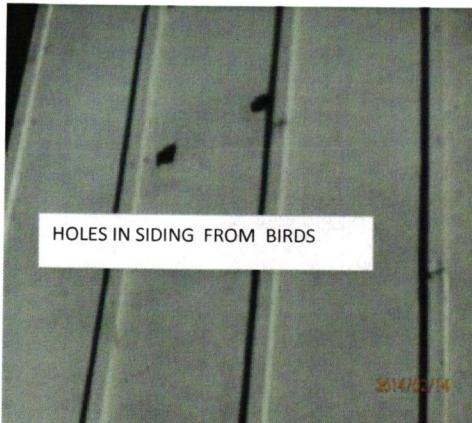
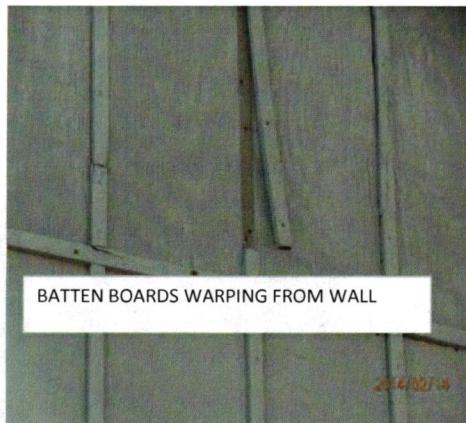
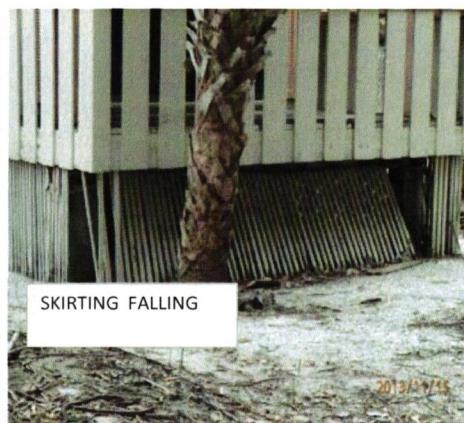
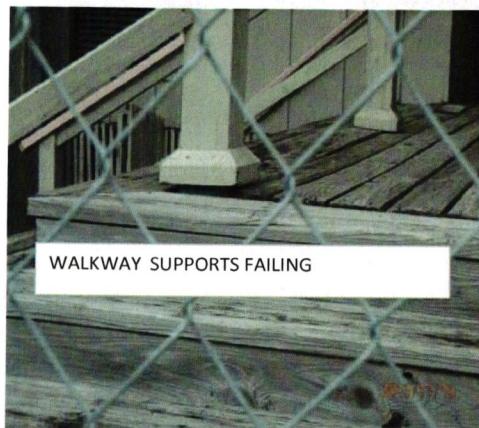
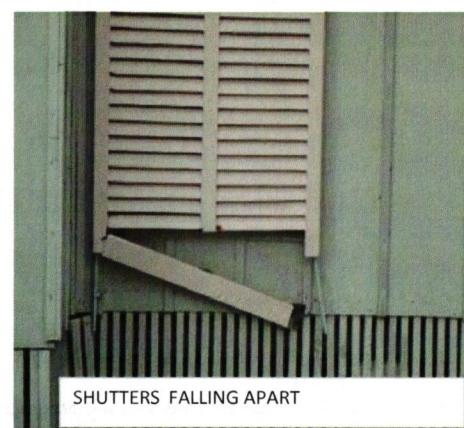
Siding, trims, floor framing, wood shutters, fascia and soffits. The entry stairs and lower walkway show signs of failing to support. Railings pulling from walls. Railing missing balusters.

Excessive cutting and notching

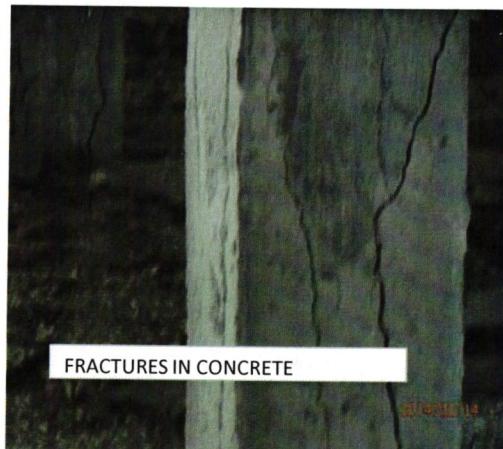
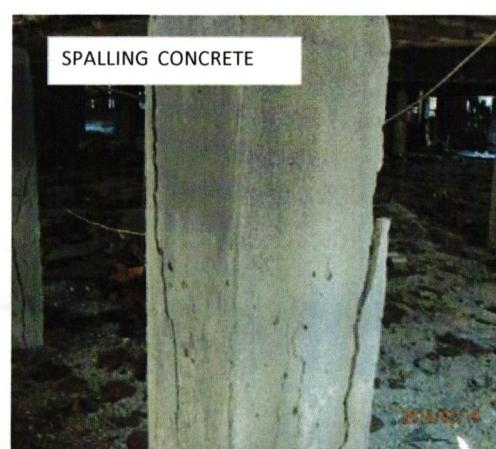
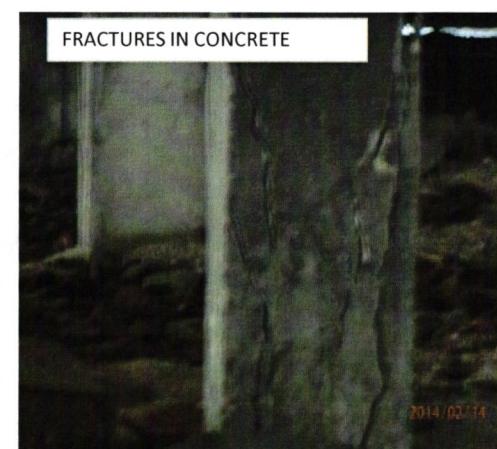
This building appears seaward of the coastal construction control line. Code limitation associated to working on the foundation.

Approximately 15% of the piers

Extensive on approximately 10% of the piers

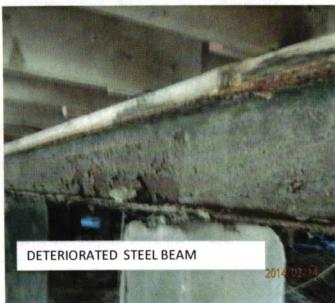
Bottom of I-beams. Some joist hangers and visible clips. Many A/C units are showing signs of failure.

A/C units at the bottom

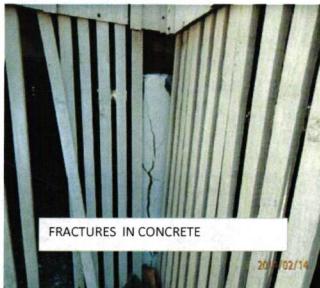
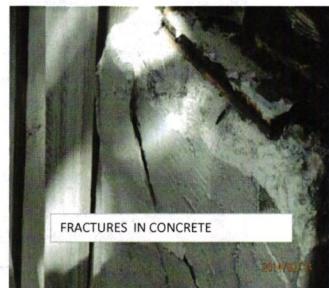
This building is seaward of the coastal construction control line. Code limitation associated to working on the foundation.

Approximately 20% of the piers

Extensive on approximately 10% of the piers

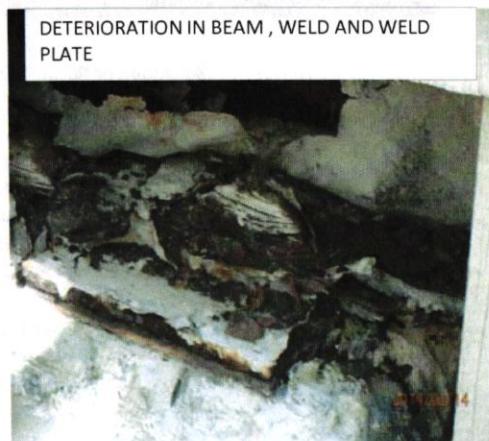
Bottom of I-beams. Some joist hangers and visible clips. Many A/C units are showing signs of failure.

A/C units at the bottom
