ENGINEERING INSPECTION REPORT

THE COLONY BEACH and TENNIS RESORT

Longboat Key, Florida

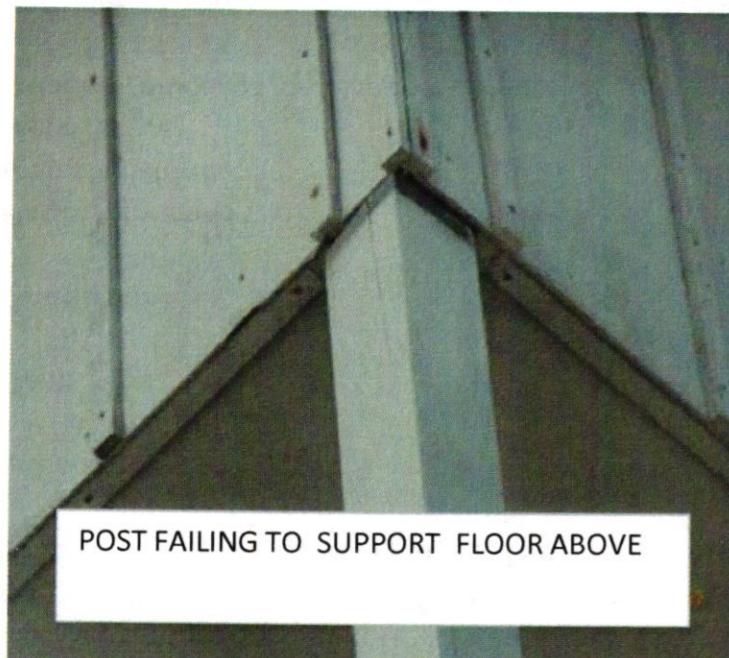
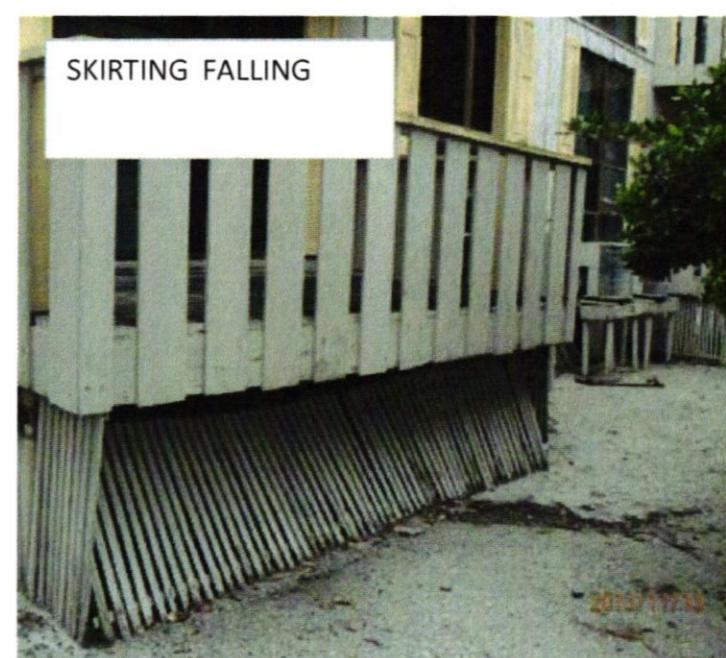
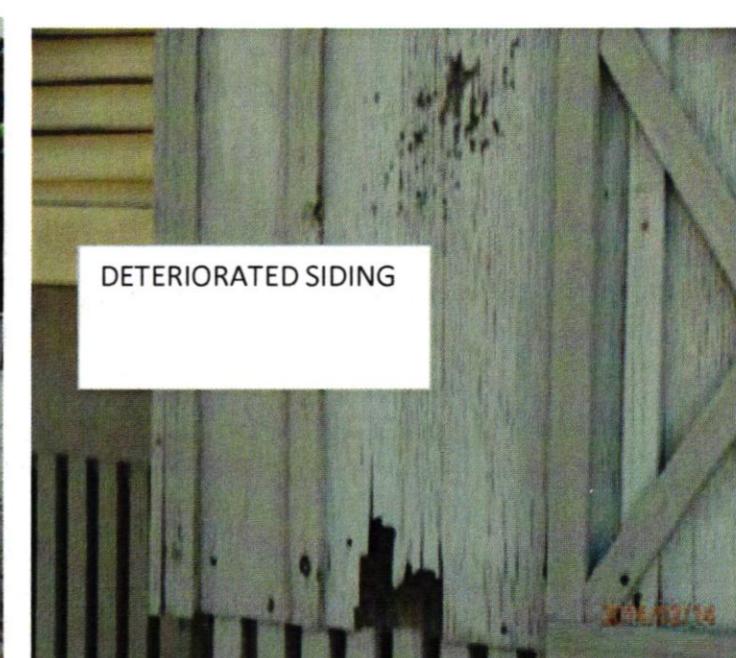
Siding, trims, floor framing, wood shutters, fascia and soffits. The entry stairs and lower walkway show signs of failing to support. Railings pulling from walls. Railing missing balusters.

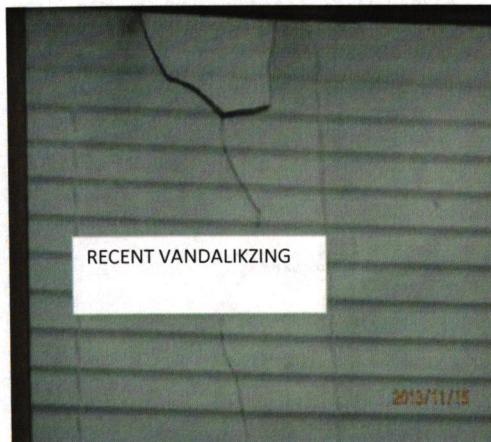
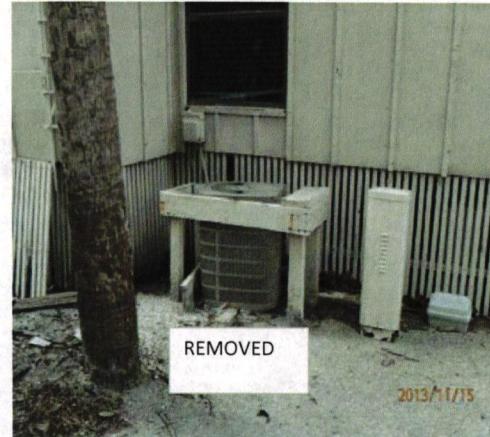
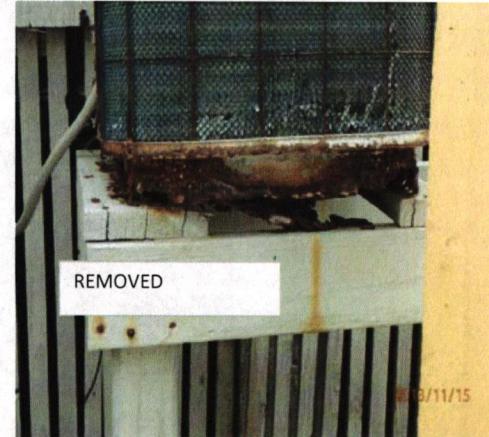
Cast iron building drains corroded and broken

Boarded up windows and doors due to vandalizing. Broken window due to recent vandalizing.

Air conditioning unit are beginning to fail. A/C unit may fall and have potential to have electrical issues as well as possible leaking for the refrigerant. One unit has dropped to the ground.

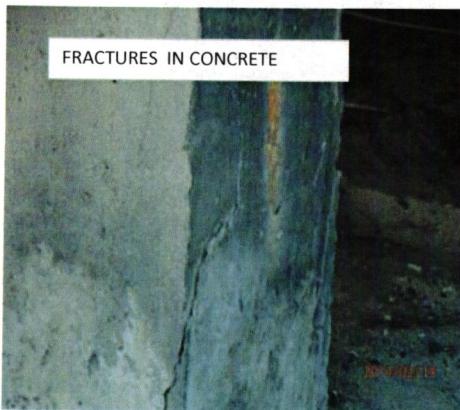
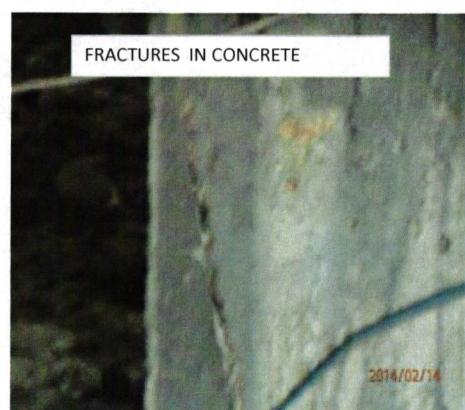
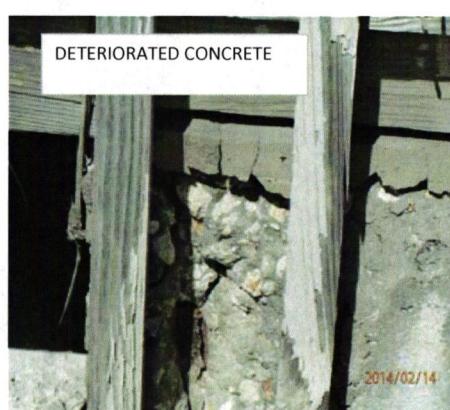
Deterioration
Ultimate deformation
Fractures
Fissures
Spalling
Exposed reinforcement
Detached, dislodged, or failing connections

Approximately 50% of the piers, some extensive
75 % or more of the piers.
Approximately 40% of the piers
Extensive on approximately 40% of the piers

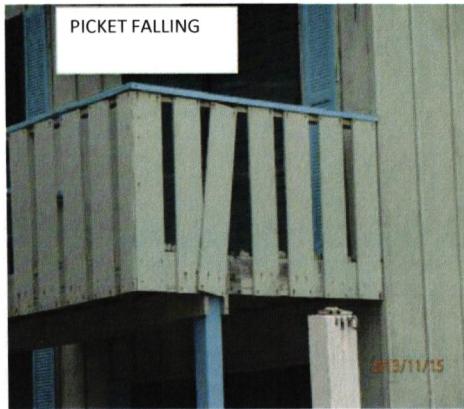
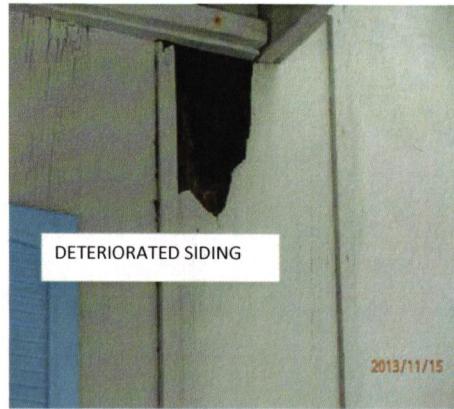
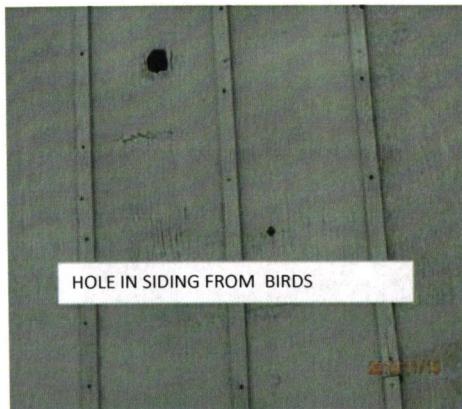
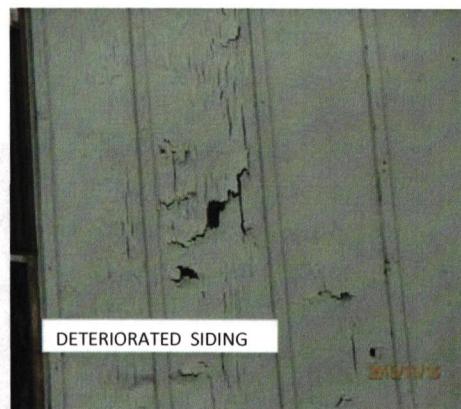
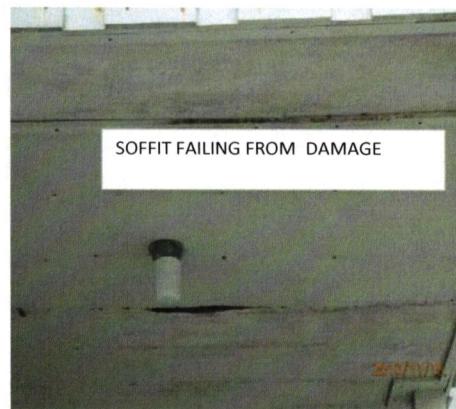
Signs of termite and other insect damage. Extensive on the siding. Currently has wasp nests.

Siding, trims, floor framing, wood shutters, fascia and soffits. The entry stairs and lower walkway show signs of failing to support. Railings pulling from walls. Railing missing balusters.

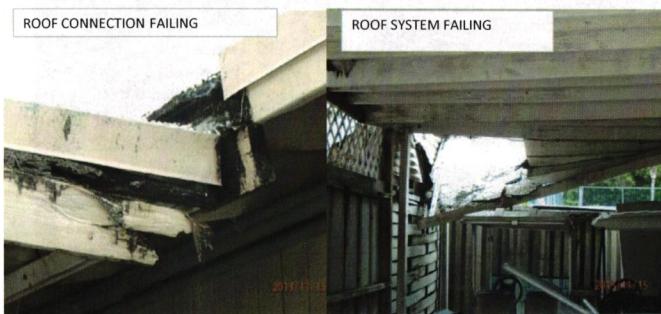
One shed roof is collapsing. Siding damage due to vandalizing.

ROOF CONNECTION FAILING

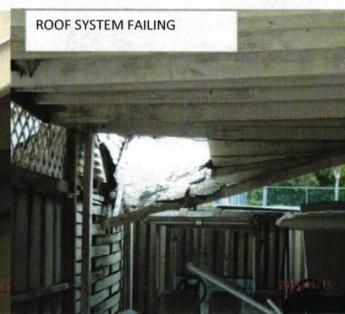
ROOF SYSTEM FAILING

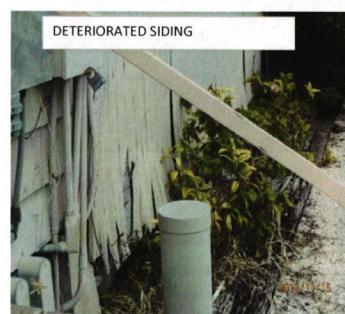
DETERIORATED SIDING

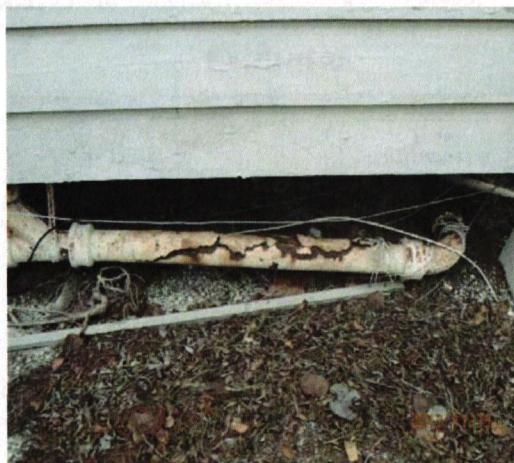
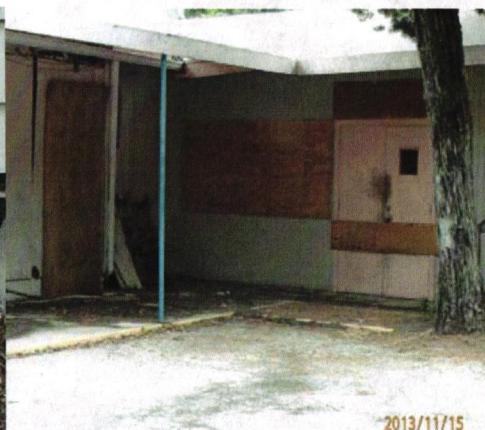
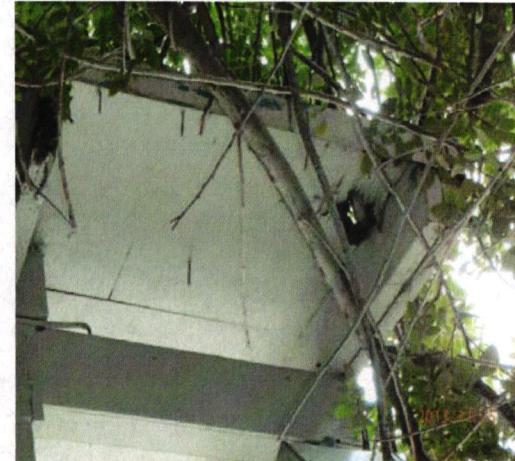
Broken, corroded, and cracked building drains.

Roofing at end of its life.

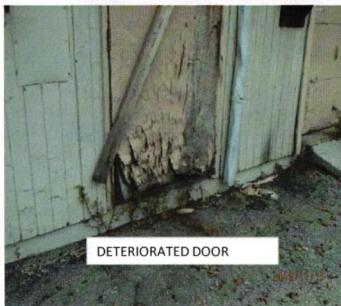
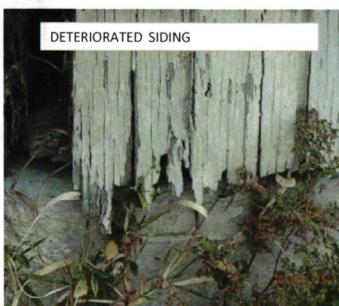
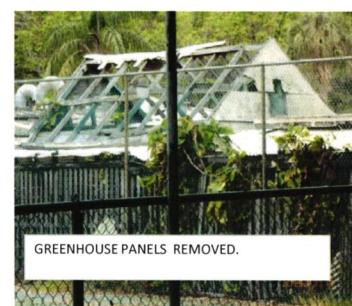
Siding, fascia boards, trims, doors. Roof framing over green house
Appears to have some kind of animal under slab at rear.

Doors from building openings.

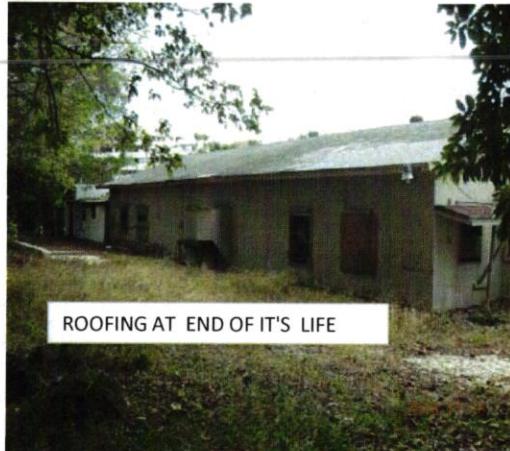
Roofing at end of its life. Many areas have patches.

Boarded up due to vandalizing and door condition.

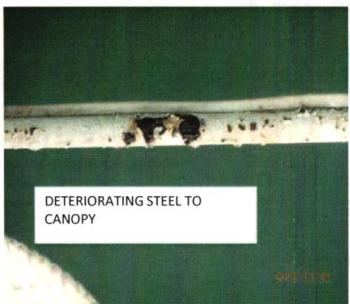
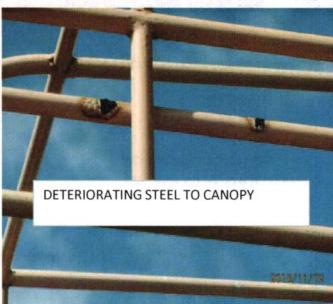
Fabric canopy frames

Fabric awning structures

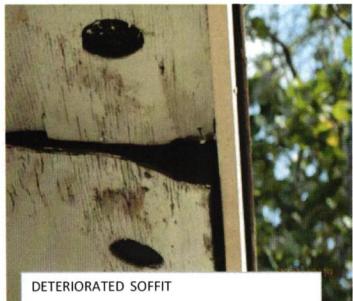
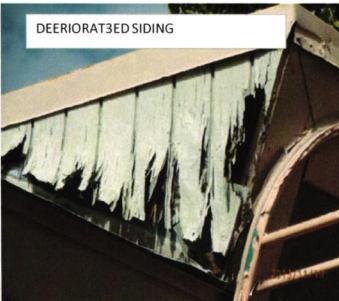
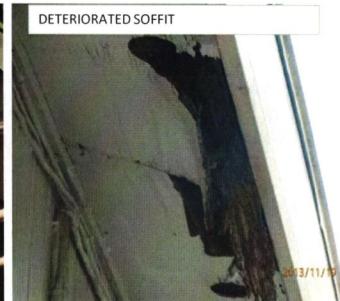
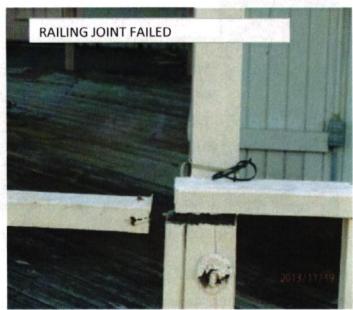
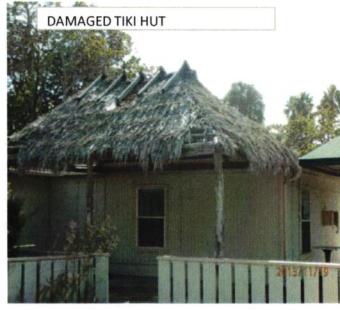
Signs of termite damage.

Doors from building openings. Rear deck walking surface is lifting and signs of rot.

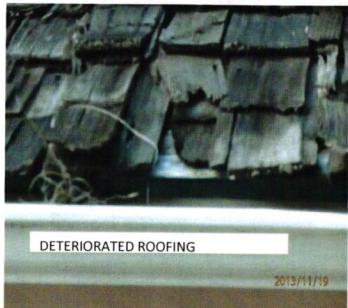
Siding, fascia boards, roof shakes.
Signs of termite damage
