**Longboat Key
Stormwater Atlas
Aerial Map**

Figure 2

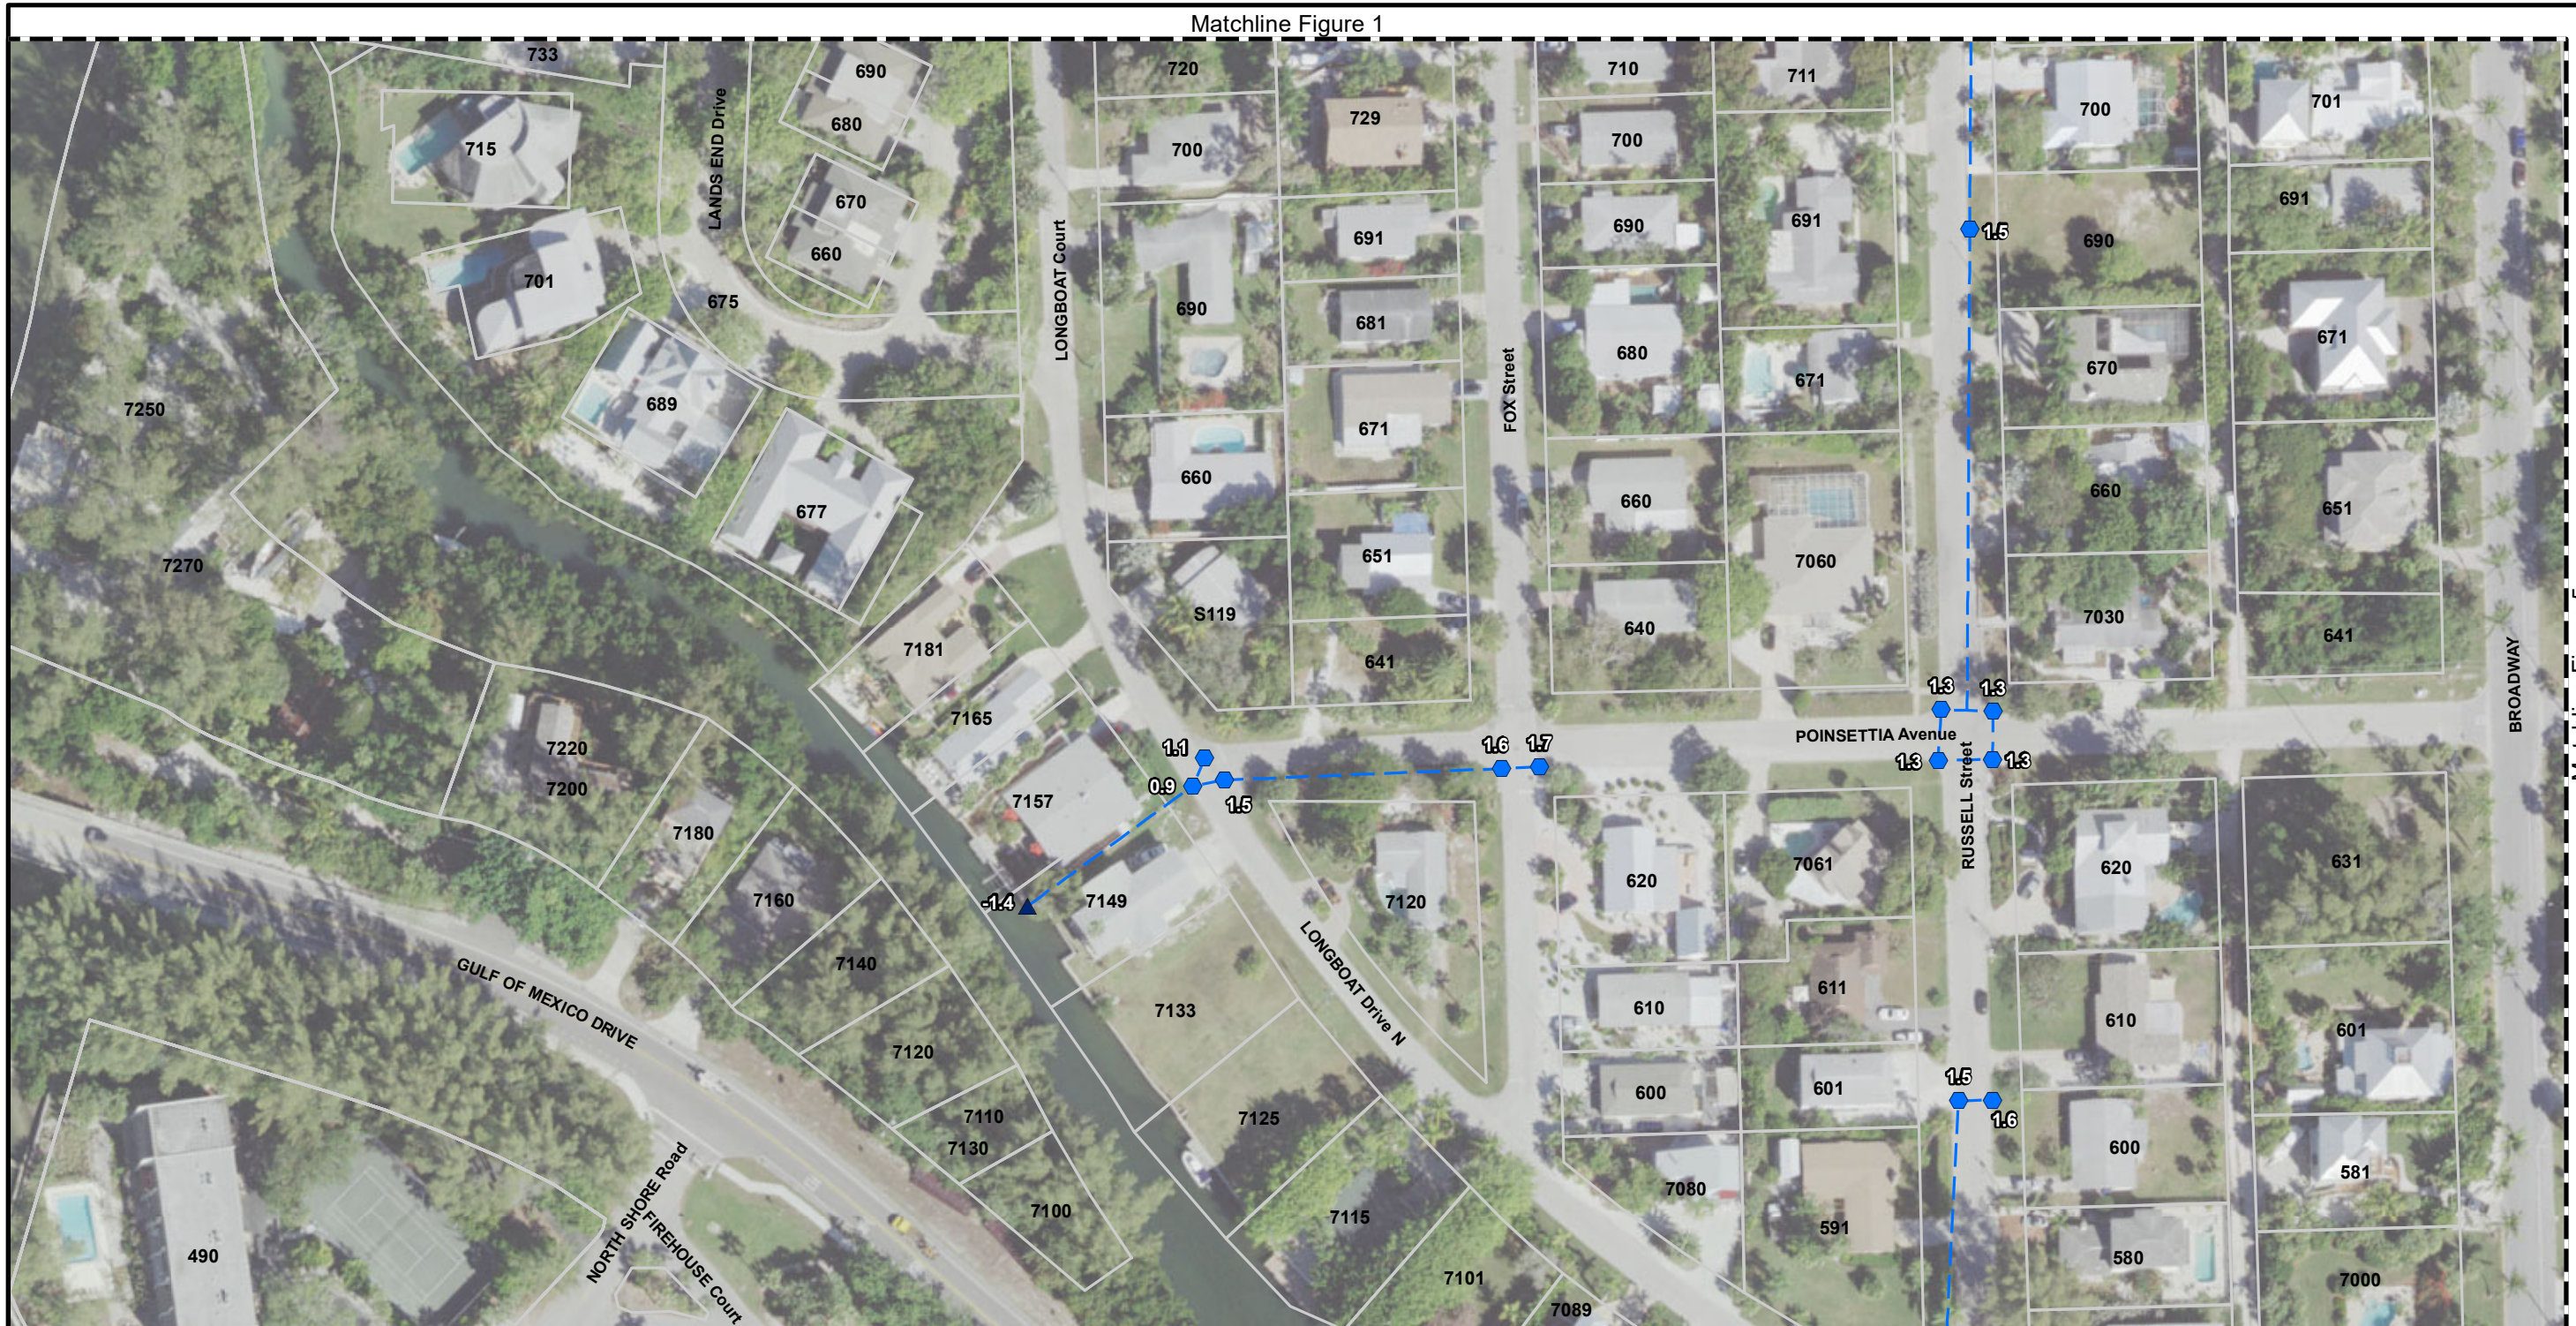
- Data were collected by APTIM on the following dates:
 October 29 through November 1, 2019
 November 18 through November 21, 2019
 December 17 through December 19, 2019
 March 23 through March 27, 2020
- Dashed lines represent interpreted subsurface pipelines and were not surveyed in the field.
- Elevations are in feet NAVD88.
- Background imagery is ESRI's World Imagery basemap.
