Re: Bay Isles Parkway Divestiture and Conveyance for the  
Eastbound Rampway to SR 789 Pedestrian Tunnel

*The Proposed Conveyance for the  
Eastbound Rampway to SR 789  
Pedestrian Tunnel and All  
Infrastructure Assets from  
Bay Isles Parkway to the  
Town of Longboat Key*

TO: Commissioners of the Town of Longboat Key  
FROM: Bay Isles Association, Inc.  
SUBJECT: Proposed Conveyance for the Eastbound Rampway to SR 789  
Pedestrian Tunnel and All Infrastructure Assets

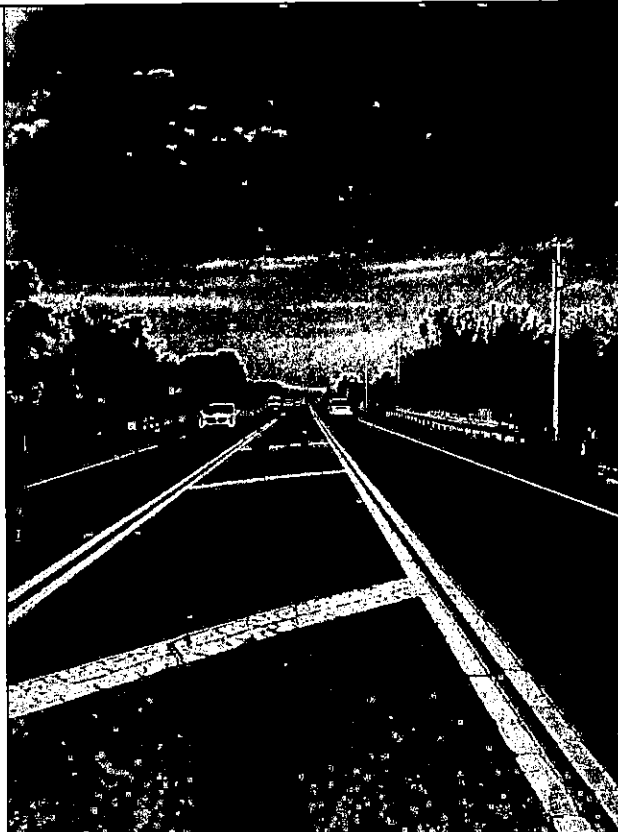
PHOTO 1	DESCRIPTION	APPROACH (LOOKING NORTH)
---------	-------------	--------------------------

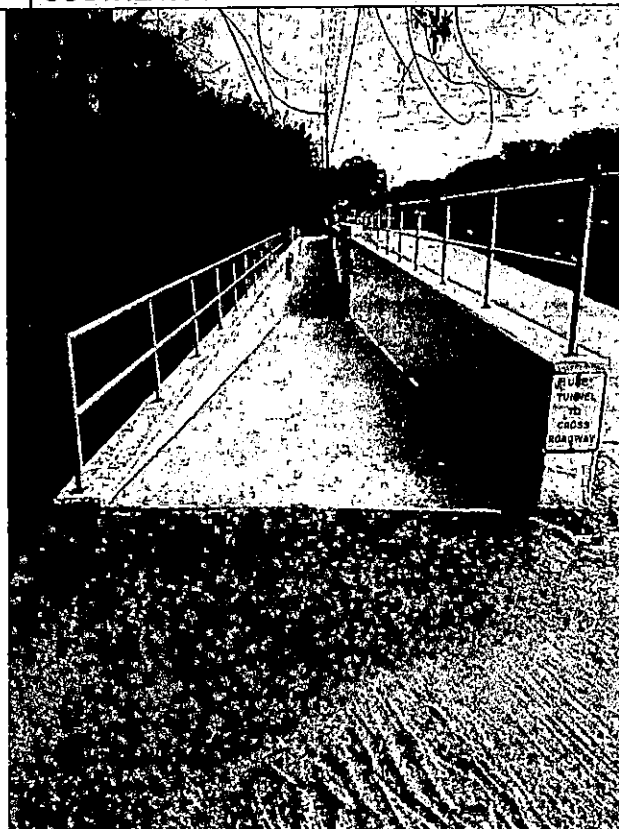
PHOTO 4	DESCRIPTION	NORTHEAST TUNNEL ENTRANCE
---------	-------------	---------------------------

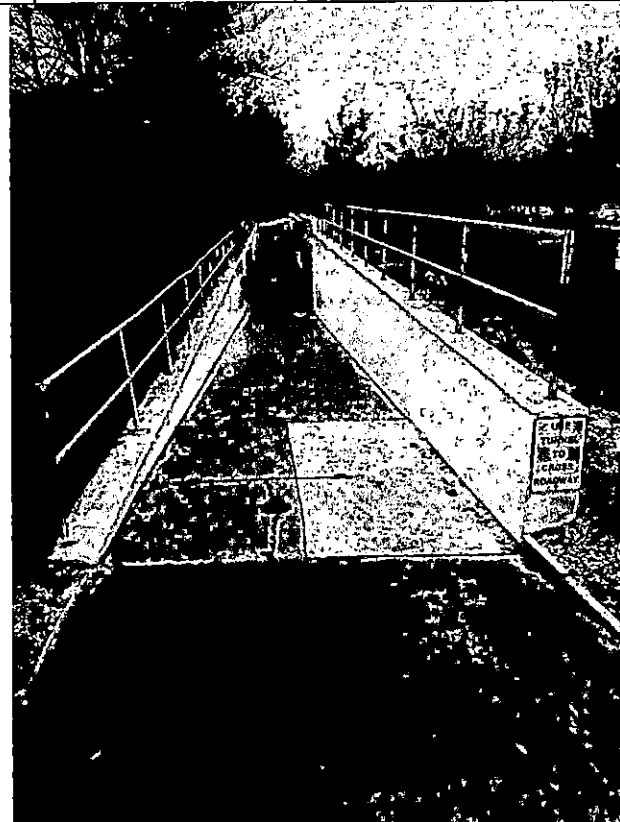
PHOTO 6	DESCRIPTION	SOUTHWEST TUNNEL ENTRANCE
---------	-------------	---------------------------

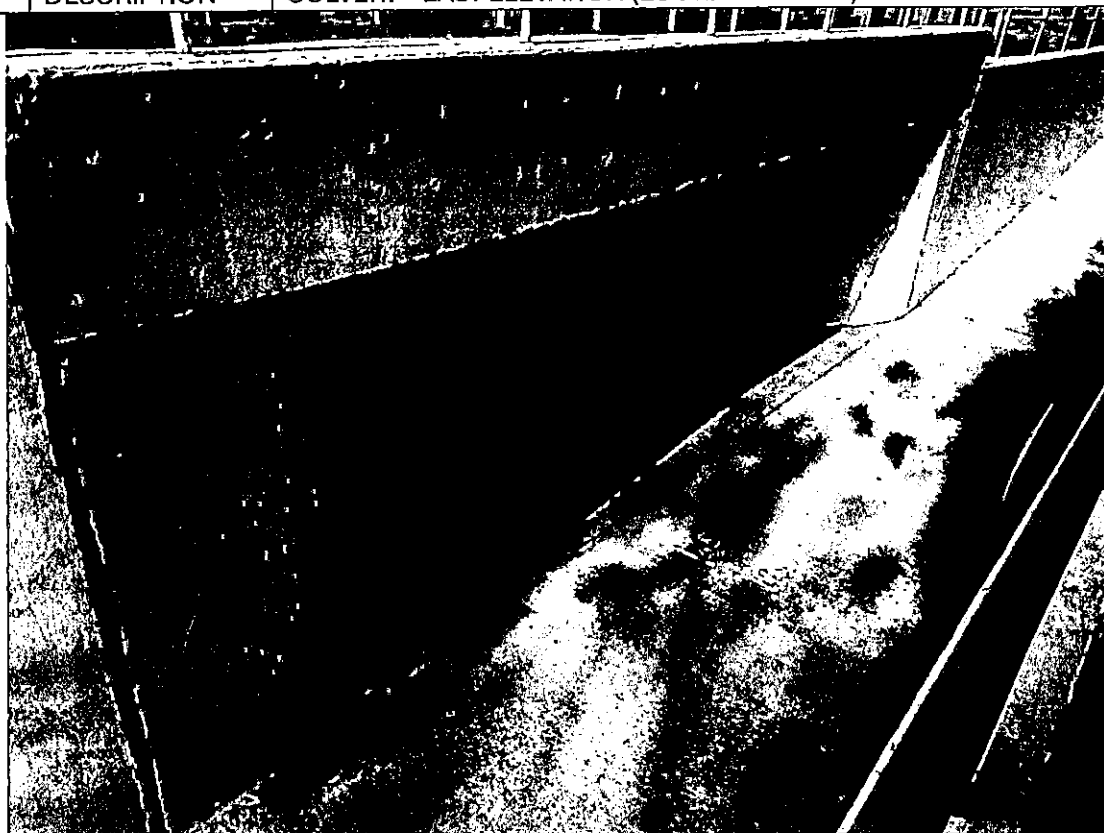
PHOTO 8	DESCRIPTION	CULVERT - EAST ELEVATION (LOOKING NORTH)
---------	-------------	--

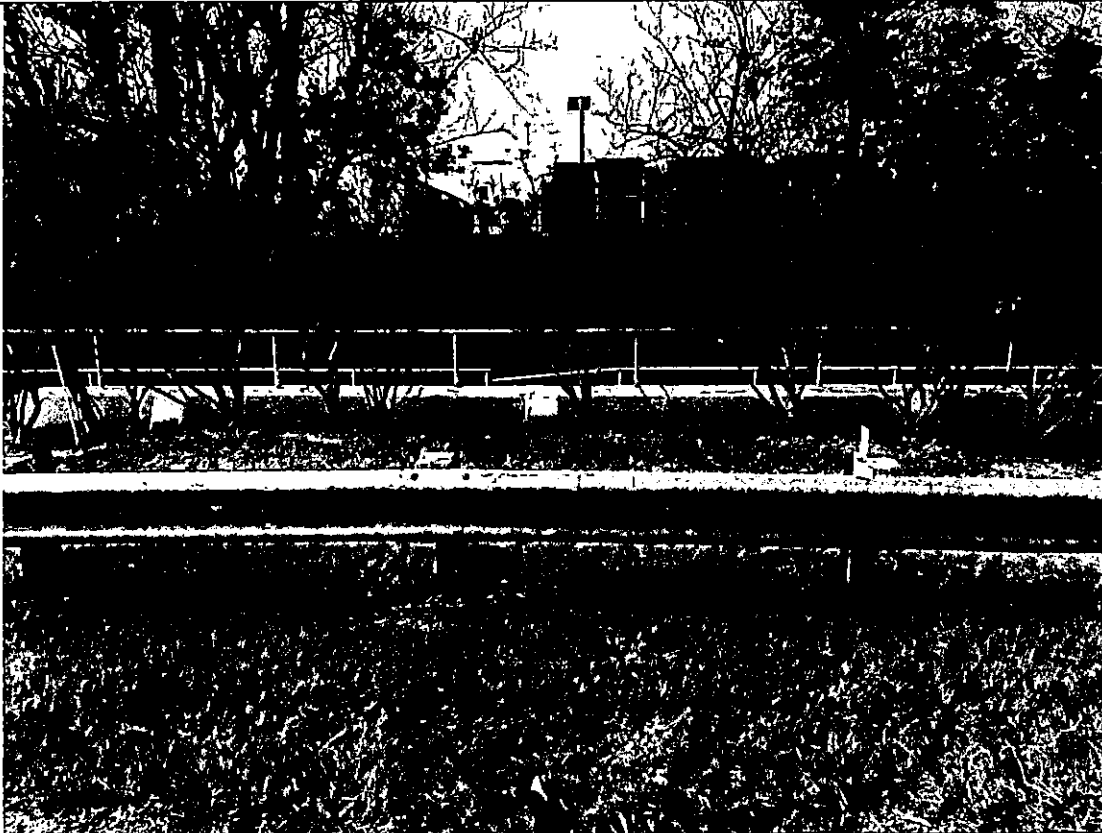
No defects were observed in the headwall.

PHOTO 11	DESCRIPTION	WEST HEADWALL & COUNTERFORTS
----------	-------------	------------------------------

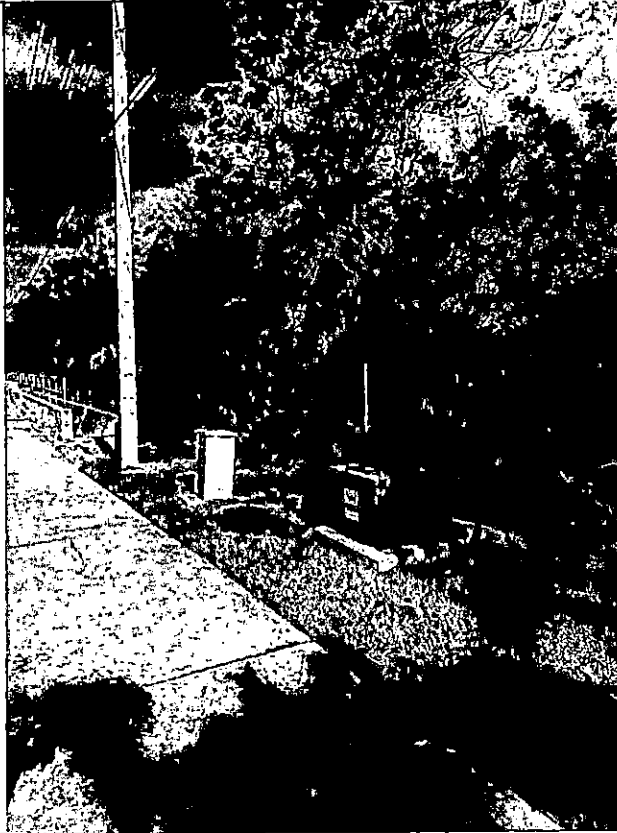
PHOTO 19	DESCRIPTION	UTILITIES AT THE SOUTHEAST TUNNEL ENTRANCE
----------	-------------	--

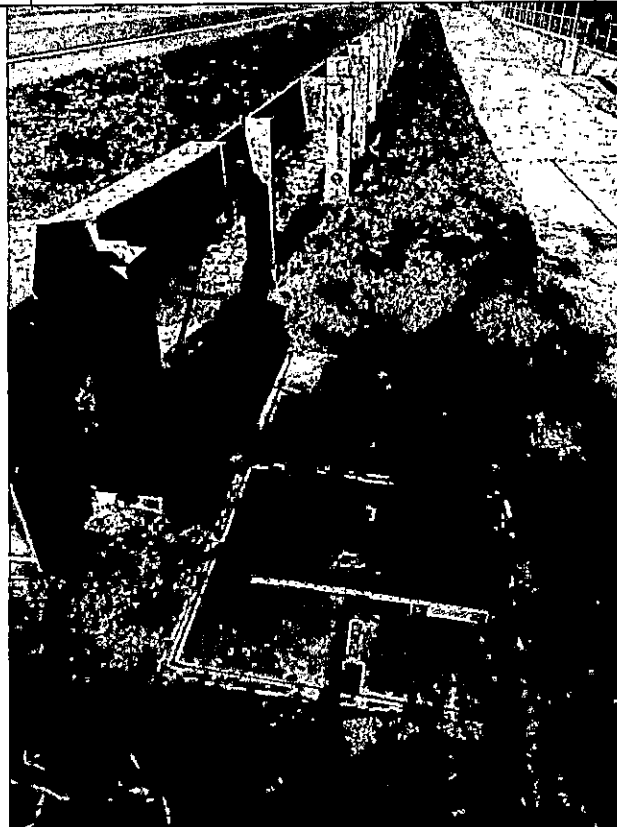
PHOTO 20	DESCRIPTION	UTILITIES AT THE SOUTHEAST TUNNEL ENTRANCE NEAR BRIDGE RAILING
----------	-------------	--

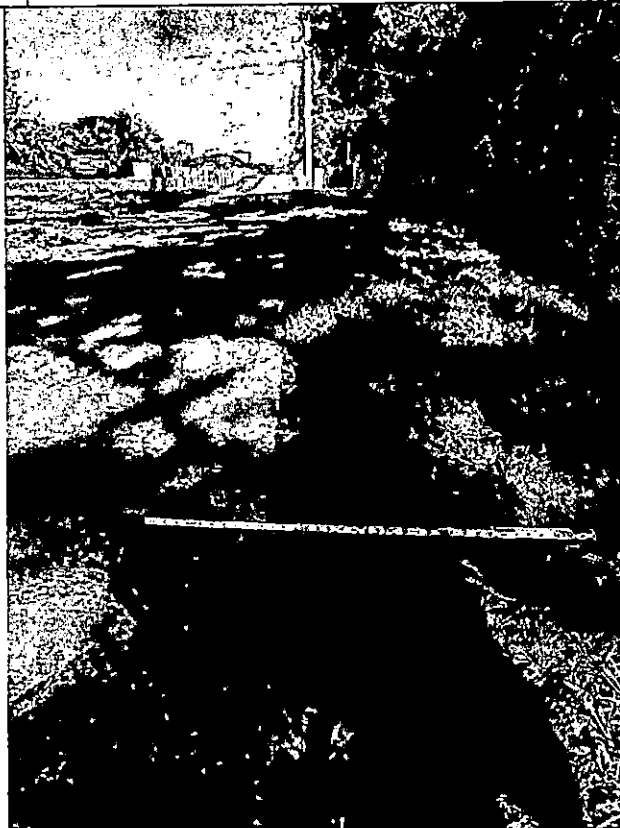
PHOTO 22	DESCRIPTION	TELEPHONE UTILITY NEAR SOUTHEAST TUNNEL ENTRANCE
----------	-------------	--

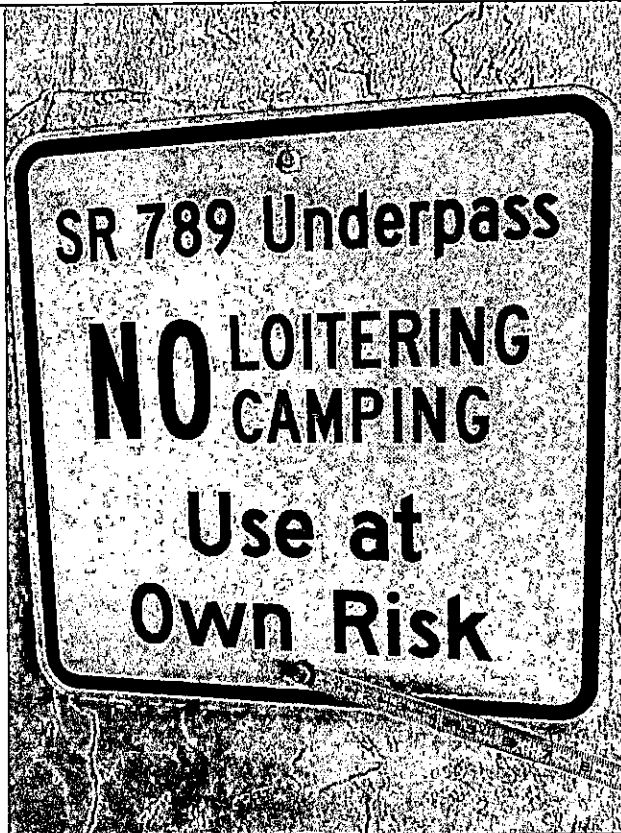
PHOTO 25

TUNNEL SIGN ON NORTHWEST WALL

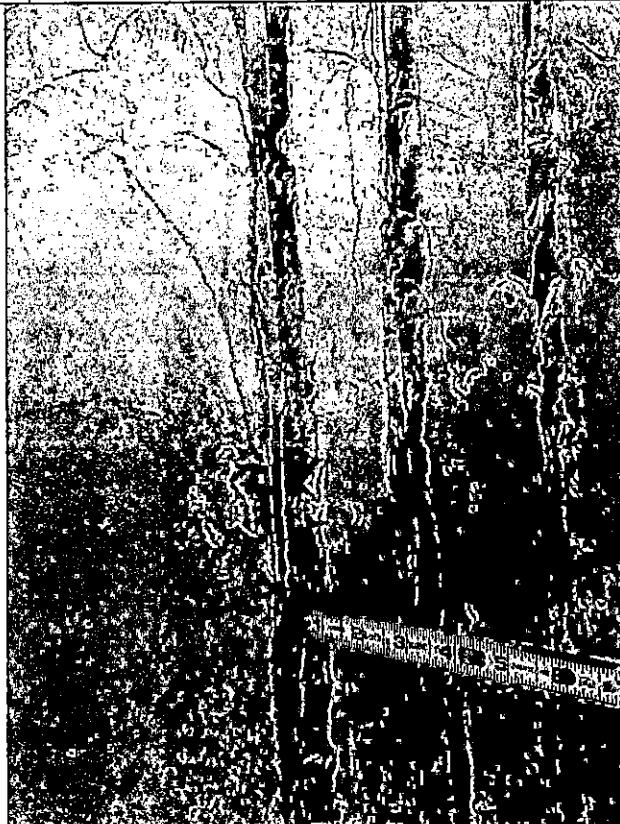
PHOTO 34

TYPICAL WING WALL REVEALS

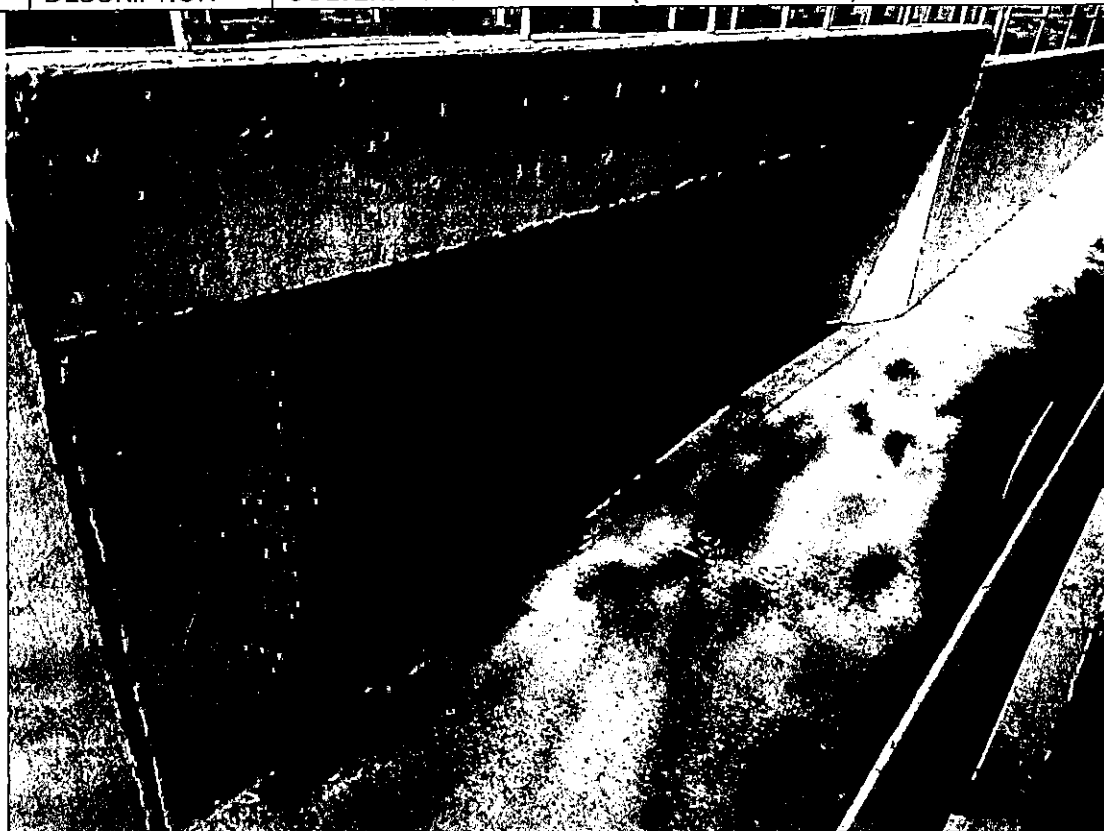
PHOTO 7	DESCRIPTION	CULVERT - EAST ELEVATION (LOOKING SOUTH)
---------	-------------	--

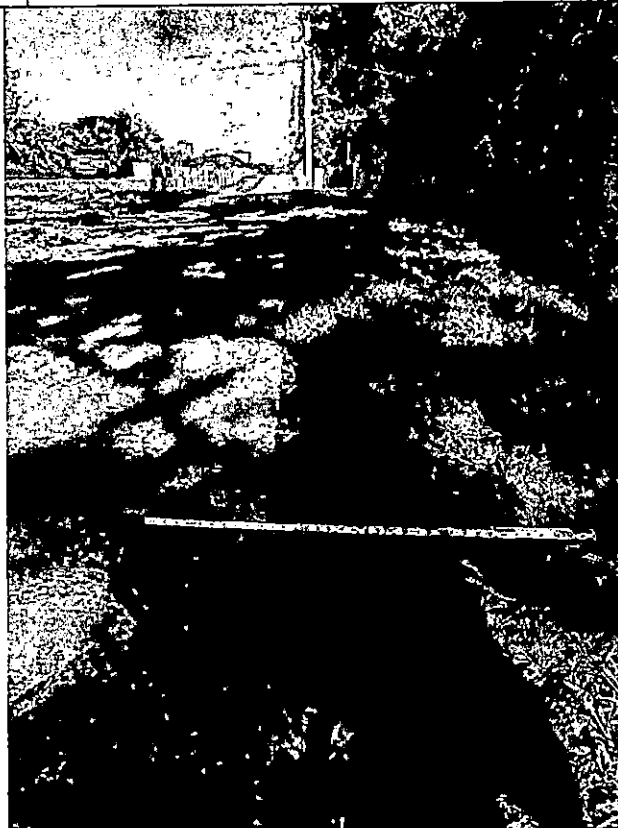
PHOTO 21	DESCRIPTION	EXPOSED WATER UTILITY PIPE NEAR BRIDGE RAILING NEAR SOUTHEAST TUNNEL ENTRANCE
----------	-------------	---
